EVALUATION OF EXPERIMENTAL RAILROAD-HIGHWAY
GRADE CROSSINGS IN LOUISIANA

FINAL REPORT
(1970-1985)

Research Report No. 183

Conducted by
LOUISIANA DEPARTMENT OF TRANSPORTATION
AND DEVELOPMENT
Louisiana Transportation Research Center
In Cooperation with
U. S. Department of Transportation
FEDERAL HIGHWAY ADMINISTRATION

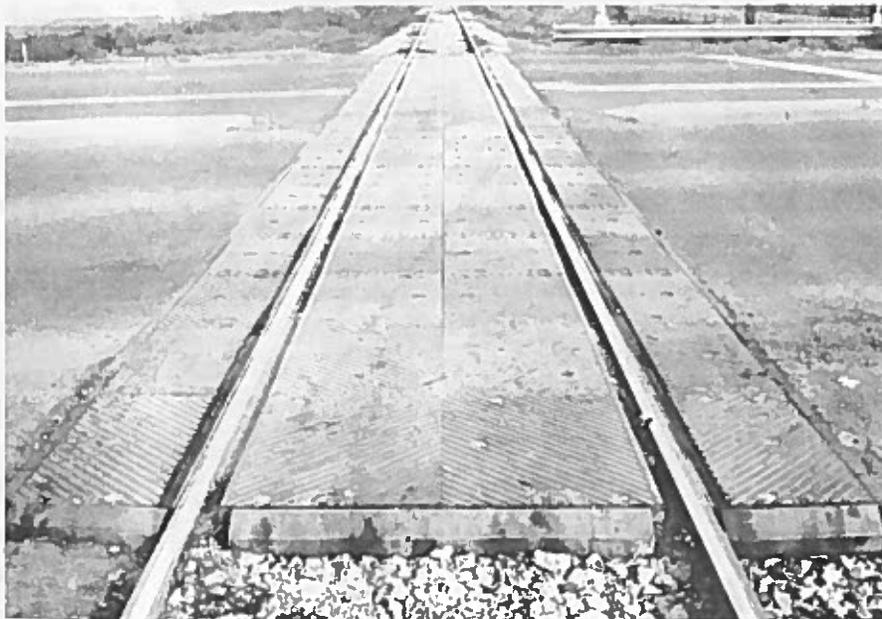
FIGURE 2

Installed in March 1983, this 72-foot-long crossing is a busy two-lane divided asphalt city street (Figure 2). With a 1985 ADT of 24,045 with 18% trucks, this single main-line track carries two freight trains per day at approximately 10 mph.

*GEN-TRAC II Rubber Panel Crossing on
Benton Road in Bossier City*

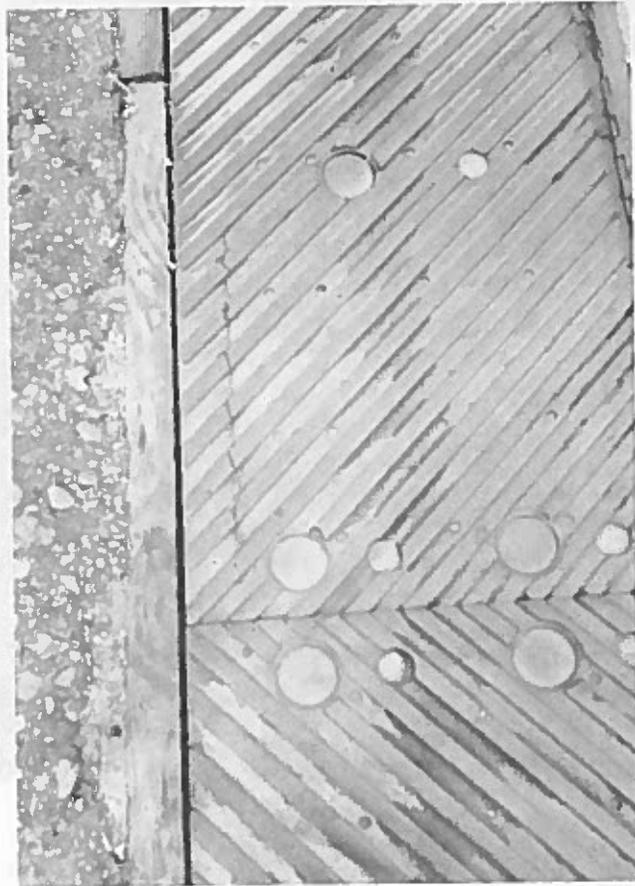
FIGURE 3

After only two years, however, it is already showing signs of distress. The most readily apparent indication of this is in the field side panels adjacent to the rail (Figure 3). This condition was precipitated by the heavy rail traffic. Figure 3 also depicts a more subtle variation of failure as the reflection cracks in the rubber indicate internal fracturing of the steel substructure.

Indication of Internal Fracturing or Failure

3
This type of failure was predominant in a similar GEN-TRAC II crossing at Patoutville, Louisiana. There are also many places where the rubber is delaminating from the steel substructure in the wheelpaths.

Overall, the installation is still structurally sound at this time, with good to excellent rideability. However, early indications of failure preclude its being considered for addition to the QPL at this time. It is apparent that its productive life in heavy ADT situations would be questionable. Radiographs of seemingly sound panels removed from Patoutville revealed extensive internal metal fatigue in progress. Once initiated, this stress cracking tends to propagate rapidly. At both locations, the track structure and drainage are in excellent condition with no indication of subbase failure which might contribute to this deterioration. There are no plans for future installations in Louisiana at this time.

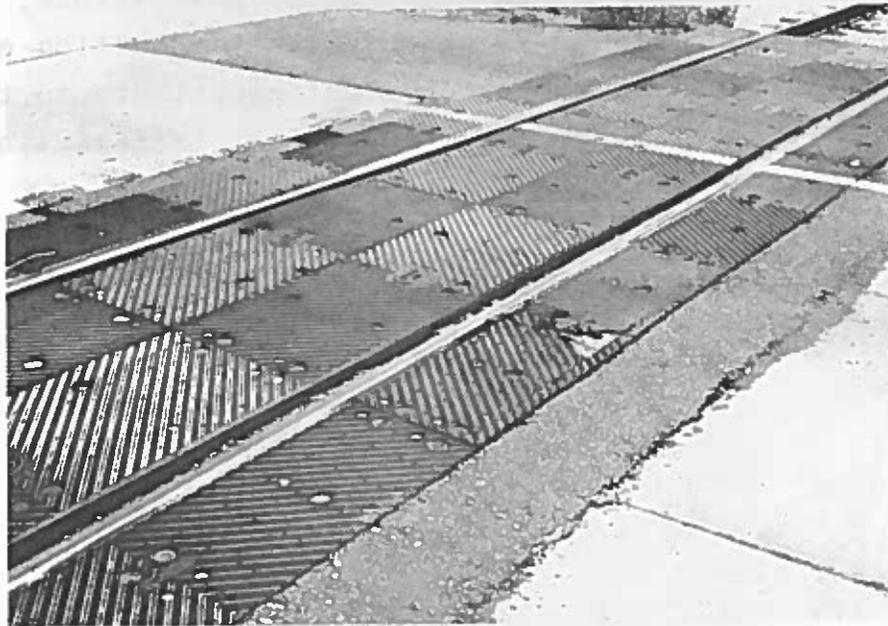
FIGURE 4

Installed in June 1983, only three months after the installation in Bossier City, Louisiana, this GEN-TRAC II crossing had two panels experience complete failure in the wheelpaths prompting their removal in June 1984. Figure 4 depicts the extensive surface damage in evidence one month before failure.

GEN-TRAC II Crossing at Patoutville at Ten Months

In June 1984 the panel shown in Figure 4 fractured completely, strewing metal and rubber all over the highway. Temporary asphalt backfill was installed and the panel pieces were returned to the lab. Figure 5 shows a portion of the failure.

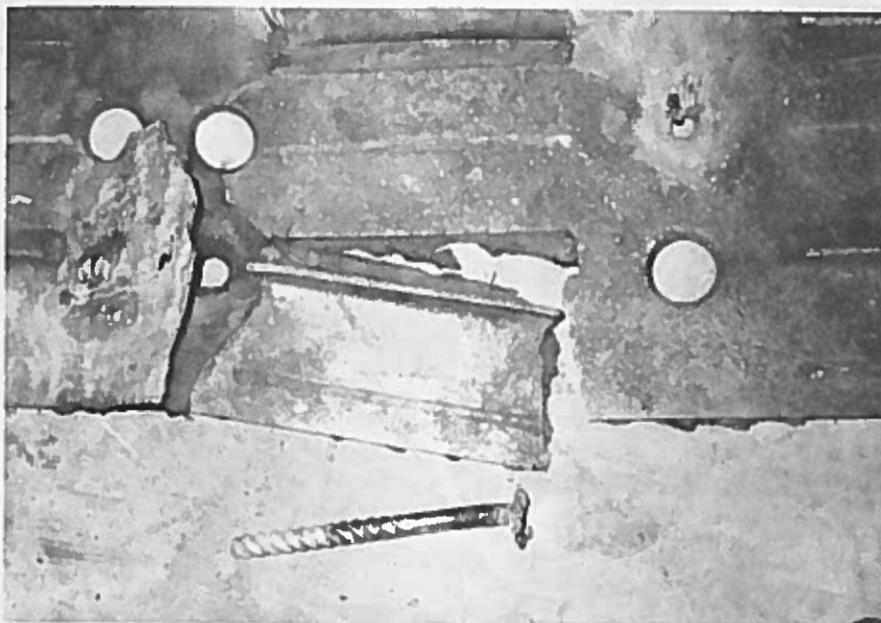
FIGURE 5

Broken Pieces of Panel

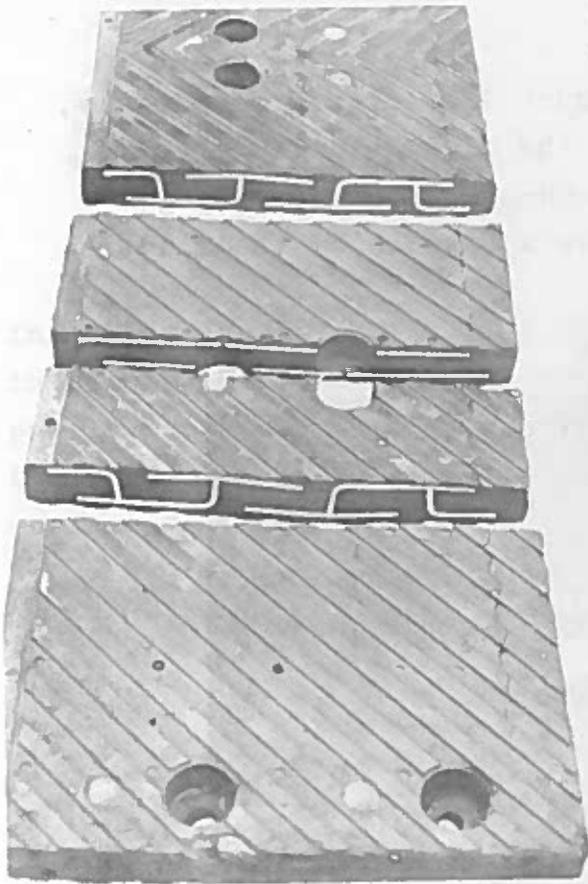
FIGURE 6

In order to determine the cause of failure, a seemingly sound panel was removed from which samples were taken using a band saw for radiograph analysis. The radiographs revealed myriad internal fracturing in progress, propagating from the edges of all cutouts (Figure 7) where the mild steel substructure was bent.

*GEN-TRAC II Panel Band-Sawed
Apart for Closer Examination*

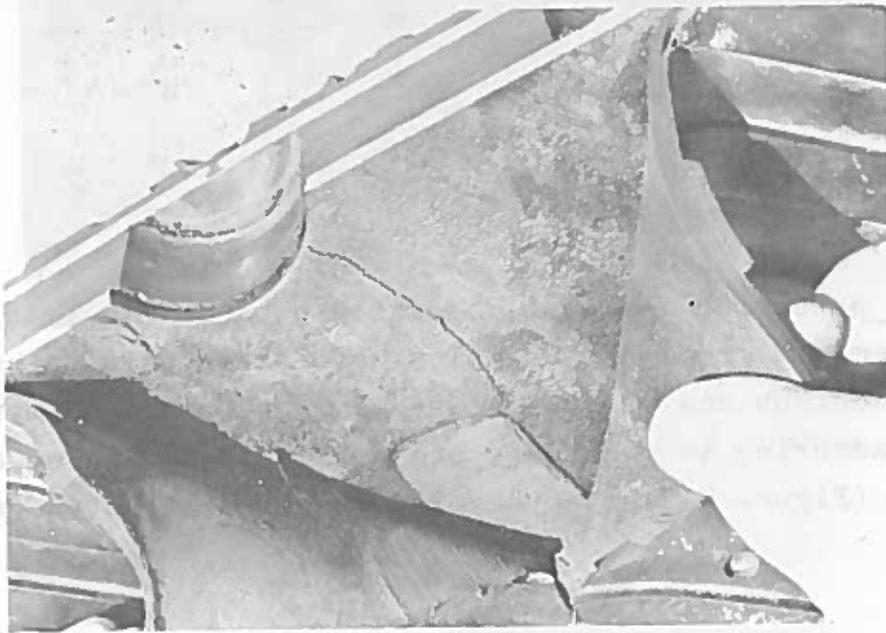
FIGURE 7

Internal Fracturing Propagating From Cutouts

As the rubber separated, it permitted moisture to reach the steel, allowing oxidation and rust to form (Figure 7). Once started, panel deterioration was rapid and could be readily detected from the surface. Because of the one-foot concrete subbase and all new track structure, no movement or rocking of panels or shims was noted. Neither the installation nor subbase condition was considered a contributory factor in the rapid deterioration of the product.

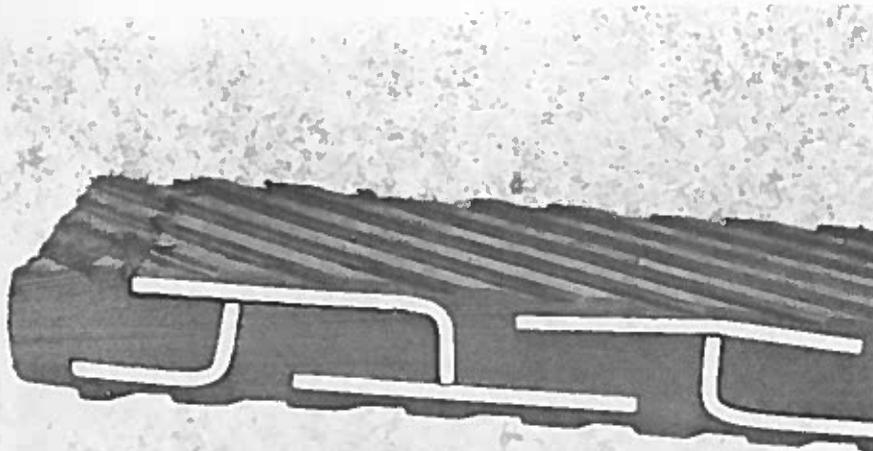
FIGURE 8

The cyclic loading action of traffic caused the encapsulated steel to rock and bend (Figure 8), allowing the rubber to fatigue and separate.

Rocking and Bent Steel Causing Delamination

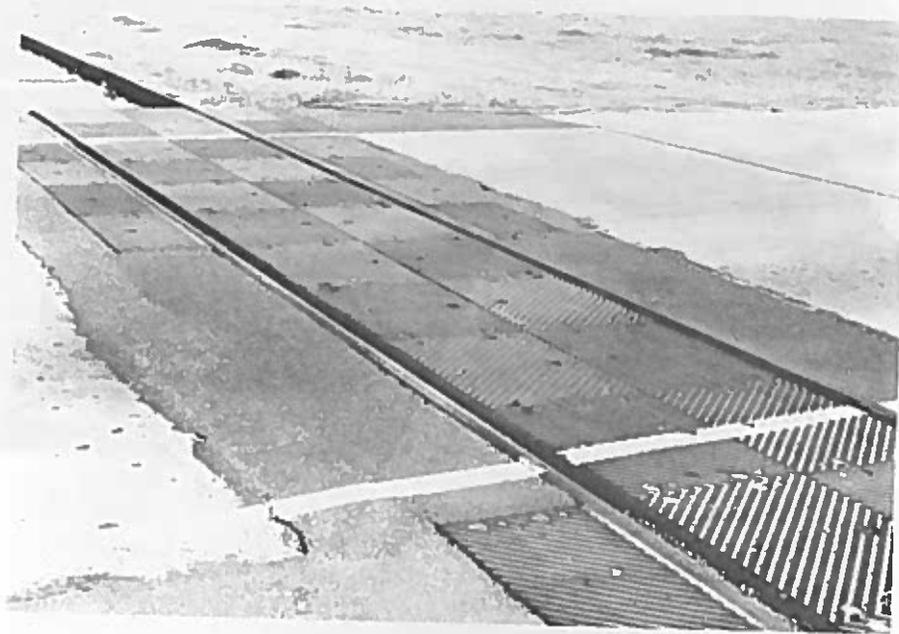
FIGURE 9

*Present Condition with Temporary Asphalt
Backfill in Place*

It was decided to leave the temporary asphalt backfill in place rather than replace the panels (Figure 9) at this time. This was done in order to observe future developments before making a decision whether to remove the broken panels only or replace the entire crossing.

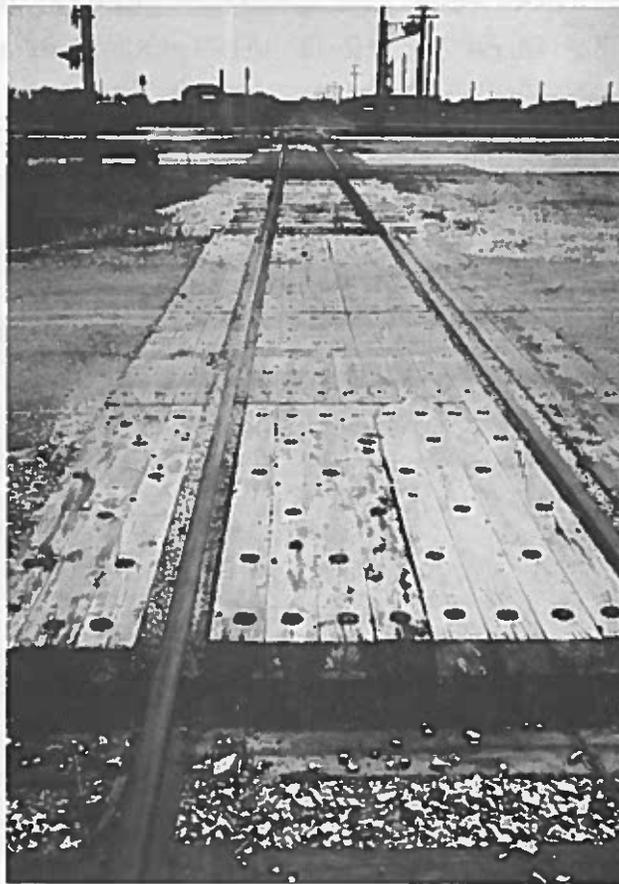
FIGURE 10

During the reconstruction of this industrial spur line, two sectional treated timber crossings were installed simultaneously on the service roads at this location (Figure 10). Due to the very light rural traffic, they are both in excellent condition after two years of service.

Low ADT Service Road After Two Years

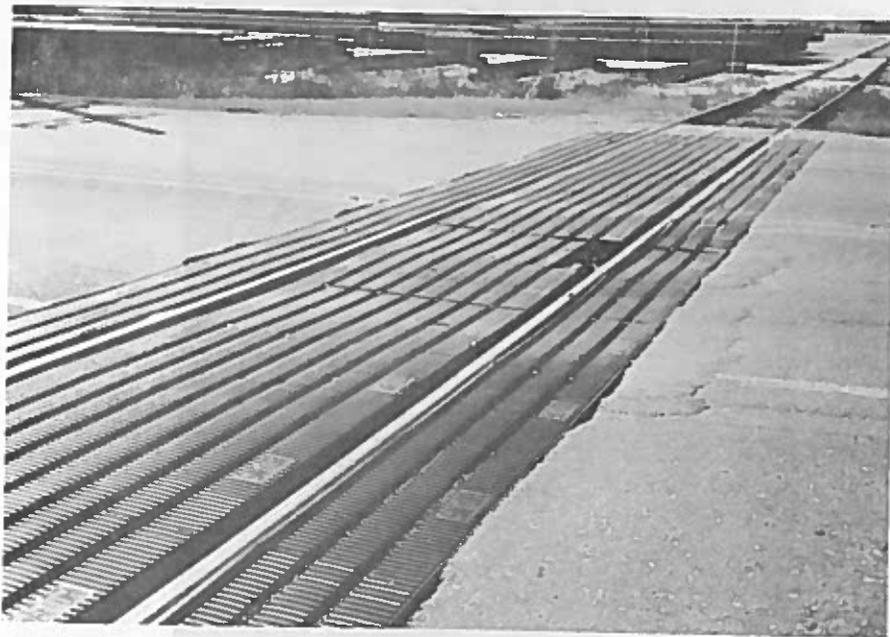
FIGURE 11

Completed in June 1982, this site marks the first installation of Structural Rubber Products SAF & DRI (Model C) in Louisiana. Researchers were not notified of this installation and were not on hand during construction. It was approximately one year old when evaluation was initiated and several panels were found to be loose and rocking. Figure 11 shows its condition after two and one-half years of service.

*SAF & DRI (Model C) of Morgan City
2½ Years After Installation*

Protruding spike heads and broken and sunken panels belie subbase or shim failure. By April 1985, approval was granted for total reconstruction. What follows are pictures and comments relative to that reconstruction.

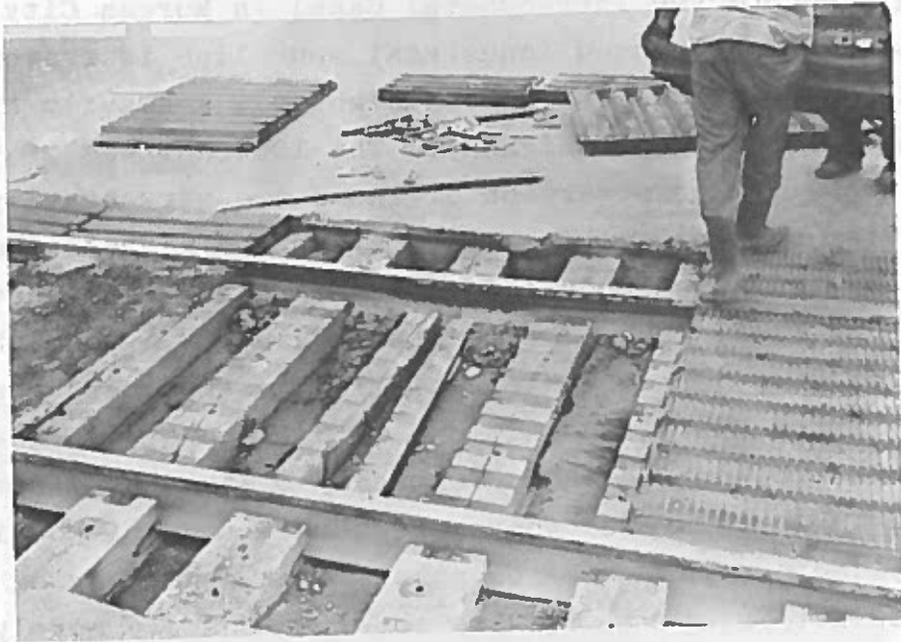
FIGURE 12

Figure 12 shows the split and broken gage shims that allowed the panels to settle, flex and eventually break off. It was unusual to find evidence of excessive pumping and clogged ballast on such a relatively new crossing.

Broken Shim(s) and Excessive Pumping

Closer inspection failed to reveal any type of drainage pipe or filter cloth. Ditches were searched for a discharge and probing failed to indicate any. Without filter cloth, even French drain could not have been formed. Unless the fines were pumped from under the roadway during the frequent showers prevalent in this area, the ballast may have contained excessive deleterious material during initial reconstruction.

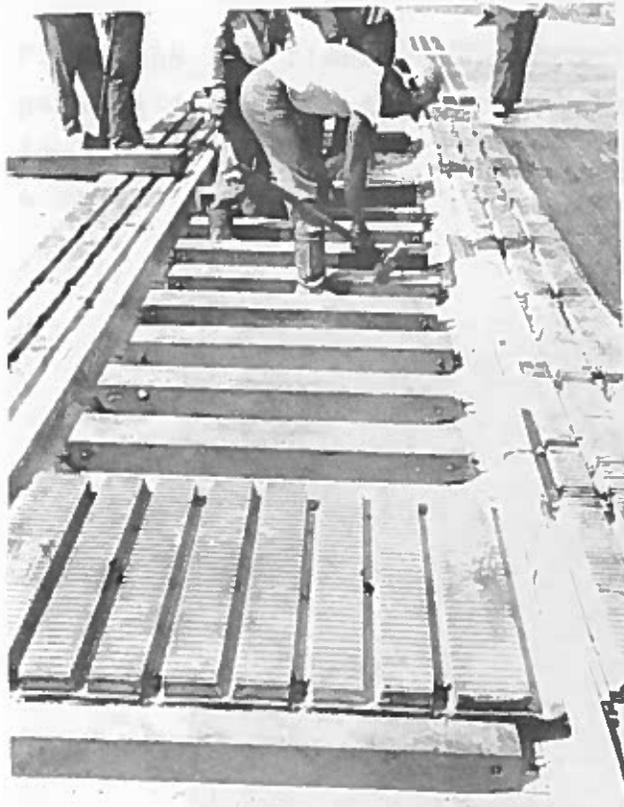
FIGURE 14

*Aligning the New Replacement
Gage Shims*

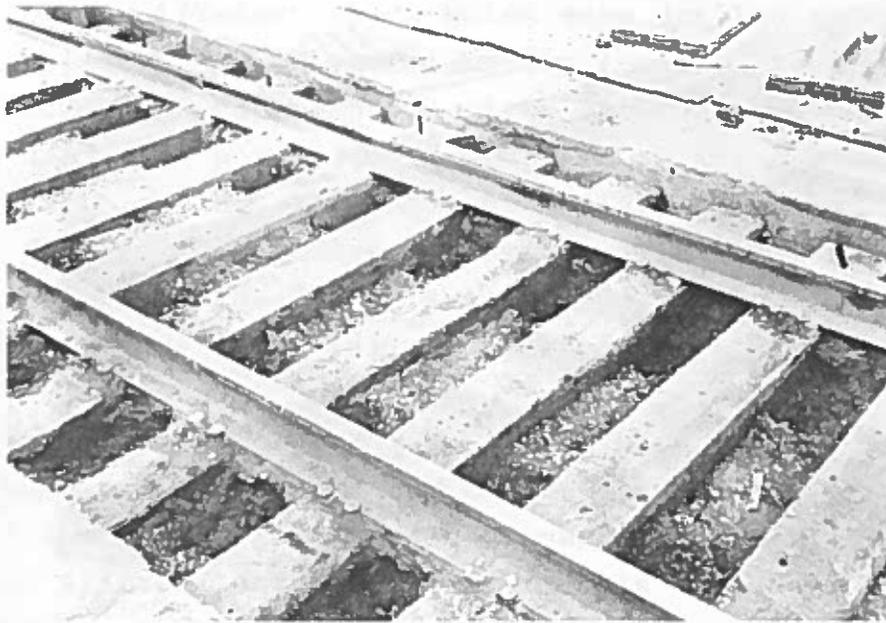
FIGURE 15

The fresh, clean ballast in the foreground is misleading as it extends only six inches deep. The original track structure was raised approximately six inches, new ballast added and a large, rail-mounted vibrator used for consolidation. It will not take long, however, for the excessive fines and dirt (Figure 15) of the original, underlying ballast to clog the new ballast and create more pumping action. At the authors' suggestion, the new replacement and sound, reusable panels were reinstalled 18 inches off-center of their original position. The pin configuration of these panels allows approximately 50 percent of the drive pins to get a fresh "bite" in a previously unspiked tie, whereas the rest were driven into previously used holes that were plugged. Designers should bear in mind that should track work or replacement be necessary, it would be beneficial if panels could be staggered or reversed to avoid reuse of spike-killed ties.

The Underlying Ballast of the Original Structure

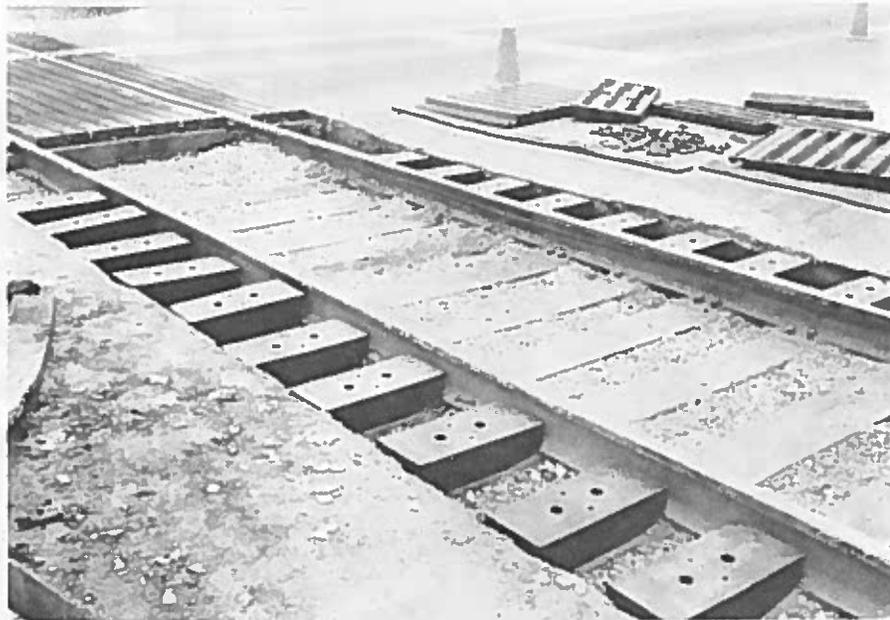
FIGURE 16

As previously mentioned, a problem common to all high type crossings utilizing shims is the tendency of wooden shims to split under the rocking movement of traffic. This was addressed by SAF & DRI with the introduction of a dense, solid rubber field side shim (Figure 16).

New Solid Rubber Field Side Shims

This marks the first installation of these shims in Louisiana. They appear to be a logical solution to a common problem and could be adapted to other brand panels as well. Their moderate cost is justifiable when considering the fact that they should not be as prone to splitting, cracking or rotting as their wooden counterparts.

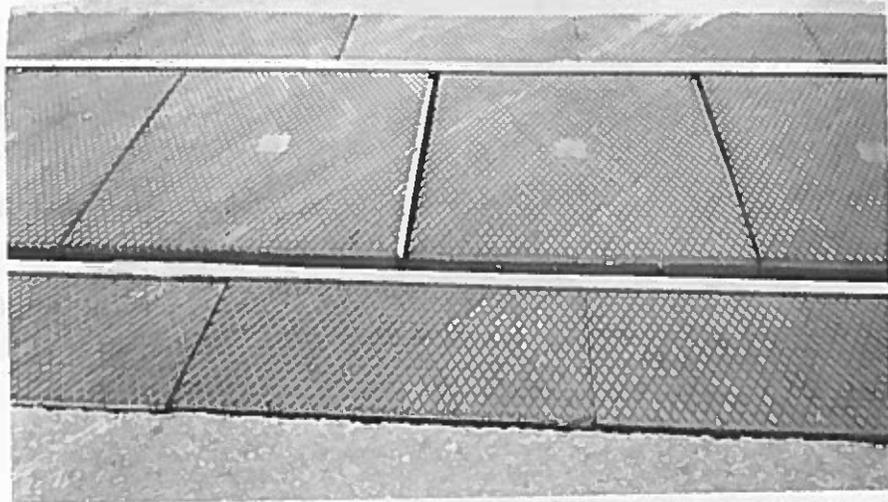
FIGURE 19

The full-depth field side panels require no header boards and are held in place only by the wedging action of the asphalt pavement juncture material. This non-destructive method of attachment permits rapid installation or removal in the event that track work should be required. The only deficiencies noted to date were when traffic forces tended to wedge the panels tighter, creating a one-inch separation in the panels (Figure 19). There was also minor rocking of the field side panels that was not considered detrimental.

Separation Caused by Traffic Forces

Situated at an angle to the roadway, this minor urban two-lane asphalt highway is located on the outskirts of Crowley, Louisiana. It had a 1985 ADT of 3,064 with 9% trucks. The spur line carries less than two freight movements per day and has excellent drainage. The recently rehabilitated highway provides excellent rideability and is extremely quiet. It was recommended that the panels be retightened and the gopher plates repositioned in order to minimize moisture and debris intrusion.

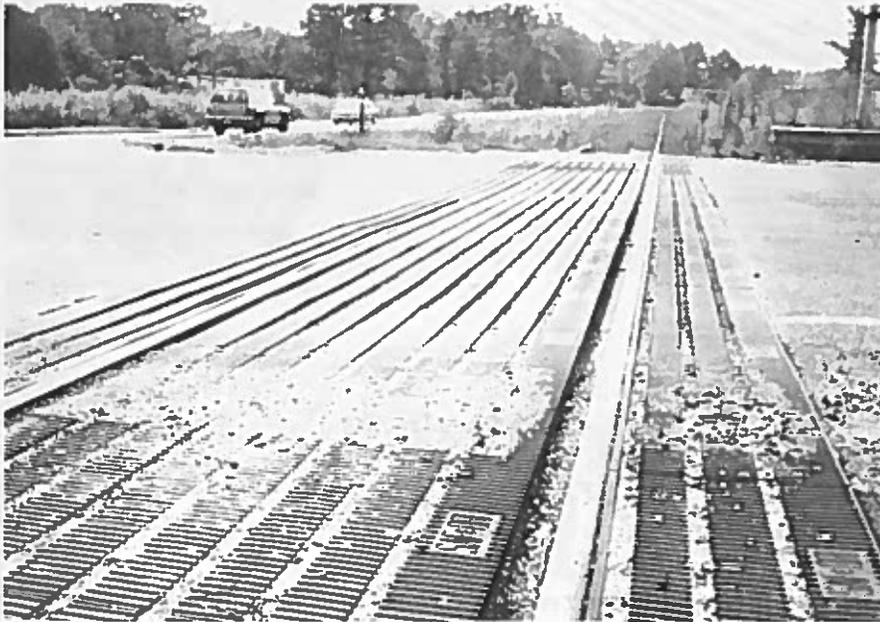
FIGURE 20

At this location, La. 139 is a four-lane, undivided asphalt highway with a 1985 ADT of 5,758 with 18% trucks. Completed in September 1983, there is an excessive accumulation of debris and evidence of minor panel warpage noted in the wheelpaths (Figure 20). The industrial spur line is rarely used.

*SAF & DRI Model C in Bastrop
After Approximately Two Years*

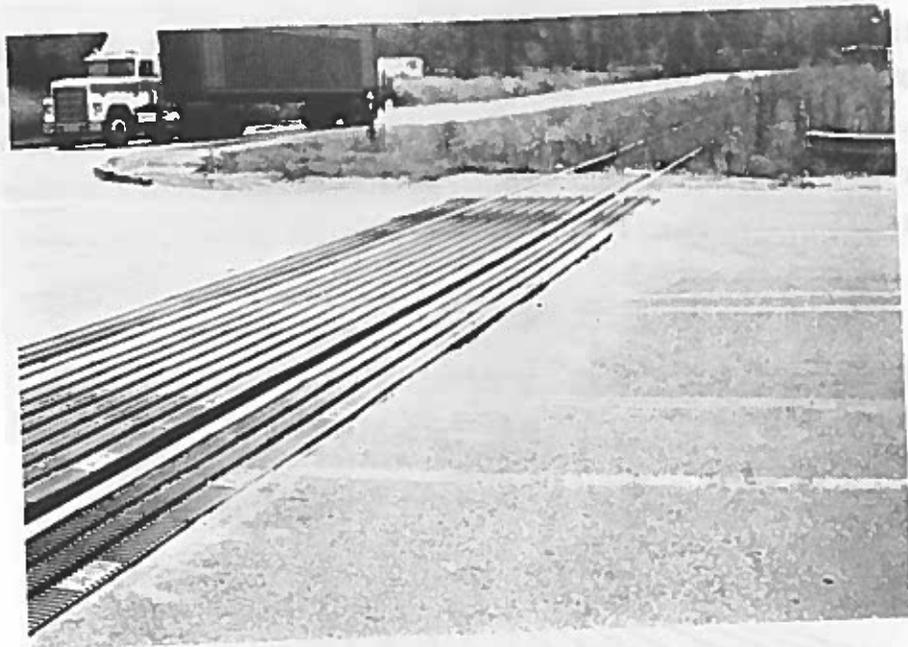
FIGURE 21

Rutting is developing in the wheelpaths, providing for a slightly harsh ride (Figure 21). This is created by extremely heavy logging and agricultural truck traffic.

Rutting in Wheelpaths

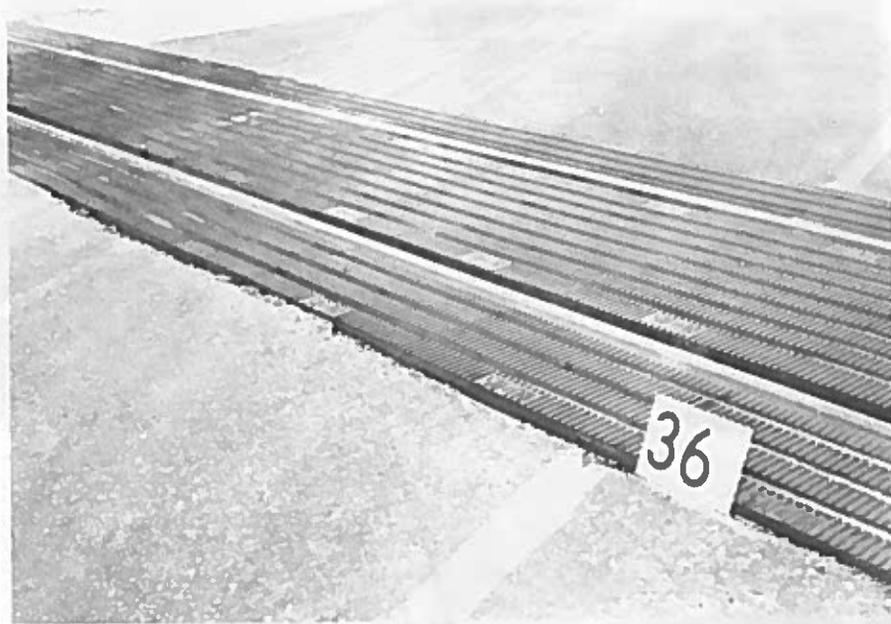
FIGURE 23

With a 1985 ADT of 6,870 and 10% trucks, this well-established roadbed has excellent drainage. The seldom used old main line is scheduled for abandonment, at which time the crossing will probably be removed. In the interim period, the only shortcoming of this crossing was in the pavement relief juncture (Figure 23) which is in need of rejuvenation. At present, it provides for a somewhat harsh ride.

Poor Condition of Pavement Relief Juncture

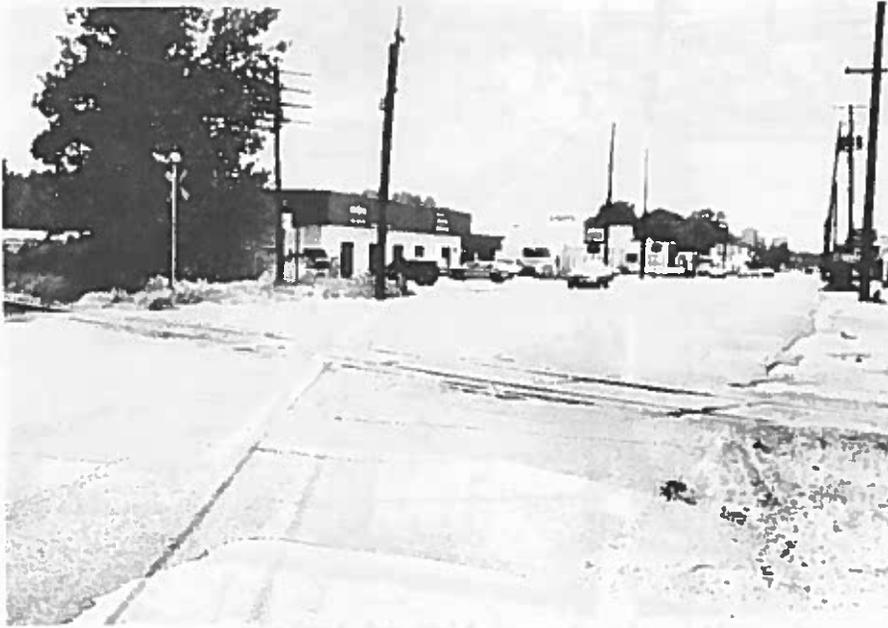
FIGURE 24

Figure 24 depicts the badly deteriorated wooden crossing on La. 72 in Bossier City that was replaced in July 1984 with a Strail "HI-RAIL" rubber panel crossing.

*Wooden Crossing in June 1984
Prior to Replacement*

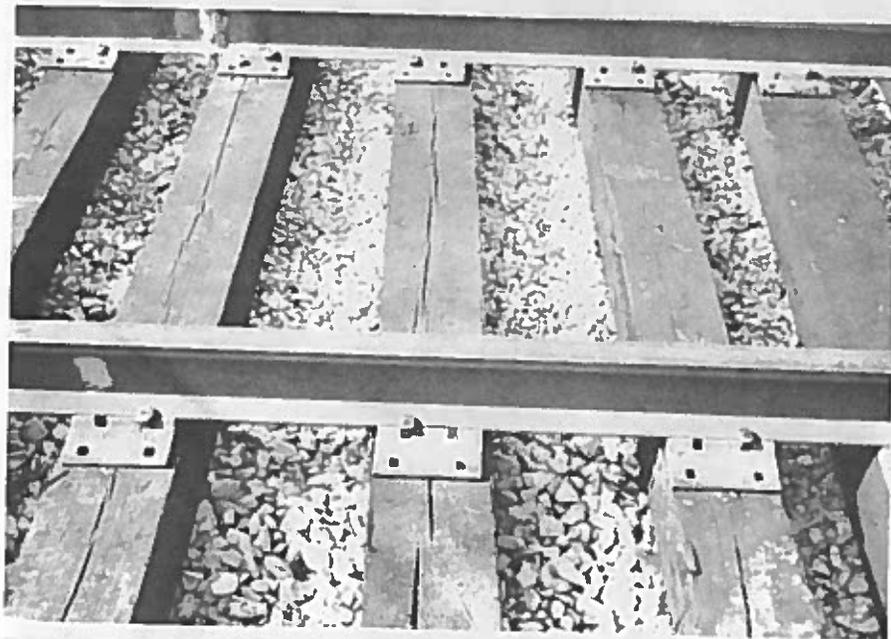
FIGURE 29

The failure of any high-type crossing material is often a reflection of a combination of practices wherein inferior materials such as these ties are used (Figure 29). If wooden shims of similar quality are added, and numerous drive pins or timber screws inserted, the constructive life of the crossing can be greatly diminished.

Typical Example of Ties

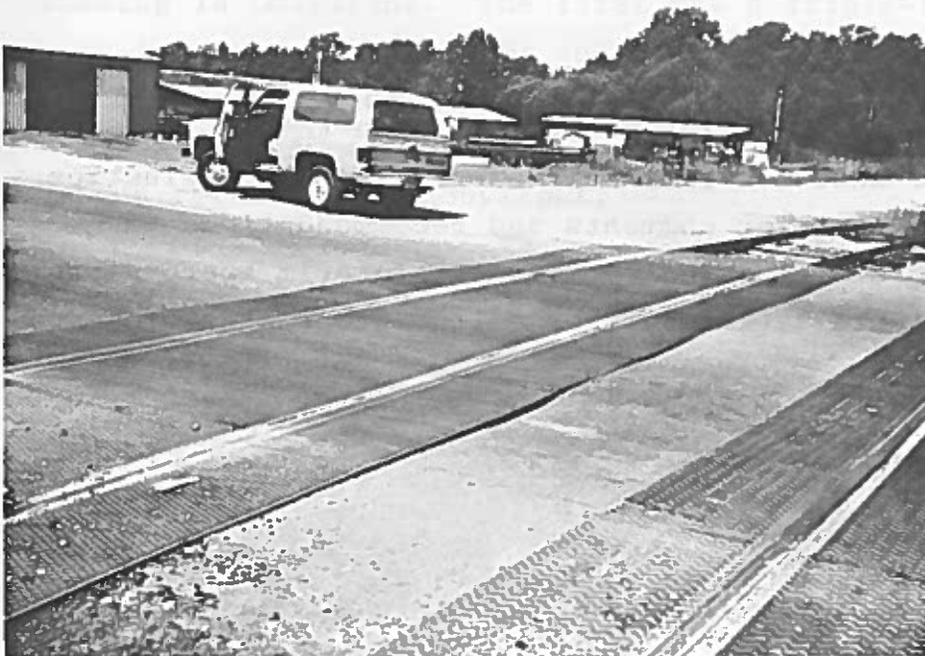
FIGURE 30

Early indications of the ballast consolidation and, perhaps, tie settlement, can be noticed in the asphalt next to the Strail "HI-RAIL" crossing adjacent to the Red Hawk rubber in Figure 30. Although not affixed to the ties, some rocking of the field side panels was noticed. This photo was taken approximately six months after installation.

Asphalt Rutting or Ballast Settlement?
