EVALUATION OF SAND FILLS

Research Report No. 74

Research Project No. S-23

Conducted by  
LOUISIANA DEPARTMENT OF HIGHWAYS  
Research and Development Section

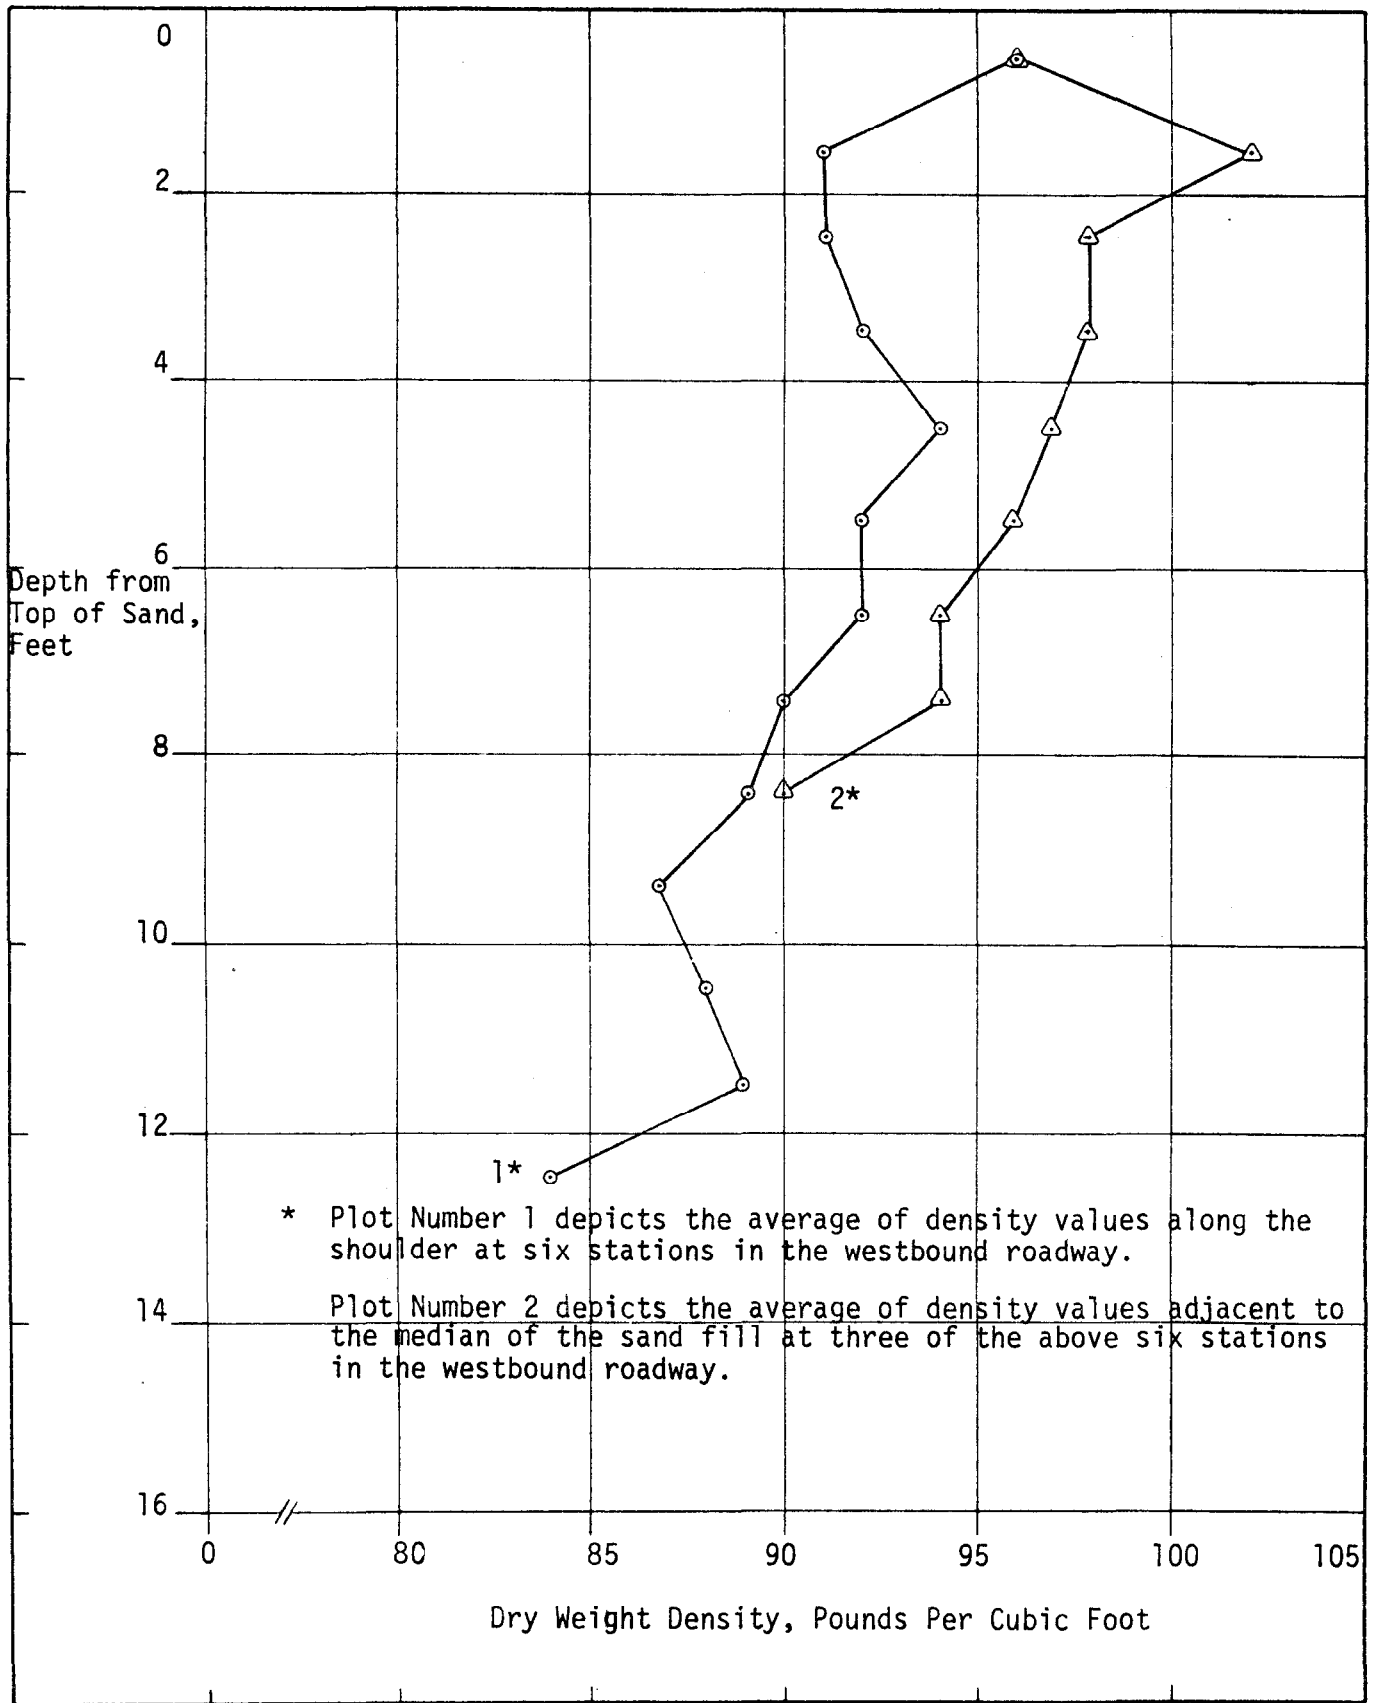
Relation of Density and Depth of Sand Fill  
 Sorrento - LaPlace Highway  
 Route I-10  
 FIGURE 2

The depressions mentioned above were discernible only after the black base had been placed on the fill. This suggests that the depressions were precipitated by the action of the vibratory roller. However, no definite conclusions can be derived from this data since it indicates the condition of the fill after the fact only.

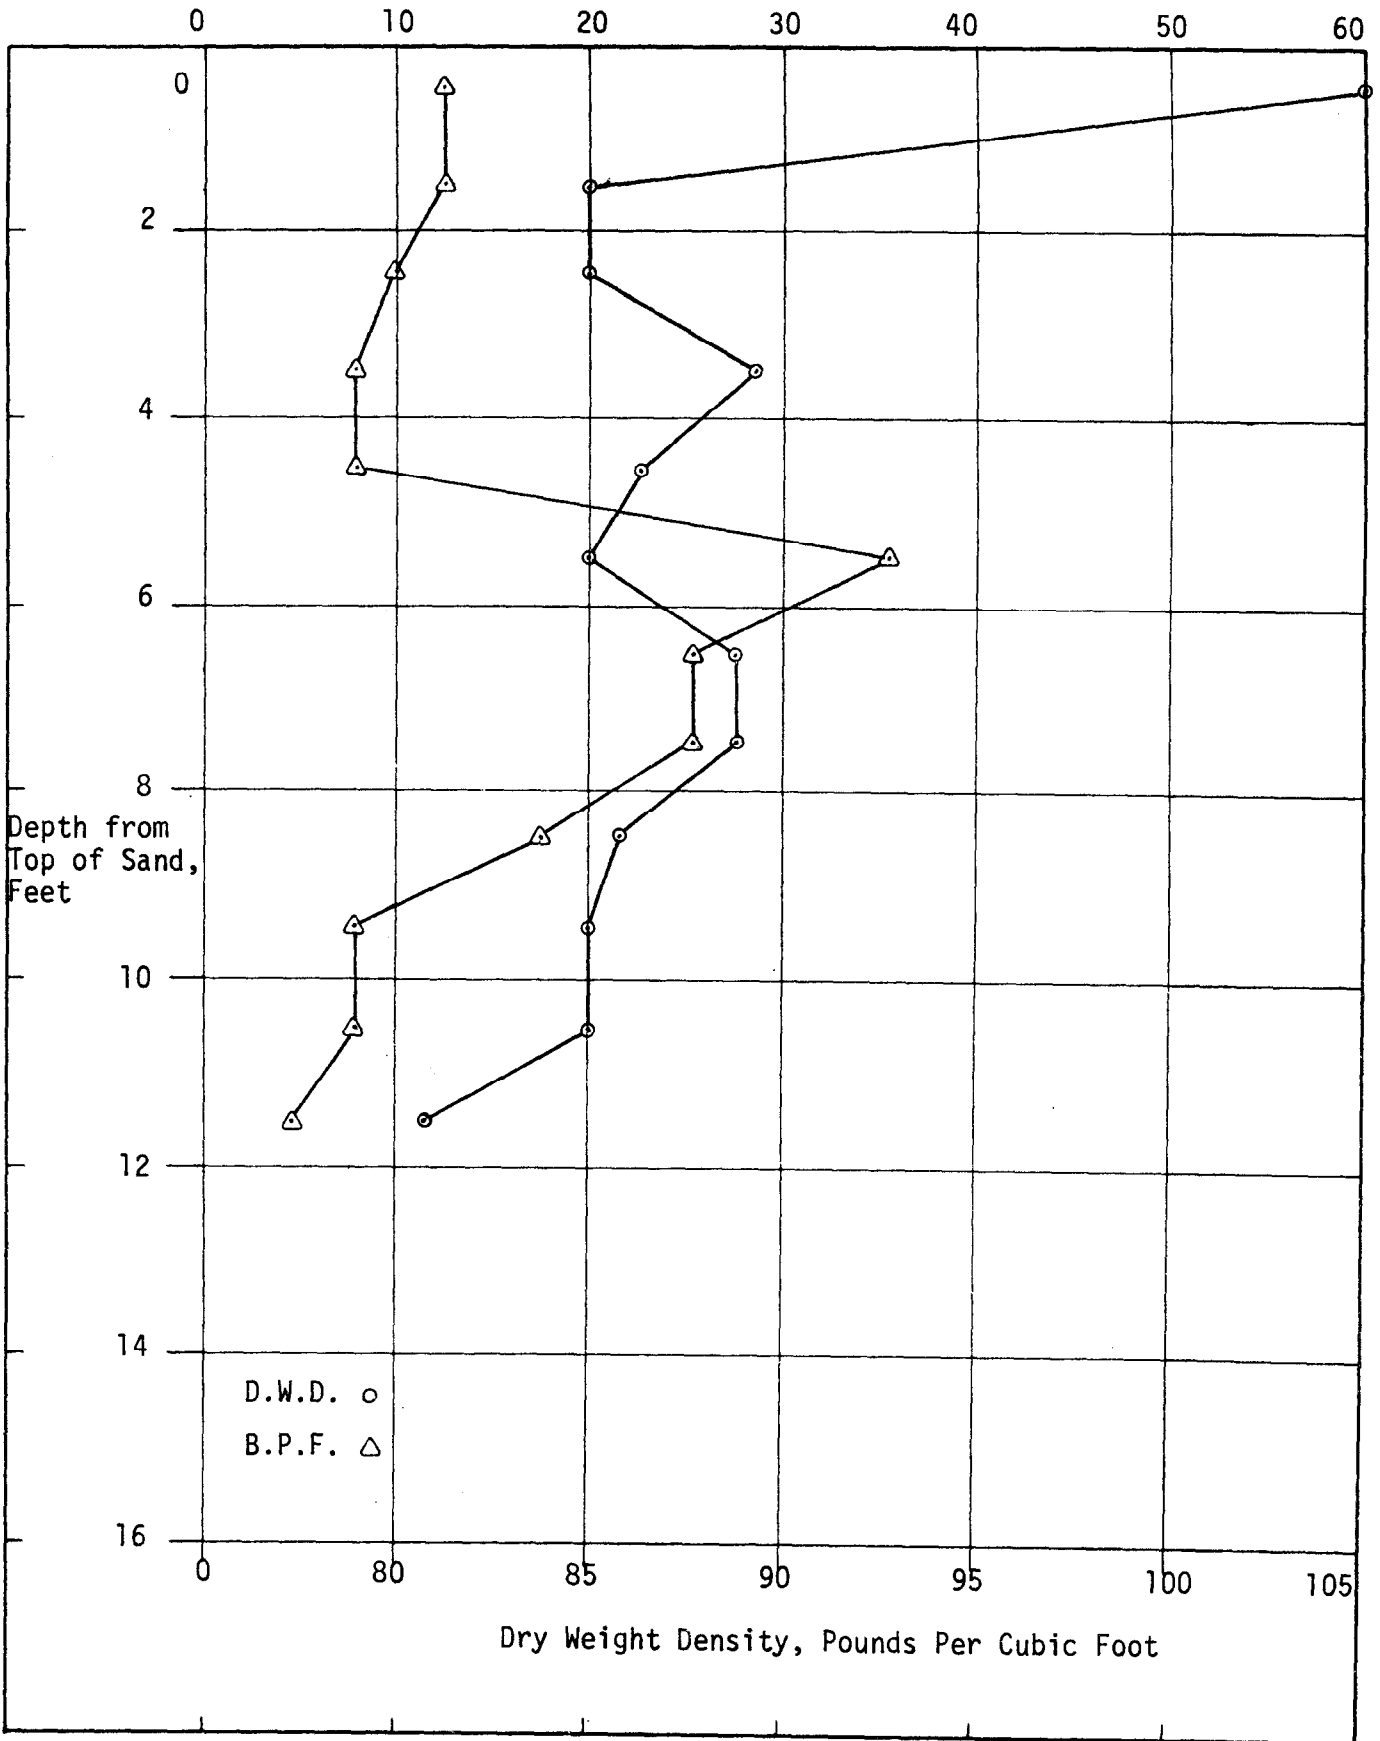
Density and Standard Penetration Values Versus Depth of Sand Fill  
Williams Boulevard - Veterans Memorial Highway

Table 5 (Appendix) and Figure 3 illustrate the relations of dry weight density and standard penetration test blows per foot with depth of sand fill. One's initial observation might well be the non-uniformity of density and penetration values versus depth. The decrease in density and penetration values at depths below seven and one-half feet is also noteworthy, as one might expect density values to increase with depth. The fill is quite moist even at the upper levels. Again the most significant factor seems to be the variation in density and penetration values through the fill.

Hole Number 2 of Table 5 (Appendix) is presented as additional information. Excavation of muck was limited to the confines of the roadway. An attempt to establish hole number 2 at the outside edge of the shoulder apparently resulted in intersection of only a portion of the sand fill and then penetration of in-place organic deposits. Data from hole number 2 does provide a review of the characteristics of the in-place material immediately adjacent to the sand fill. What small lateral restraint (at the backfill-muck interface) must be afforded by a saturated soil with dry weight density of only 29.7 pounds per cubic foot! Extending the limits of excavation past the boundaries of the roadway would seemingly provide a factor of safety against lateral movement of the sand fill.

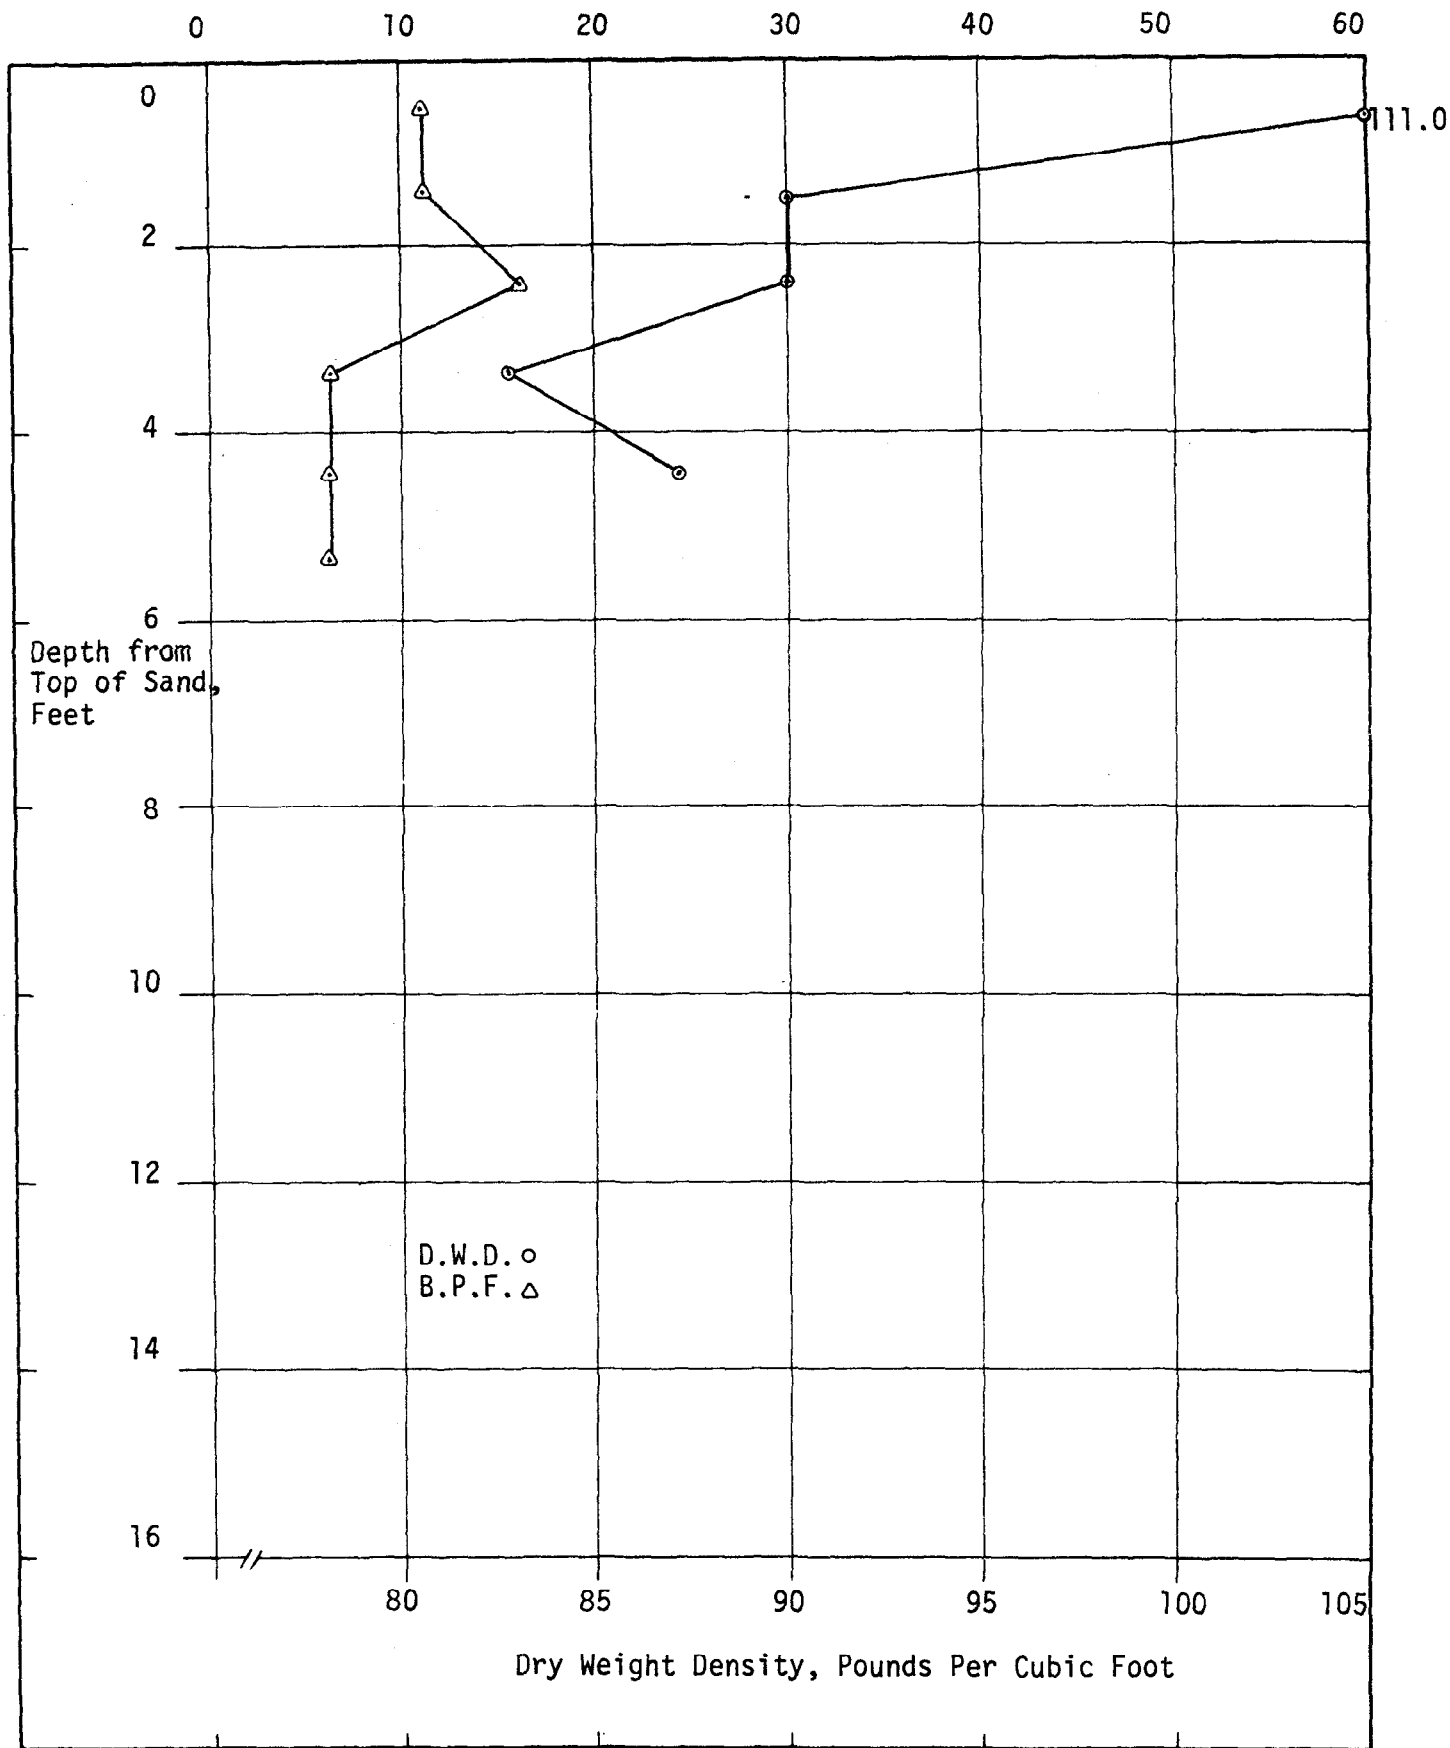
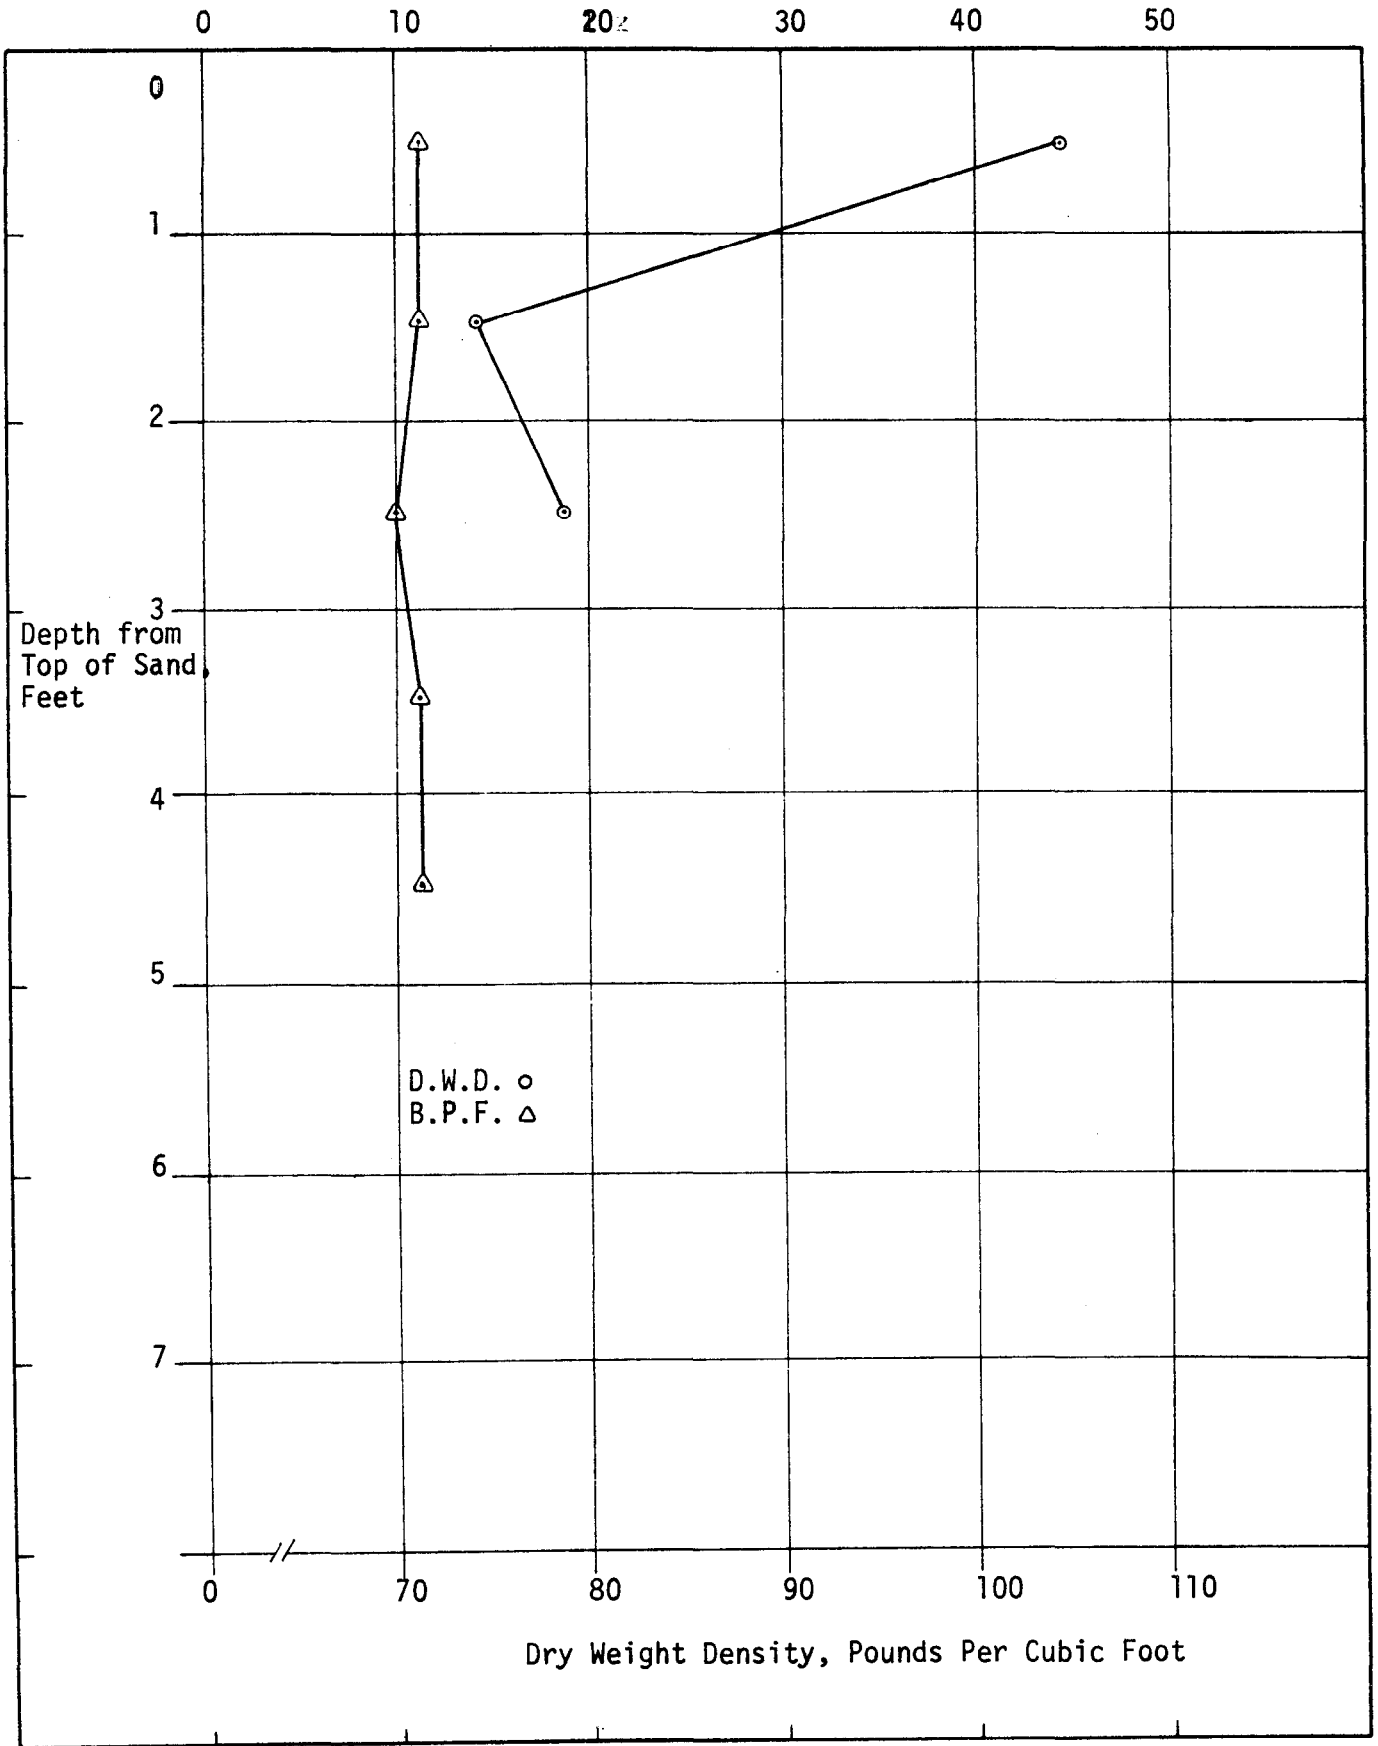
Unfortunately, detailed performance data is not available for this project. Moreover, the shallow depths of this fill do not lend themselves to detailed analysis. See Table 7 (Appendix) and Figures 4 and 5. Perhaps of most interest in Table 7 (Appendix) is the low density and high moisture values at certain levels beneath the sand fill. Pavement performance on this project is satisfactory at this time.

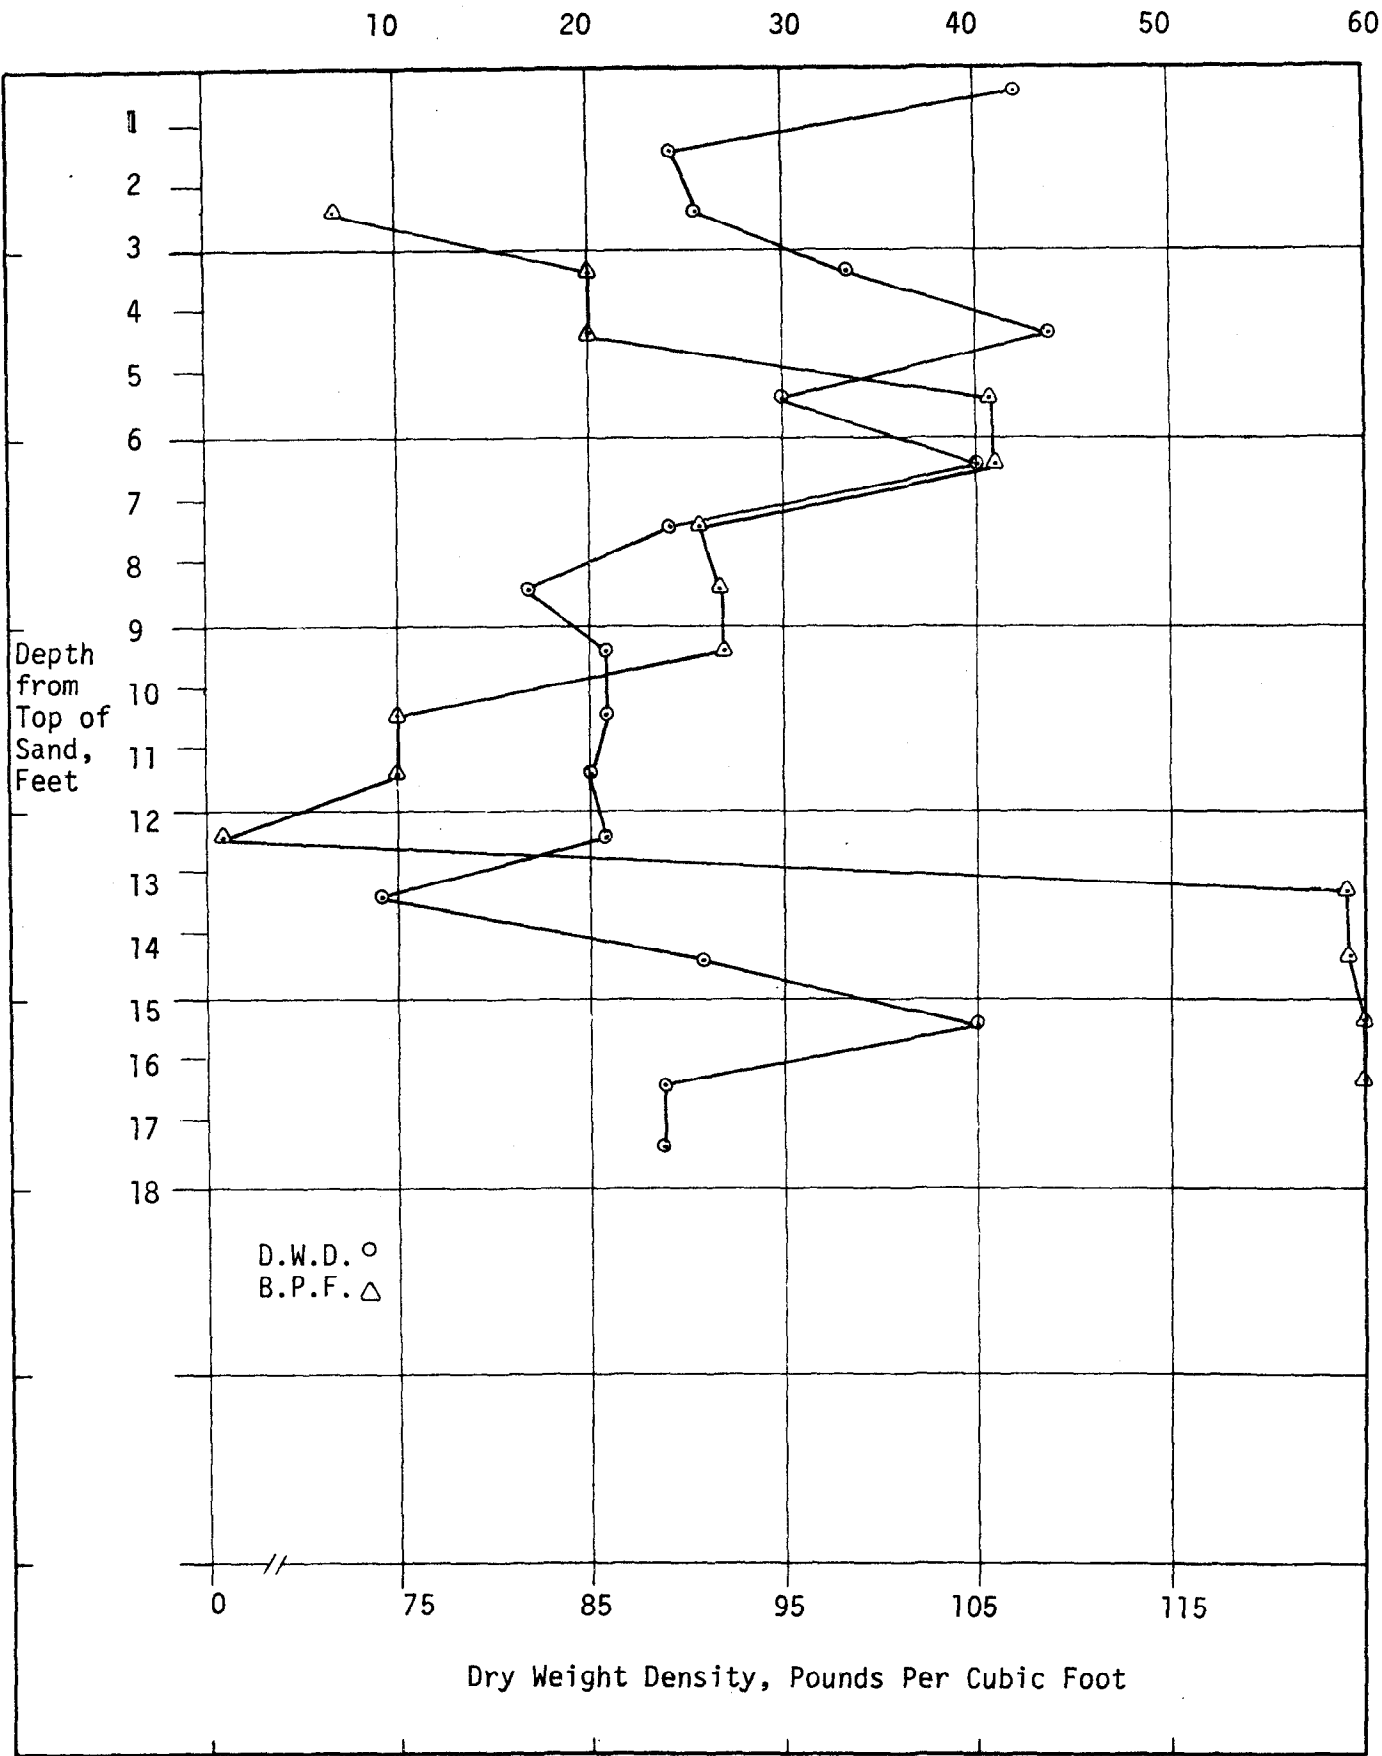
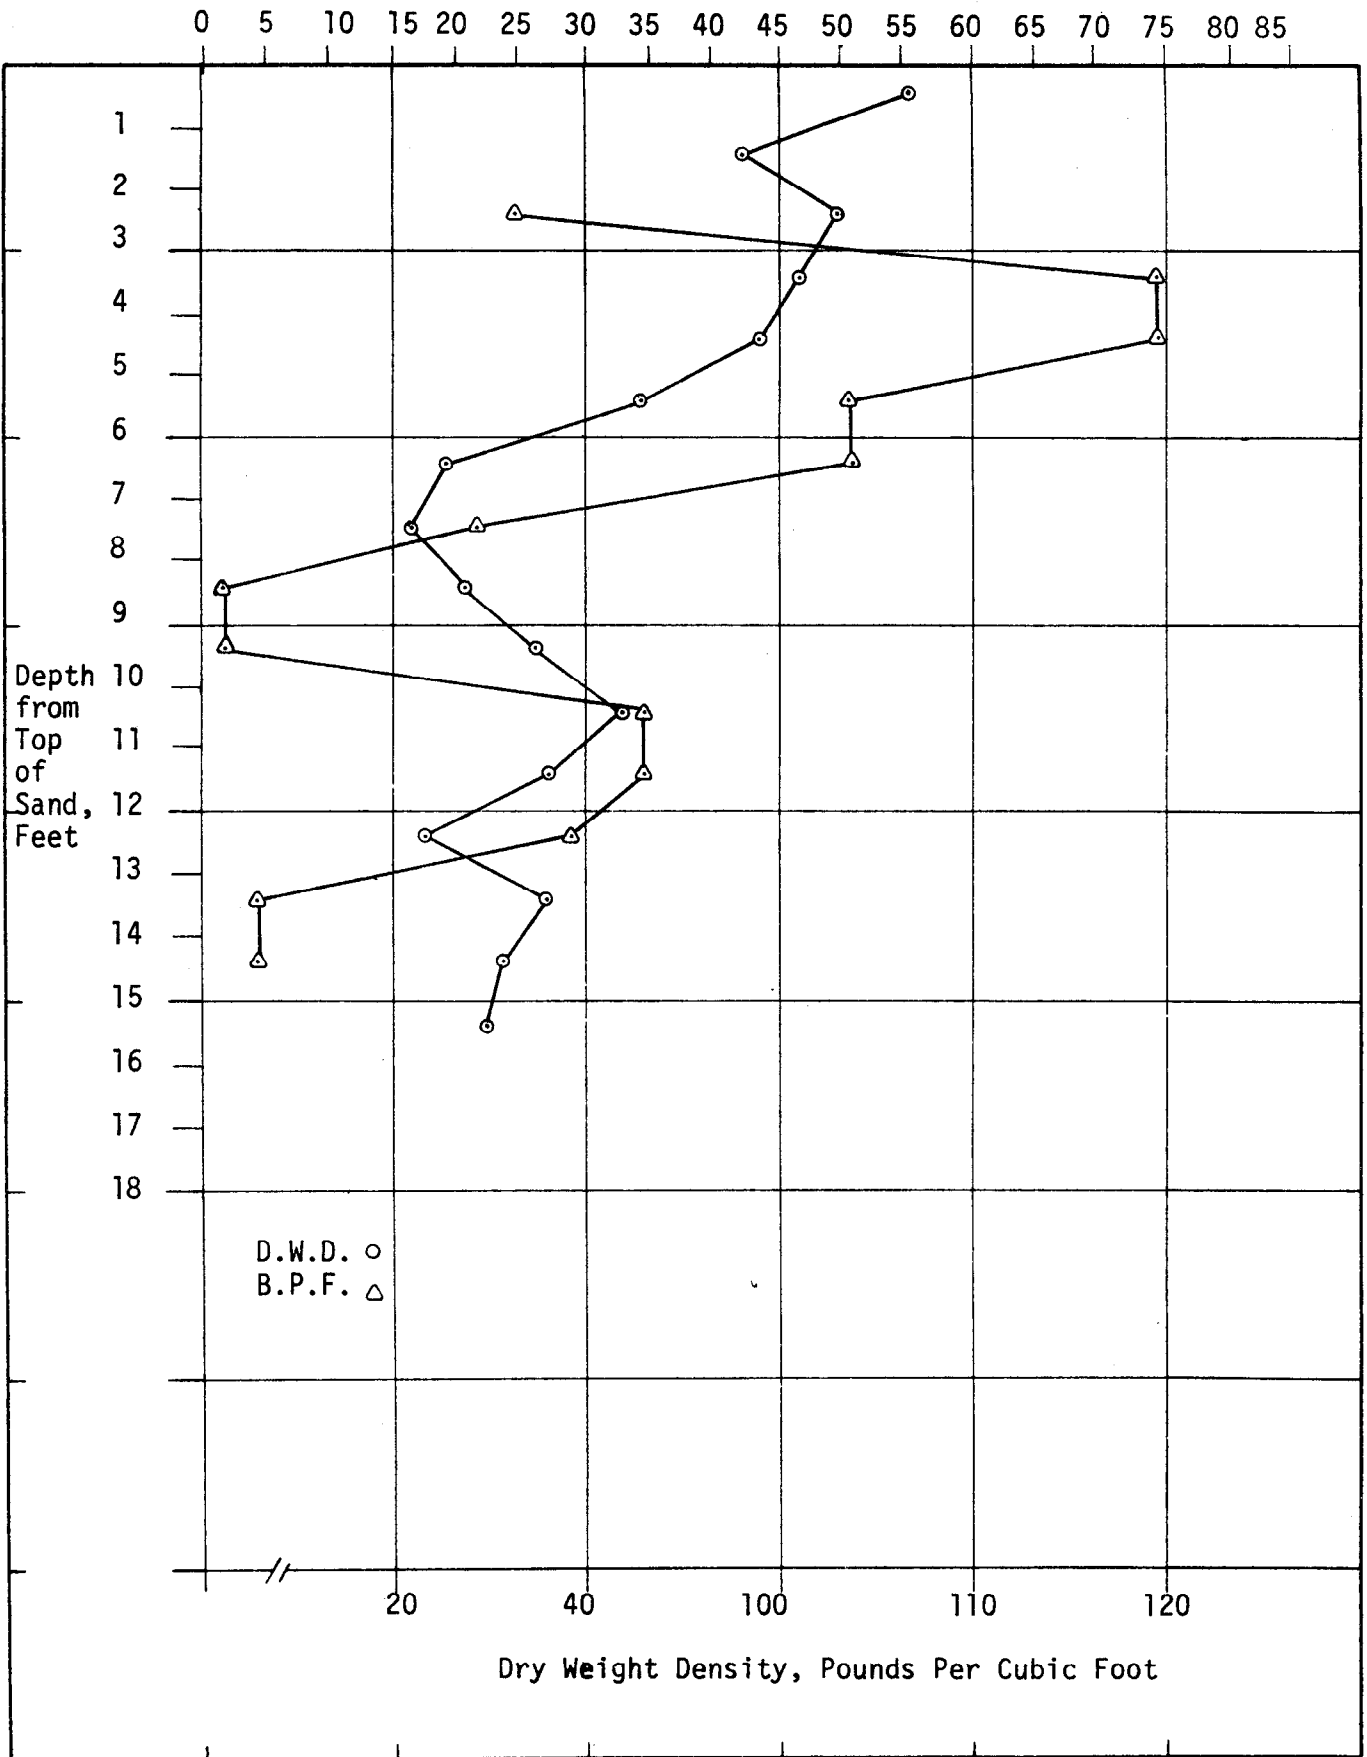
The plots of the density results and blows per foot of the standard penetration, Figures No. 6 and 7 and Table 8 (Appendix), are very similar. The results of the density tests taken in hole number 1 indicated a non-uniform condition between 4 to 7 feet. This was not indicated by the Standard Penetration Tests. The sand

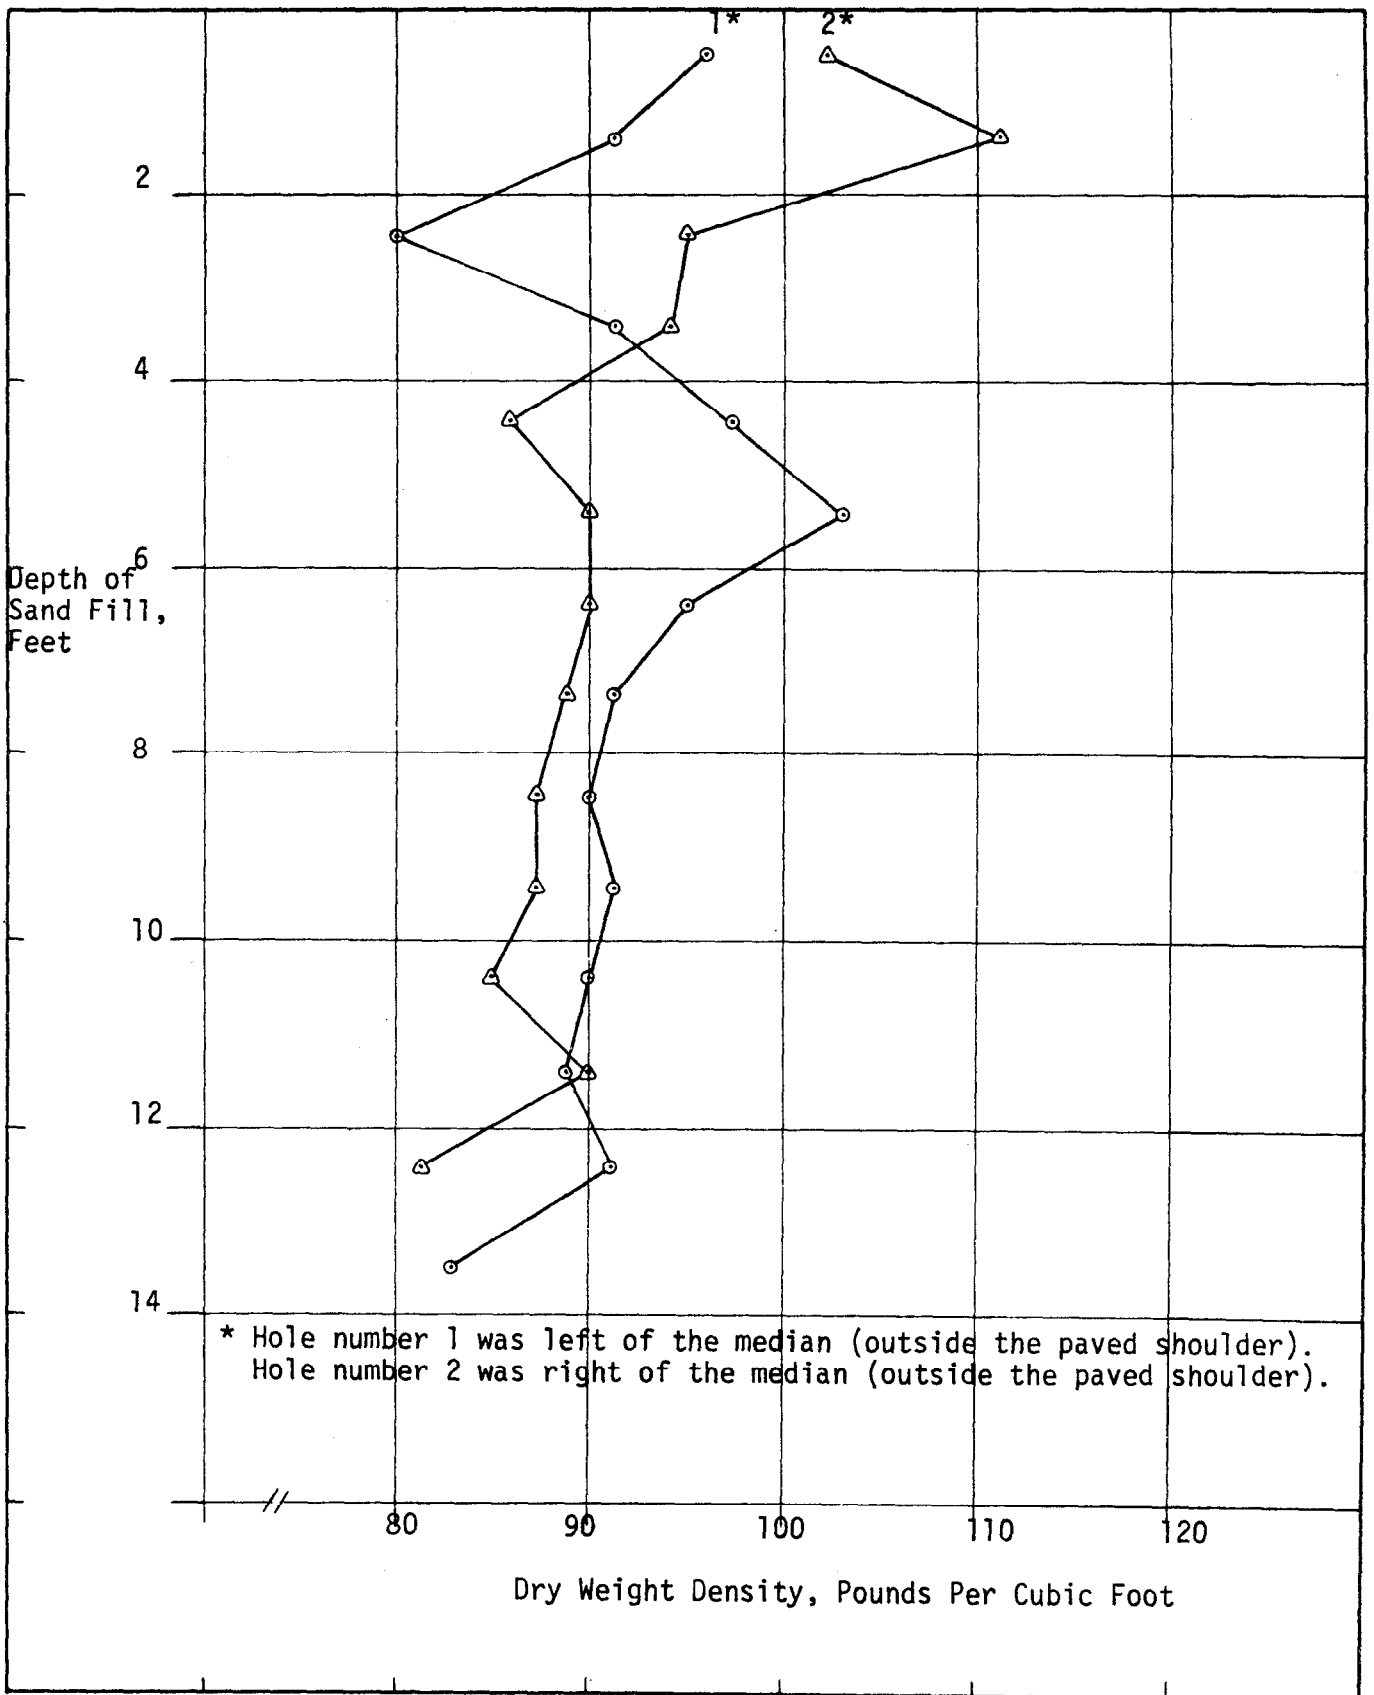
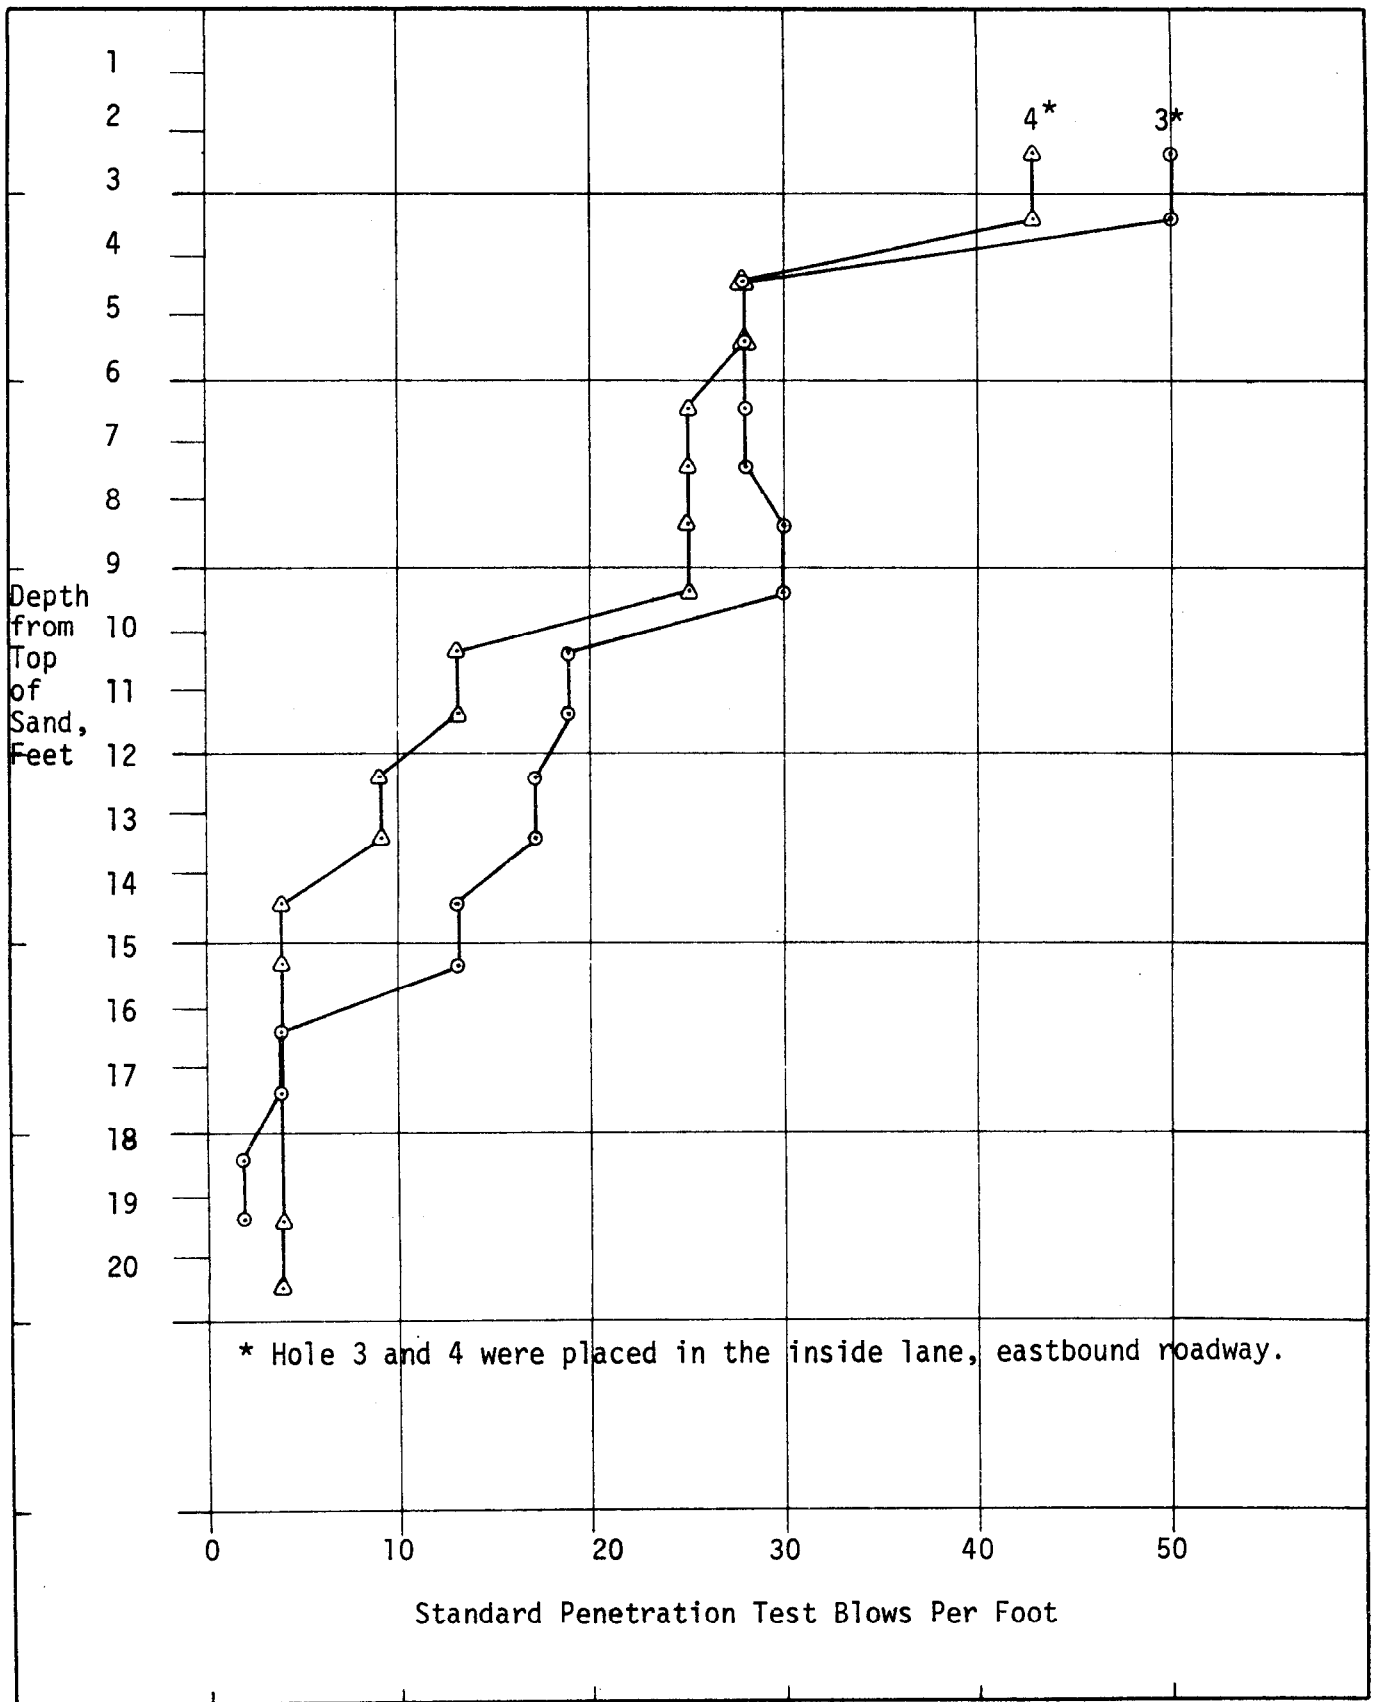
Density results obtained left of the median (outside the shoulder) indicate that the highest value is at 5 to 6 feet below the surface of the sand fill. A very loose and wet layer was observed at 2 to 3 feet. Borings showed this was caused by a thin (6 inch) layer of saturated silty clay. This was not observed in the borings under the roadway or on the opposite side of the roadway in hole number 2. Results of hole number 2 indicate a loose, moist sand zone at 4 to 5 feet. See Table 10 (Appendix) and Figures 9 and 10.

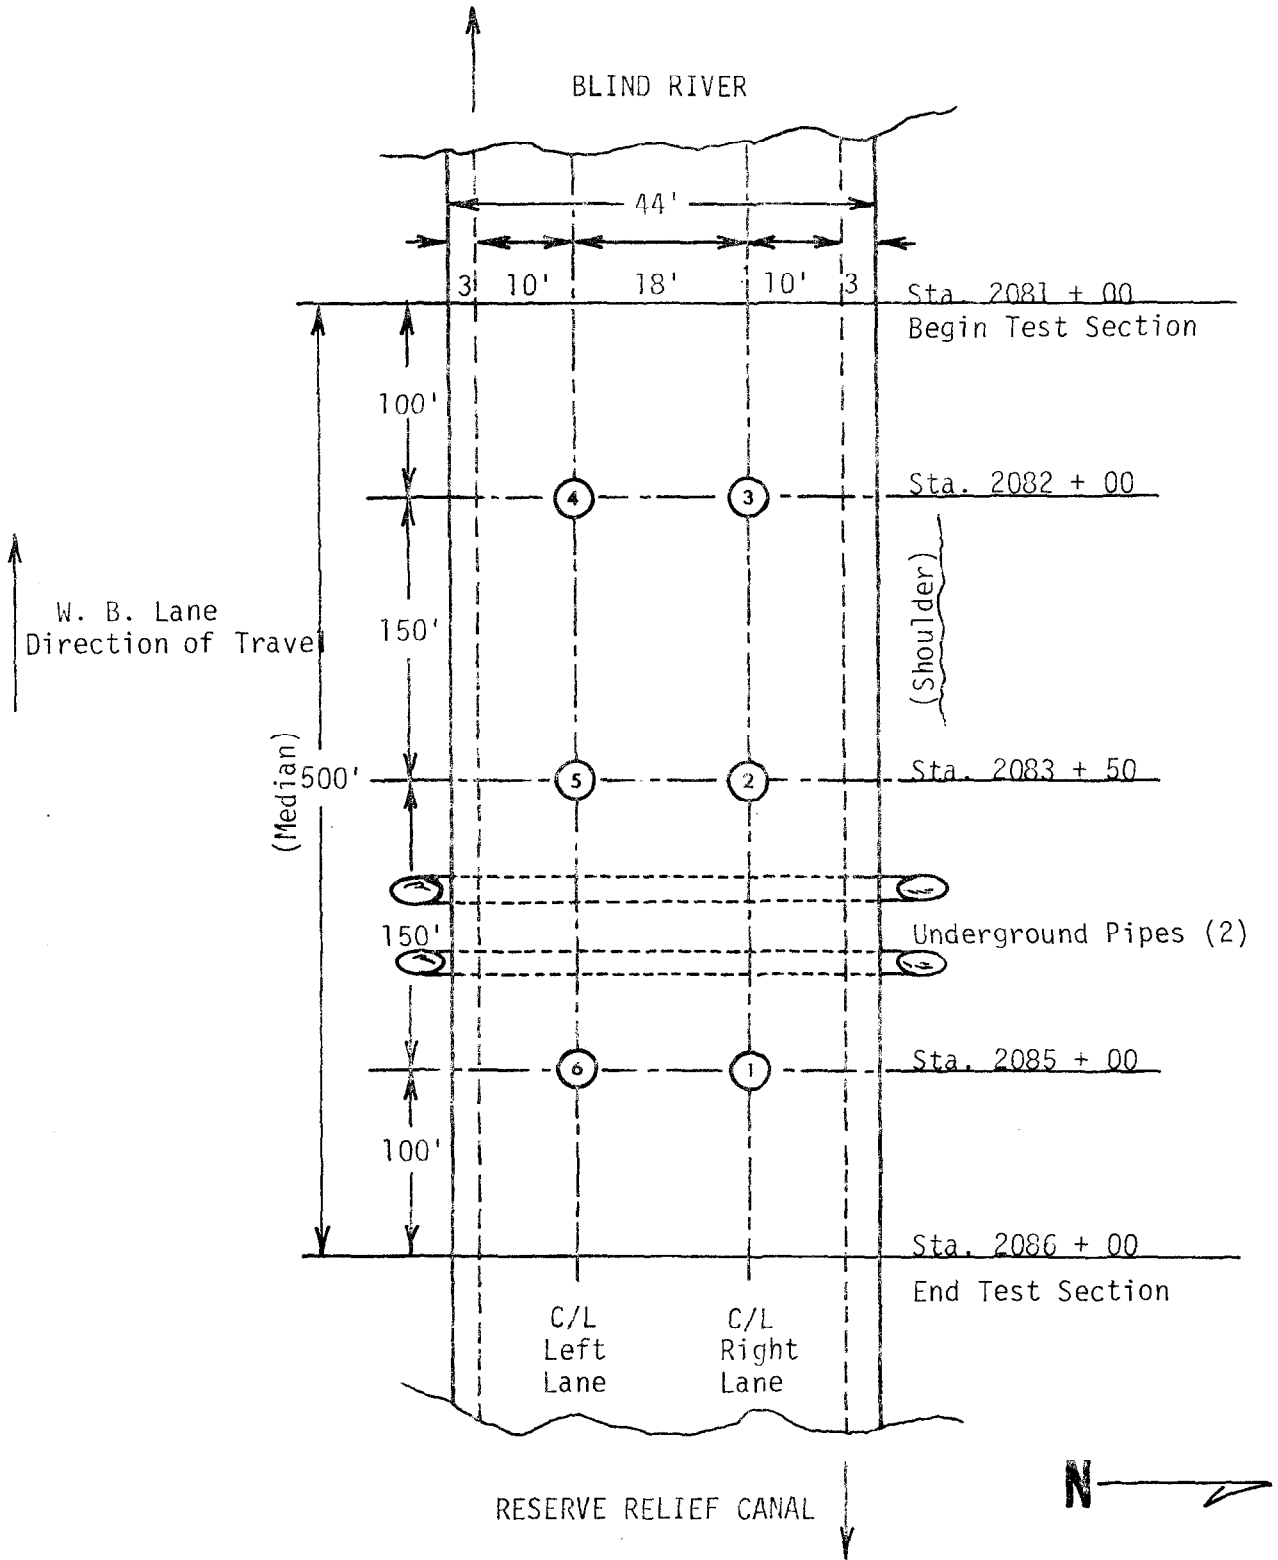
FIGURE 13

Due to this lack of preliminary data, a 500 foot sand fill test section was chosen where the 12 inch shell sub-base had been placed without vibratory compaction and the black base had not yet been placed. Six spots were selected for density determination before and after various passes of a vibratory roller\*. Figure 13 of the Appendix depicts the test section.
