EVALUATION OF DRAINAGE PIPE BY FIELD EXPERIMENTATION  
AND SUPPLEMENTAL LABORATORY EXPERIMENTATION

Interim Report No. 1

Research Report No. 101

MARCH 1977

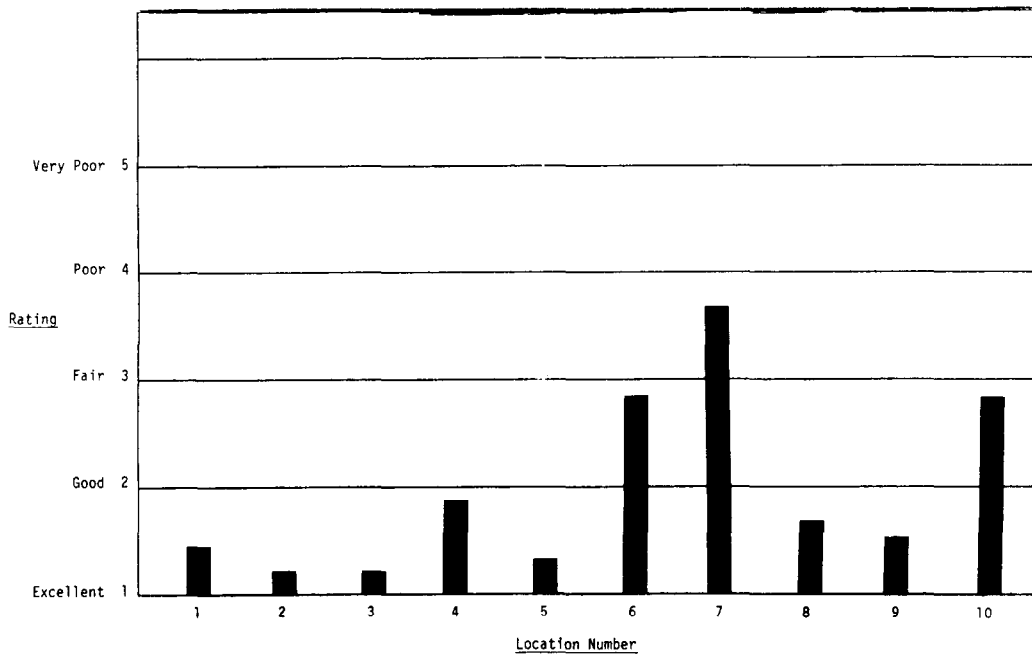
*Panel Ratings of Galvanized Steel Culverts*  
 FIGURE 9

At four of the test sites (numbers 1, 2, 3, and 5), the galvanized steel pipes are performing very satisfactorily. At sites 4, 8, and 9 the panel noted small amounts of corrosion primarily on the outside walls of these test culverts. The galvanized steel test culverts at sites 6, 7, and 10 are corroding at fast rates and bear further discussion.

At site number 6, the soil and effluent both exhibit low electrical resistivity values of 395 and 92 ohm-cm., respectively. This conductive medium appears to be the cause for corrosion occurring inside and outside of the test pipe.

At site number 7, which is a canal, the soil and brackish water have low electrical resistivity values of 688 and 111 ohm-cm., respectively. The test pipe was extensively corroded.

At site number 10, the pipes are resting in a canal of brackish water with an electrical resistivity of 105 ohm-cm. The silty clay soil also has a low electrical resistivity value of 283 ohm-cm. The galvanized steel pipe is deteriorating very heavily at this site. (All of the test pipes at site number 10 were encrusted with barnacles at the time of inspection.)

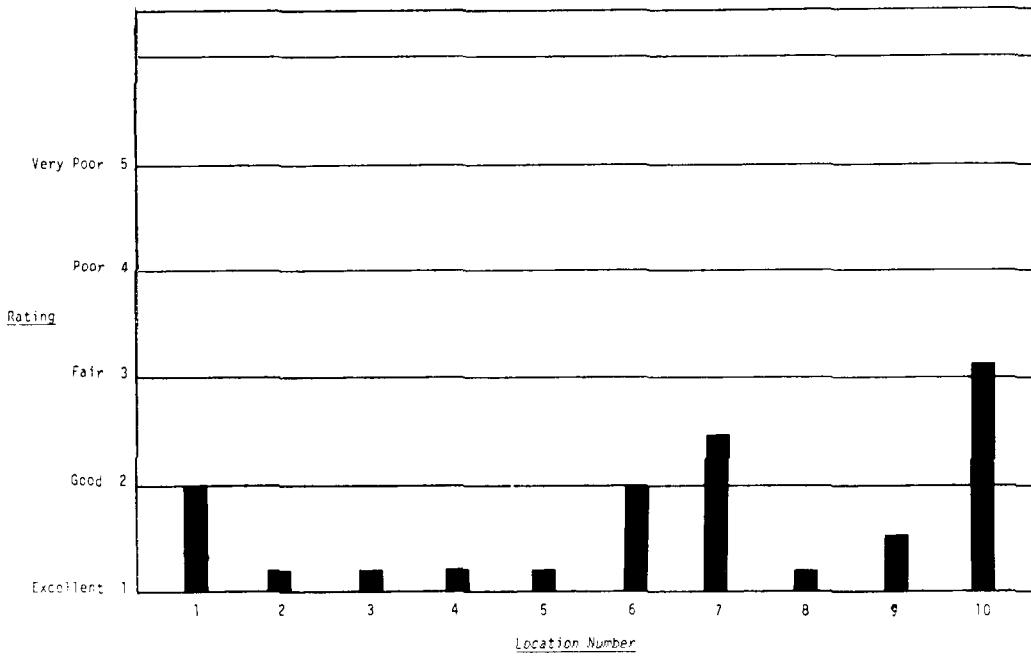
*Panel Ratings of U. S. Steel Nexon  
Precoated Culverts (12-mil Coating)  
FIGURE 11*

At sites 2, 3, 4, 5, 8, and 9, field and laboratory ratings were very favorable for these U. S. Nexon precoated culverts. However, the panel and the laboratory evaluation did note corrosion in progress at three sites, and these cases will be discussed further.

At site number 6 the soil and effluent have low electrical resistivity values of 395 and 92 ohm-cm., respectively. The test pipe has the coal-tar-based coating on the outside at this one site. Corrosion was noted on the inside of the pipe where the thin organic (0.3-mil modified epoxy) coating was generally removed.

At site number 7 the pipe lies in brackish water with a low electrical resistivity of 111 ohm-cm. The metal comprising the pipe is corroding, as are rivets on the pipe. The 12-mil protective coating is blistering, peeling, and partially removed.

At site number 10 the pipe lies in brackish water with an electrical resistivity of 105 ohm-cm. The metal is corroding, the inside protective coating is peeling, and the outside thin organic coating is generally removed.

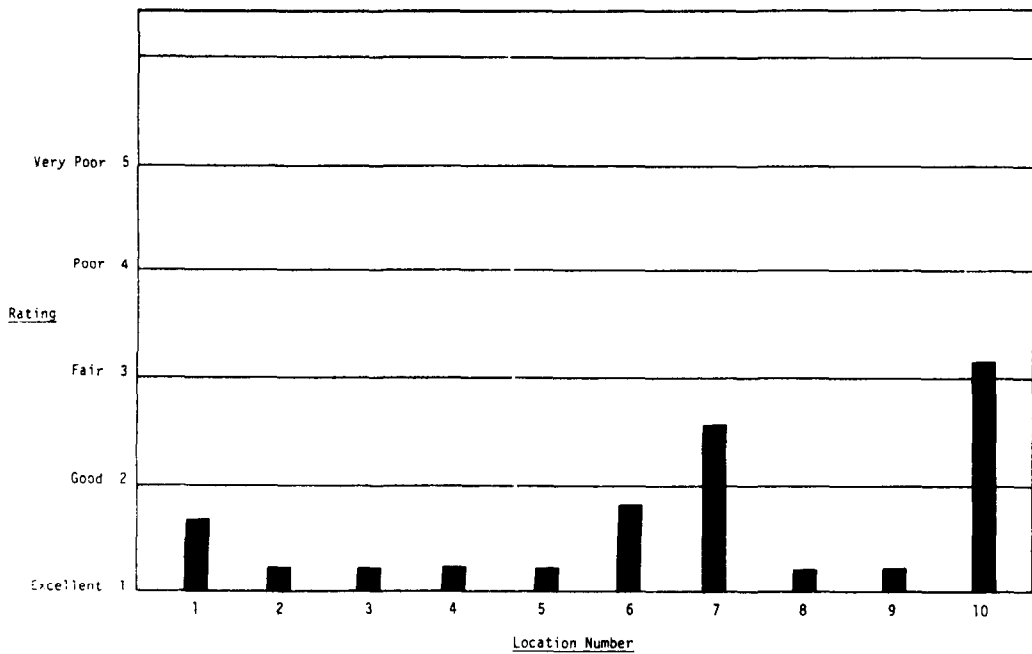
*Panel Ratings of U. S. Steel Nexon  
Precoated Culverts (20-mil Coating)  
FIGURE 13*

At sites 2, 3, 4, 5, 8, and 9, the panel and laboratory ratings of the resistance to corrosion of this type of pipe were almost excellent. At sites 2, 5, 8, and 9, the panel did observe that the protective coating was separating from the pipe. The panel and the laboratory evaluation noted corrosion of the galvanized steel at three sites and these cases will be discussed further.

At site number 6 the electrical resistivities of the soil and effluent are low values of 395 and 92, respectively. The protective coating is on the outside of this test pipe, and corrosion is occurring inside the pipe.

At site number 7 the pipe lies in a canal of brackish water having low electrical resistivity (111 ohm-cm.). The pipe is corroding in spots, and the rivets are corroding severely. The inside protective coating is separating from the pipe at one end.

At site number 10 the pipe is located in a canal with water having low electrical resistivity of 105 ohm-cm. The pipe is corroding, and the coating is peeling.

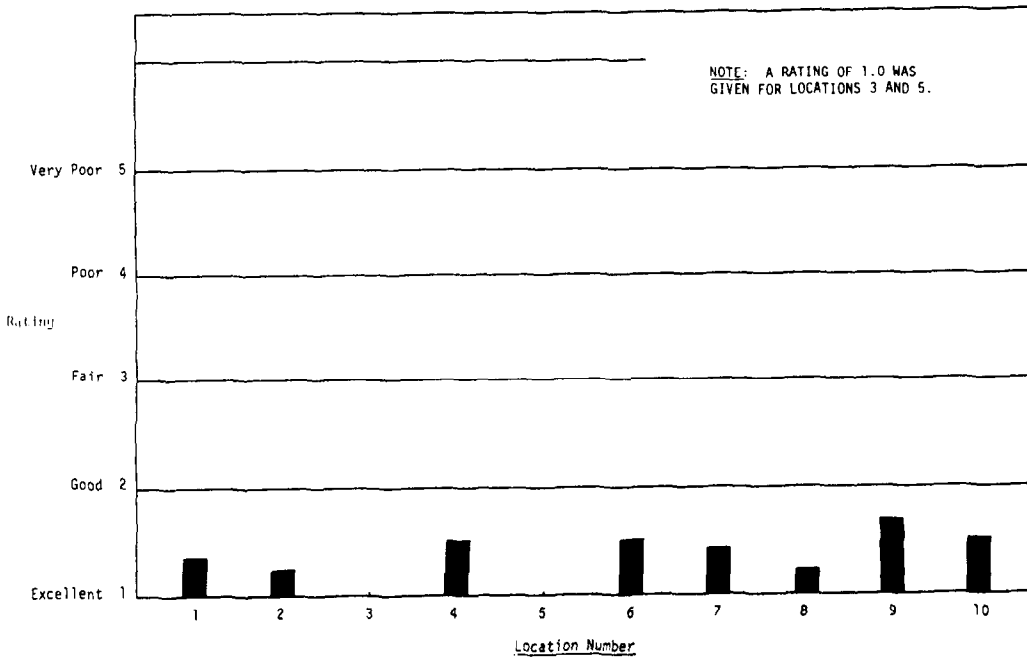
*Panel Ratings of Inland Steel Polyethylene-Coated Culverts (10-mil/3-mil Coatings)*  
 FIGURE 15

Figure 15 relates the panel ratings and Figure 16 presents the laboratory ratings of the resistance to corrosion exhibited by this pipe after two years in the field. The polyethylene coatings have thus far functioned very well in protecting the galvanized steel of this pipe from corrosion.

The panel did note that rivets exposed on the exterior of this pipe are corroding at six of the ten sites. The panel was also concerned about the durability of the coating in environments where both soil and effluent have low electrical resistivity values. At sites numbers 6, 7, and 9, the panel and the engineer in the laboratory both noted that the polyethylene coating was blistering and peeling.

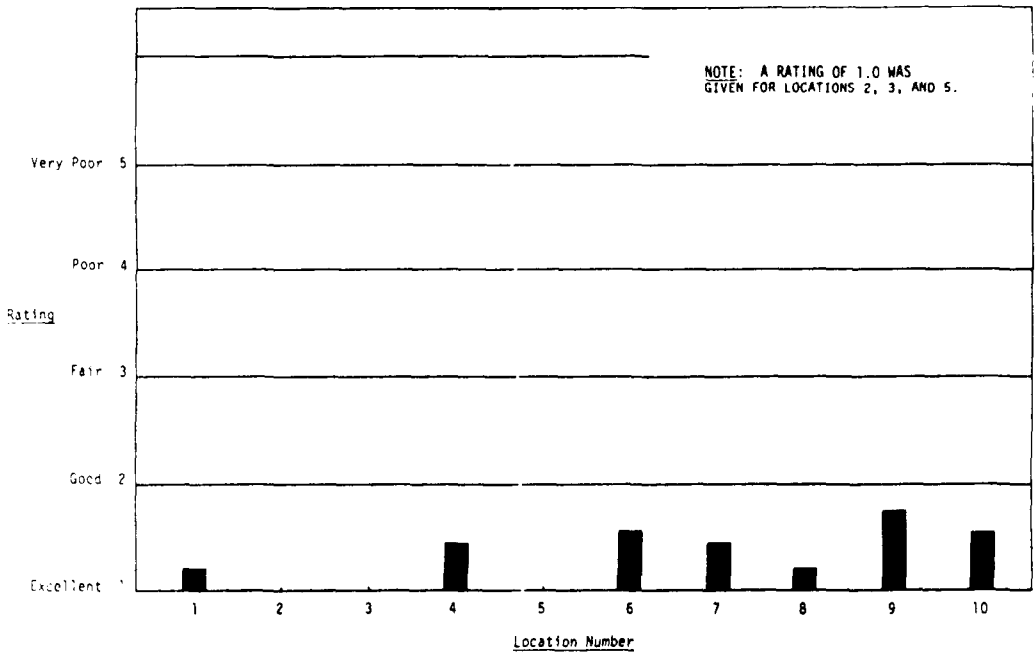
*Panel Ratings of Inland Steel Polyethylene-Coated Culverts (12-mil/5-mil Coatings)*  
 FIGURE 17

Figures 17 and 18 relate that this type of test pipe is resisting corrosion very well after two years in the variety of environments.

The panel did observe that the rivets on the test pipes at six of the sites had corroded. The panel and the laboratory evaluation both noted that the polyethylene coating was blistering and peeling at sites 6, 7, and 9.

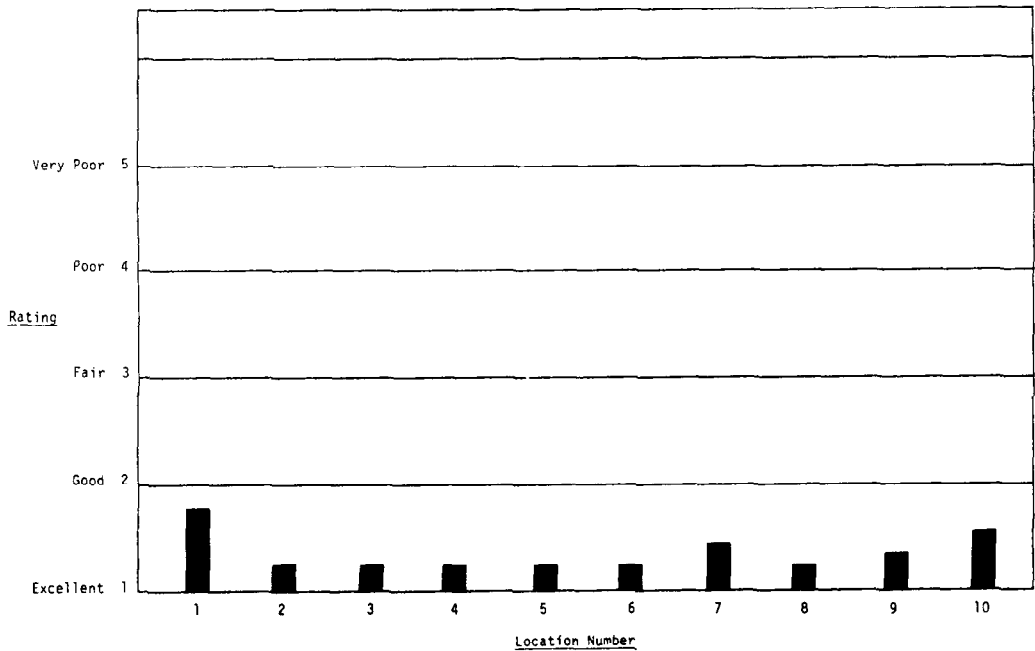
*Panel Ratings of Asbestos-Bonded  
Asphalt-Coated Galvanized Steel Culverts  
FIGURE 19*

Figures 19 and 20 relate that this type of test pipe is consistently performing very well in regard to corrosion resistance.

The panel did note that the asphalt-asbestos coating was cracking, primarily in an alligator pattern. However, at 200 mils (5.1 mm.) this is the thickest coating under evaluation (Table 4 in appendix), and it is doing an excellent job in protecting the galvanized steel from corrosion.

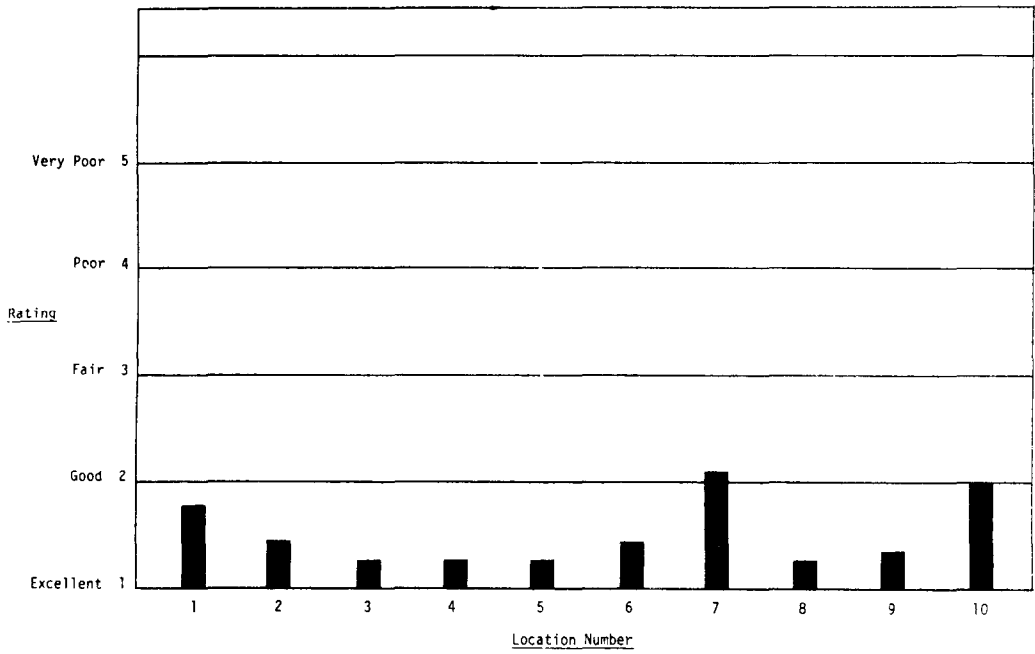
*Panel Ratings of Asphalt-Coated Galvanized Steel Culverts*  
 FIGURE 21

Figures 21 and 22 relate that this type of pipe has resisted corrosion quite well at most sites after two years of field exposure. However, the panel and the laboratory evaluation noted corrosion in progress at sites numbers 7 and 10.

The panel reported that the asphalt coating was generally experiencing cracking and partial removal on the interior and exterior. At two of the sites, the panel reported that the outside coating was coming off as the surrounding soil was removed for the inspection.

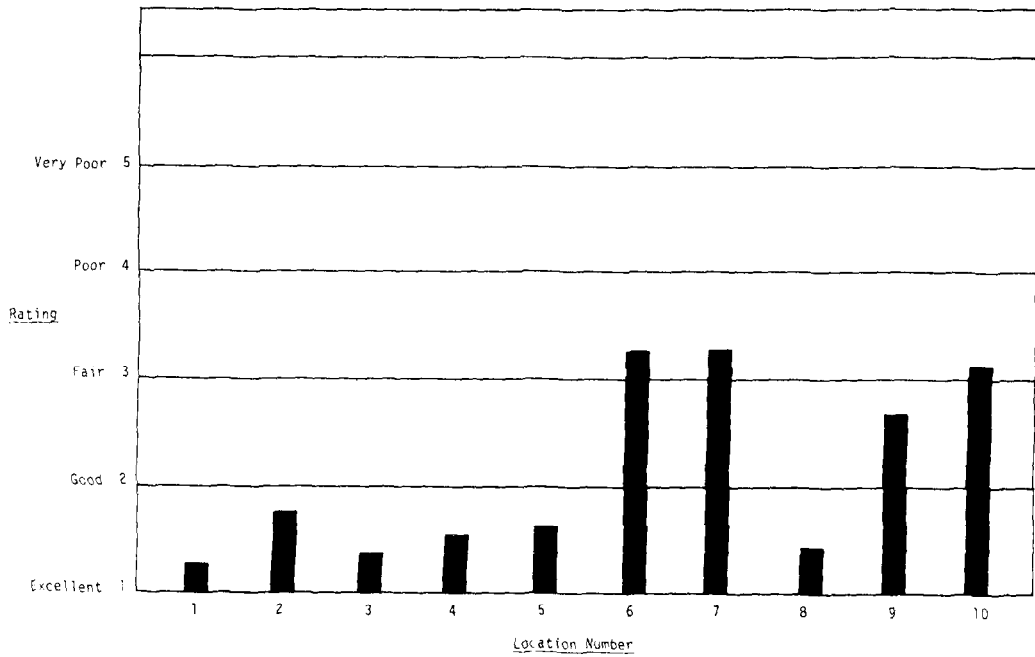
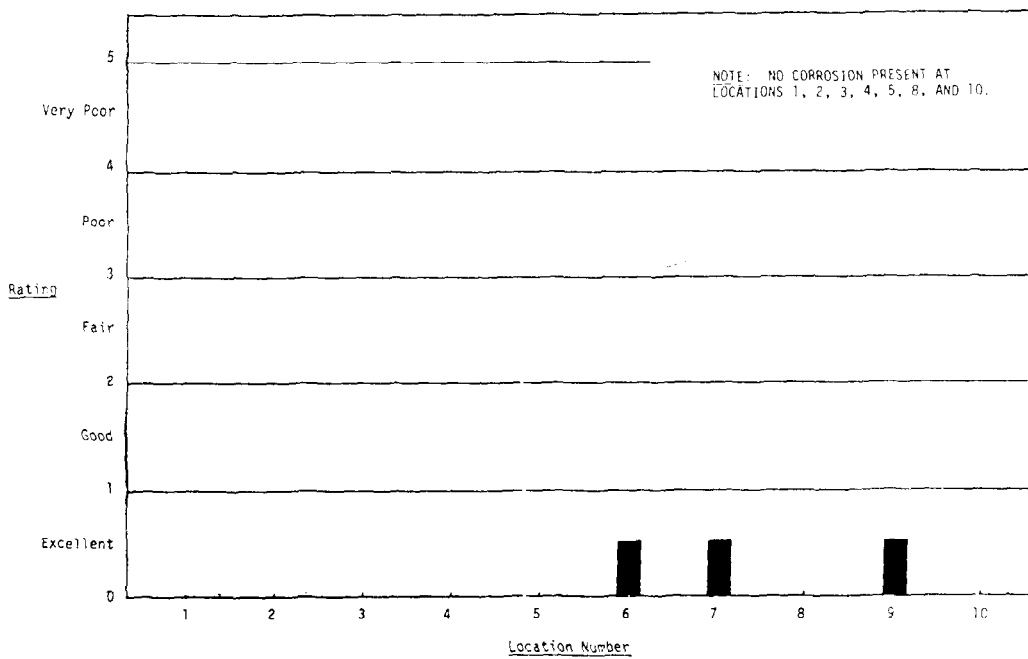
At sites which met the above pH and resistivity criteria, the aluminum pipe performed very well in resisting corrosion. At sites where the soil and/or effluent exhibited electrical resistivity values near or below the threshold value of 500 ohm-cm., the aluminum pipe exhibited staining, pitting or localized thickness loss after the two years of field exposure.

The panel noted extensive oxidation on the aluminum pipes at the brackish water sites (numbers 6, 7, 9, and 10). Laboratory evaluation of the samples taken from the ends of the test culverts at sites 6, 7, and 9 indicated an average maximum thickness loss per square inch of 10% of the original thickness (rating 0.5). Such an average maximum thickness loss would indicate total penetration of the cladding and probably a portion of the core alloy at some spots on the sample. The field and laboratory ratings are presented as Figures 23 and 24, respectively.

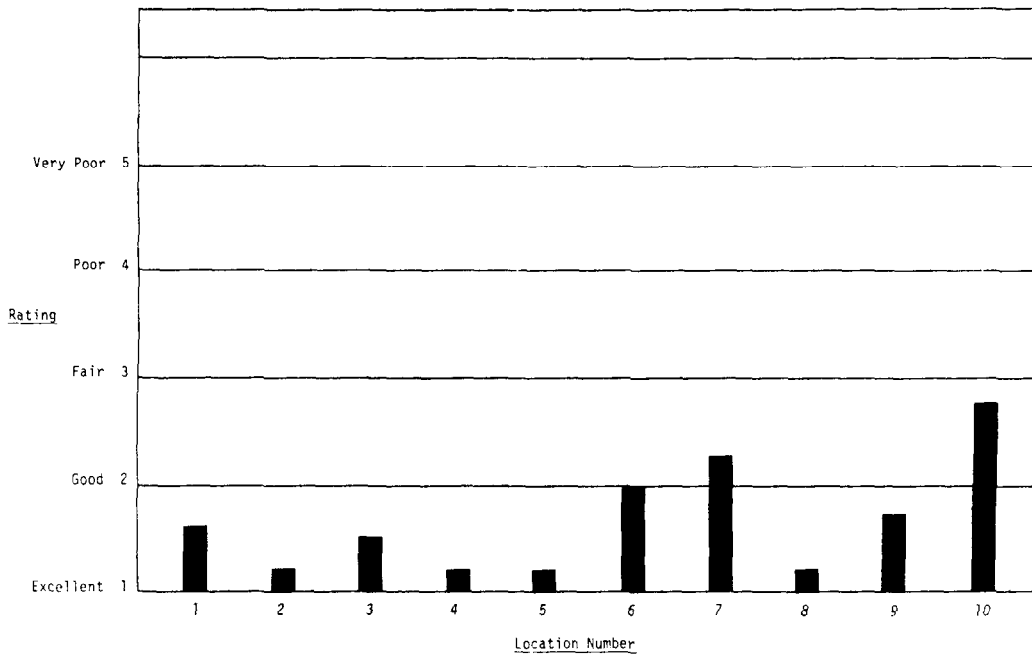
*Panel Ratings of Asphalt-Coated  
Corrugated Aluminum Pipe*  
FIGURE 25

The panel's ratings for this type of test pipe are shown in Figure 25. The panel commented that the asphalt coating was extensively removed from these test pipes. The group made special note of the oxidation manifested on the aluminum at sites 3, 6, 7, 9, and 10. Laboratory evaluation revealed that the stains on these pipes at sites 6, 7, 9, and 10 are more than just signs of oxidized cladding, and reported thickness loss penetrating the core alloy at these four sites. For example, the rating of 1.0 at site 7, as shown in Figure 26, indicates an average maximum thickness loss per square inch of 20% of the original thickness.

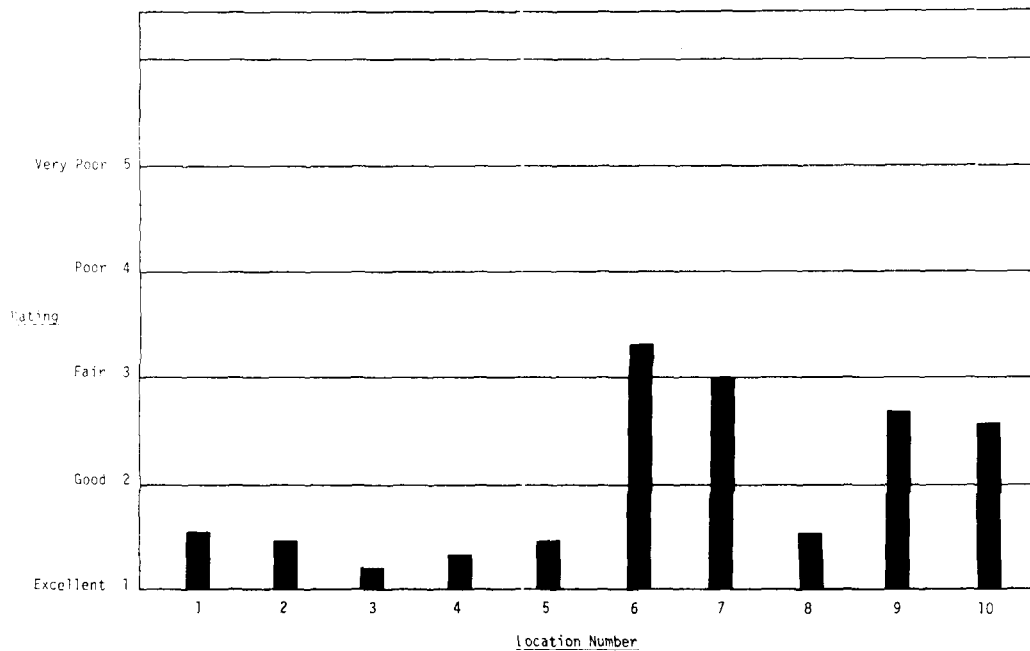
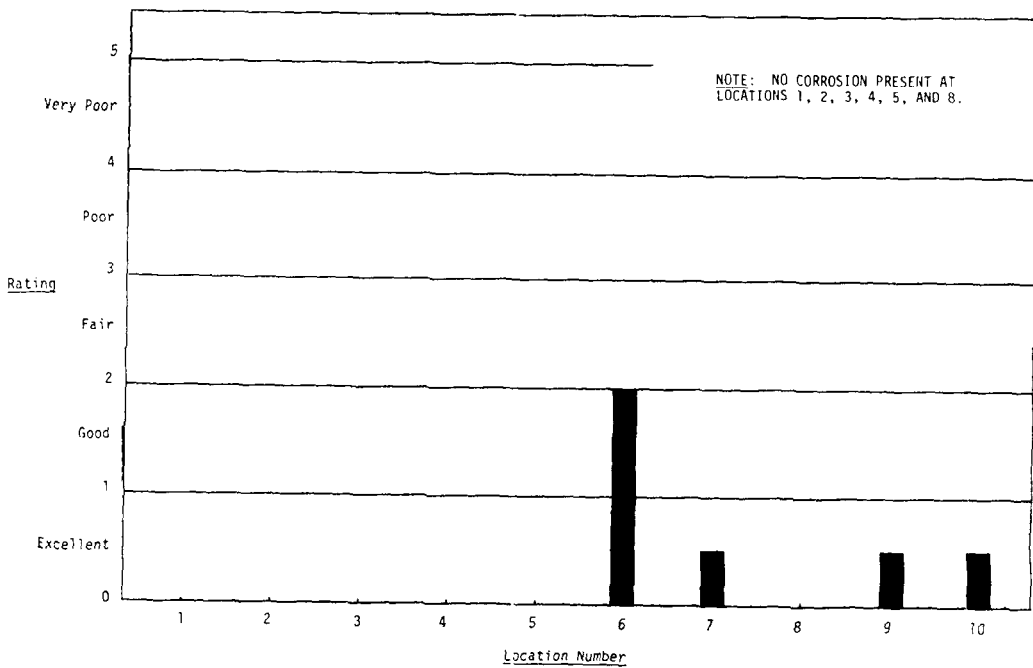
The panel noted that oxidation of this type of culvert was noticeable at all ten sites. Figures 27 and 28 relate that those aluminum plate arches at sites 6, 7, 9, and 10 were in the worst condition. These four sites are near the Gulf of Mexico and the electrical resistivity values of soil and effluent are low.

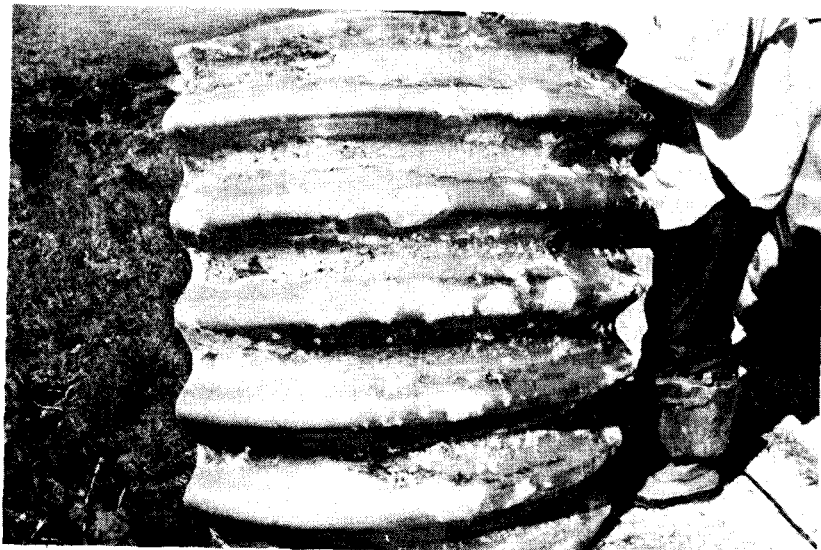
Figure 29 is a photograph of the aluminum plate arch at site 9 after two years of field exposure. Figures 30 and 31 demonstrate the two types of deterioration occurring in the aluminum culverts--pitting and general thickness loss.

*Photograph of Aluminum Plate Arch  
at Site No. 9 after Two Years  
FIGURE 29*

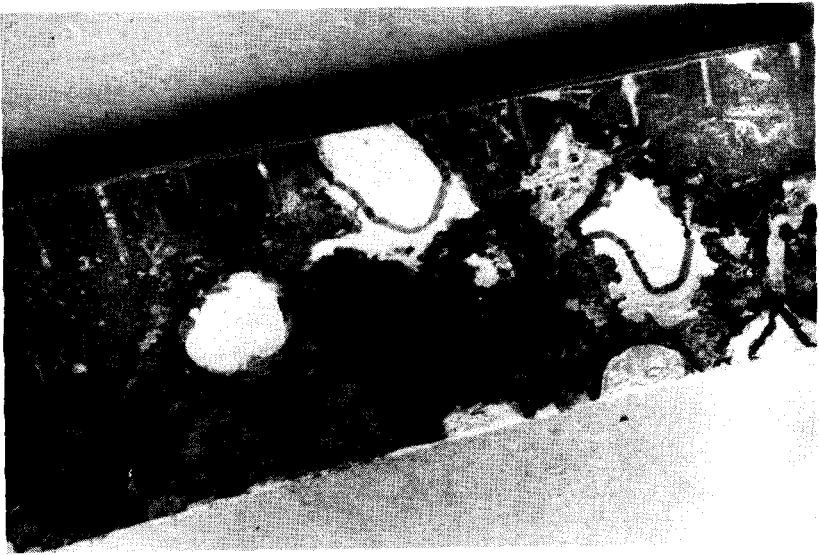
Pitting of the aluminum metal was primarily found in areas where the culvert had been exposed to what appeared to be a growth of organisms. One reference (2) has related corrosion and resultant pitting of steel and iron to microorganisms. However, the authors are not aware of any source establishing a relationship between microorganisms and corrosion (with pitting) in aluminum. The researchers plan additional study of this possible relationship.

*Fitting of Aluminum Plate*  
FIGURE 30

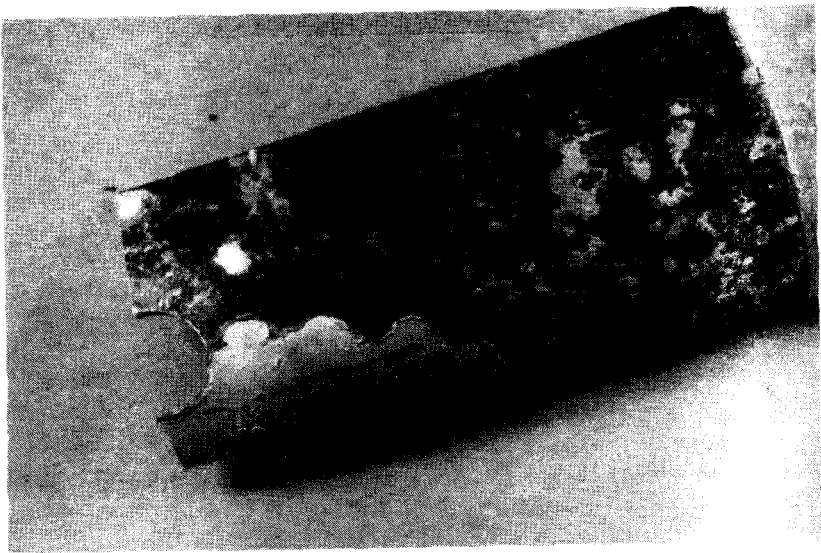
The aluminum culverts displayed two types of deterioration. Pitting of the surface was noticed on samples from some test sites. The second type of deterioration was a uniform loss of thickness for a given local area of the culvert.

*General Thickness Loss of Aluminum Plate*  
FIGURE 31
