EVALUATION OF ZINC COATING PROCEDURES

FINAL REPORT

Research Report No. 116
Research Project No. 72-1CH(B)
Louisiana HPR 0010(001)

Conducted by
LOUISIANA DEPARTMENT OF
TRANSPORTATION AND DEVELOPMENT
Research and Development Section
In Cooperation With
U. S. Department of Transportation
FEDERAL HIGHWAY ADMINISTRATION

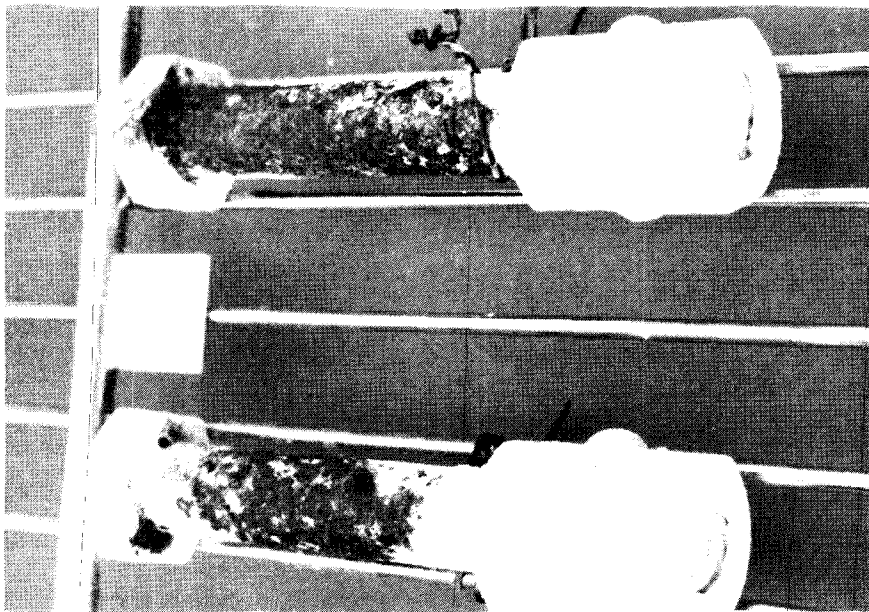
The performance of bolts and nuts coated with an LS grade of electroplating was inferior to that of the two types of coatings discussed in the preceding paragraph. Rusting of this LS grade was first noticed at the inspection made after 3 3/4 months of exposure in the environmental chamber set 150°F (66°C) and a relative humidity in excess of 95% as can be seen in Figure 5.

Figure 5. LS grade of electroplating after 3 3/4 months of exposure in the environmental chamber

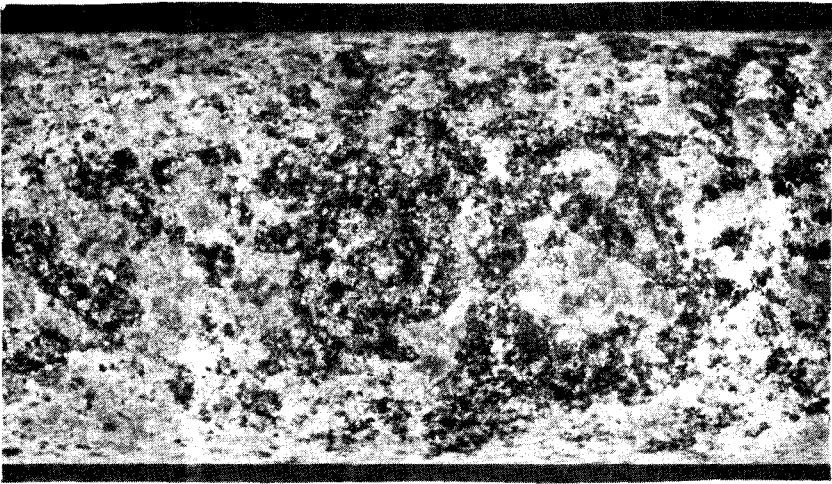
A comparison of the corrosion of the electroplated and the hot-dip galvanized hardware can be seen in Figures 6 through 8.

Figure 7. Side view of a GS grade electroplated bolt after being exposed in the environmental chamber for 15 months

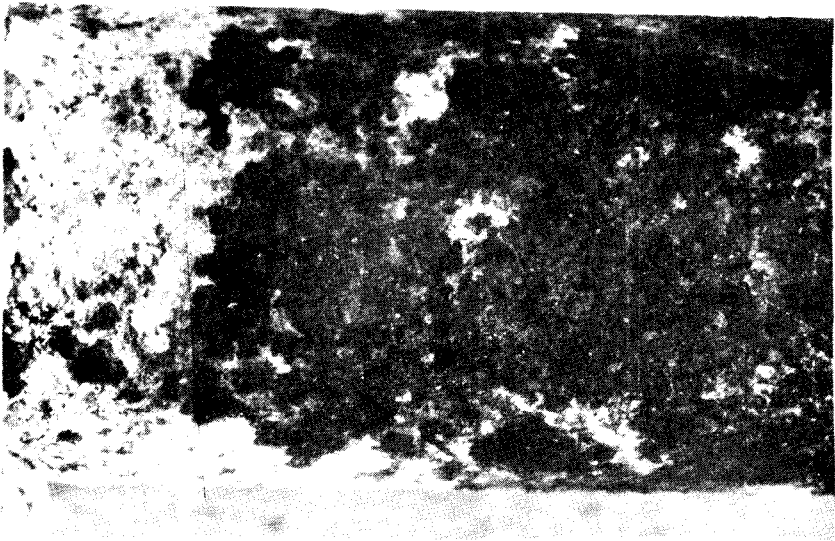
Figure 8. Side view of an LS grade electroplated bolt after being exposed in the environmental chamber for 15 months

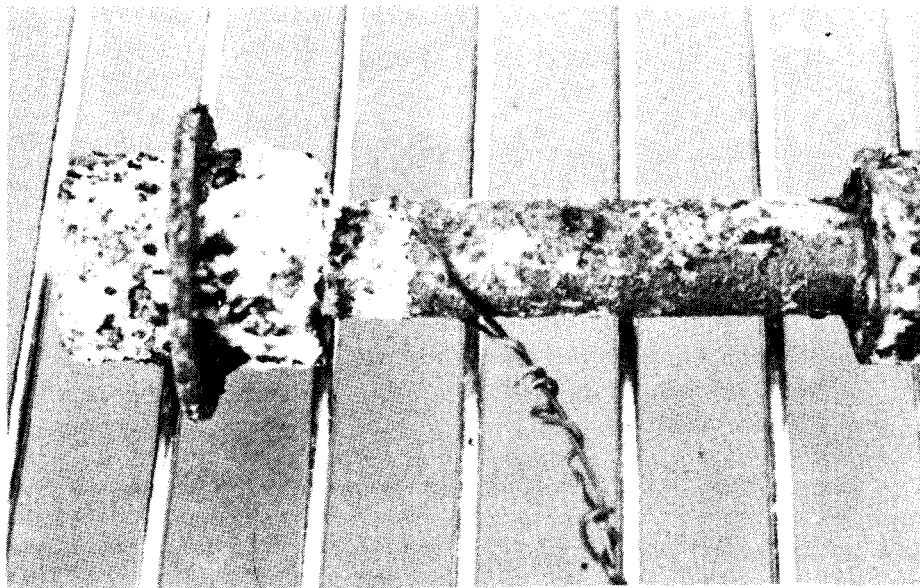
The hardware coated with an organic zinc-rich paint showed severe rusting after 3 3/4 months in the environmental chamber, as can be seen in Figure 9. However, these results were not listed in Tables 1, 2 and 3 due to a contradiction with the results obtained in testing the repair systems. After 12 months in the humidifier, set at the same controlled condition, the portion of the bolts coated with the organic zinc-rich paint which was tested as a repair system, were in excellent condition. This apparent contradiction will be discussed later.

Figure 9. Painted bolt after being exposed in the environmental chamber for 3 3/4 months

After 3 3/4 months of exposure in the environmental chamber, the painted hardware showed severe signs of rusting. However, exposure of the painted bolts included in the test of repair systems showed superior performance even though the paint used was the same organic zinc-rich primer. The superior performance may have been due to either a thicker coating of material or a more uniform mixture of the paint. A difference in color suggests that the zinc powder was not well mixed with the base portion of the paint when it was used to coat the first set of hardware. However, the results of the first set of bolts, which quickly rusted, could be used as a control to monitor the rate of corrosion in the field. The set of the painted hardware should have been the first to rust in the field. However, after four years of field exposure only the threads of the painted bolts were showing signs of significant rusting along with a few specks of rust on the washers. Due to this slight amount of corrosion, the only correlation that could be made was that two months exposure in an environmental chamber at 150°F (66°C) and a relative humidity in excess of 95% was much more severe than four years of field exposure in either north or south Louisiana.

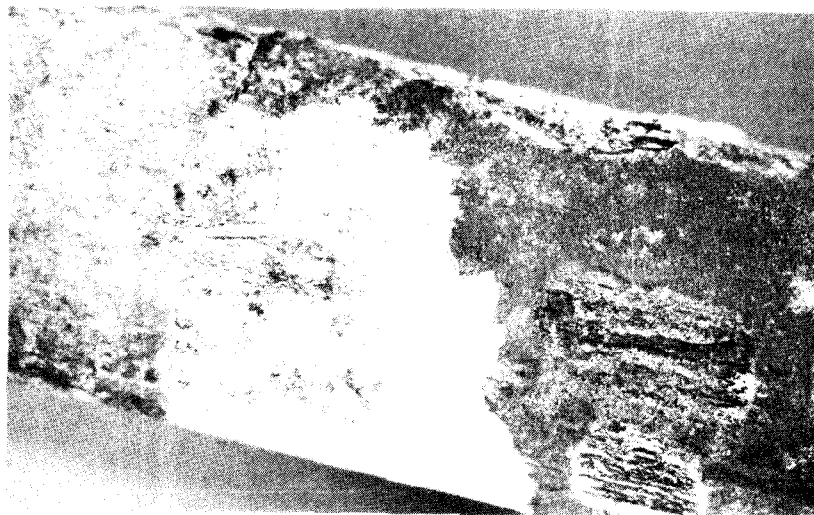
After 12 months of exposure in an environmental chamber set at a temperature of 150°F (66°C) and a relative humidity in excess of 95%, all three paints used as repair systems blistered to some degree where they overlapped the original hot-dip galvanized or electroplated zinc coating. In some cases, it was noticed that the blisters promoted further corrosion due possibly to entrapment of moisture beneath the painted coating.

As can be seen in Figure 10, an area near the blister is observed to be in excellent condition upon scraping the painted coating,

Figure 10. Scratched area of painted coating yields original uncorroded zinc coating (Notice area in lower right corner)

This characteristic of poor adhesion of paint over a zinc-coated surface has been a problem for some time. The present solution is to treat the zinc coating with a wash primer prior to painting. This procedure should aid in the prevention of premature failure.

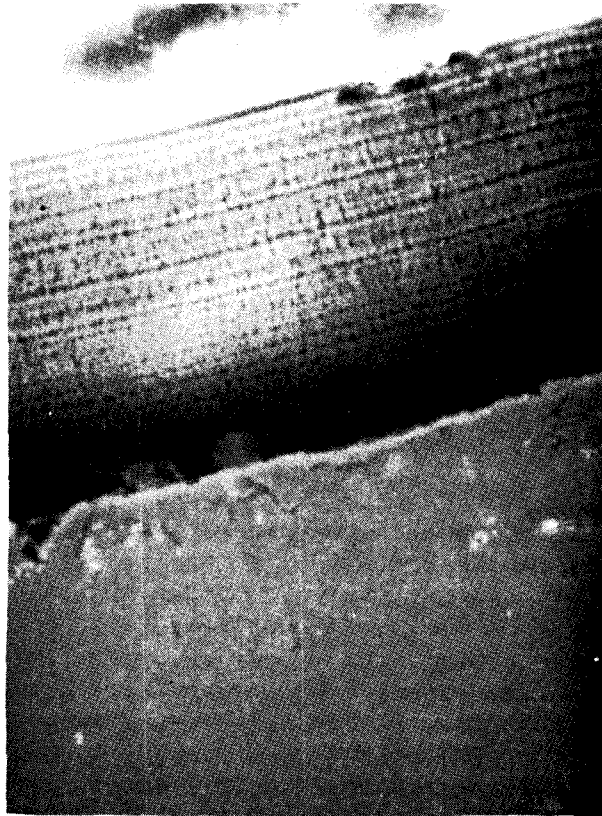
Analysis of the zinc-steel interface, using a scanning electron microscope, showed that the alloy layer of the hot-dip galvanized washer was much larger than that of the electroplated washer. In fact, as can be seen in Figure 11, no detectable alloy layer was present in the photomicrograph taken at a magnification of X 1680 of the interface of the electroplated washer.

Figure 11. Cross section of electroplated washer showing the zinc-steel interface (X 1680)

The cross section of an electroplated washer observed in Figure 11 showed no steel present in the zinc layer. The surface of the zinc layer also appeared much smoother than that of the hot-dip galvanized washer.

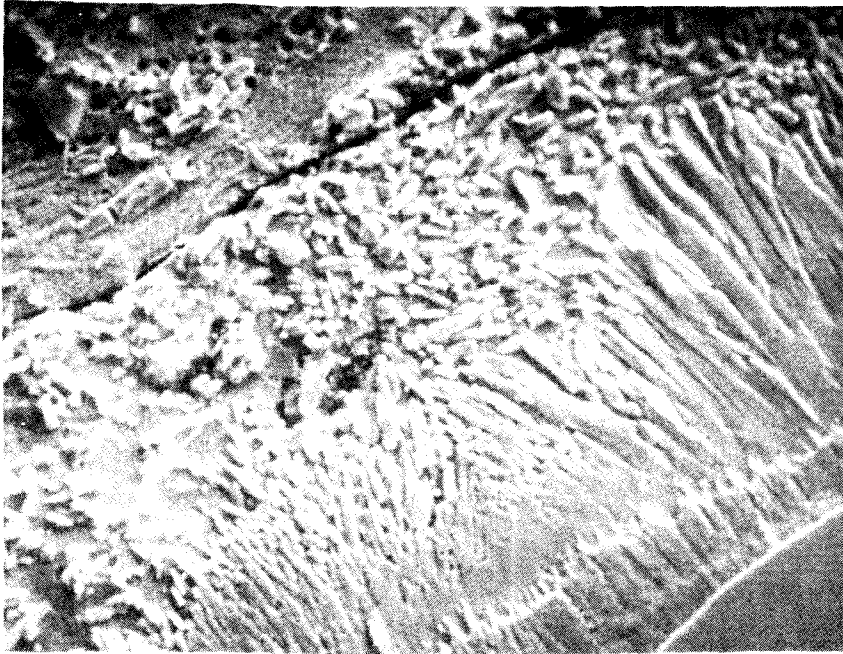
However, Figure 12, taken of the hot-dip galvanized washer, shows that the outer zinc layer, known as the eta layer in the literature, contains a small amount of steel.

Figure 12. Cross section of hot-dip galvanized washer showing the zinc-steel interface (X 750)

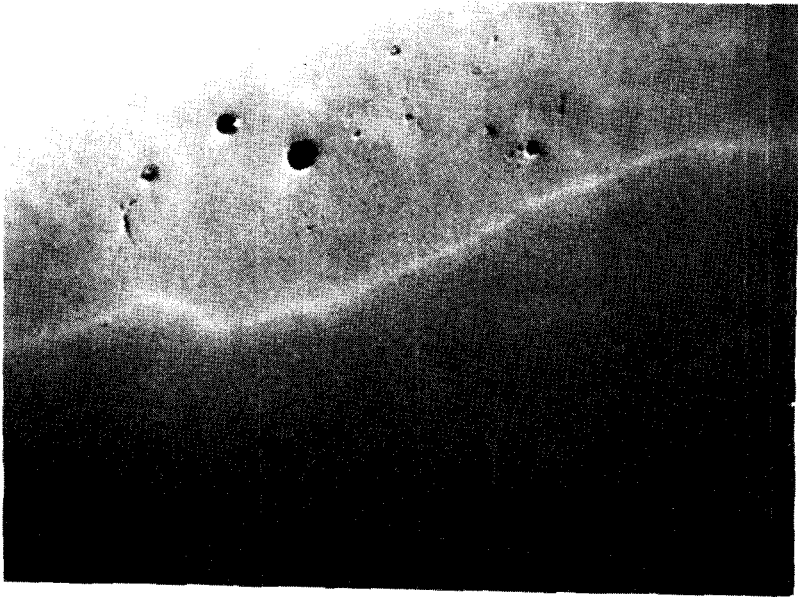
As can be seen in Figure 13, small voids were detected in the coating of the hot-dip galvanized washer. Voids, such as these, were not found in the zinc layer of the electroplated washer which was analyzed.

Figure 13. Cross section of hot-dip galvanized washer showing voids present in the zinc coating (X 400)

As seen in Figure 13, voids were present in the hot-dip galvanized coating of the washer examined. Although these voids did not appear to be significantly detrimental to corrosion protection, they may have been the initial cause of pinhole formation.
