INVESTIGATION OF ACCIDENT REDUCTION
BY GROOVED CONCRETE PAVEMENT

Final Report

Research Report No. FHWA/LA-79/133

Research Project No. 73-1G(B)
Louisiana HPR 0010(002)

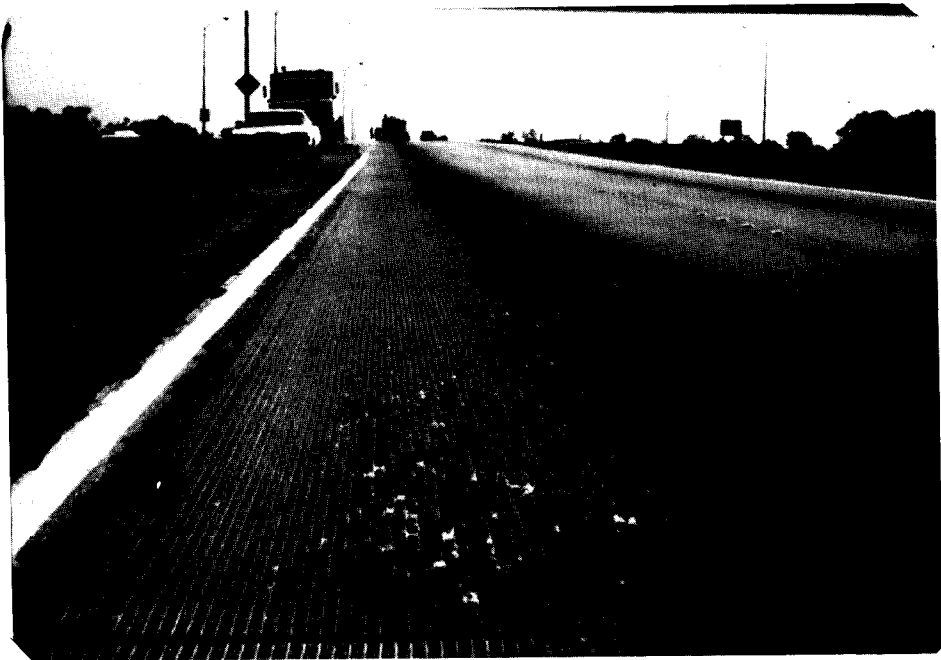
Figure 7

Grooving on I-10/I-12 was started on April 2, 1973, over two and a half years after the initiation of the idea. Then the contractor had his problems. Three-sixteenth inch (4.7 mm), the minimum depth of cutting, as it turned out, was much harder to maintain than was thought. After the first 100 feet (30.4 m) or so, the shoulders of the grooves began spalling, and the aggregate began breaking rather than being cut. Figures 7 and 8A show the first of the spalled grooves, and the situation kept getting worse (Figure 8B). The contractor changed blades, believing that the problem was with the matrix bonding the diamonds to the cutting edge. With this change he was able to cut the grooves, but at a slower rate--approximately 300 feet/10-hour day (91 m/10-hr. day). Early on the fourth day, the cooling system failed and the blades burned up. With no other blades on hand, the original ones were put back on. When this again produced spalling, the project was shut down.

Spalled Grooves

During several meetings between the contractors, blade manufacturers, Federal Highway Administration, and Louisiana Department of Transportation and Development personnel, it was established that grooving was too deep. The cutting contractor asked, therefore, to reduce the depth of cut from 1/4 to $1/8 \pm 1/16$ inch (6.3 to 3.15 ± 1.57 mm). They stated that this would not hurt the safety project. The reason California used 1/4-inch (6.3-mm) depth was strictly for wear and that this concrete probably wouldn't wear as fast as the pavement in California since the aggregate was so hard. Reasons given for the failure were two: the 3/16-inch (4.71-mm) cut in hard aggregate developed abnormally high temperatures which fractured the aggregate, and this particular concrete was constructed with insufficient mortar to keep the blades sharp. It was said that the fines are needed to hone the matrix away from the diamonds and keep them from glazing. As a result of the meetings it was agreed to reduce the cut to 1/8 inch (6.3 mm) for a reduction in price to \$1.05/square yard ($\$1.26/m^2$).

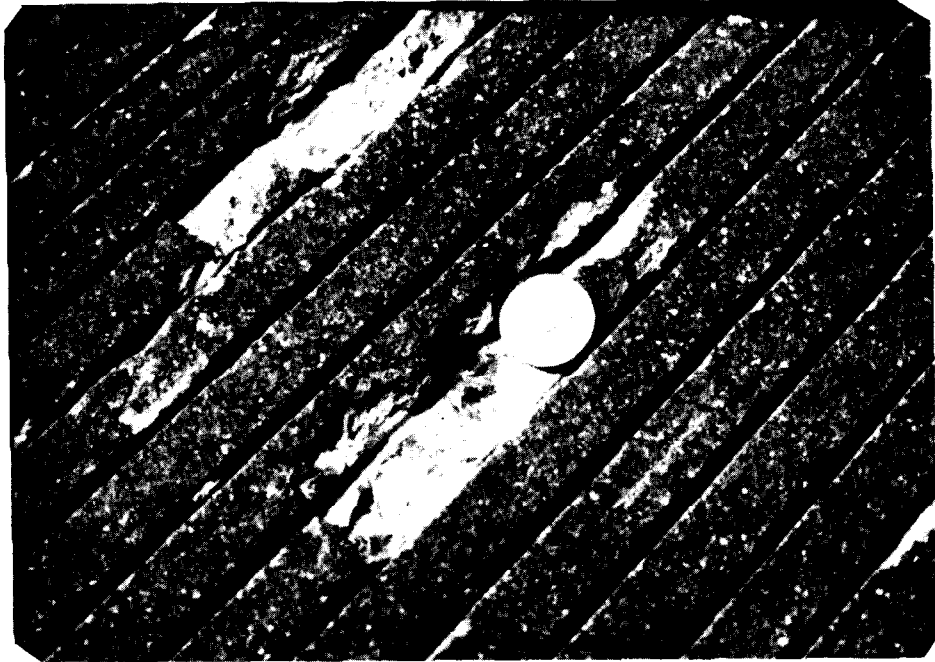
Figure 8A

Close-Up of Spalled Grooves

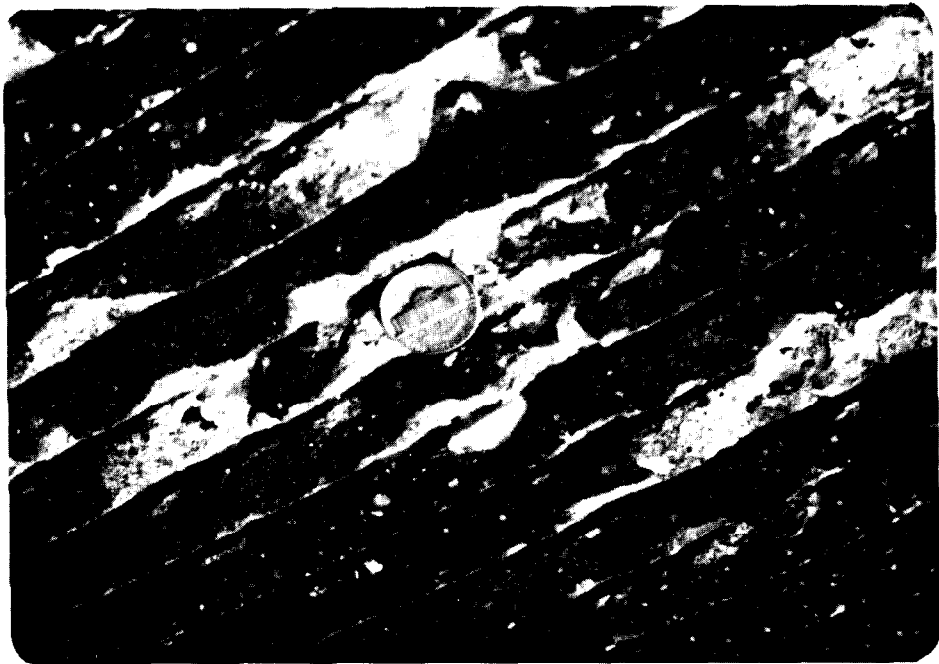
Figure 8B

Worsening of Spalling

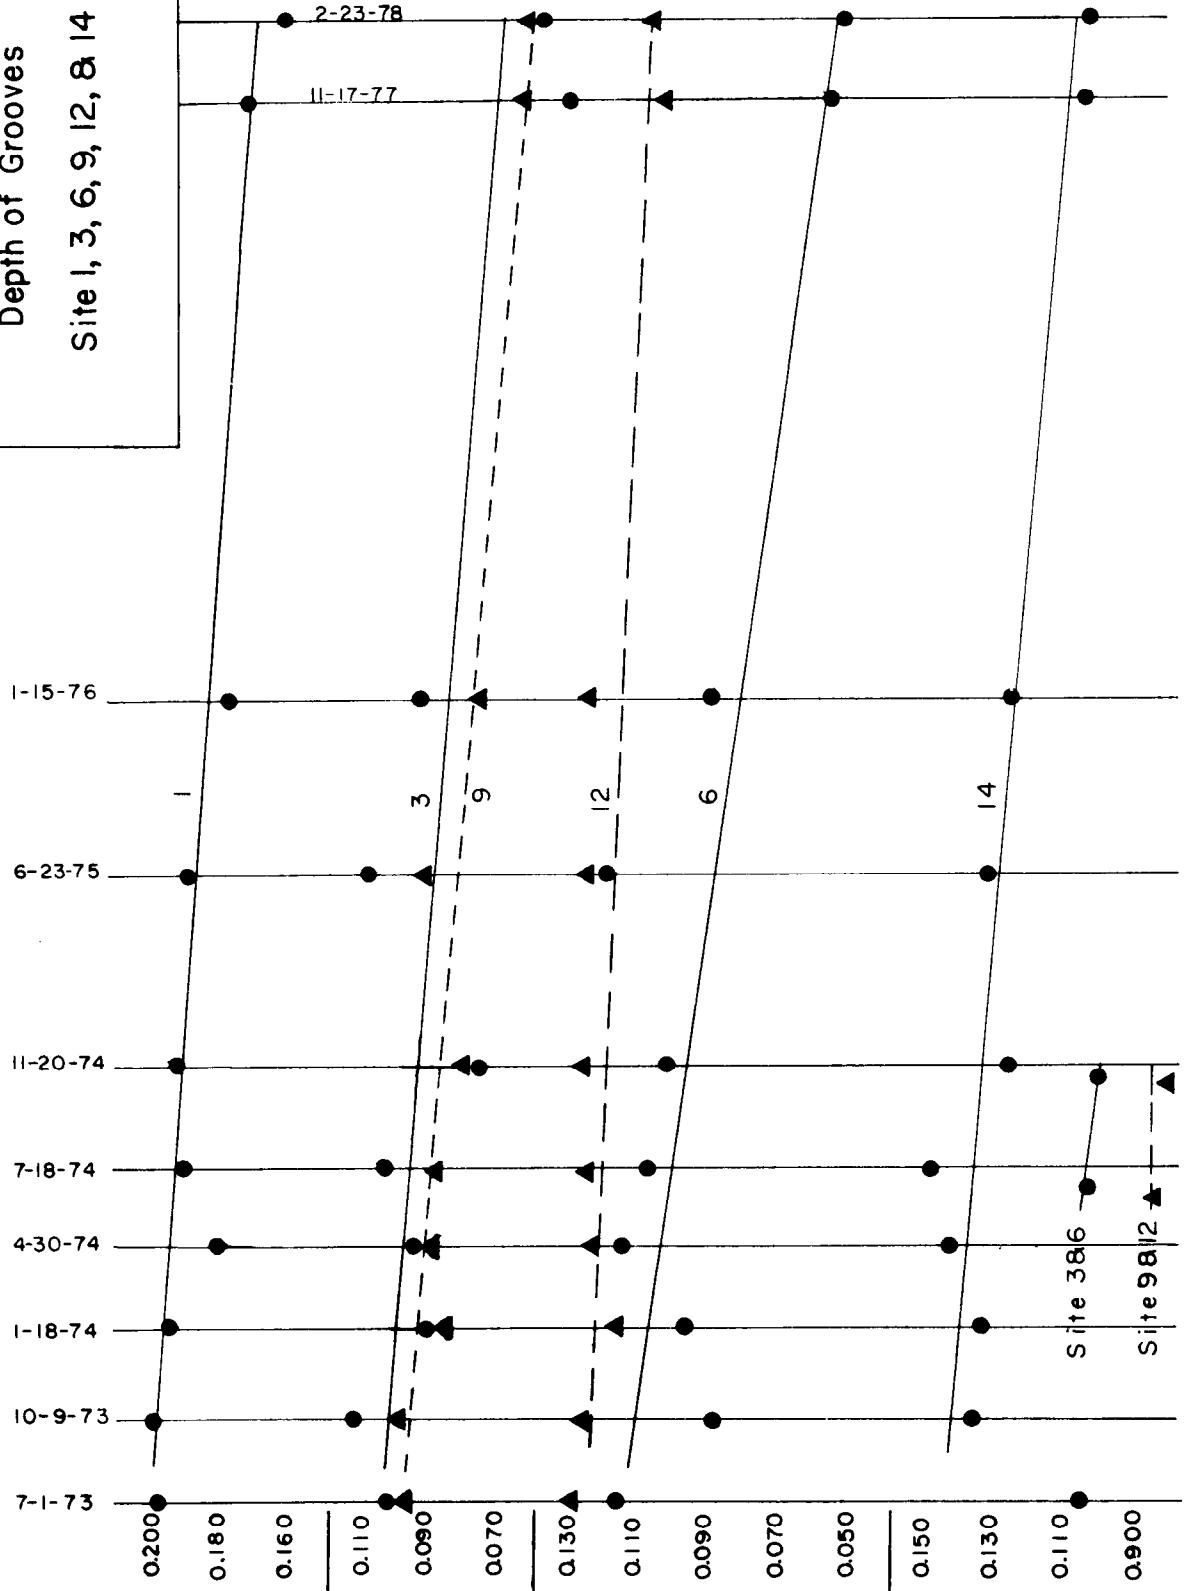
FIGURE 12

Depth of Grooves
Site 1, 3, 6, 9, 12, & 14

Figure 12 shows the wear rates of six sites picked at random to represent the entire grooved section. Four of the random sites exhibit essentially the same wear rate of 0.007 inches/year (0.178 mm/yr) (i.e., 1, 3, 9 and 14), while site 12 has approximately 0.004 and site 6 has 0.015 inches/year (0.102 and 0.381 mm/yr). The wear rates range between 0.003 and 0.015 inches/year (0.076 and 0.381 mm/yr) with an average of 0.007 inches/year (0.178 mm/yr). At that average the grooves should last approximately 9 to 18 years at the grooving depth of $1/8 \pm 1/16$ inch (3.2 mm \pm 1.6 mm).

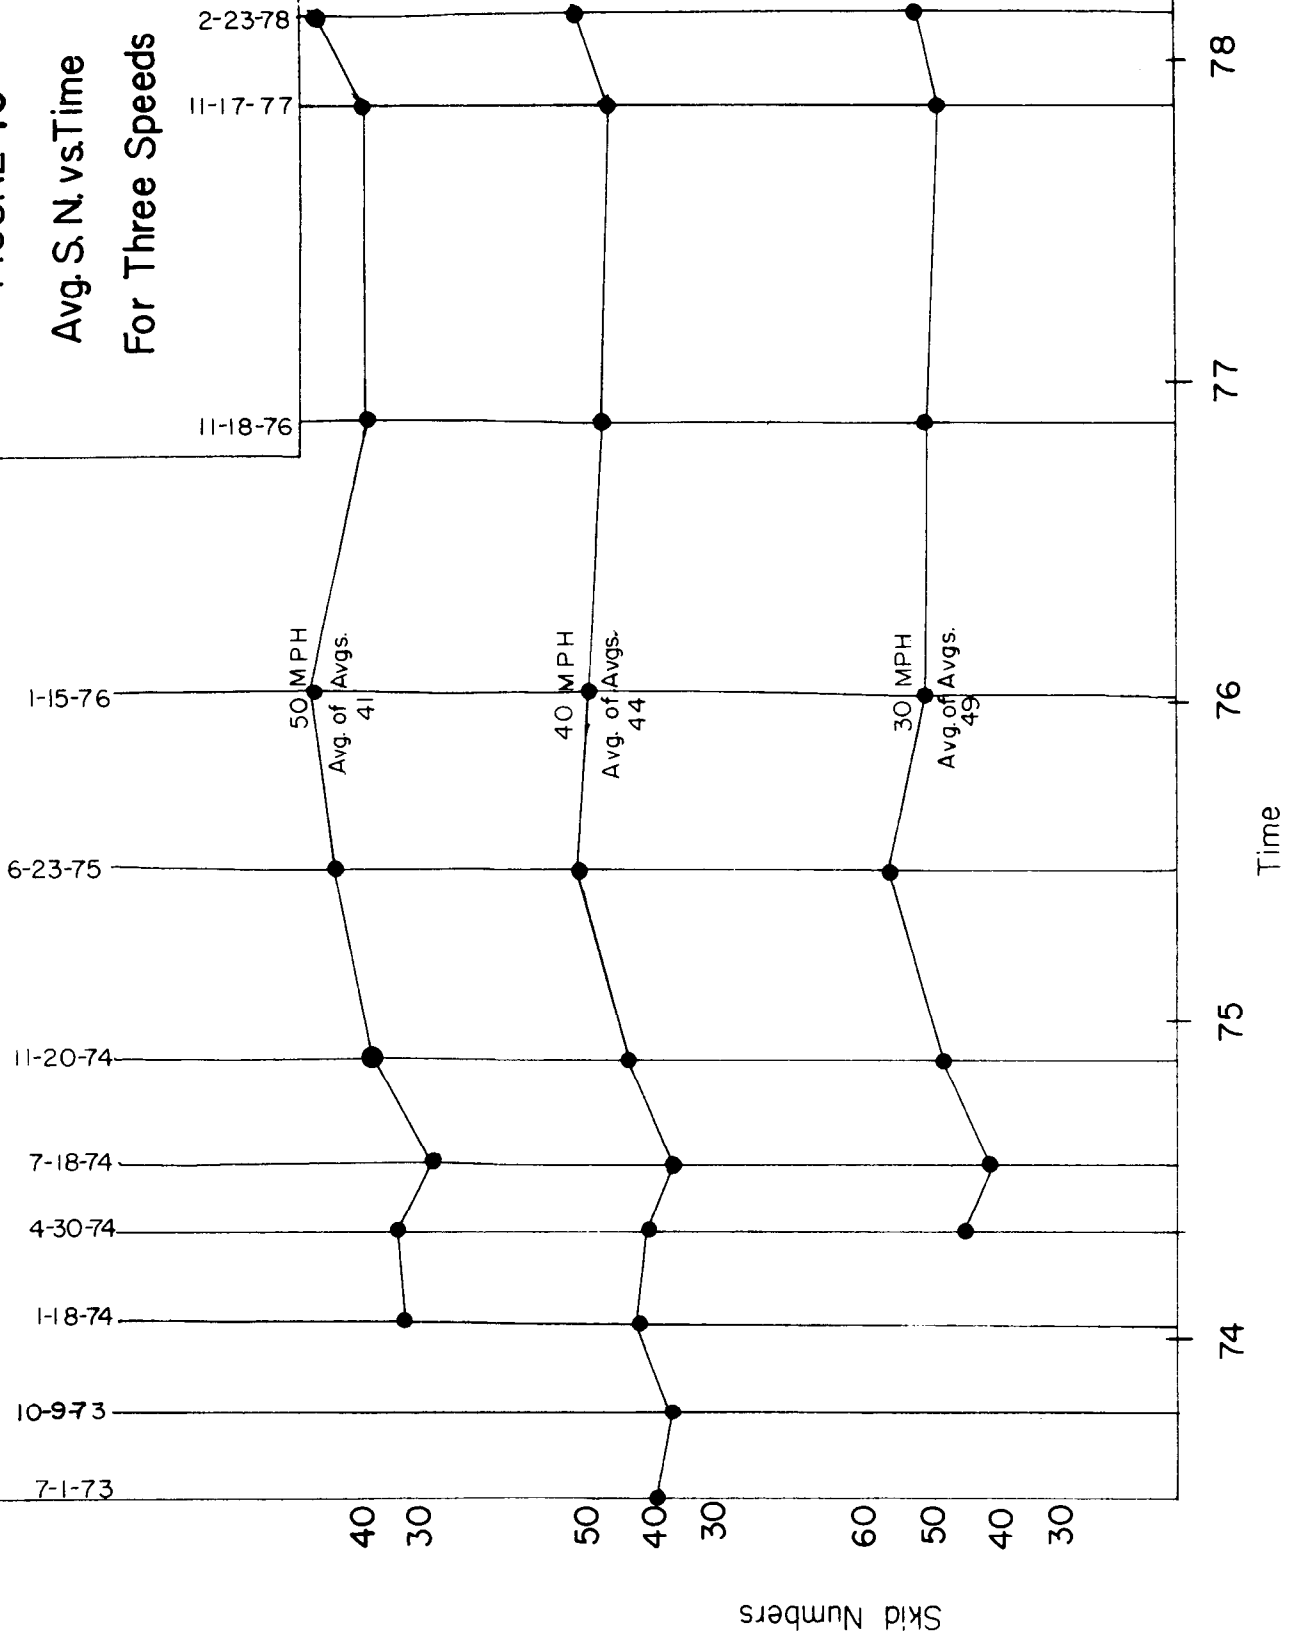
FIGURE 13

Other than the face value of the numbers, it is difficult to interpret the trends of these figures. Figure 14, for instance, indicates the skid resistance rose after approximately one year of traffic (average ADT 24,000). This is explained only by the variability of skid resistance. It has long been known to those

Avg. S. N. vs. Time
For Three Speeds

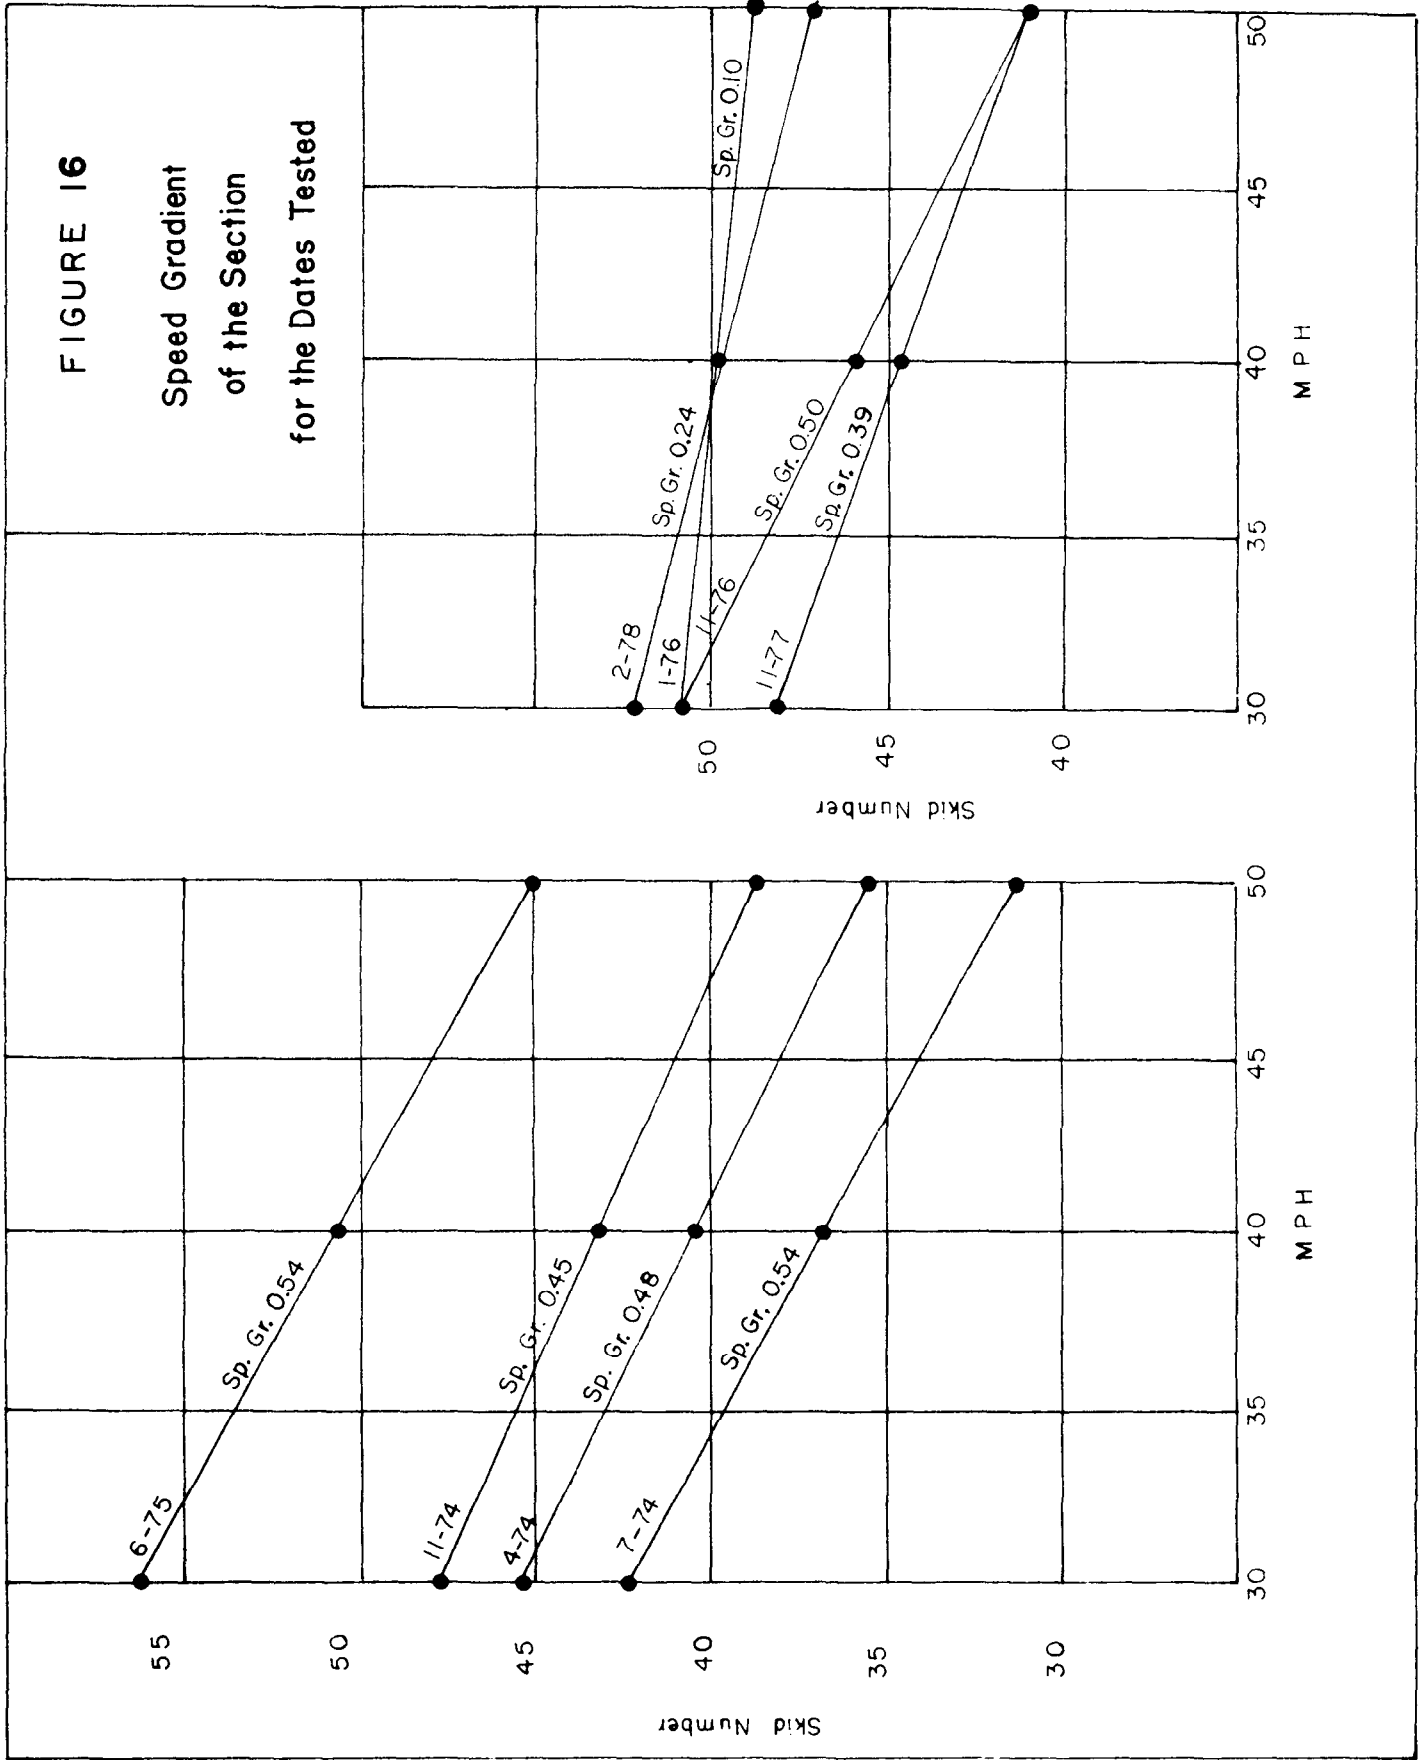
FIGURE 16

Speed Gradient
of the Section
for the Dates Tested

dealing with slippery pavements that the skid numbers are fickle, i.e., just after a trend has been established that trend blows up in his face. Even Figure 16 shows this. Speed gradients after the first year range from around 0.45 to 0.55 to anywhere from 0.10 to 0.50 thereafter.
