EVALUATION OF DRAINAGE PIPE BY FIELD EXPERIMENTATION
AND SUPPLEMENTAL LABORATORY EXPERIMENTATION

Final Report

Research Report No. 174

Conducted by
LOUISIANA DEPARTMENT OF TRANSPORTATION
AND DEVELOPMENT
Research and Development Section
In Cooperation with
U. S. Department of Transportation
FEDERAL HIGHWAY ADMINISTRATION

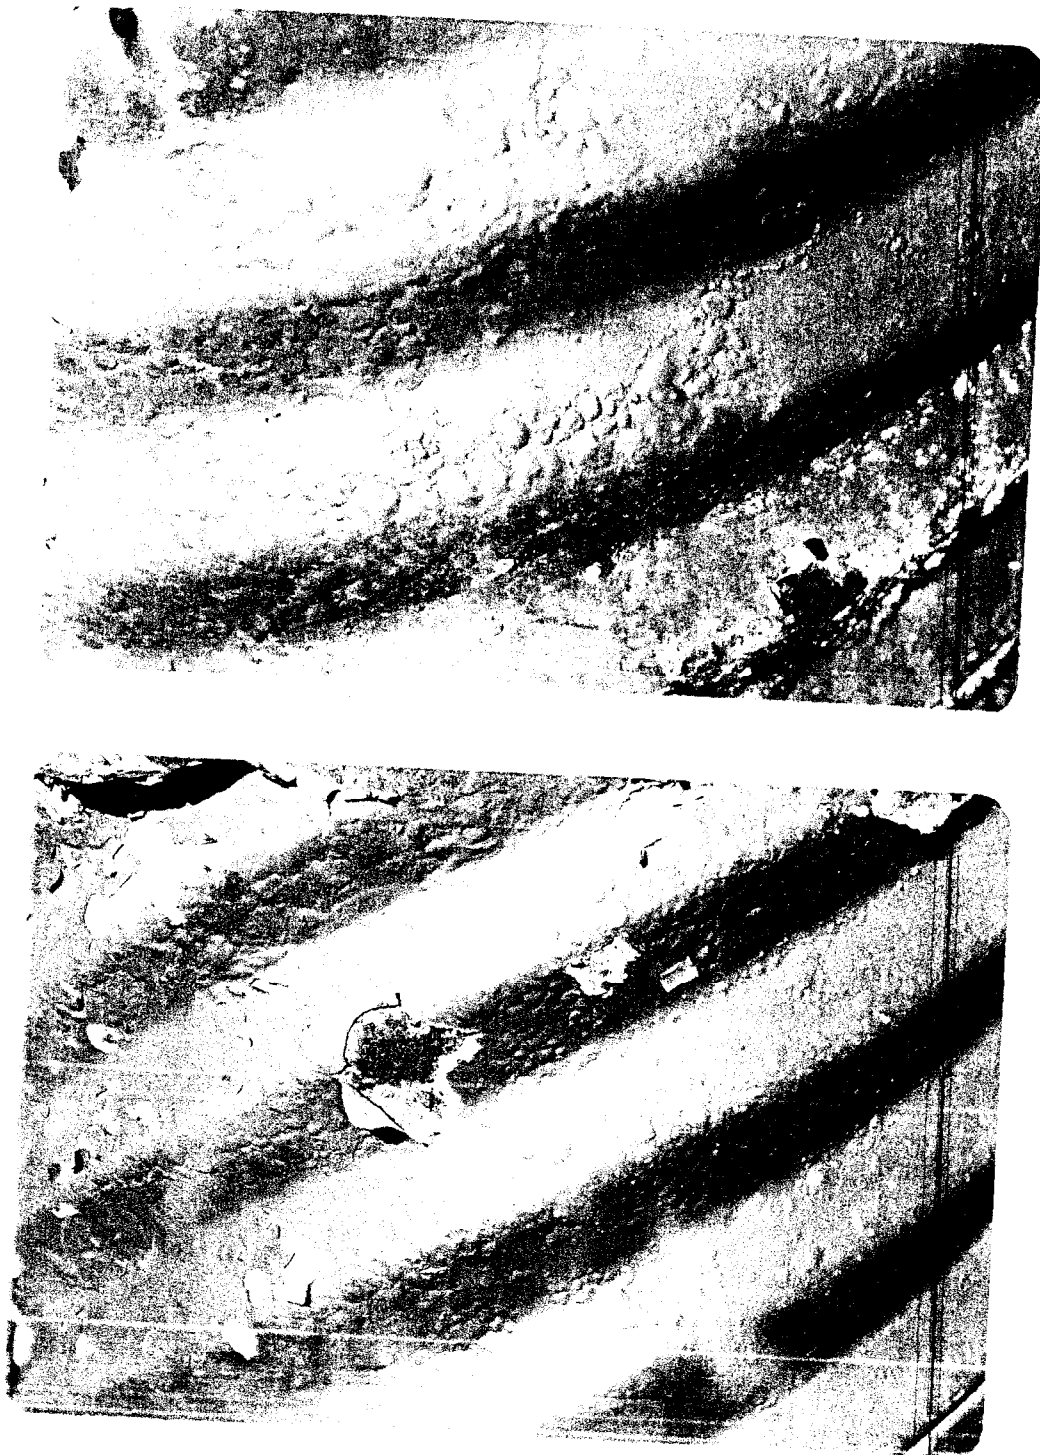
Figure 10

POLYMERIC COATINGS - BLISTERS AND
PEELING IN HARSH ENVIRONMENTS
