THIN BONDED P.C.C. RESURFACING

FINAL REPORT

Research Report No. 181

Research Project No. 80-3P(B)

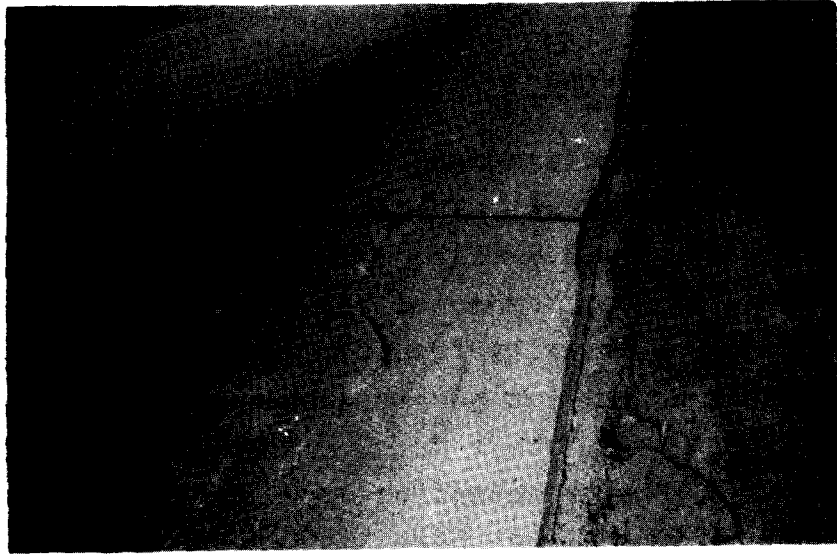
FIGURE 1

Minor longitudinal cracks extending from the transverse contraction joints and located over dowel bars, may be observed in Figure 1, page 6. This type of cracking is usually found in older pcc pavements in Louisiana which do not contain stabilized base courses, and are usually located in the outside wheel path of the truck lanes. On the US 61 project few of these cracks spanned the 20-foot panels, with a typical crack length being approximately three feet. In most instances the cracks were still very tight with no evidence of faulting; therefore, repair was not considered necessary.

*Longitudinal Cracks Over Dowel Bars
(No patching required)*

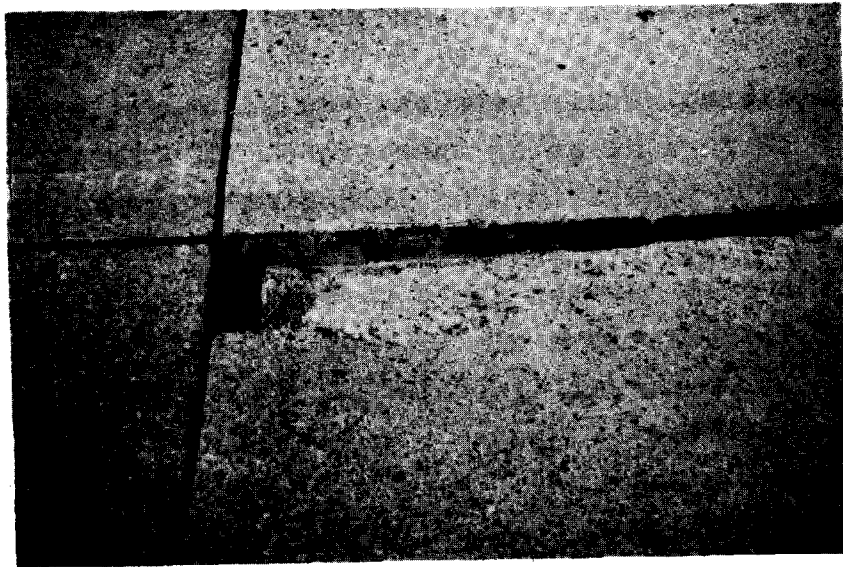
FIGURE 2

The existing 20-year-old pavement required only a small amount of repair prior to resurfacing. The estimated quantity for repair was 10 square yards for the 0.8-mile, two-lane section. The predominant cause of broken concrete was dowel bar misalignment. In most instances the concrete, usually fractured from the dowel bars up through the surface, had not become loose under traffic loads.

All areas requiring repair were patched with portland cement concrete prior to the surface cleaning operations. Concrete removal as a result of dowel bar misalignment is depicted in Figure 2. It should be noted that in the special provisions for the pcc resurfacing there is an item for only partial depth pavement patching. This is because a full depth patching item was already included in the specifications for the H.M.A.C. resurfacing project of which the pcc resurfacing comprised 0.8 miles.

Concrete Removed Prior to Patching

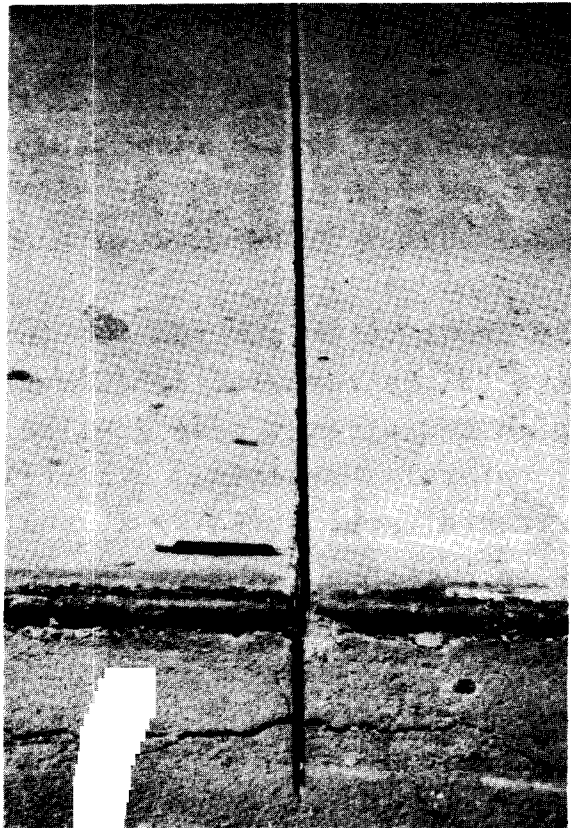
FIGURE 4

Slab Movement Due to Stress Relief

Approximately six months after the road was opened to traffic several cracks appeared in the resurfacing adjacent to one of the pressure relief joints. The cracks were closely spaced diagonal cracks near an exterior slab corner in the outside lane. The impact sounding of a three-pound hammer in conjunction with a coring operation indicated that a large portion of a 10-by-24-foot slab on one side of the relief joint had disbonded. The neoprene compression seal which was used to seal the relief joints had been extremely compressed by this time, as the joint now measured 1-1/4 inches. Upon removal of the neoprene seals, it was concluded that placement of the seal only at the upper portion of the relief joint created excessive stresses in the overlay as the joint continued to close. The 10-by-24-foot panel on the other side of this relief joint was bonded for approximately one-half of its surface area. The other two relief joints also experienced some exterior corner disbonding. The neoprene seals were removed from all three relief joints and were replaced with a hot-poured sealant.

3. Pressure relief joints are recommended for pavements with a history of blowups; however, care must be taken not to construct or seal the joints in a manner which will transmit the stress to the resurfacing bond. One solution would be to cut the relief joints far enough in advance of the resurfacing operations to allow most of the stresses to dissipate, resaw the joints if necessary, and then resurface the pavement.

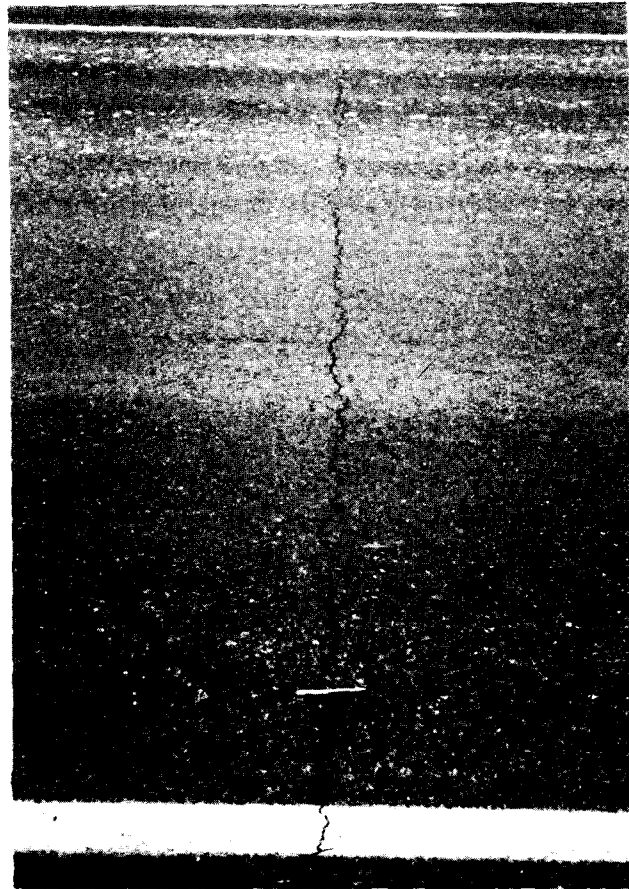
FIGURE 8

The process of cleaning and subsequent resealing of transverse contraction joints during the pcc overlay process provides a potential performance advantage over bituminous overlays of pcc pavements with contaminated joints. Pcc slabs continue to shift and displace as a result of pressure from locked joints even after an asphalt overlay has been placed. Also, potential for joint/crack reflection is eliminated in the pcc resurfacing. Transverse joints reflected through the adjacent 6-inch bituminous overlay within six months following the overlay, as depicted in Figure 8, page 17. Surface water collecting in this type of crack has been observed to cause stripping of the asphalt in the joint areas leading to fatigue of the overlay.

Reflection Cracking in Asphalt Overlay

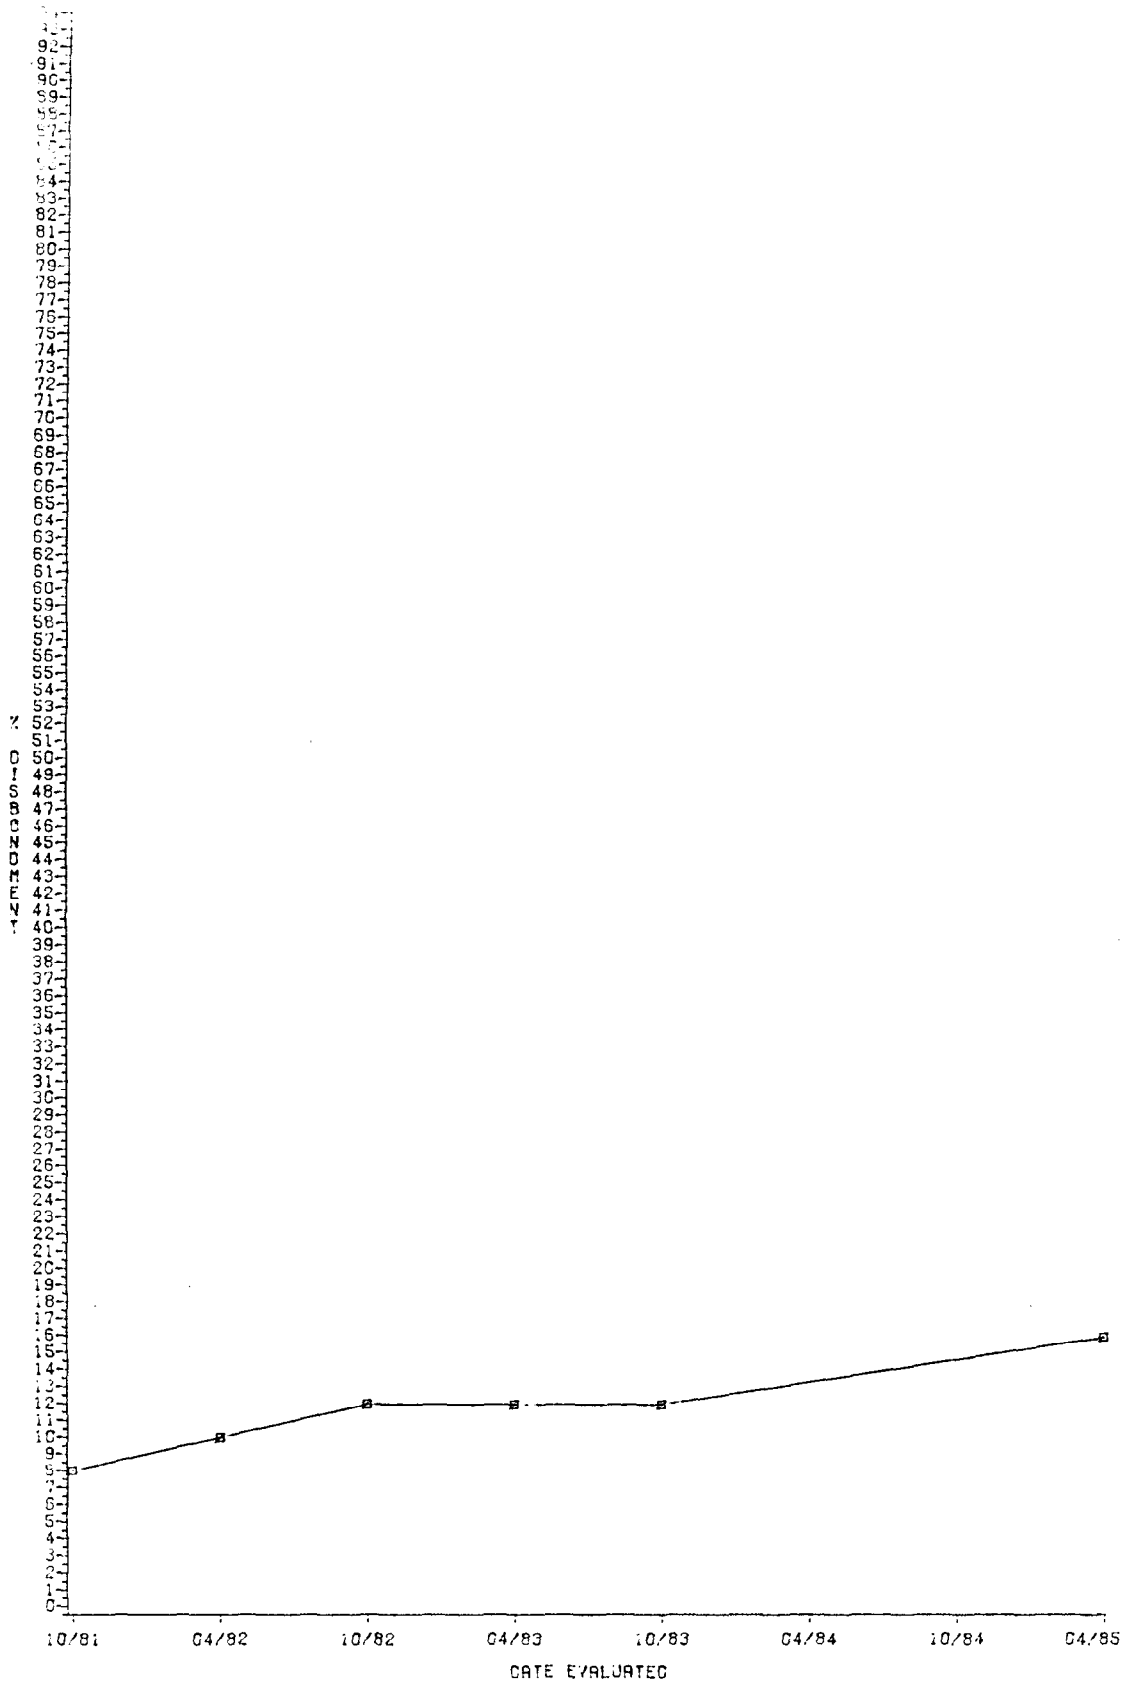
Figure 9 graphically indicates the percentage increase of disbonded exterior corners during the four-year evaluation period. At present 16 percent of exterior slab corners have disbonded, of which 12 percent have cracked on the diagonal from pavement edge to transverse joint.

It is felt that the majority of the disbonding problems can be attributed to inadequate bond obtained during construction caused

*Plot of the Percent of Exterior Slab Corners
Disbonded Versus Date Evaluated*

by either the grout drying out prior to overlay and/or excessive air content in the mix. Disbondment occurring adjacent to the central and southernmost relief joints is attributed to excessive stress resulting from joint closure.

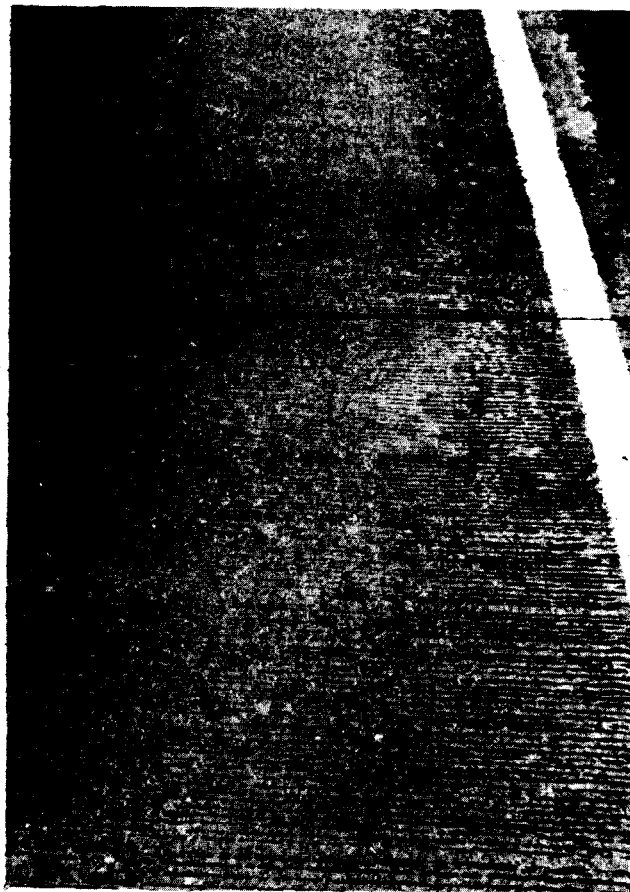
FIGURE 10

The skid number obtained after resurfacing showed a considerable improvement. The skid number of the original pavement surface was 36, which is typical for a 20-year-old concrete pavement, untextured by either tining or grooving. The skid number after construction was increased to 62 by adding the textured concrete surface. Presently the tined surface is visually wearing (Figure 10) in the

Wearing of Tined Finish in Wheel Paths

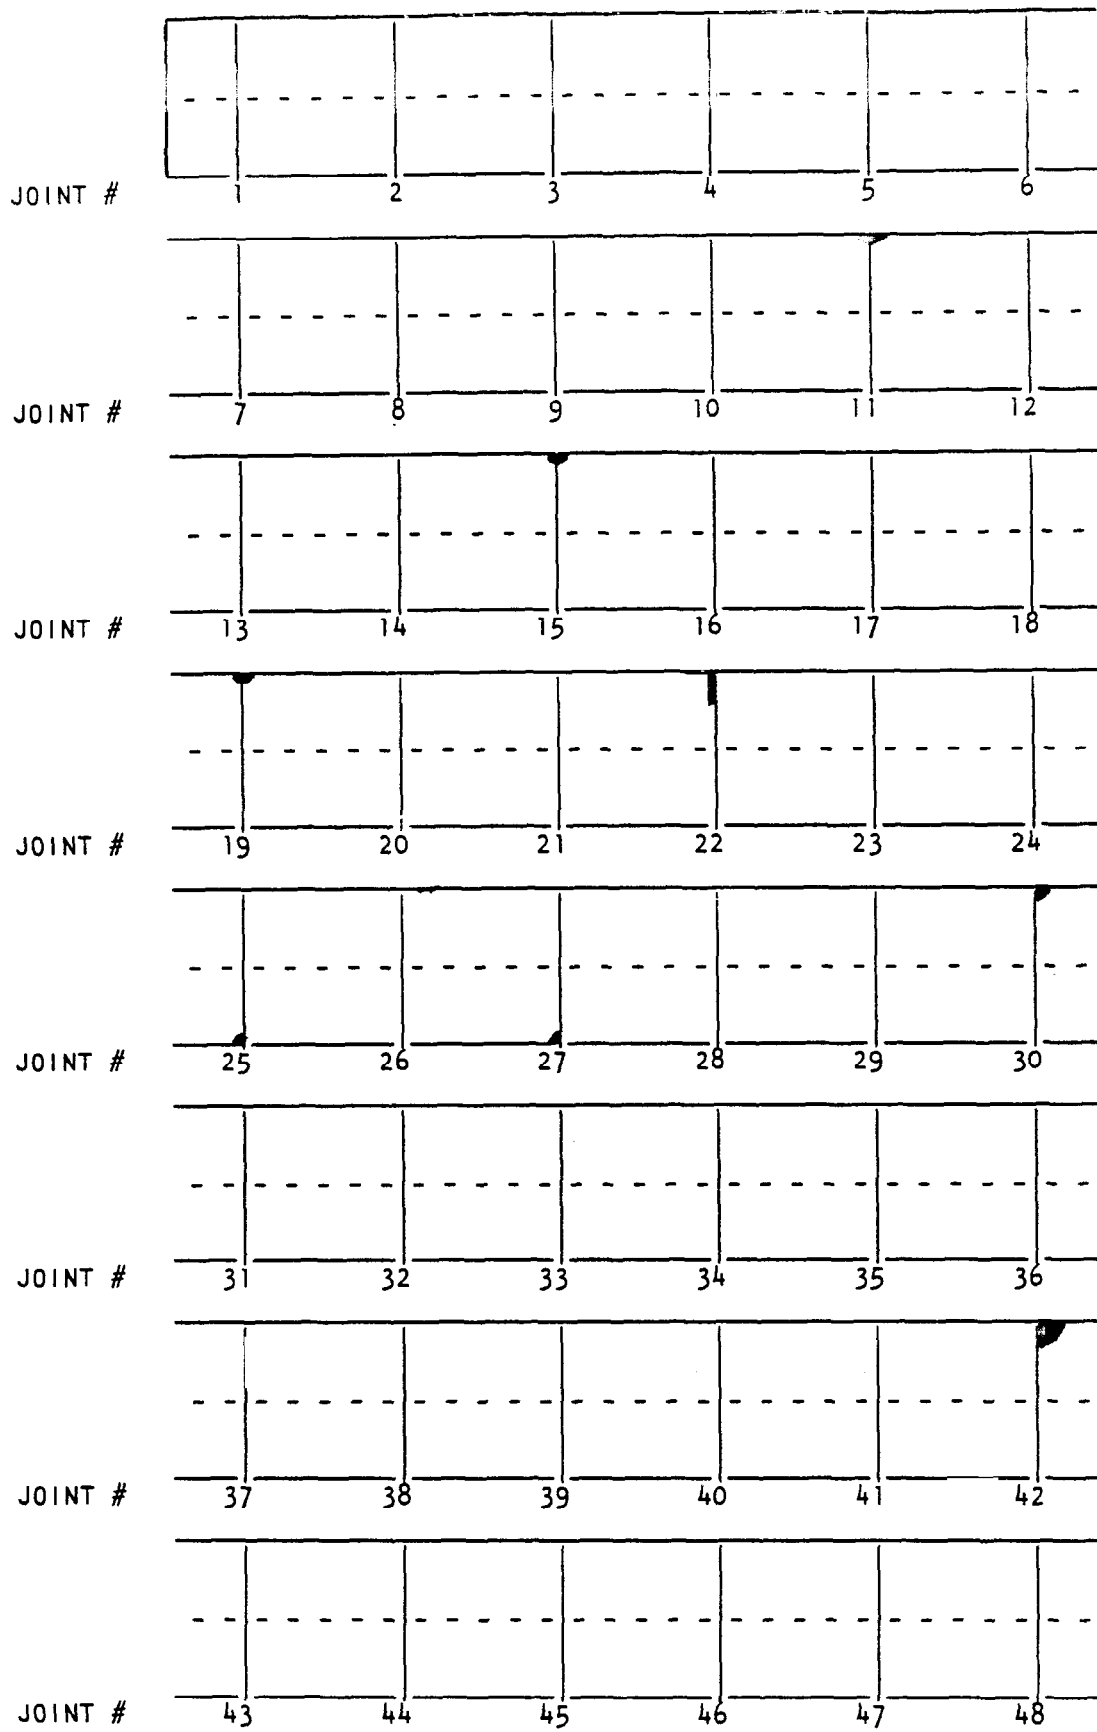
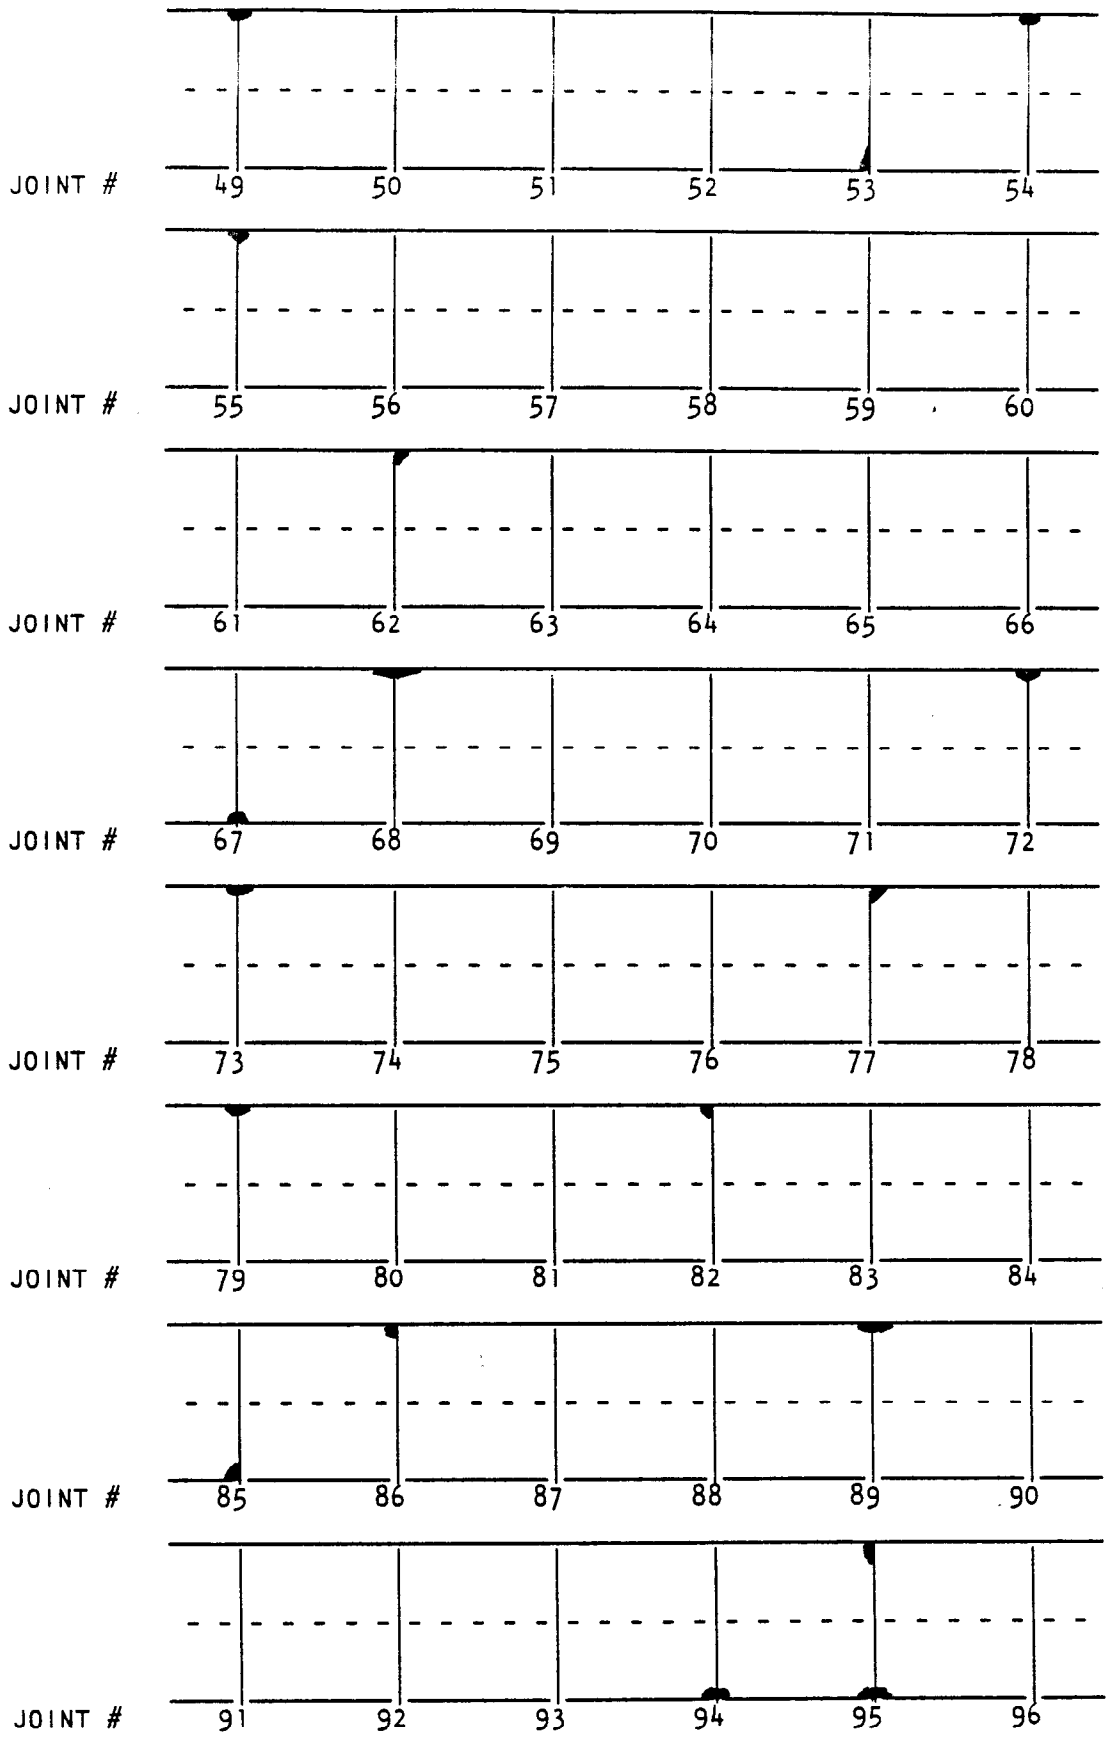
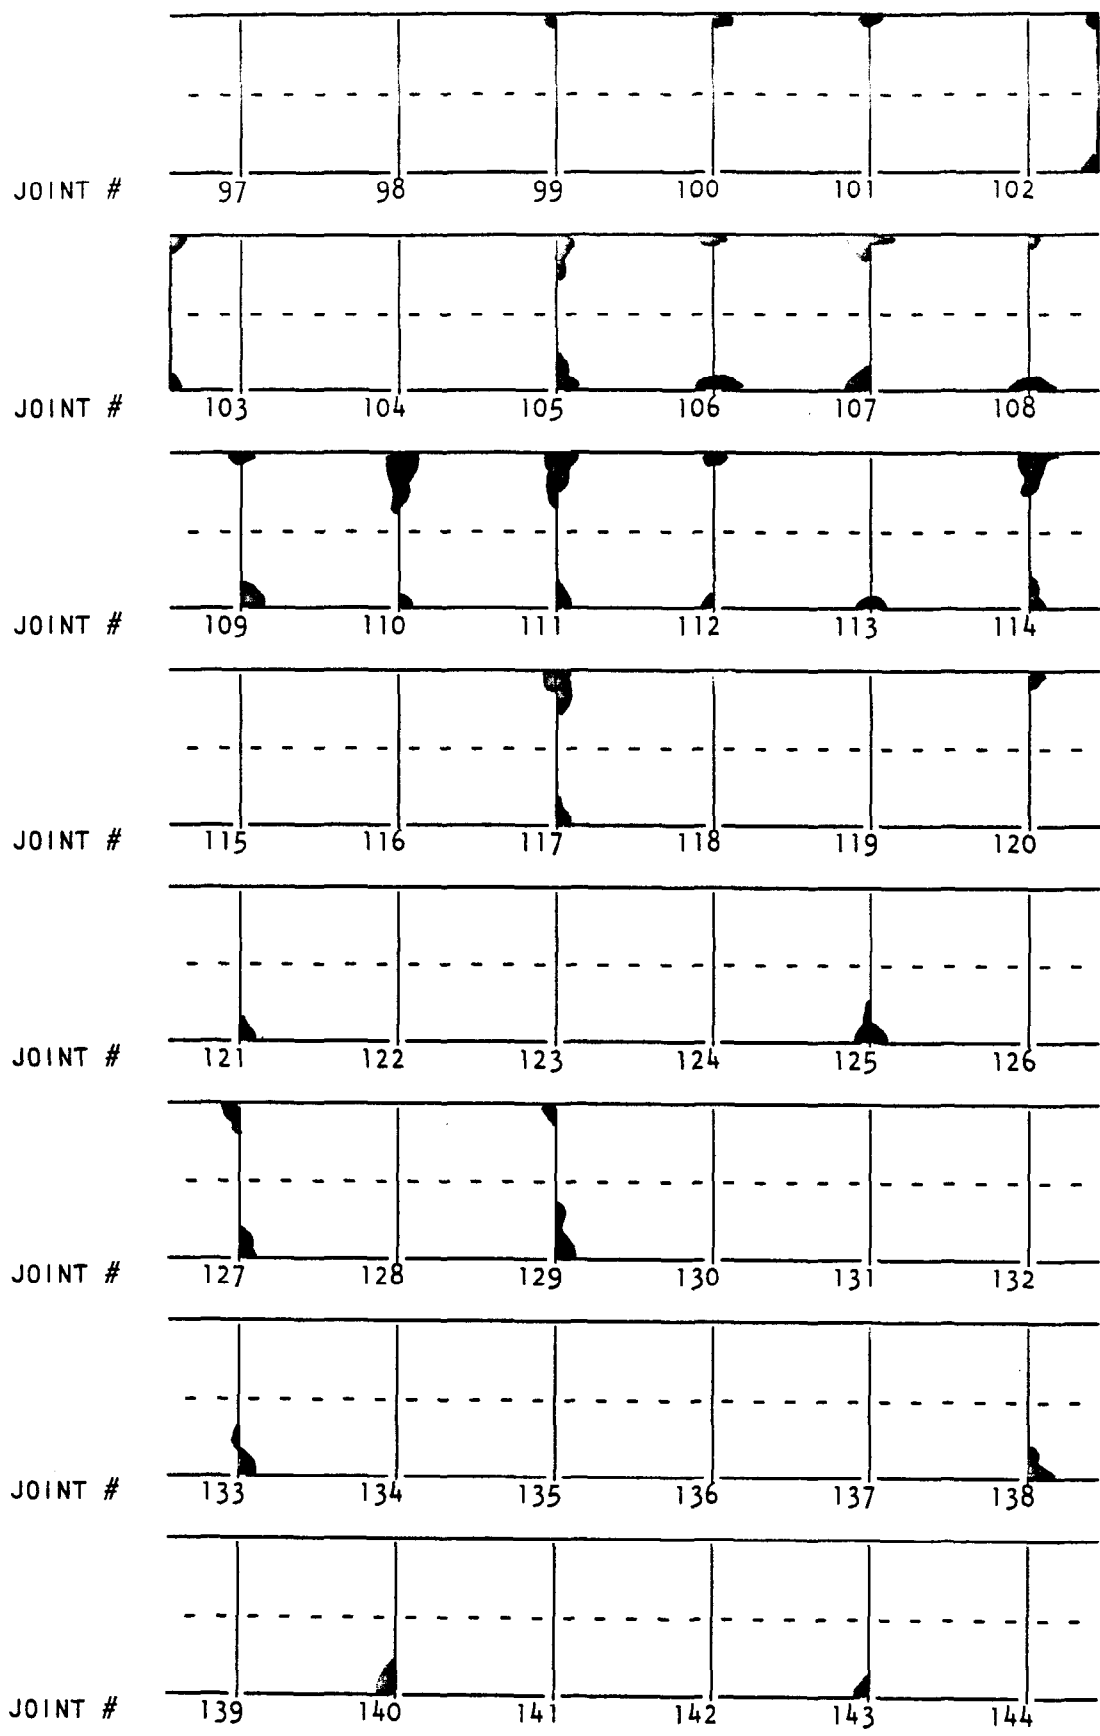
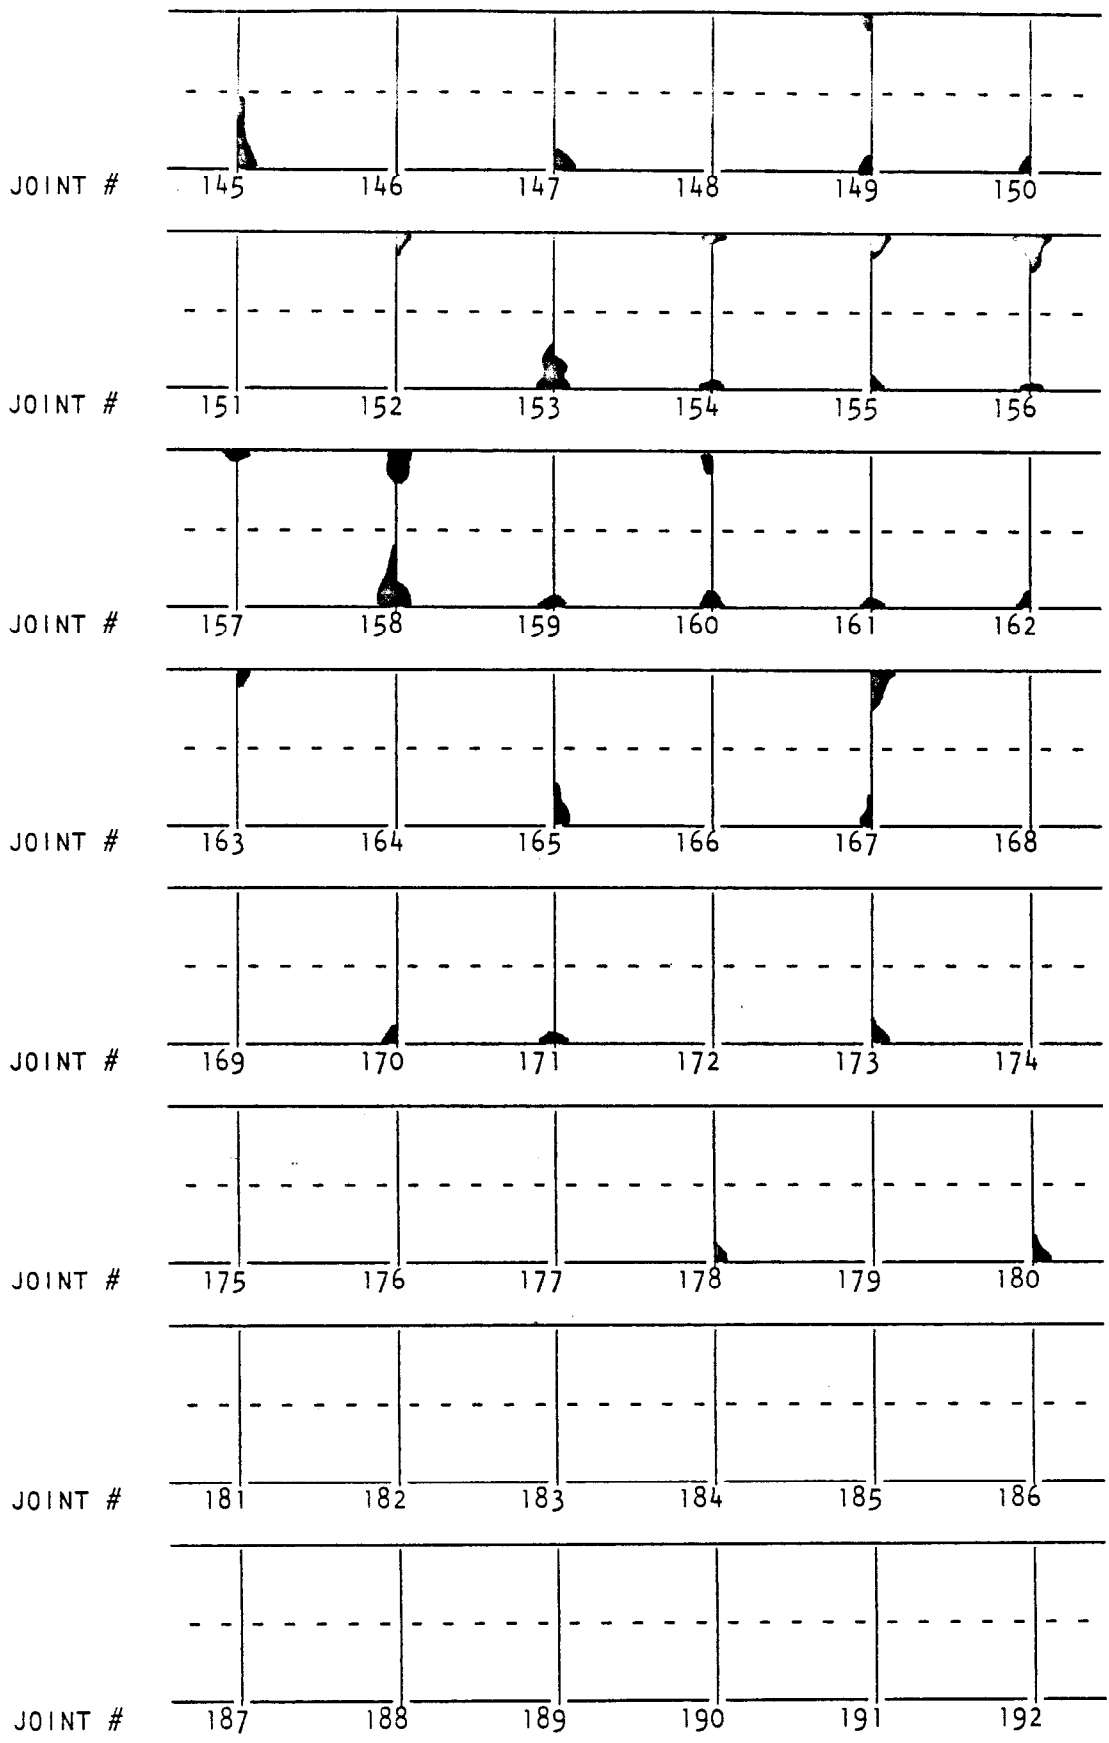
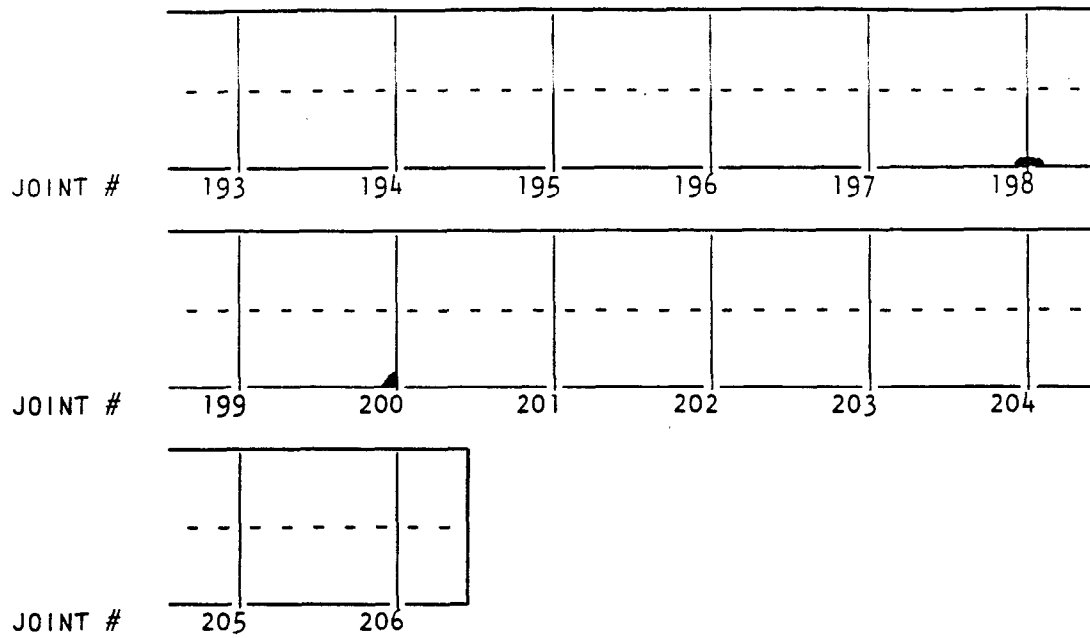
FIGURE 14

Areas of disbondment are not restricted to exterior slab corners only. Disbondment also has occurred at isolated locations, at the transverse joints, and occasionally extend well into both lanes of pavement. The majority of disbondment occurring at these interior slab locations are between stations paved during the fourth and fifth days. The 200-foot-long section removed during construction due to excess air content was paved on the fourth paving day. It is felt that areas beyond the 200-foot removal, paved during the fourth day, may have also been partially contaminated by excess air resulting in reduced bond strength. Cores obtained at some of these isolated locations had low compressive strengths, which may be an indication of excessive air content (as in the 200-foot-long section removed during construction) and may have resulted in an inadequate bond strength. To date, a total of approximately 0.3 percent of the surface area of the overlay has disbonded. A disbondment survey of the thin-bonded overlay project is included as Appendix C of this report.
