Assessment of Tri-Dyne Precast Concrete Panels

LTRC Project Number 08-2TA

Louisiana Department of Transportation and Development
Louisiana Transportation Research Center
4101 Gourrier Ave
Baton Rouge, LA 70808
www.ltrc.lsu.edu

January 2008

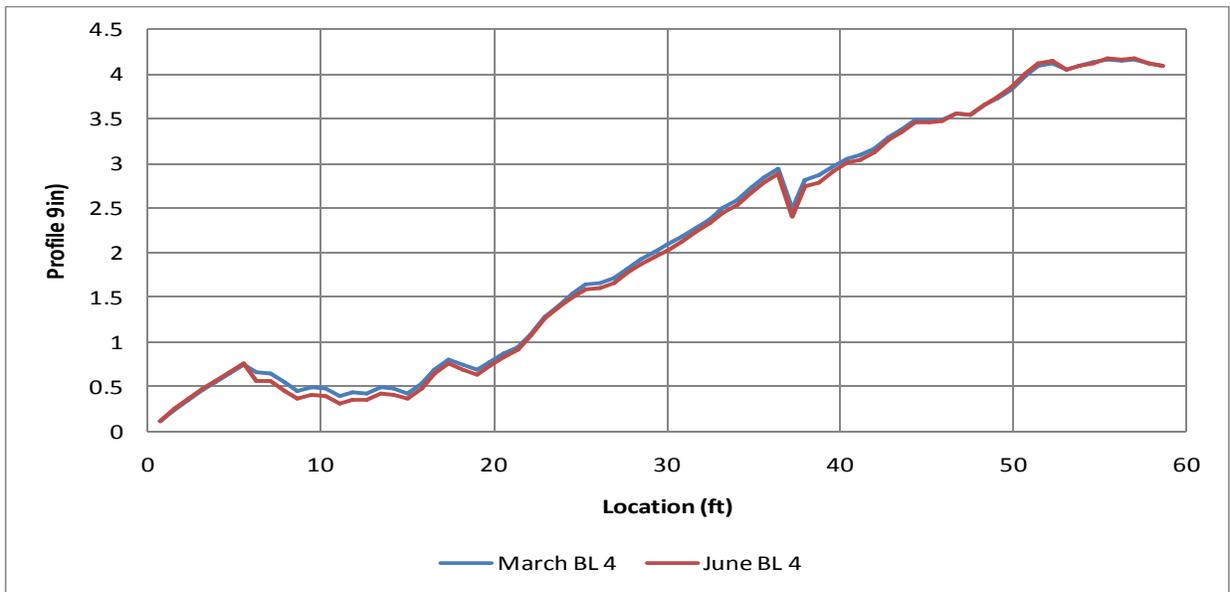
Figure 18: Profiles for BL 4

Walking profiler: Base lines 1 through 4 were each tested with the walking profiler in March and June of 2007. Profile plots for BL 4 are shown in Figure 18, and the average IRI values are shown in Table 3. Profile plots for BL 1, 2, and 3 are in Appendix 1. The profile data indicates that the slabs were rough, with IRI values ranging from 296 to 382, in the March 2007 assessment. The leveling material operation in June of 2007 did not improve the roughness, as the IRI values ranged from 294 to 413. The precast panels installed on this project did not meet DOTD ride specifications and had IRI values (150 – 165) greater than those reported by others for PCPS (9)(10).

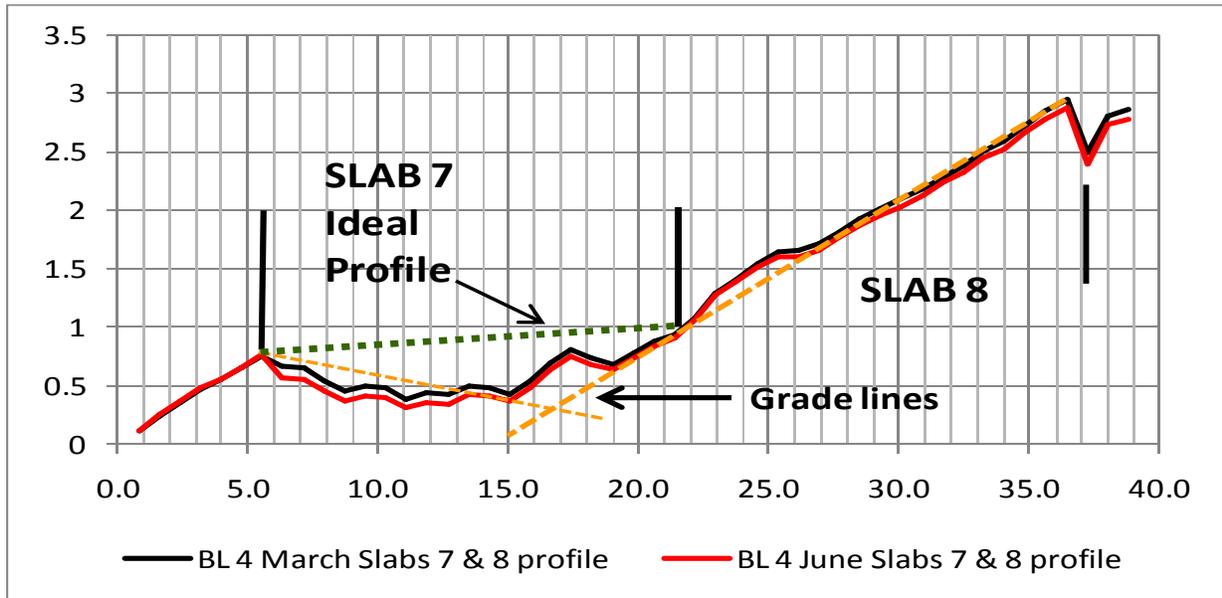
Figure 19: Slab 7 and 8 profile

Judging from the profile data, slab 7 appears to have been bending downward in relation to slab 8, as shown in Figure 19. This scenario was observed in slab 2 and 3 profiles also; see Appendix 1. Further discussion of the ramifications of such will be presented in the pressure sensor section.

at location 21; profile differential between slabs 7 and 8, as shown in Figure 19; and the mechanism of load transfer, as shown in Figure 25; the load applied at location 21 was carried predominately by the base at location 22 (slab 8).

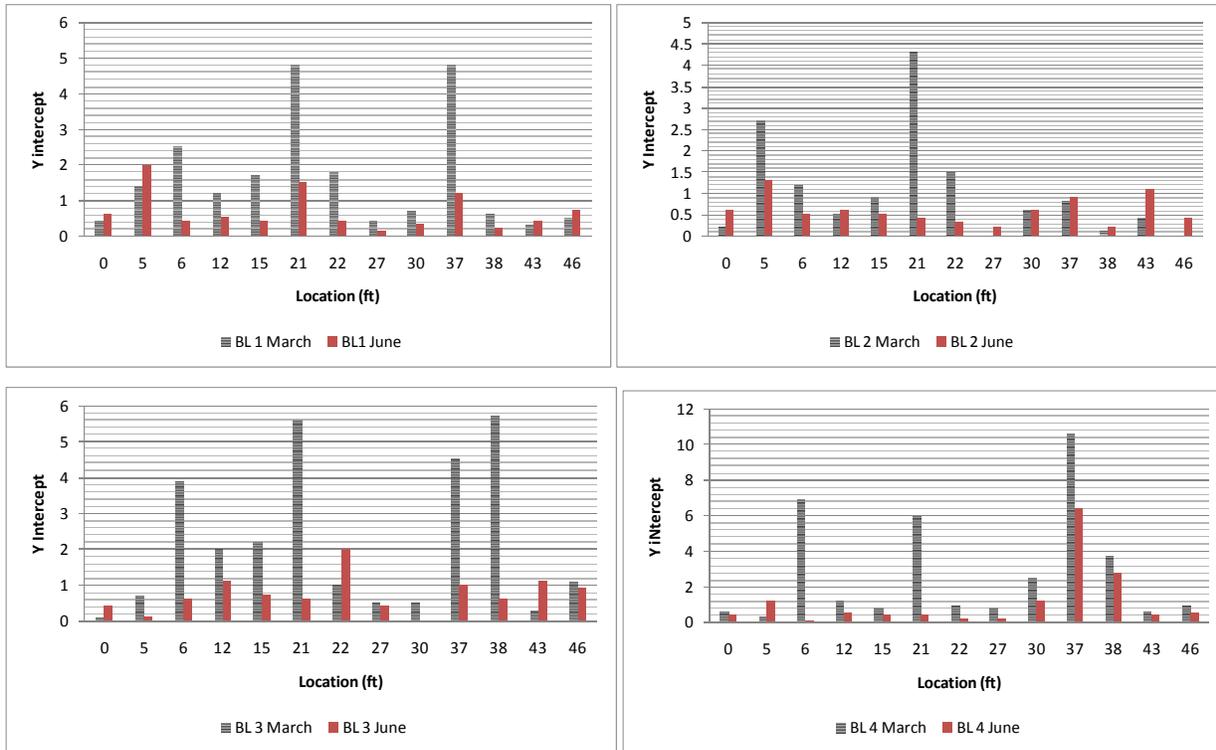
Figure 20: Y intercept values

Void detection from FWD: Figure 20 presents the Y intercept values for testing conducted on the four base lines in March and June. When the Y intercept value is greater than 2, there is potentially a void or loss of support present at that location. On base line 1, voids were present at locations 6, 21, and 27 for the March data set, and no voids were present for the June data set. Voids were present at locations 5 and 21 on base line 2 for the March data set, and no voids were present for the June data set. Base line 3 had voids present at locations 12, 15, 21, 37, and 38 for the March data set and voids present at location 22 for the June data set. Base line 4 had voids present at locations 6, 21, 30, 37, and 38 for the March data set and voids present at locations 37 and 38 for the June data set.

Judging from the void detection tests, one may infer that there is a higher incidence of voids present beneath the slabs when they are placed directly on the subgrade. Injecting leveling material beneath the slabs did reduce the number of voids but did not eliminate them.

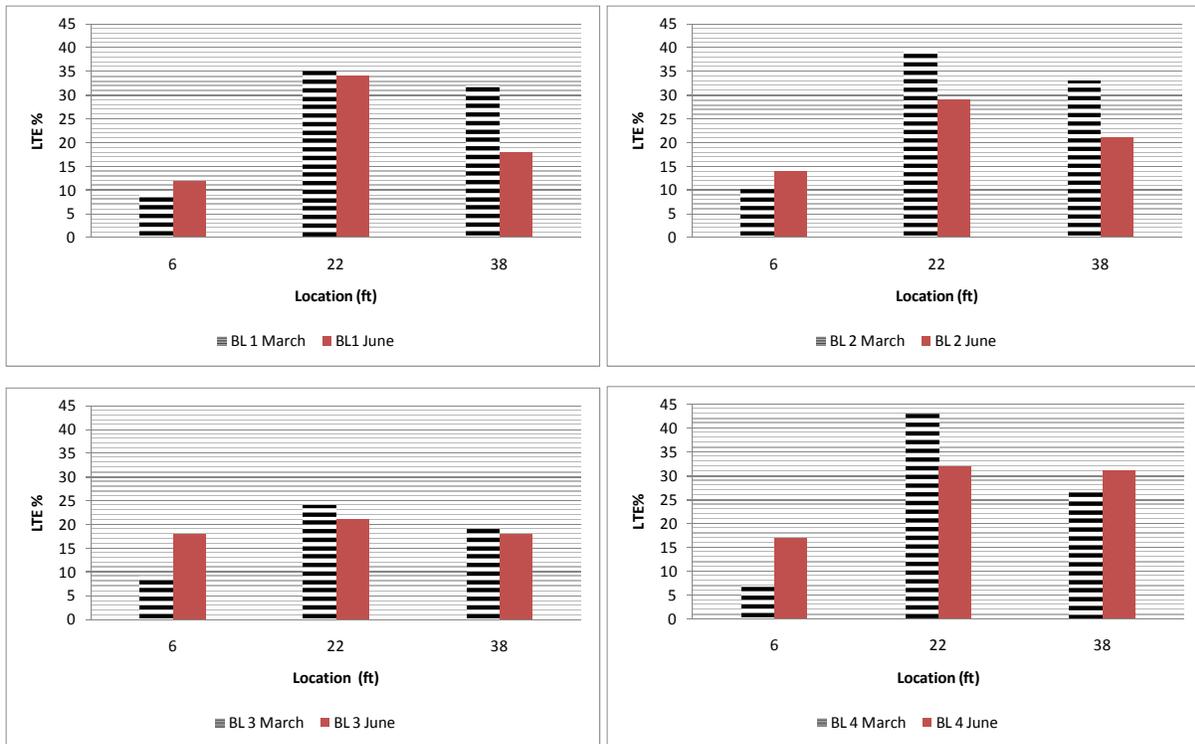
Figure 21: Load transfer efficiency

Load transfer efficiency as determined by the FWD: In both the March and June data sets, all transverse joints on all base lines had load transfer efficiencies below 43 percent, as shown in Figure 21. Therefore, the transverse joint load transfer mechanism evaluated on the PCPS produced poor load transfer.

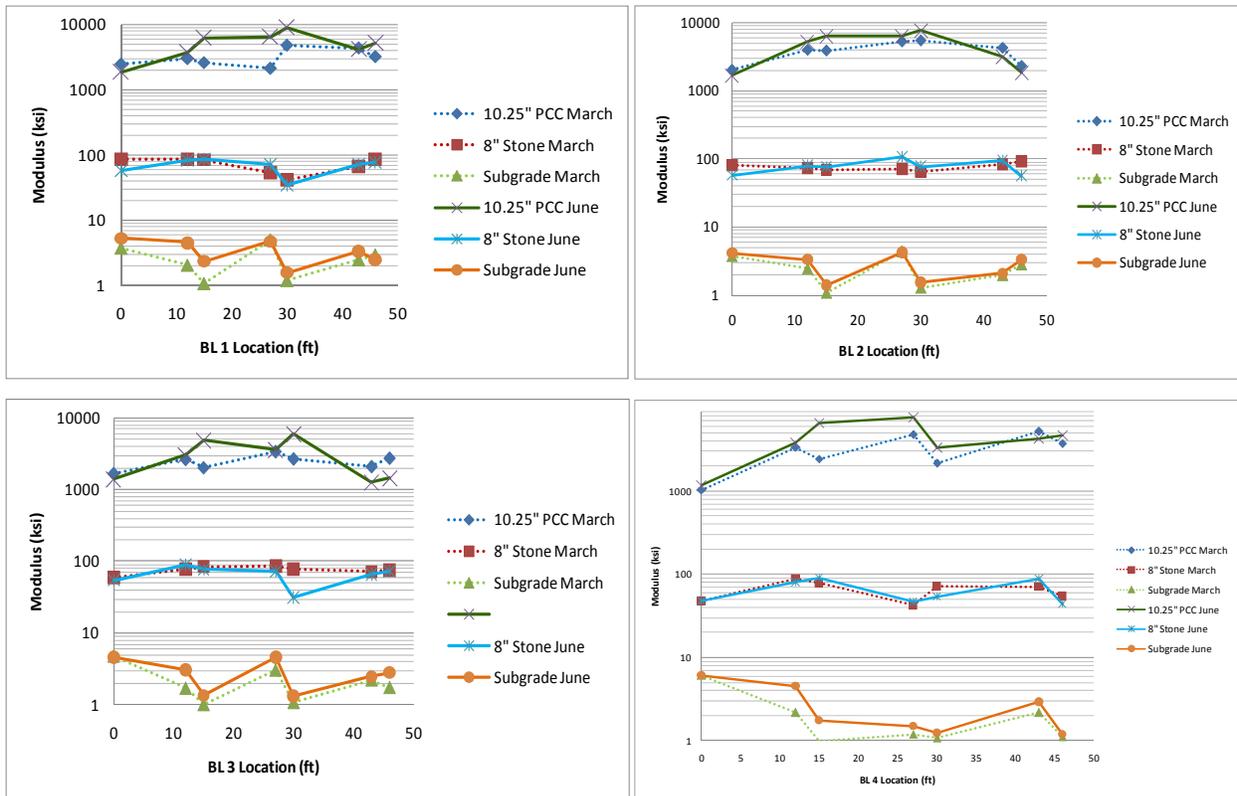
Figure 22: Layer Moduli values

Layer Moduli values from FWD tests: The layer moduli were determined for the concrete pavement, stone base course, and subgrade for the March and June assessments and are shown in Figure 22.

Modulus values in the 4,000 to 5,000 ksi range are generally found in good concrete pavements typically used on DOTD highways. The modulus values for the cast in place slab were generally less than 2,000 ksi, below the acceptable range. Modulus values for the precast panels in the March data set ranged from 2,600 to 4,198, below the acceptable range. However, these values could be inaccurate due to the instability of the slabs during testing.

The June data set had higher modulus values than the March data set and ranged from 3357 to 5822 ksi. These values were generally acceptable and were higher than the March data set, probably because the slabs were more stable due to the injection of leveling material.

Values for the stone base course modulus were generally higher than 45 ksi, indicating that the base course was acceptable. Subgrade soil modulus was on average 2.4 ksi and was very weak.

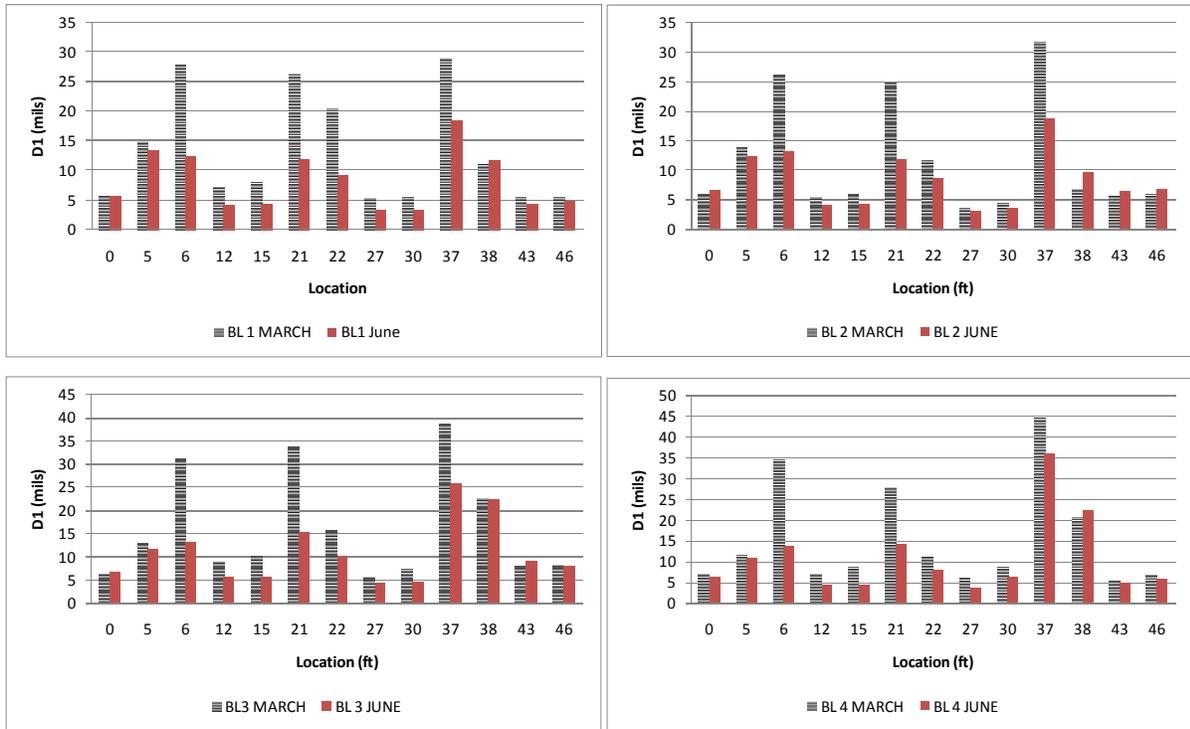
Figure 23: FWD first sensor deflections

First sensor deflection analysis from FWD: Figure 23 presents the first sensor deflections for the March and June assessments. Trends toward lower deflections were generally observed for the slabs once they were injected with leveling material (June data set). Deflections at the joint locations (2, 21, 22, 37, and 38) were higher than deflections at locations near the center of the slab (12, 15, 37, 30, 43, and 46), indicating a decrease in stiffness at the joints, which is typical. Deflections on the approach side of the joints (21, 37) were higher than deflections on the leave side of the joints (22, 38). This will be discussed further in the section on pressure sensor readings.

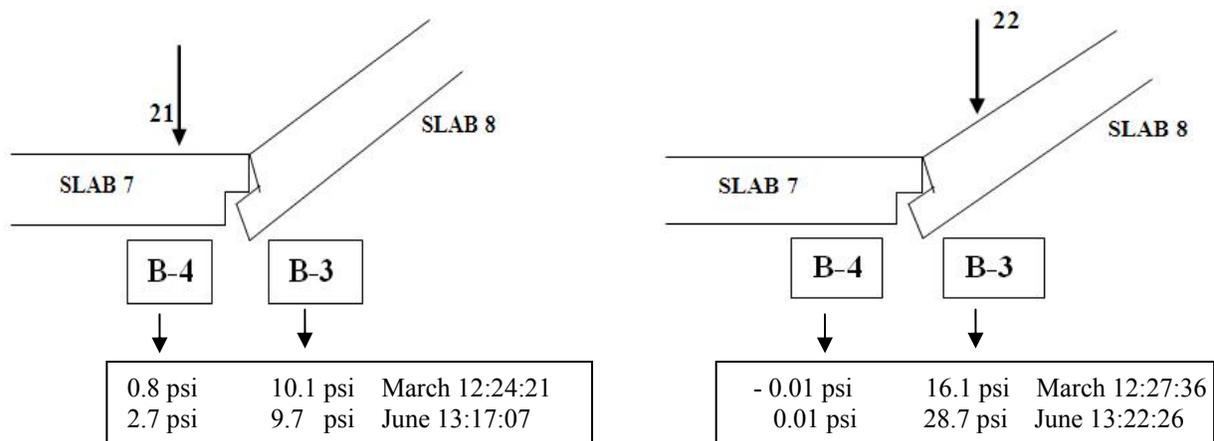
Figure 25: Data summary for slabs 7 and 8

Loading at locations 21 and 22: Figure 25 presents the pressure cell readings (B-4 and B-3), measured when dead loading from the front wheels of the large cone truck was applied at the approach side (21) and leave side (22) for the March and June evaluations, as shown in Figure 26.

When the load was applied to location 21 (March 12:24:21), the pressure cell readings for B-4 and B-3 were 0.8 psi and 10.1 psi, respectively. If the slabs were equally and fully supported by the base course and properly aligned vertically and horizontally, the pressure readings from pressure cells B-3 and B-4 should be similar when loaded at location 21 and different when loaded at location 22 due to the load transfer mechanism, as shown in Figure 25. However, there was a pressure differential of 9.3 psi across the joint when loaded at location 21. Due to the void

With one exception, a similar scenario was observed for the June data set (June 13:17:07) when the load was placed at location 21. FWD data did not indicate a void at location 21, but the deflections differed significantly from location 21 (14.13 mils) to location 22 (7.97), as with the March 12:24:21 data set. Injecting leveling material beneath the slabs did not fix the problems caused by profile differentials, voids, and the load transfer mechanism.

Applying the dead load to location 22 (slab 8) barely influenced sensor B-4 (slab 7 - location 21) due to the design of the joint.

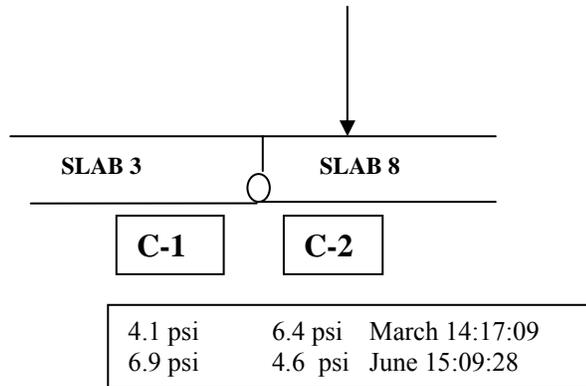
Figure 30: Pressure sensor readings for loading on slab 8

As shown in Figure 30, the pressures for C-1 and C-2 were 4.1psi and 6.4 psi, respectively, for the March 14:17:09 data set and 6.9 psi and 4.6 psi, respectively, for the June 15:09:28 data set. Similar pressures across the longitudinal joint at slabs 3 and 8 were observed for both the March and June data sets.

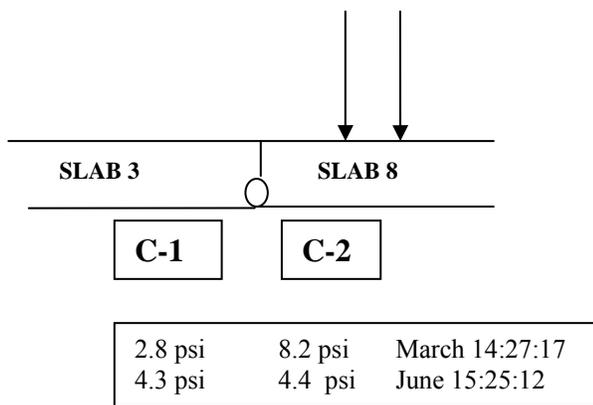
Figure 32: Front wheel load near sensor C-2

As shown in Figure 32, the pressures for C-1 and C-2 were 2.8 psi and 8.2 psi, respectively, for the March 14:27:17 data set and 4.3 psi and 4.4 psi, respectively, for the June 15:25:12 data set. The reason for the differing pressures between the March and June data set could be that the better contact between the slab and base course was created by the injection of leveling material in June.
