Evaluation of the LA 1 Bridge at the Morganza Flood Control Structure

LTRC Project No. 11-1TA

November 2010

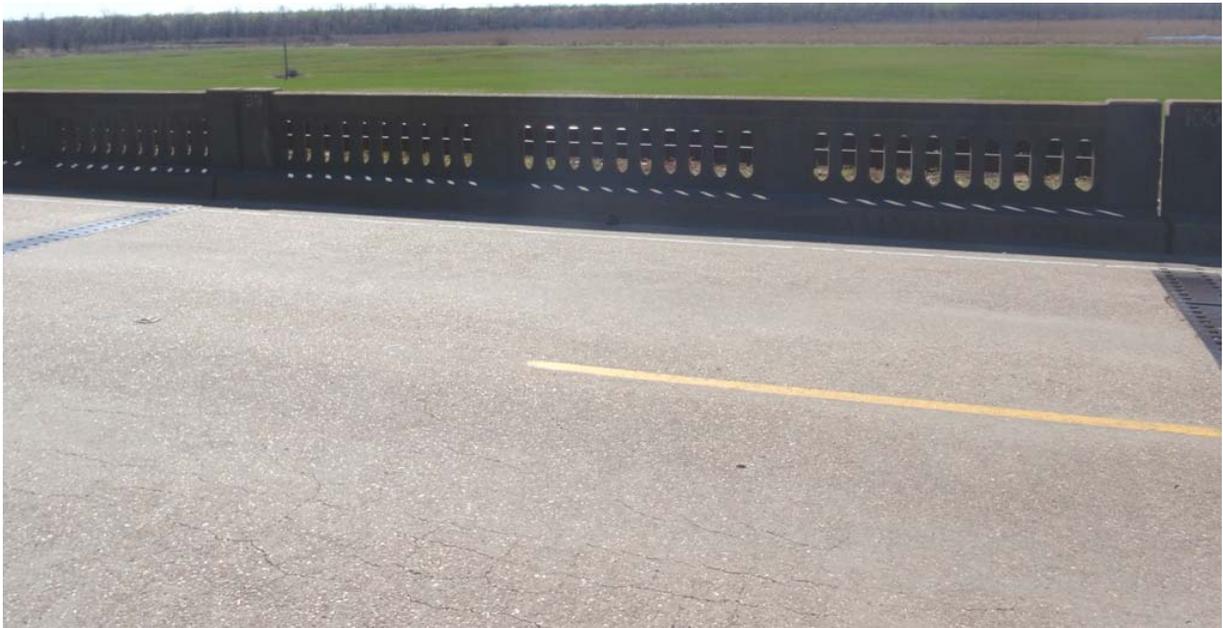
This report will concentrate on the LA 1 bridge deck at the Morganza flood control structure. On March 9, 2010, the Louisiana Department of Transportation and Development (LADOTD) bridge design section contacted the author regarding a specific cracking pattern on the LA 1 Bridge at Morganza, LA. The cracking pattern can be seen at the bottom of Figure 1. Bridge design's concern dealt with the extent of the deck damage, whether the cracking was due to corrosion of reinforcing steel, and any possible concrete delamination.

Figure 1
Span 99 looking west (Northbound lane is closest)

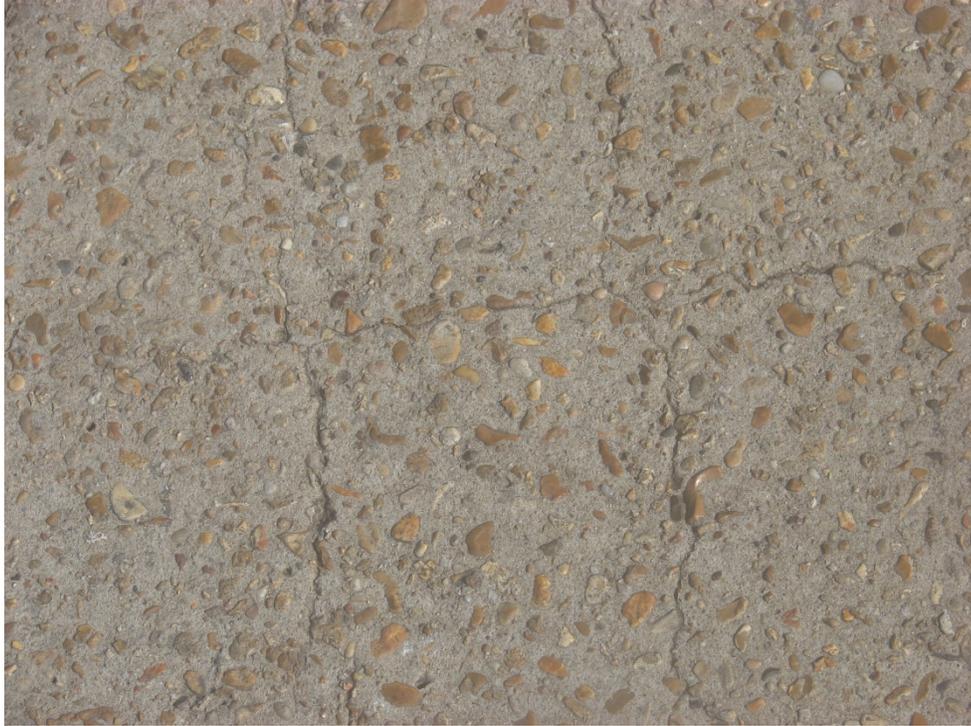
This section will detail the deck condition, delamination assessment, and in-place steel condition. The deck condition as noted on July 20, 2010, was typical of a deck that has undergone many years of wear. The deck surface had exposed gravel aggregate and many spans exhibited the cracking pattern shown in Figure 2. The cracks were observed to generally occur above reinforcing steel but were usually limited to a depth less than 1.5 inches. Figure 3 gives an indication of crack depth in one of the most affected spans where the crack depth was about 2.5 inches. The author was asked to investigate the effect of fire on the deck surface. A fire had occurred sometime in the past five years on spans 104 and 105 southbound. The fire-affected spans (104 and 105 southbound) did exhibit a noticeably different surface texture and color shown in Figure 4. The field investigation team noted that the fire-affected spans had been repaired with a cementitious based surface treatment in the past. Based on laboratory results, the author believes this is surface damage due to the fire and not structural.

Figure 2
Exposed aggregate and crack pattern (Note the crack pattern is approximately 4 – 6 inches square)

The in-place condition of the bridge deck showed signs of wear in terms of exposed aggregate and cracking. The depths of the cracks generally did not extend to the reinforcement steel. The condition of the reinforcing steel showed little to no corrosion in the full depth and partial depth cores. No delamination was found when the site was visited. The tensile and compressive strengths proved adequate and the pull-off test strengths showed that an epoxy type overlay will be very well suited as a rehabilitation technique.

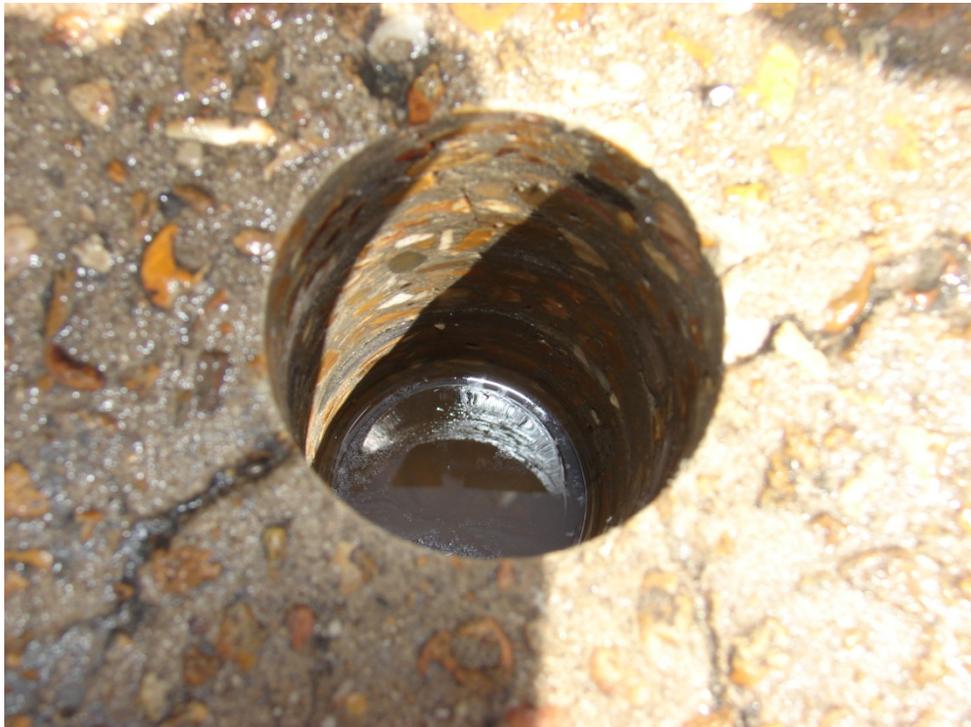
Figure 3
Cracked deck in span 99 northbound (Note the crack depth here was about 2.5 inches)

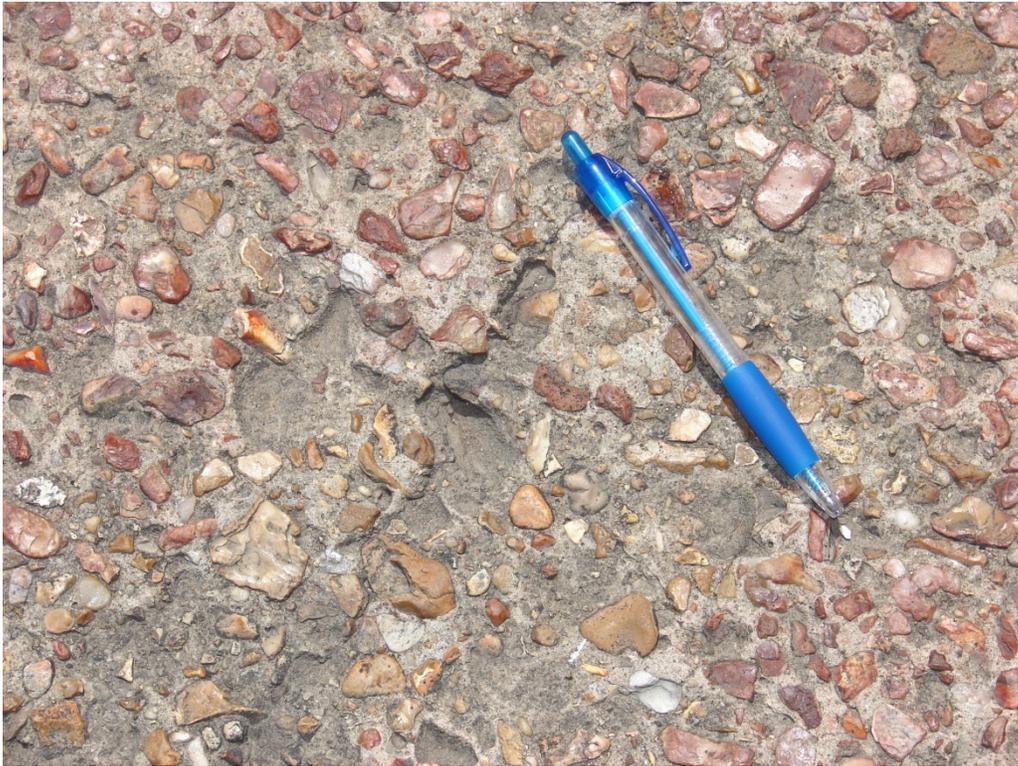
Figure 4
Surface texture and color in span 105 southbound, a fire affected span

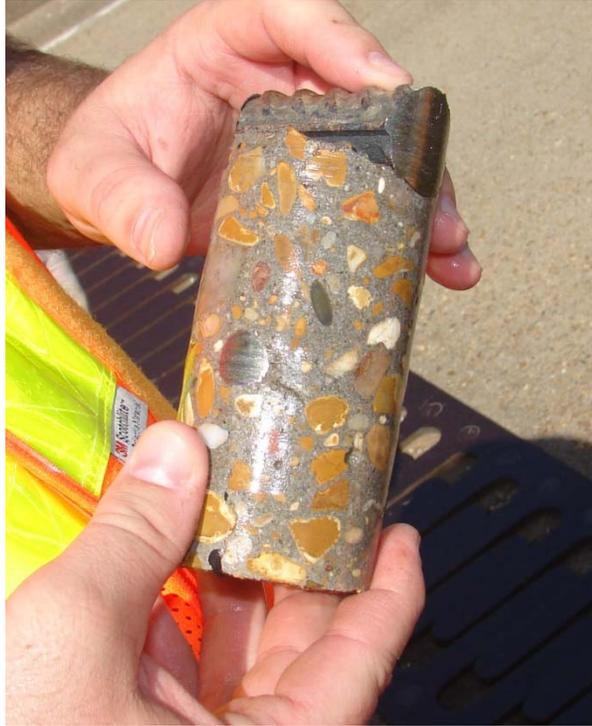
The in-place steel condition was much better than expected for the author. The in-place steel showed little to no signs of corrosion either in the partial depth cores or in the full depth retrievals. Figure 5 and Figure 6 illustrate the state of the reinforcing steel as encountered on July 20, 2010. The condition of the steel and noted crack depths led the team to reduce the number of core samples by about one third.

Figure 5
Full depth core showing no steel corrosion

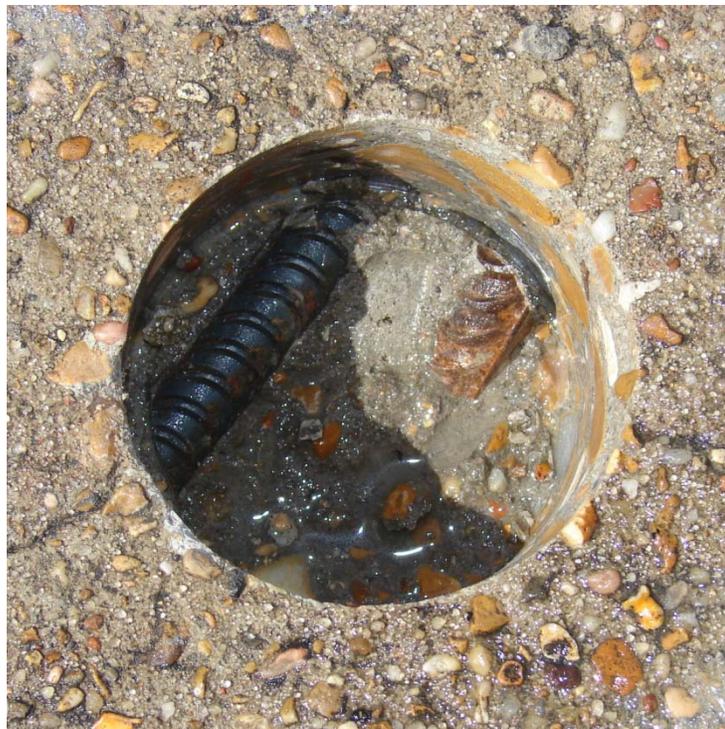
Figure 6
Partial depth core showing little steel corrosion
