1. Report No. FHWA/LA.13/13-01TA-B		2. Government Accession No.	3. Recipient's Catalog No.
4. Title and Subtitle Evaluation of Rutting Distresses on I-20 near Mound to Delta Scales		5. Report Date January 2014

Evaluation of Rutting Distresses on I-20 near Mound to Delta Scales

LTRC Project No. 13-01TA-B

January 2014

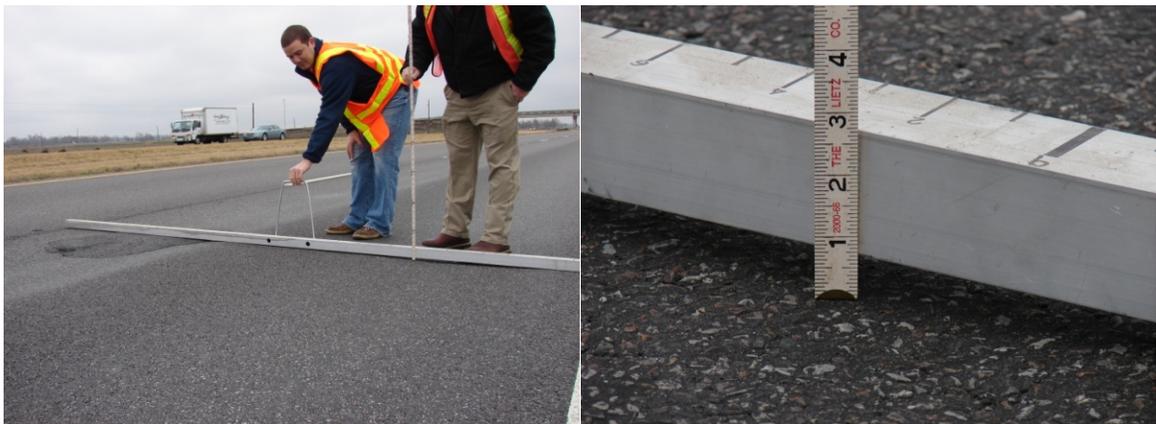
Figure 2
Localized rut measurement using traditional straight edge

To assess the overall condition of the pavement, a visual condition survey and a nondestructive distress condition survey were conducted at first. As shown in Figure 2, rut depths were measured randomly using a traditional straight edge and measuring gauge at severely rutted areas. Afterwards, an automated laser profiler was utilized to record the rut depth for the entire length of the project. Historical records such as design details, preliminary engineering reports, and construction records were also reviewed to find the possible clues to the pavement failure. After the preliminary site investigation, 21 full depth 6-in. diameter asphaltic concrete roadway cores were taken from four strategic locations to evaluate the current in situ pavement condition. Roadway cores were sampled from sites that rutted (wheel paths) along with samples from non-distressed areas (center line). The locations of cored test sections and the schematics of coring are illustrated in Figures 3 and 4, respectively; whereas, a brief description of those cores is presented in Table 1. All cores had 4-lifts of Superpave mixture with approximately 2-in. thickness per lift in addition to the 2-in SMA. The arrangement of various lifts found in the roadway cores is illustrated in Figure 5. According to the plant production data and roadway reports, the bottom two lifts, Lift A and Lift B were deemed as the leveling courses; whereas, the top two lifts, Lift C and Lift D were the binder courses. It should be noted that all Superpave lifts were produced in accordance with the same Job Mix Formula (JMF).

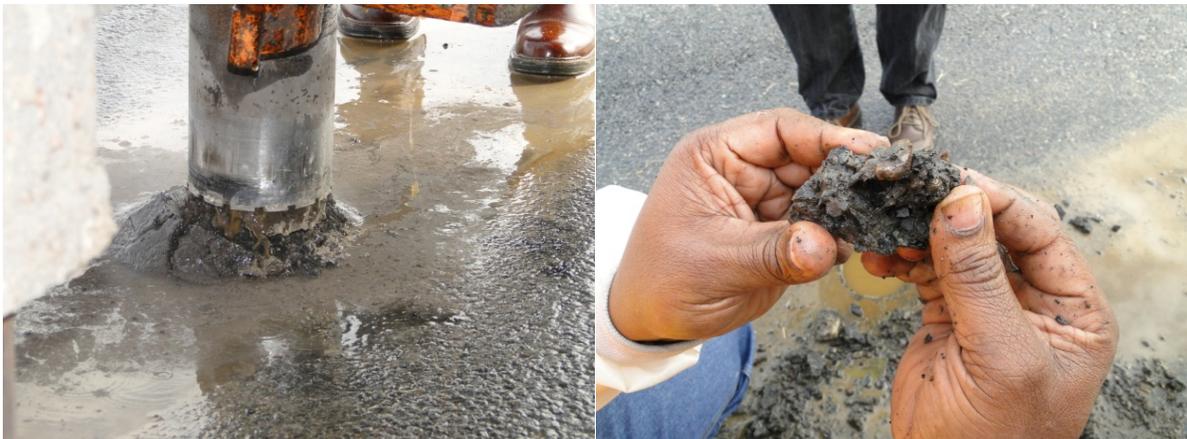
Figure 6
Observation of moisture damage during coring

During the recent coring operation, it was noticed that the permanent deformation was only occurring at the wearing course or SMA lift. However, moisture damage was noticed at a couple of locations where the corresponding cores fell apart completely (Figure 6). The moisture damage was mainly noticed in the binder/ leveling course lifts and the mixtures of those layers seemed to be soft and lacking cohesion. It should be noted that the soil cement base underneath the CRCP is generally highly impermeable to water. It is anticipated that the water or water vapor was getting into the pavement structural system from underneath and finding no place to escape due to an inadequate subsurface drainage conditions. In addition, the differential thermal expansion of water vapor during day-night cycle and the cyclic stresses from moving traffic increases the pore water pressure which may rupture the asphalt-aggregate bond and cause stripping [3].

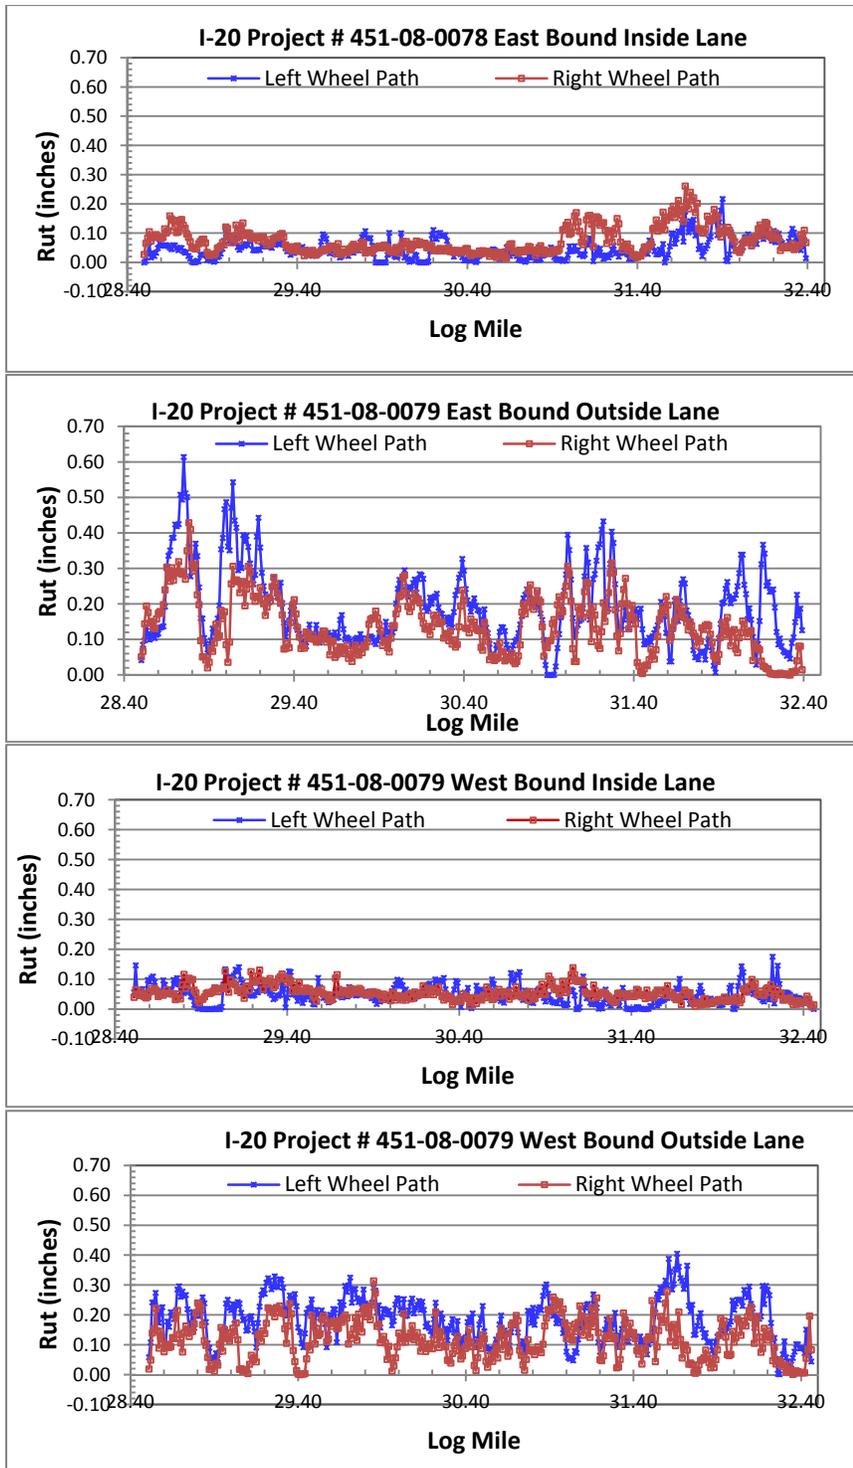
Figure 7
Rut measurements of I-20 sections

In an effort to measure the extent of premature rutting, the LTRC pavement research group collected rut measurements at every 0.10 mile interval for the entire length of the project. As shown in Figure 7, it is clear that the outside lanes in both directions rutted more than their inside counterparts. The highest rut depths of 0.61 inch and 0.41 inch were noticed in the outside lanes in the eastbound and westbound directions respectively. The outside lanes usually experience more and heavier traffic which may be the possible reason behind the higher rutting results. Interestingly, the scenario of having higher rutting in the outside lanes also supports the underneath moisture damage phenomenon. The roadway was built with a slope towards the outside lane, which may allow the moisture to flow in that direction and eventually deposit under those lanes.

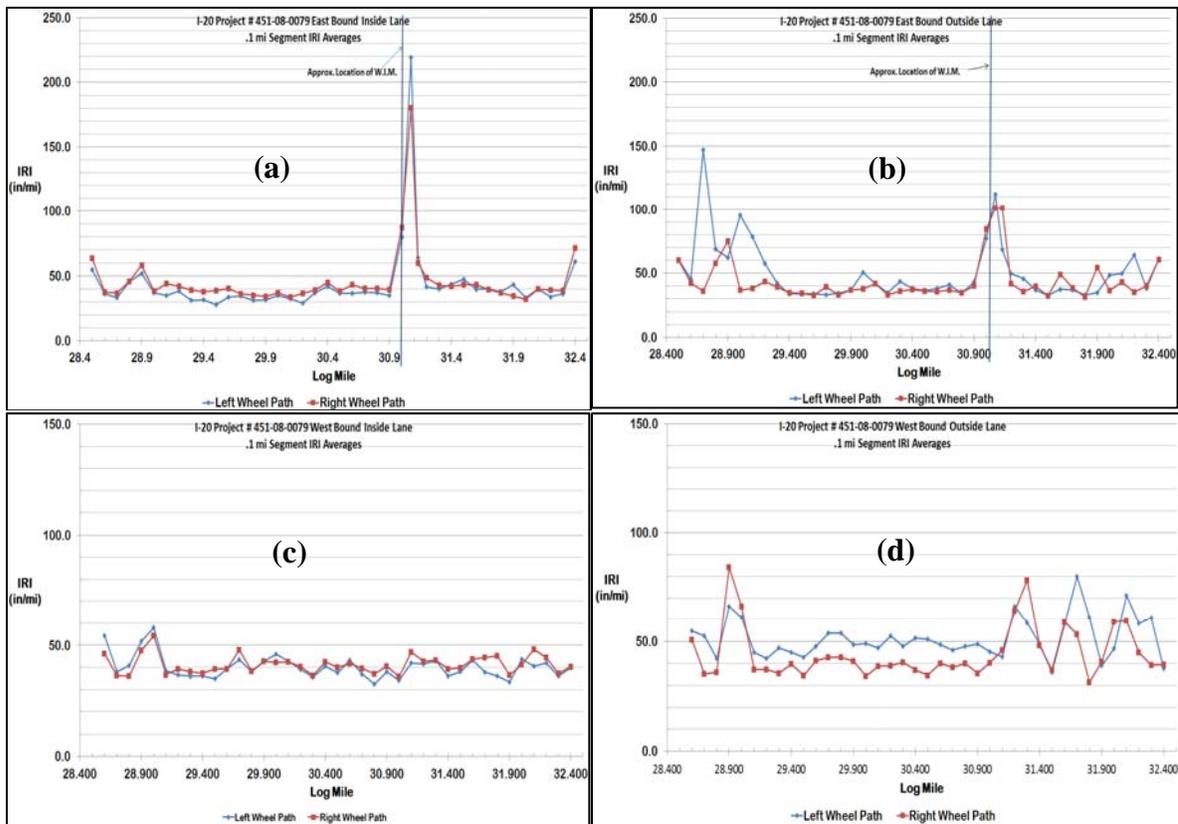
Figure 8
IRI data

The IRI values as presented in Figures 8a to 8d indicate that, for the most part, the project is smooth (IRI < 80) according to the FHWA criteria. The east bound inside lane (EBIL) had IRI values generally less than 50 except for the locations near the weigh-in-motion (WIM) station at CSLM 31 as presented in Figure 8a. The east bound outside lane (EBOL) had a similar trend to the EBIL except for the first mile of the project, which had IRI values up to 150 as presented in Figure 8b. The west bound inside lane (WBIL) had IRI values around 40 indicating a very smooth ride as presented in Figure 8c. The west bound outside lane (WBOL) had a different trend than the WBIL with more variation in IRI values and notably higher IRI values at CSLM 29 to 29.1 and CSLM 31 to 32.4.

In both the east and west bound directions, the outside lanes had rougher trends than inside lanes, though, generally, the IRI values were within FHWA's criteria for a smooth roadway.

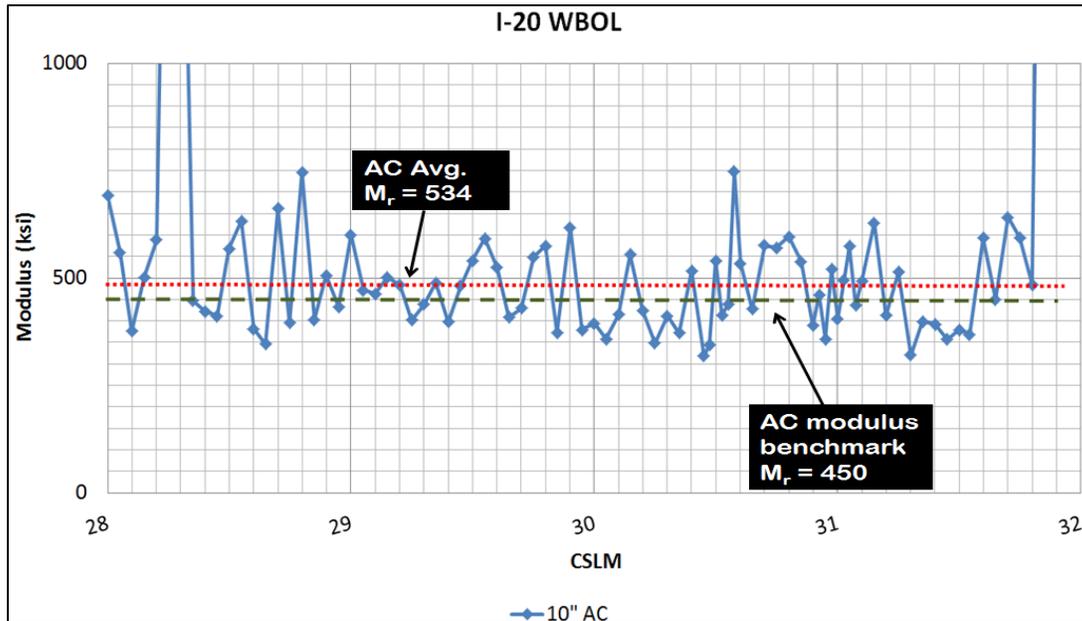
Figure 9
Westbound outside lane

The asphalt mixture (AC) moduli values for the west bound outside (WBOL) are presented in Figures 9 to 10. Outliers, values which were far out of range, were not removed. Even though the average AC modulus was 534 ksi, which was greater than the 450 ksi benchmark, many test locations were below the 450 ksi benchmark as presented in Figure 9. Approximately 45 percent of the AC modulus values were less than 450 ksi as presented in

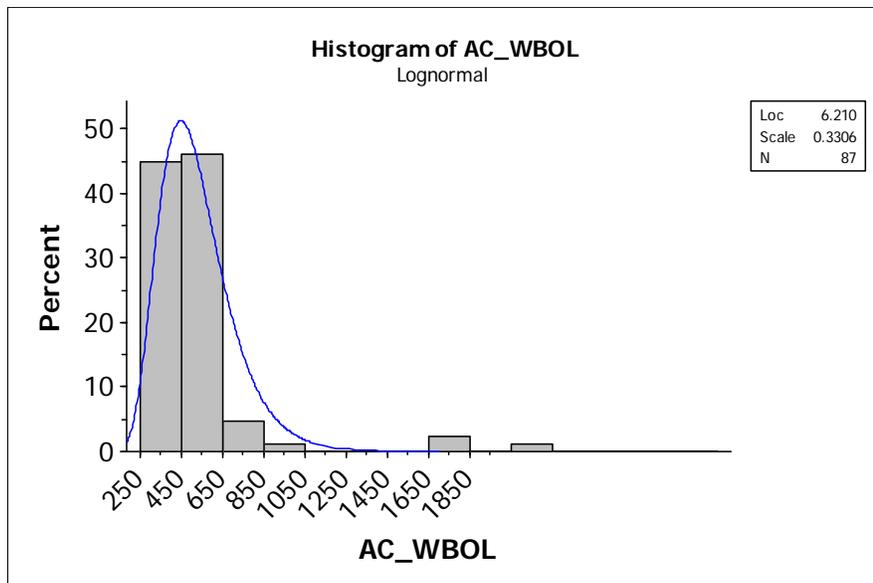
Figure 10
Westbound outside lane histogram

Figure 10. That could indicate that stiffness of the AC layer was significantly impacted by stripping at those locations.

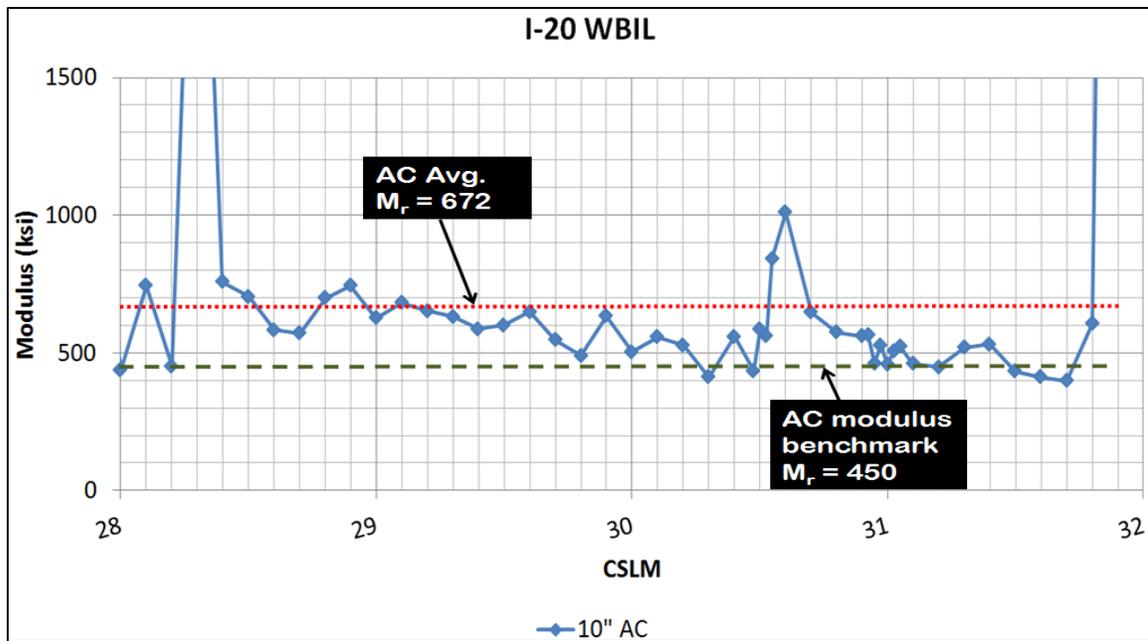
Figure 11
Westbound inside lane AC modulus

Figures 11 and 12 present the AC modulus results for the WBIL. The average AC modulus was 672 ksi as presented in Figure 11. Unlike the WBOL, only a few test locations were below the 450 ksi benchmark. The histogram for the WBIL indicated that approximately 15 percent were below the 450 ksi benchmark as presented in Figure 12.

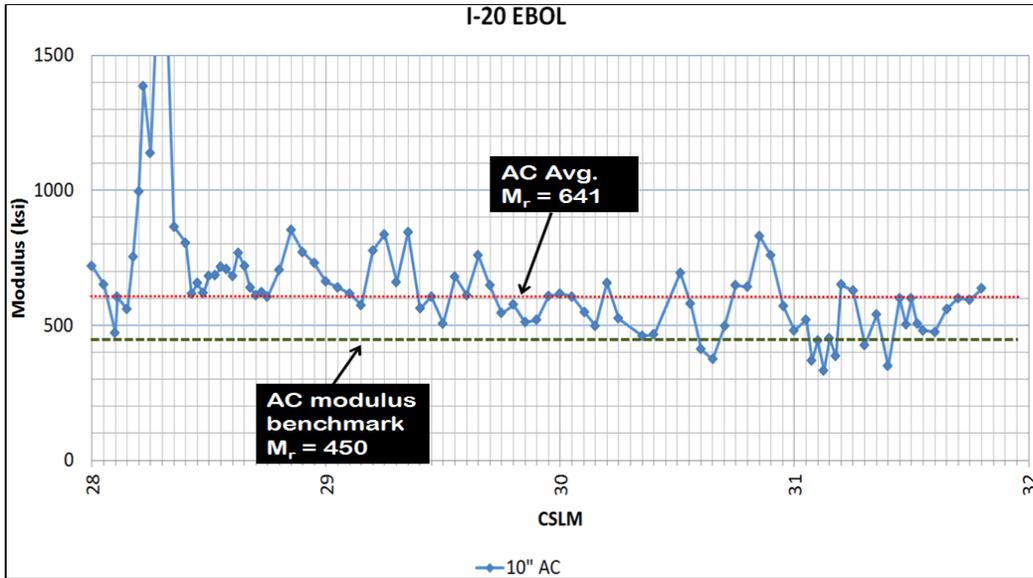
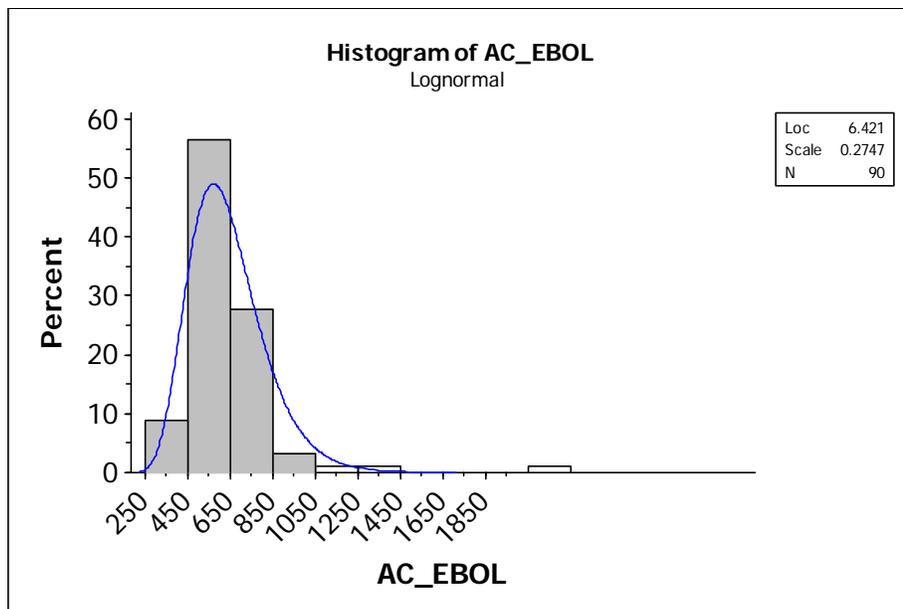
The AC moduli values for the east bound outside lane (EBOL) are presented in Figures 13 to 14. Outliers, values which were far out of range, were not removed. The results indicated that the average M_r value was 641 ksi with some points below the 450 ksi benchmark as presented in Figure 13. The histogram of the AC modulus data indicated that approximately 9 percent of the points were below the 450 ksi benchmark as presented in Figure 14. This implies that a significant portion (9 percent) of the pavement was impacted by the stripping.

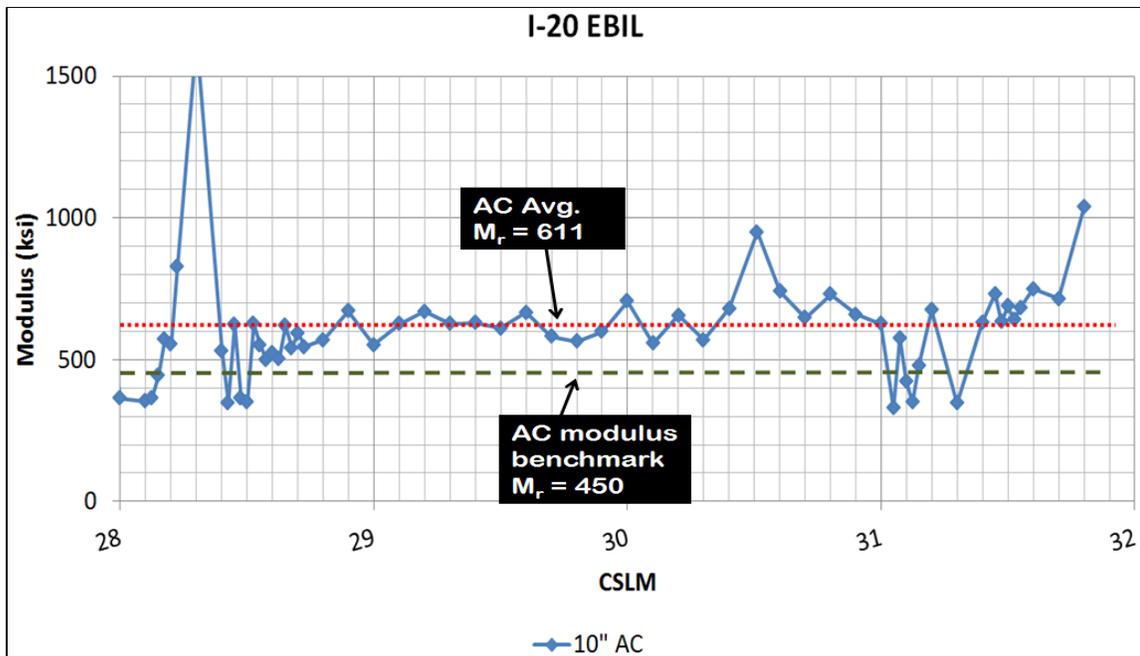
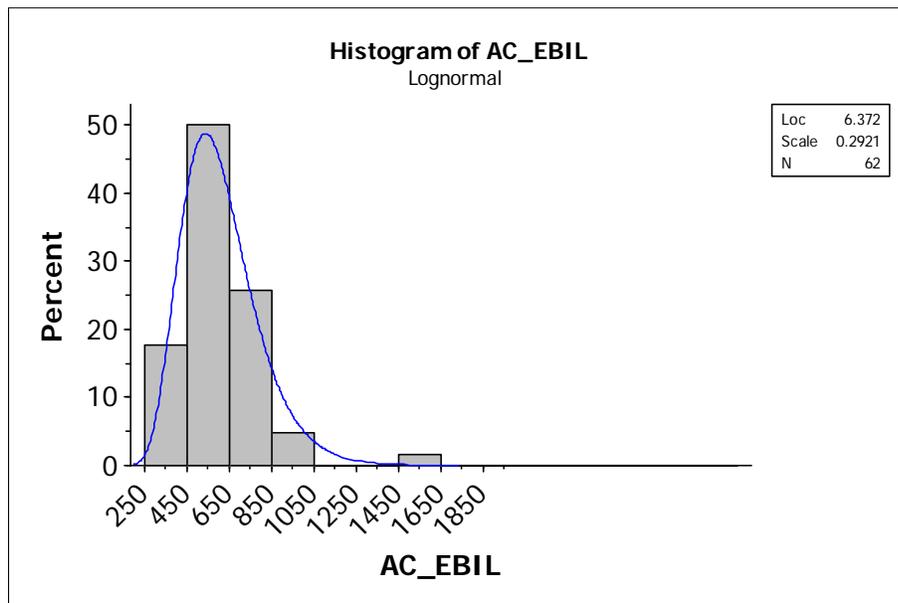
Figures 15 to 16 present the AC modulus values for the east bound inside lane (EBIL). As presented in Figure 15, the average AC modulus is 611 ksi with some points below the 450 ksi benchmark. The histogram for the AC modulus data indicated that approximately 18 percent of the points were below the 450 ksi benchmark as presented in Figure 16. This implies that a significant portion (18 percent) of the pavement was impacted by the stripping.

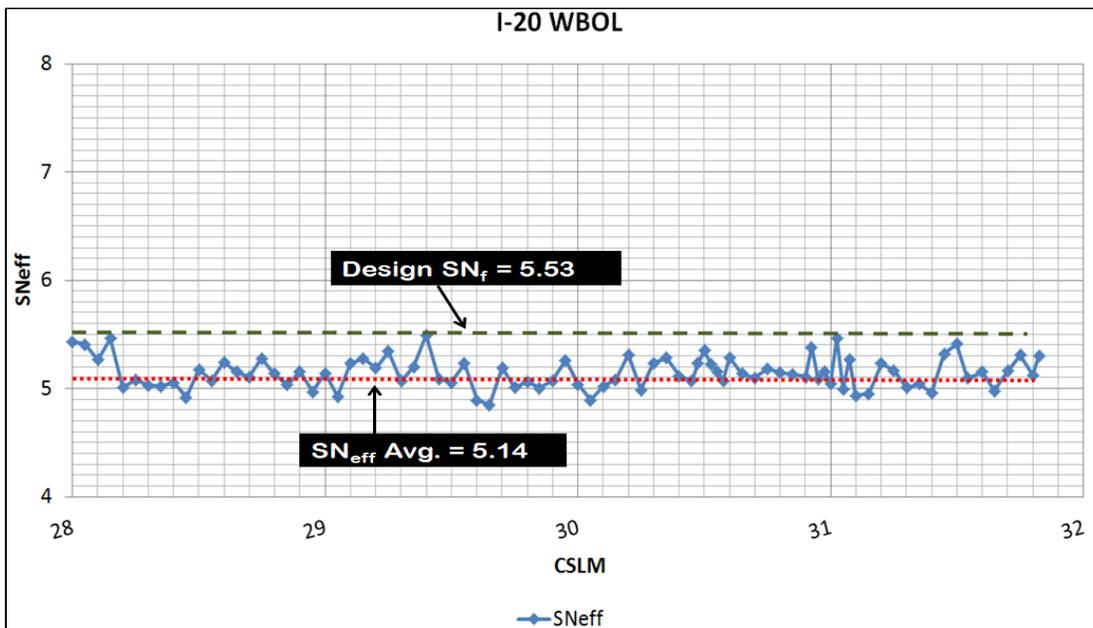
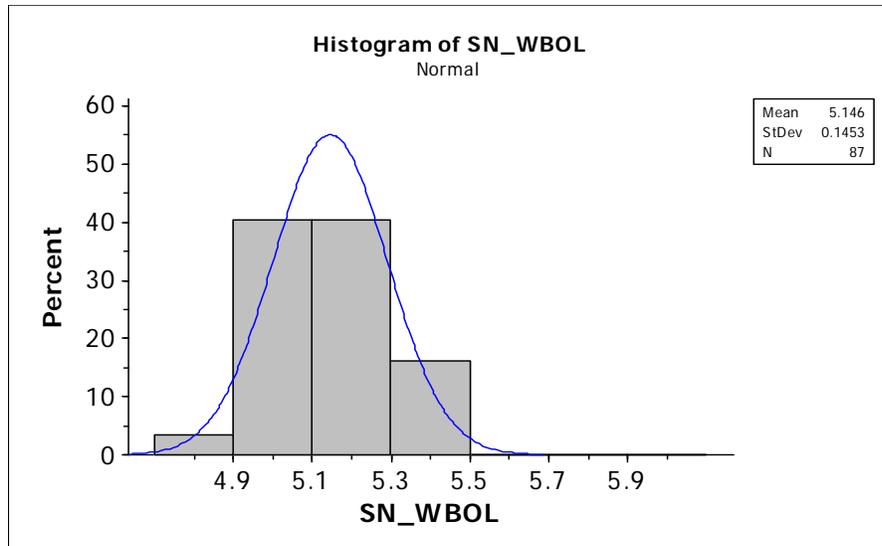
The SN_{eff} values for the west bound outside lane (WBOL) are presented in Figures 17 and 18. The results indicated that the average SN_{eff} was 5.14 and that only a few test locations were near the 5.53 benchmark as presented in Figure 17. The histogram of the SN_{eff} data indicated that all points were below the 5.53 SN_f benchmark as presented in Figure 18. The difference between the average SN_{eff} (5.14) and the benchmark SN_f (5.53) is -0.39, which equates to approximately to 1-in. of AC.

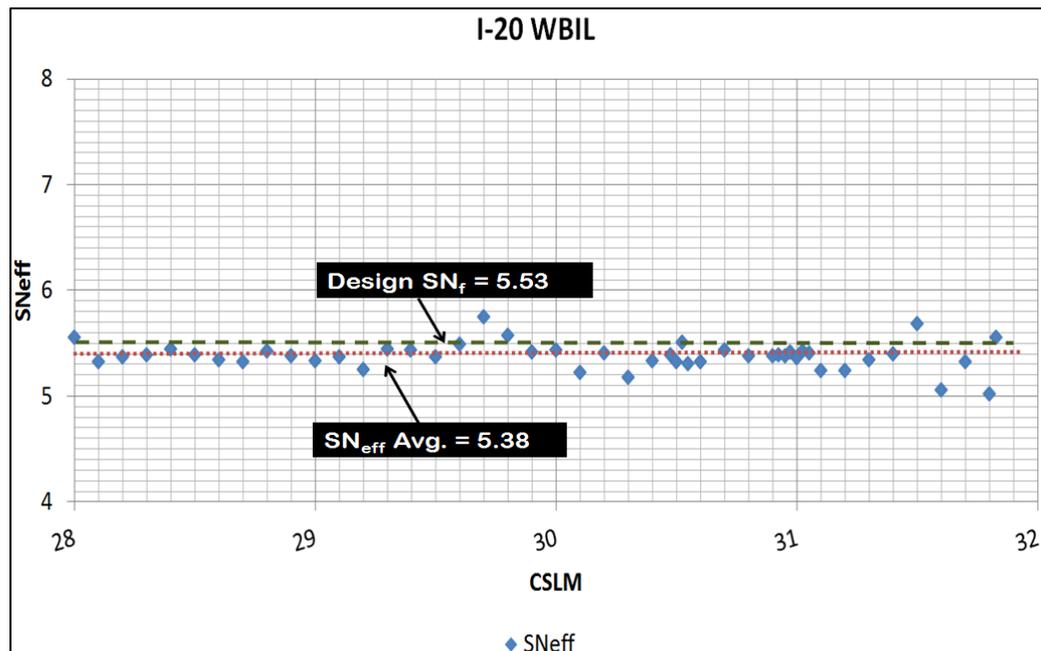
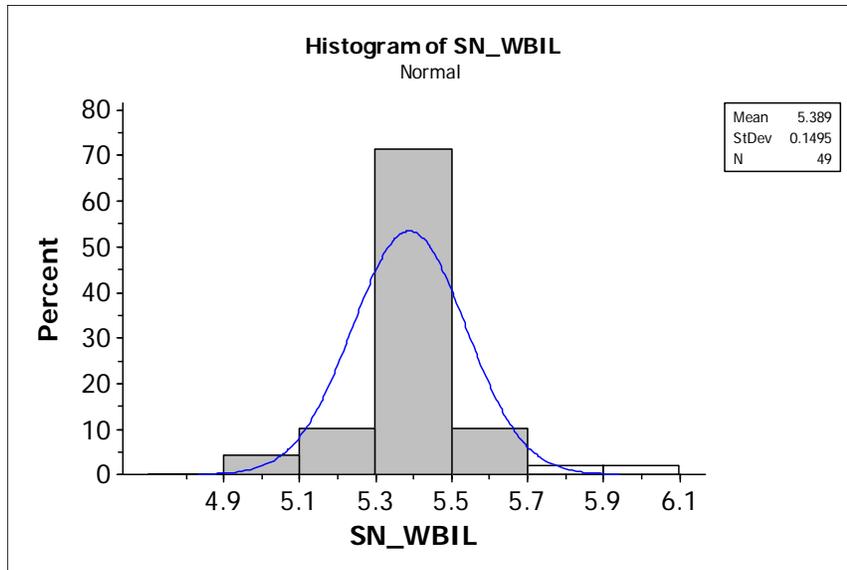
The SN_{eff} values for the west bound inside lane (WBIL) are presented in Figures 19 and 20. The results indicated that the average SN_{eff} was 5.38 and that only a few test locations were above the 5.53 benchmark as presented in Figure 19. The histogram of the SN_{eff} data indicated that approximately 86 percent of the test locations were below the 5.53 SN_f benchmark as presented in Figure 20. The difference between the average SN_{eff} (5.38) and the benchmark SN_f (5.53) is -0.15, which equates to approximately 0.34-in. of AC.

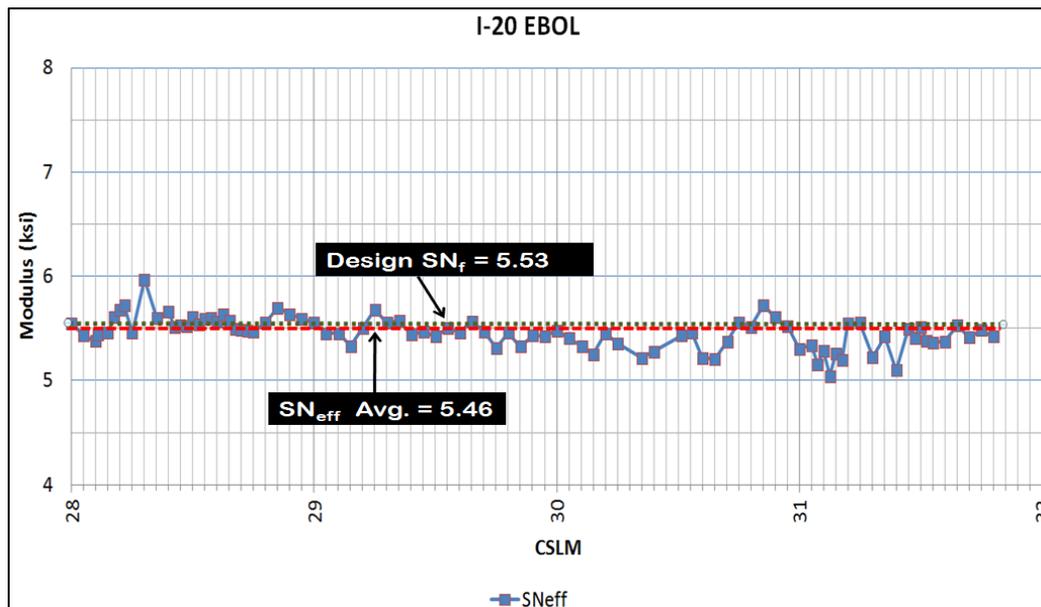
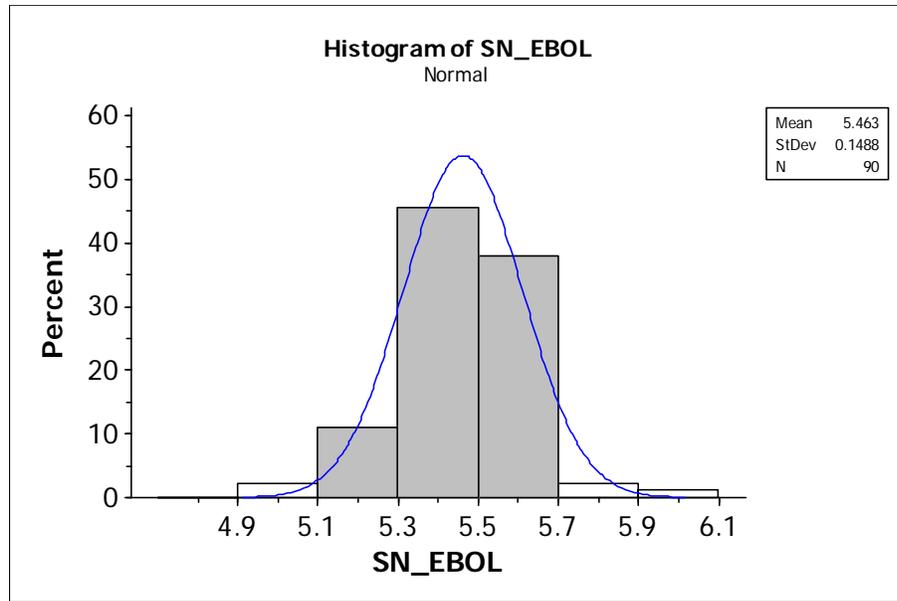
The SN_{eff} values for the east bound outside lane (EBOL) are presented in Figures 21 and 22. The results indicated that the average SN_{eff} was 5.46 and that many test locations were near the 5.53 benchmark as presented in Figure 21. The histogram of the SN_{eff} data indicated that approximately 58 percent of the test locations were below the 5.53 SN_f benchmark as presented in Figure 22. The difference between the average SN_{eff} (5.46) and the benchmark SN_f (5.53) is -0.07, which equates to approximately 0.15-in. of AC.

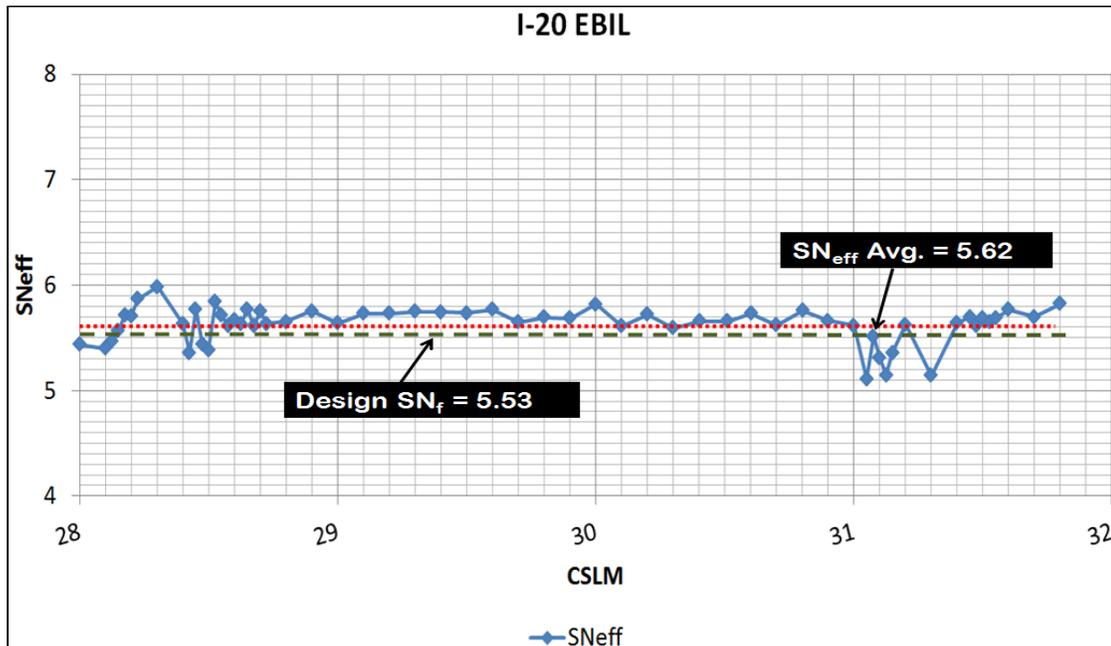
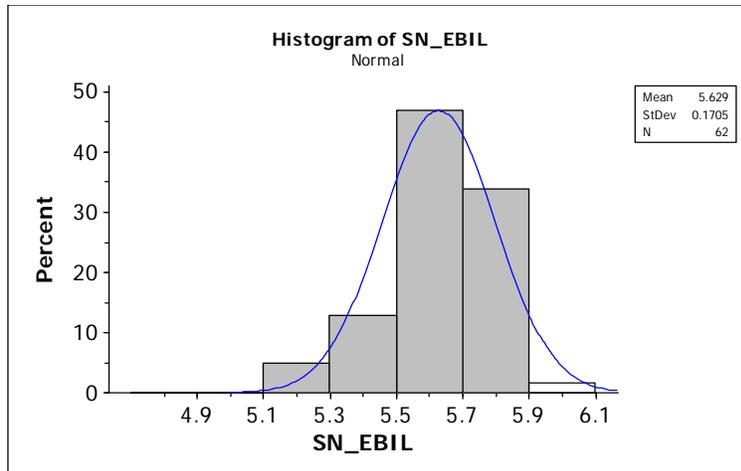
The SN_{eff} values for the east bound inside lane (EBIL) are presented in Figures 23 and 24. The results indicated that the average SN_{eff} was 5.62 and that many test locations were above the 5.53 benchmark as presented in Figure 23. The histogram of the SN_{eff} data indicated that approximately 18 percent of the test locations were below the 5.53 SN_f benchmark as presented in Figure 24. The difference between the average SN_{eff} (5.62) and the benchmark SN_f (5.53) is +0.09, which equates to approximately 0.2-in. of AC.

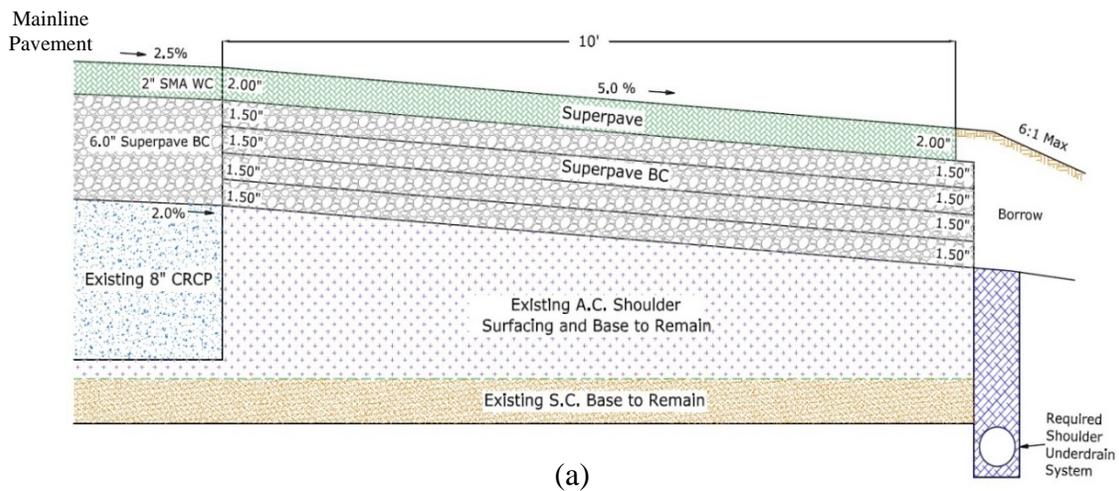
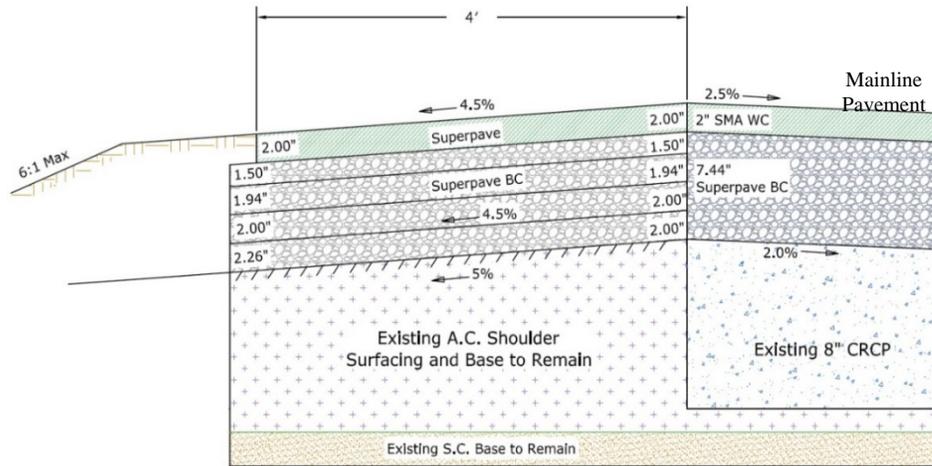
Existing shoulder cross-section: (a) outside shoulder, (b) inside shoulder

It was observed from LADOTD roadway reports that the shoulder and mainline pavements were constructed at the same time. From the typical cross-sections of inside and outside shoulders presented in Figure 25, it can be seen that the shoulders were constructed in different layers. As a regular construction practice, it is anticipated that the same layer thicknesses were maintained also for mainline roadway construction to avoid drop off and facilitate safe traffic movement during construction. However, it should also be noted that the lift thickness of asphaltic pavements is influenced by the nominal maximum aggregate size (NMAS). Generally, the minimum lift thickness is at least 2.5 to 3 times the NMAS to ensure

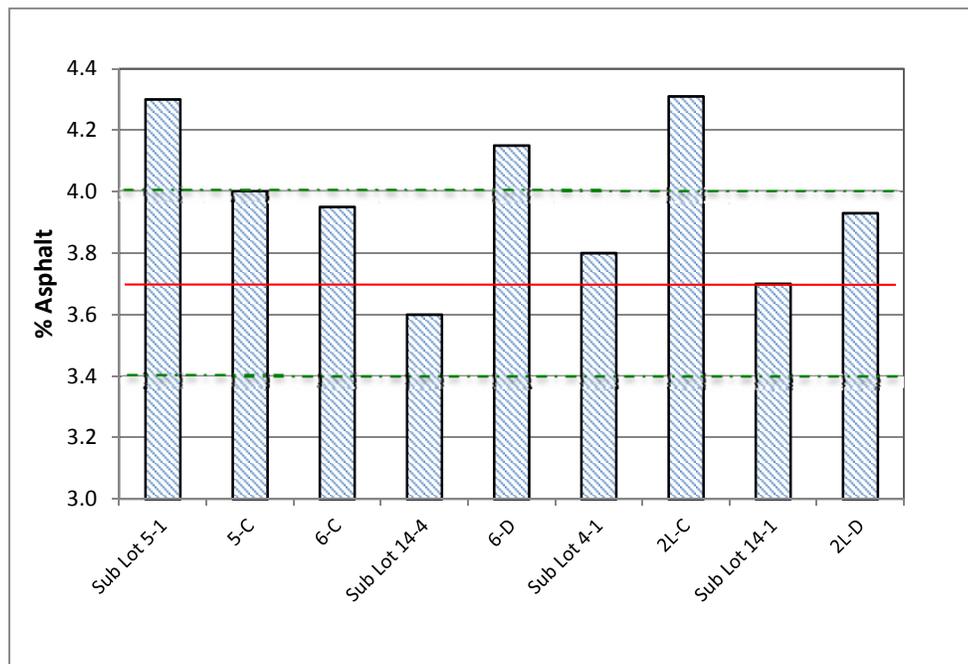
Figure 27
Comparisons of asphalt content

Figure 27 shows the percent asphalt content obtained from various cores and the corresponding Sublots respectively. Except for a couple of the specimens (Core 6: Lift D and Core 2L: Lift C), the percent asphalt for all roadway samples were within the validated JMF tolerance limits. Even though LTRC asphalt lab computed the extracted aggregate gradations and percent asphalt content for leveling course mixtures (Lift A and Lift B), a comparison between plant production data and roadway samples could not be performed due to the unavailability of plant production data at this time.

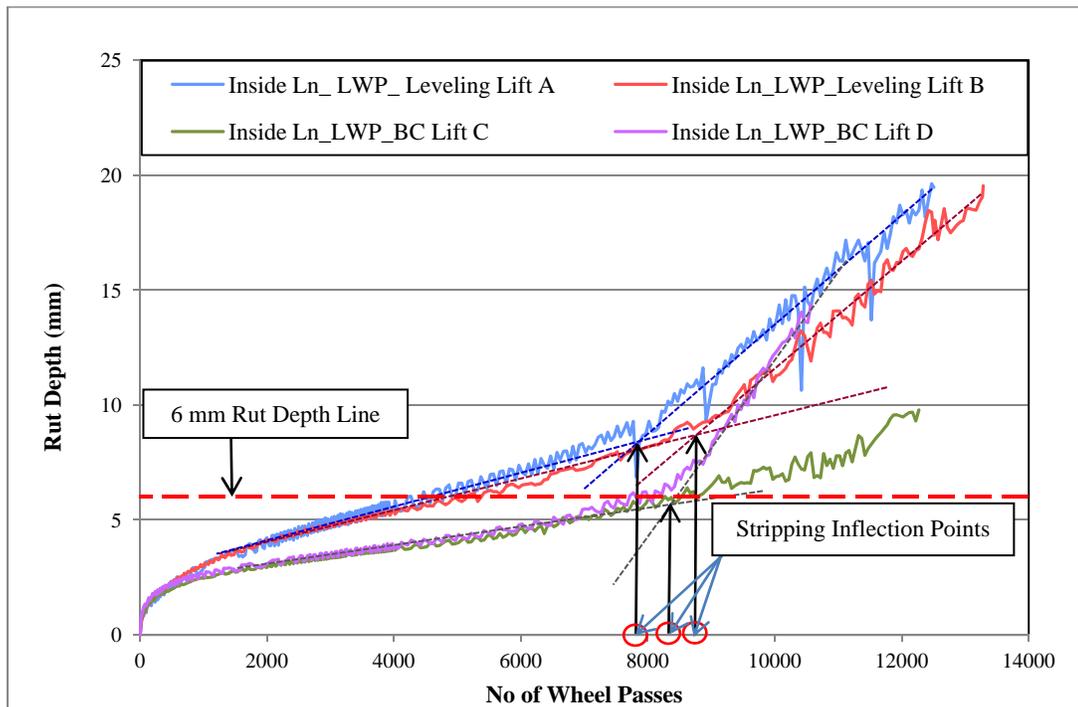
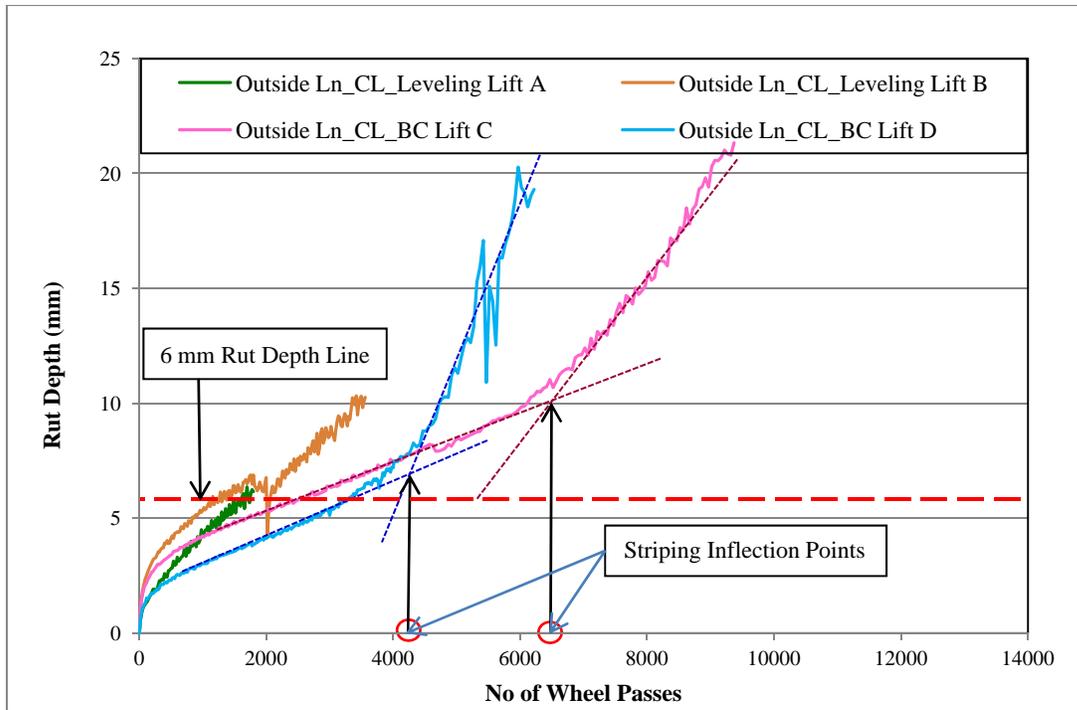
Figure 31
LWT test results

Results presented in Figure 31 clearly indicate that all roadway cores used in LWT test failed miserably and did not survive the whole 20,000 wheel passes. Regardless of the location of the cores (i.e. wheel path or centerline), none meet the current LADOTD specifications

requirement of 6.0 mm rut depth after 20,000 passes for level 2 Superpave BC mixtures. The samples also showed very high stripping potential. However, the cores taken from inside lane showed slightly better performance than the cores from outside lane. Except Lift C samples, all samples from the inside lane showed stripping inflection points around 8000 cycles whereas, the samples from Lift C and Lift D from outside lane showed stripping inflection points at 6200 and 4100 cycles respectively. Note that Colorado DOT reported that a stripping inflection point below 10,000 cycles indicated moisture susceptibility potential of that mix [13].

The graphs in Figure 31 also indicate that the lower the lift of the pavement the more moisture damage it showed. Interestingly, this also supports the underneath moisture damage phenomenon, as Lift A has the maximum potential to be exposed to the moisture. The higher traffic on the outside lane perhaps developed a pumping action of moisture in the lower lifts, which might be the reason behind the moisture damage revealed in LWT test results. The damaged samples were further investigated once the LWT test was completed. From visual inspection, the cores appeared to be completely stripped and fine sand appeared to be leaching as shown in Figure 32.

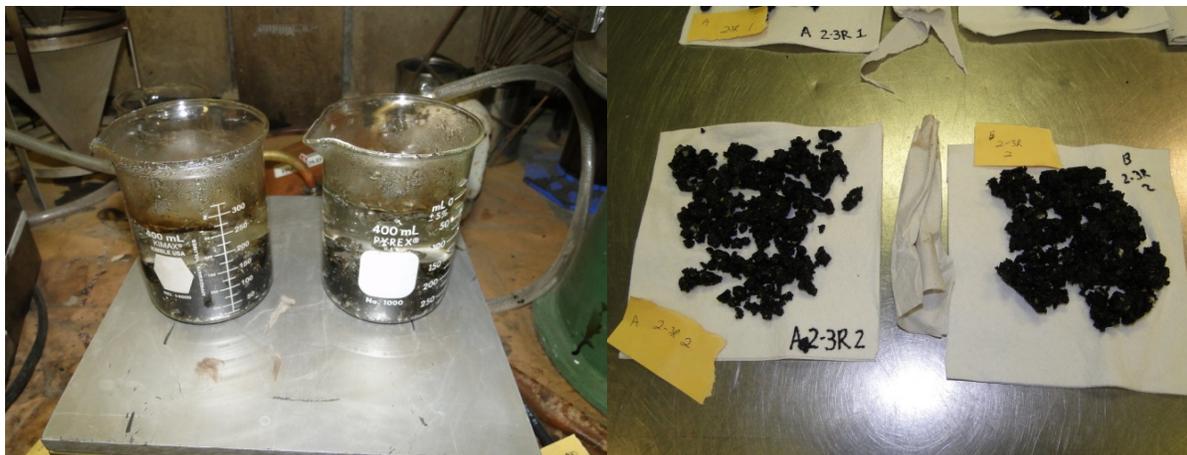
Figure 33
Boil test

As seen in Figure 33, almost no-stripping of binder was evident from the boil test. The reviewers of the test judged that, on average, 98 percent of the aggregates retained the binder coating after 10 minutes of boiling. This also indicates that there may not be any compatibility issue with the materials used in this mixture. However, it should be noted that boil test neither reflects any mechanical properties of the mixture nor accounts for the effect of traffic action. Therefore, the stripping problem noticed in the LWT test was perhaps a result of the underneath moisture and pumping action from the traffic movement rather than the compatibility of the materials.

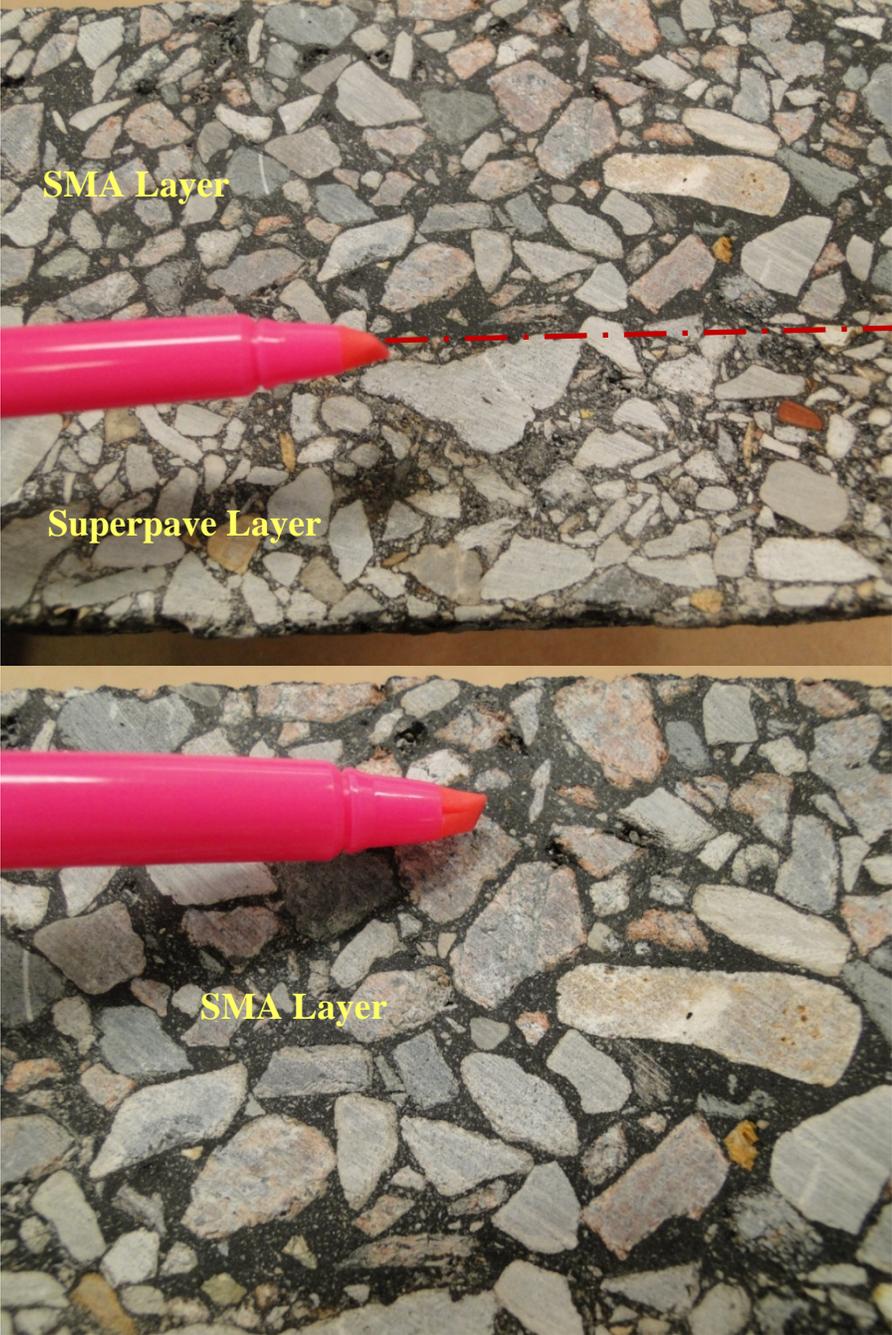
Figure 35
Aggregate arrangements in the SMA mixture

capacity relies on the stone on stone contact of the coarse aggregate skeleton. Longitudinal sectional views of a roadway core collected from a very bad section of this project are presented in Figure 35. It is evident there is lack of proper stone on stone contact for the SMA mixture used in this project.

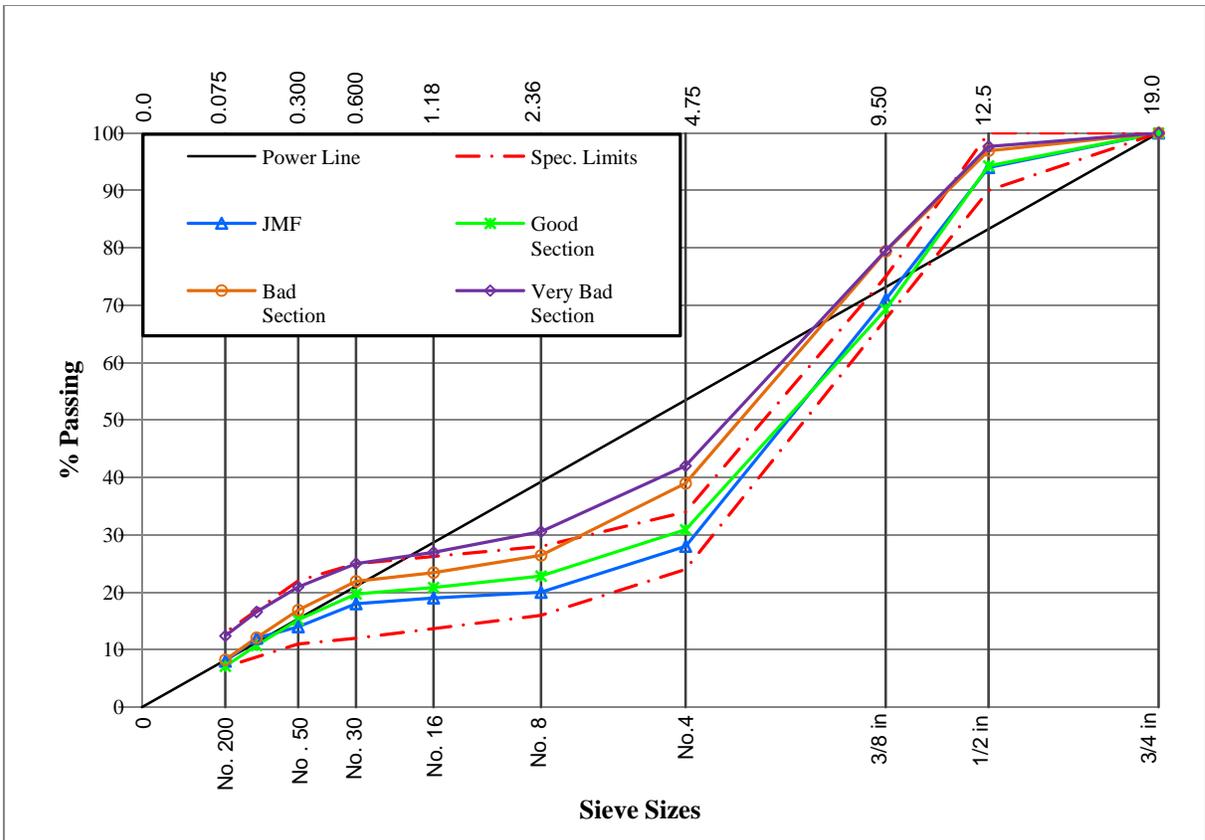
Figure 36
Aggregate blend gradations

Blended aggregate gradations and percent asphalt contents were obtained from the ignition oven method and compared with the original job mix formula (JMF) for this project and the current LADOTD specification limits for SMA mixtures. Investigation showed that the extracted aggregate gradations obtained at the LTRC Asphalt Lab were different than the approved JMF (Figure 36). Moreover, the “percent passing” values for several sieves exceeded the specification limits for mixtures representing bad and very bad sections. The use of finer graded aggregates might be the possible reason of losing stone on stone contact of aggregates as discussed previously. The percent asphalt content obtained from the roadway cores representing good, bad, and very bad sections are 6.18, 6.37, and 6.16 percent respectively, whereas the asphalt content in the approved JMF was reported to be 6.0 percent. The extracted asphalt content was within the JMF and the specifications requirement of 6.0 ± 0.4 percent.

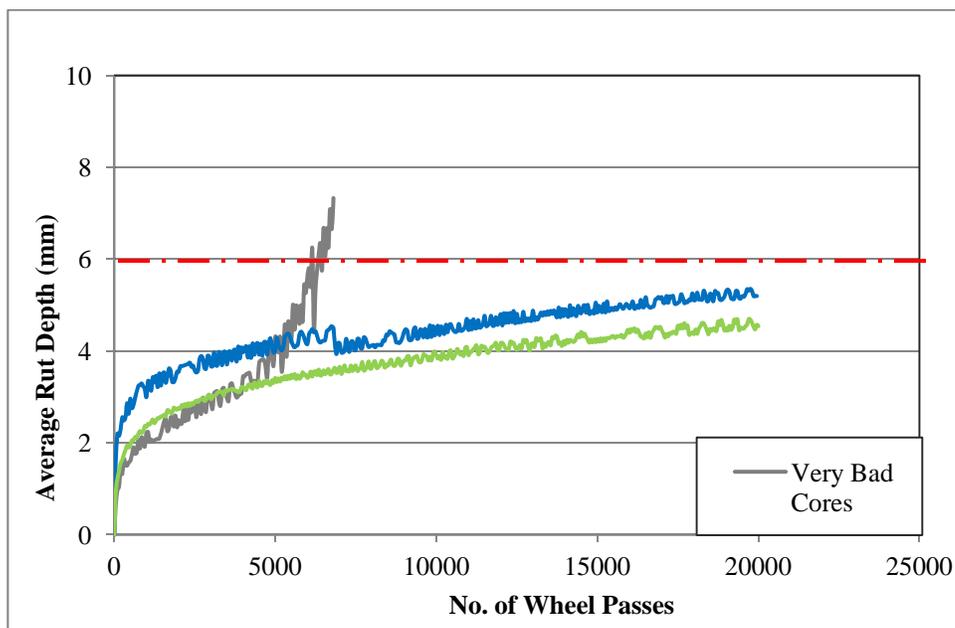
Figure 37
LWT test results

LWT (Hamburg) tests were conducted in accordance with AASHTO T 324 in an effort to evaluate the rutting potential and moisture susceptibility of SMA mixture used in this project. Roadway cores from good and very bad sections were tested in addition to laboratory fabricated superpave gyratory compacted (SGC) specimens supplied by the contractor, D & J Construction. It should be noted that the SGC specimens were prepared to replicate the plant production of the mixtures from the actual aggregate stockpiles during the construction of the project. Results presented in Figure 37 indicate that roadway cores from the good section and laboratory fabricated SGC specimens met the maximum allowable rut depth requirement of 6.0 mm after 20,000 passes. Also, no sign of stripping was observed for those specimens. Alternatively, roadway cores from the very bad section failed immediately after 6300 wheel passes and showed sign of severe stripping. As shown in Figure 38, the roadway cores from very bad section were crushed and completely destroyed after the test.
