1. Report No. FHWA/LA.13/13-01TA-B		2. Government Accession No.	3. Recipient's Catalog No.
4. Title and Subtitle Evaluation of Rutting Distresses on I-20 near Mound to Delta Scales		5. Report Date January 2014

Evaluation of Rutting Distresses on I-20 near Mound to Delta Scales

LTRC Project No. 13-01TA-B

January 2014

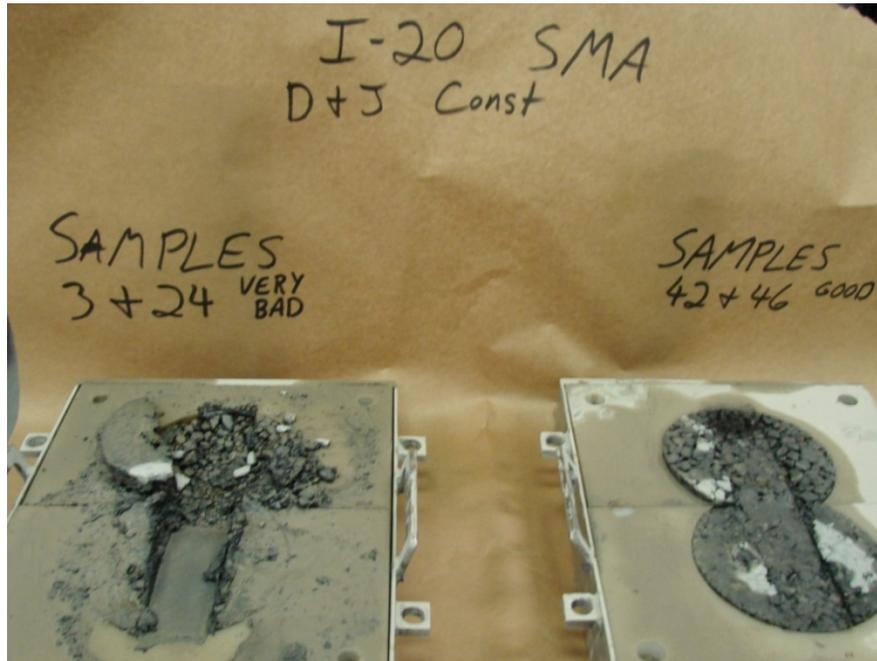
Figure 37
Roadway Core from Very Bad Section after LWT Test

LWT (Hamburg) tests were conducted in accordance with AASHTO T 324 in an effort to evaluate the rutting potential and moisture susceptibility of SMA mixture used in this project. Roadway cores from good and very bad sections were tested in addition to laboratory fabricated superpave gyratory compacted (SGC) specimens supplied by the contractor, D & J Construction. It should be noted that the SGC specimens were prepared to replicate the plant production of the mixtures from the actual aggregate stockpiles during the construction of the project. Results presented in Figure 37 indicate that roadway cores from the good section and laboratory fabricated SGC specimens met the maximum allowable rut depth requirement of 6.0 mm after 20,000 passes. Also, no sign of stripping was observed for those specimens. Alternatively, roadway cores from the very bad section failed immediately after 6300 wheel passes and showed sign of severe stripping. As shown in Figure 38, the roadway cores from very bad section were crushed and completely destroyed after the test.

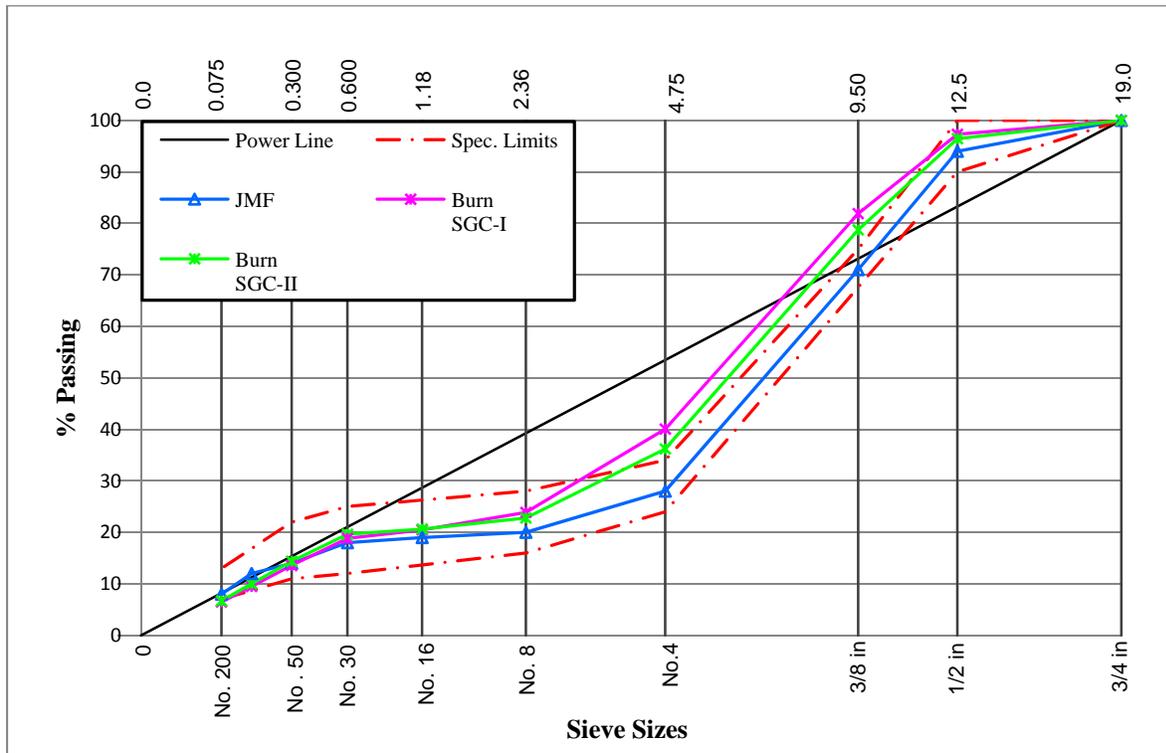
Figure 39
Aggregate blended gradations for lab-fabricated SGC specimens

Once again the ignition oven method was used to determine the blended aggregate gradations and percent asphalt contents for laboratory fabricated SGC samples supplied by the contractor. Although SGC specimens passed the LWT test, the burn gradations for that mixture failed to meet the current LADOTD aggregate blend specifications for SMA mixtures (Figure 39). Additionally, the average asphalt content for SGC samples was

found to be 5.45 percent which failed to meet the minimum asphalt content requirement of 5.6 percent for SMA mixtures.

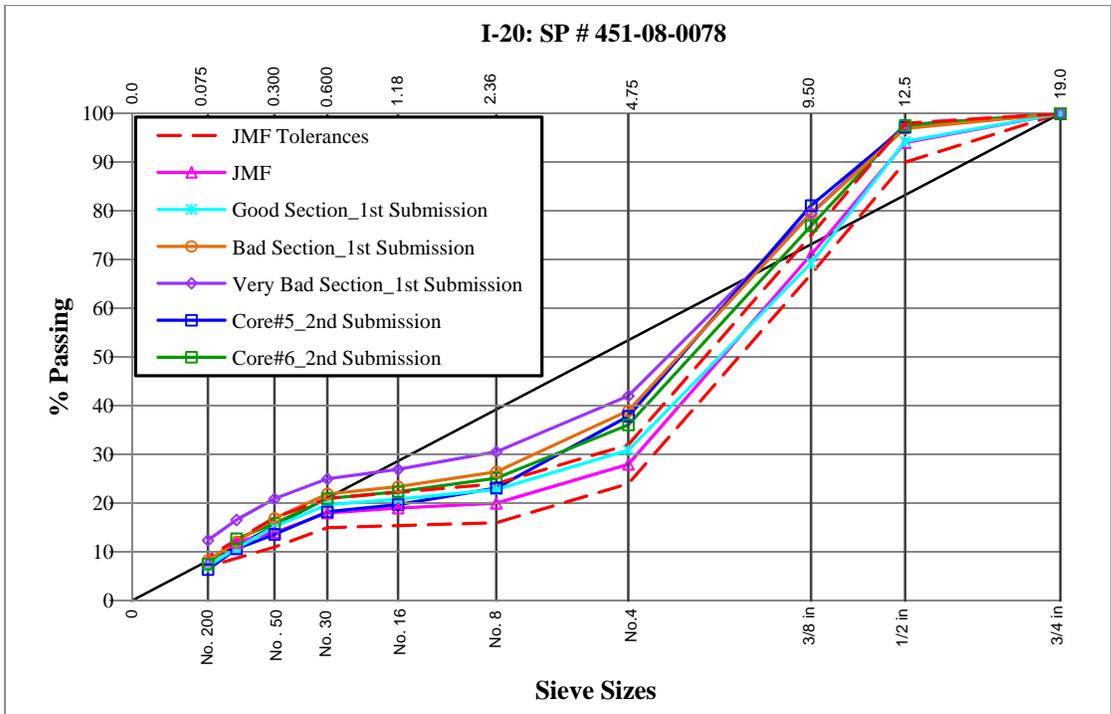
Figure 41
Aggregate blended gradations

Core # 5 and Core # 6 were used in obtaining the blended aggregate gradations and percent asphalt contents from ignition oven method. Figure 41 shows a comparison of blended gradations with the original job mix formula (JMF), specified tolerances for SMA mixtures, and the blended aggregate gradations found from the roadway cores previously submitted (roadway cores represented the good, bad, and very bad sections of the first submission). It is evident that the extracted aggregate gradations obtained at the LTRC Asphalt Lab did not match the gradations reported in the approved JMF. Also, the “percent passing” values for several sieves exceeded the tolerance limits specified in current LADOTD specifications for SMA mixtures. Interestingly, for the No. 4, 3/8 inch, and 1/2 inch sieves, the “percent passing” values from second submission of roadway cores are similar to the mixtures representing bad and very bad sections in the first submission of cores. The percent asphalt content obtained from Core # 5 and Core # 6 were 6.41 and 6.51 percent respectively whereas, the asphalt content in the approved JMF was reported to be 6.0 percent. The asphalt content for the first set of roadway cores from good, bad, and very bad sections are 6.18, 6.37, and 6.16 percent respectively. Note that the current LADOTD specifications tolerate 6.0 ± 0.4 percent of extracted asphalt in SMA mixtures.

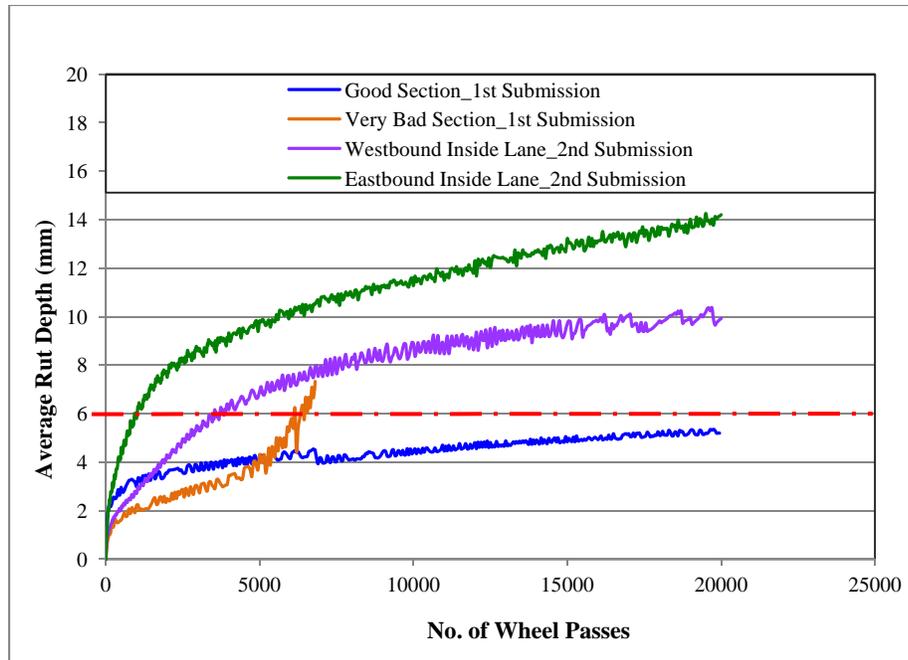
Figure 42
LWT test results

To evaluate the rutting potential and moisture susceptibility of SMA mixture used in this project, cores from Westbound (Core # 1 and 2) and Eastbound (Core # 3 and 4) lanes were used in LWT (Hamburg) tests in accordance with AASHTO T 324. Results presented in Figure 42 indicate that roadway cores from both sections exceeded the maximum suggested rut depth requirement of 6.0 mm after 20,000 passes. Also, no sign of stripping was observed for those specimens. It should be noted that the roadway cores from very bad section of first submission failed immediately after 6300 wheel passes and showed sign of severe stripping.
