TECHSUMMARY *March 2014*

State Project No. 736-99-1370 / LTRC Project No. 05-5ST

Development and Performance Evaluation of Fiber Reinforced Polymer Bridge

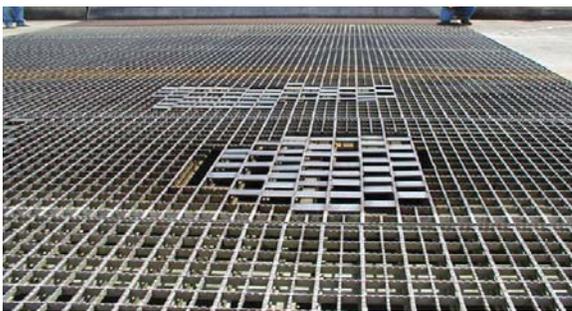
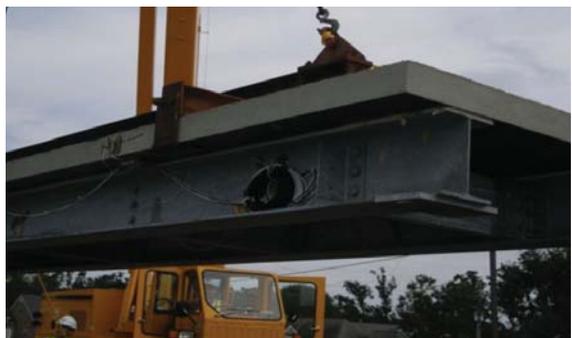
Figure 1 . Old damaged steel grid deck and new FRP-wrapped balsa wood deck
