Technical Assistance Report 17-01TA-C

Cracked Pavement Investigation

Re: H.003496
I-49 North: Segment J
Caddo Parish
DRAFT Cracked Pavement Investigation

DRAFT CRACKED PAVEMENT INVESTIGATION

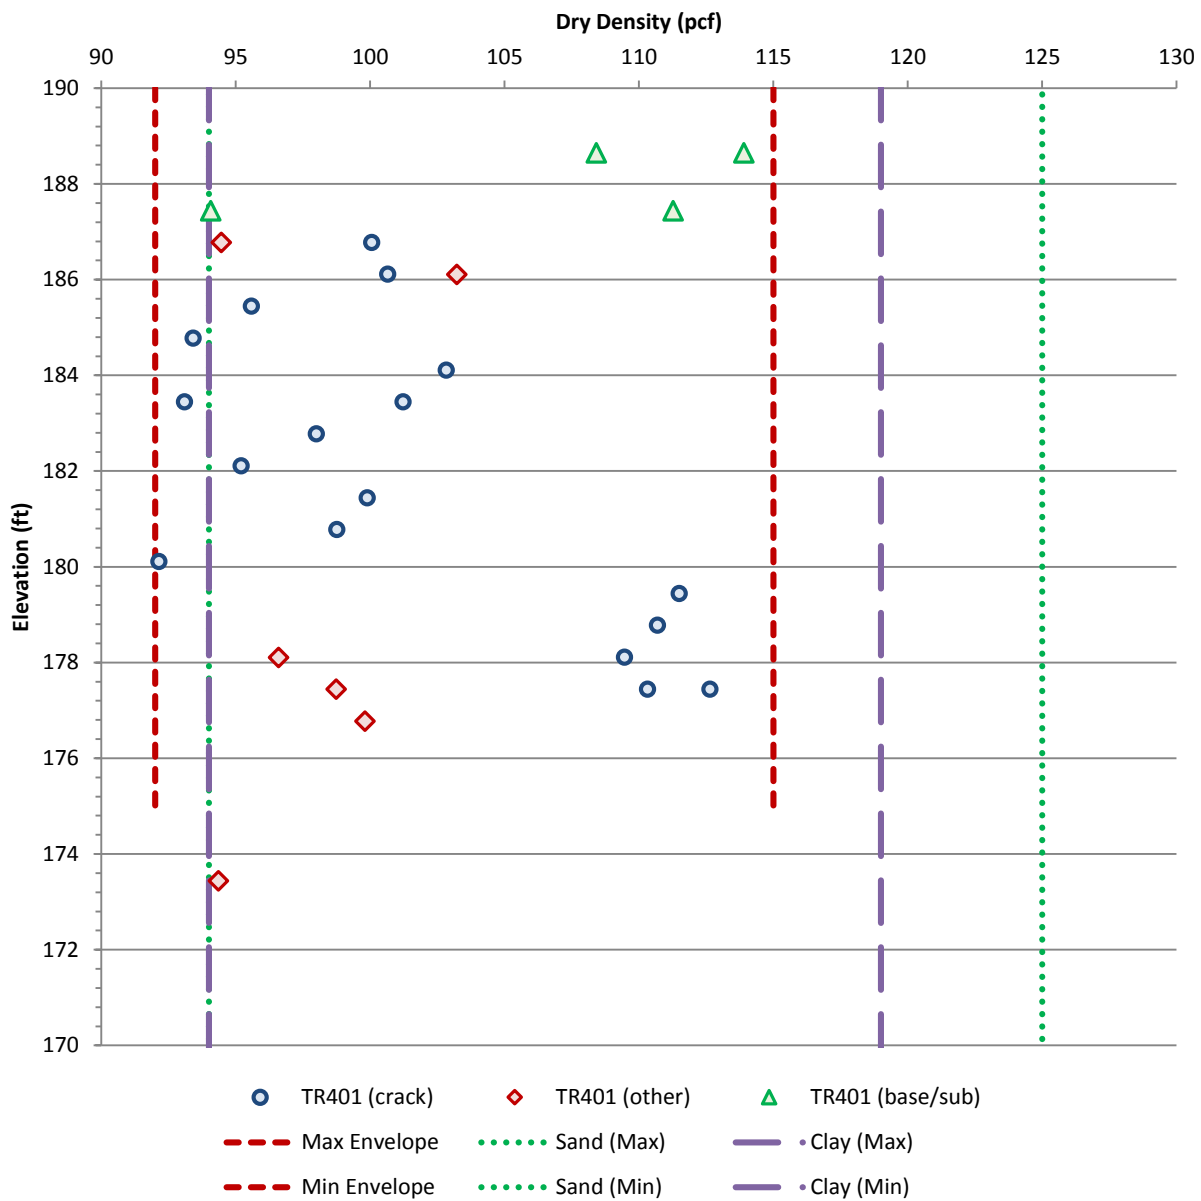
Figure 2 and Figure 3 show the field moisture contents and dry densities determined from the nuclear density testing plotted against approximate elevation. The values are divided into 3 groups: tests

performed in the crack area (based on stationing), tests performed outside of the crack area, and tests performed within the treated subgrade and base material. Several min/max envelopes are also shown: the envelope bounding the in-place testing as well as the envelopes recommended by FHWA for compacted sands and lean clays from Table 3 above.

Based on these plots, some of the test results indicate moisture contents higher than the upper bound established for compacted lean clays. Many of the tests fall significantly higher than the upper bound established for compacted sands. Similarly, several of the tests for dry density fall below the lower bound for both compacted sands and lean clays. It should be noted that the majority of the classification tests submitted for fill acceptance indicated that the borrow material was comprised of silty sand. Only a few of the tests were classified as lean clay. Unfortunately, the type of material in each tested lift was not recorded on the nuclear density test documentation, so it is not possible to separate each of the plotted points into clay and sand categories.

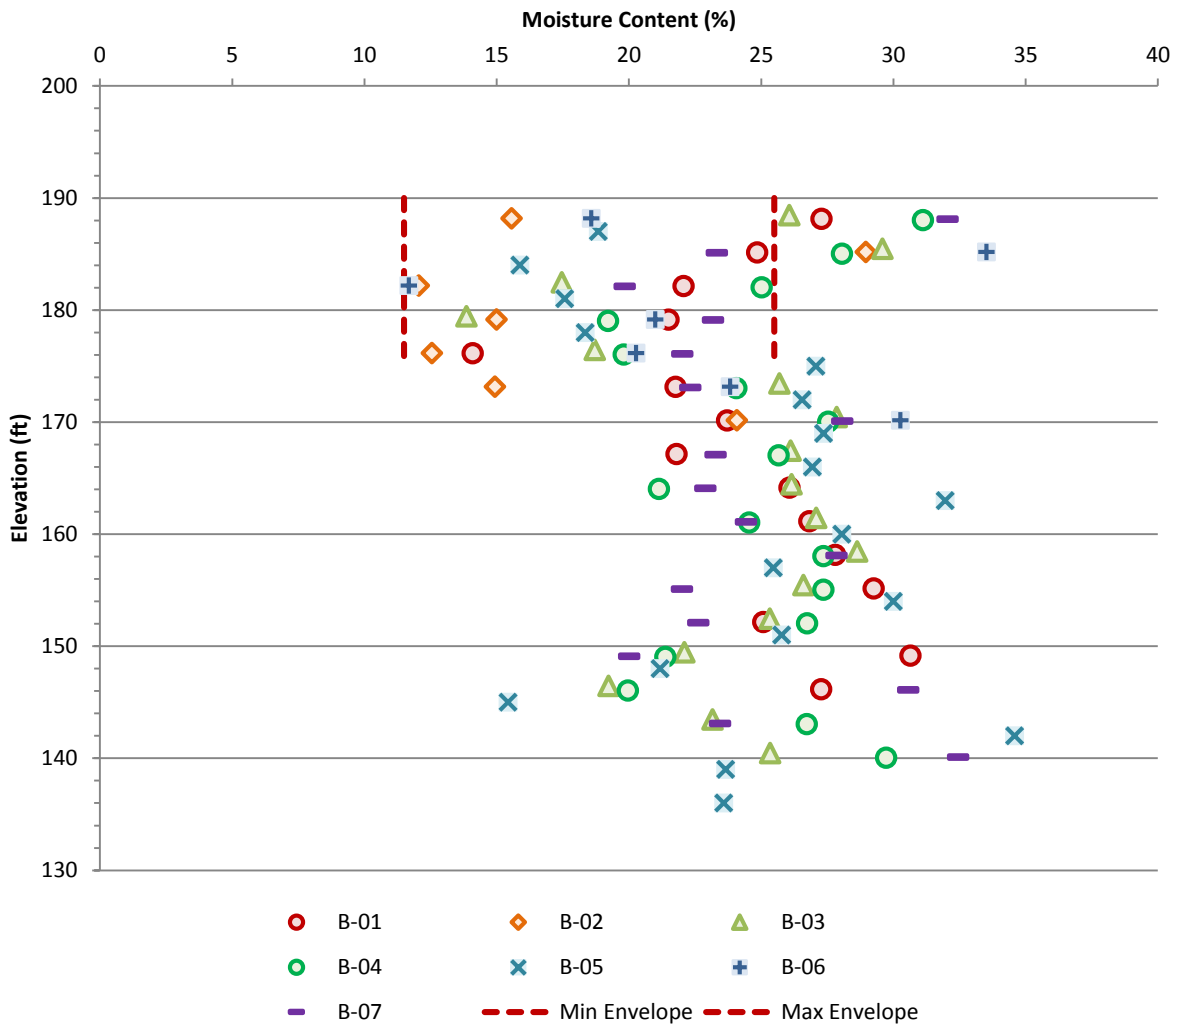
Figure 4: Moisture Content (from Laboratory Testing) vs. Elevation

The min/max envelope for the in-place nuclear density testing was then superimposed on the moisture content versus elevation data from the geotechnical laboratory, shown in Figure 4 below.
