Technical Assistance Report 18-04TA-P

**Submerged Road Characteristics and Distresses
on LA 493, Natchitoches Parish, State Project Number H.011071**

Kevin Gaspard, P.E.
Zhongjie Zhang, Ph.D., P.E.

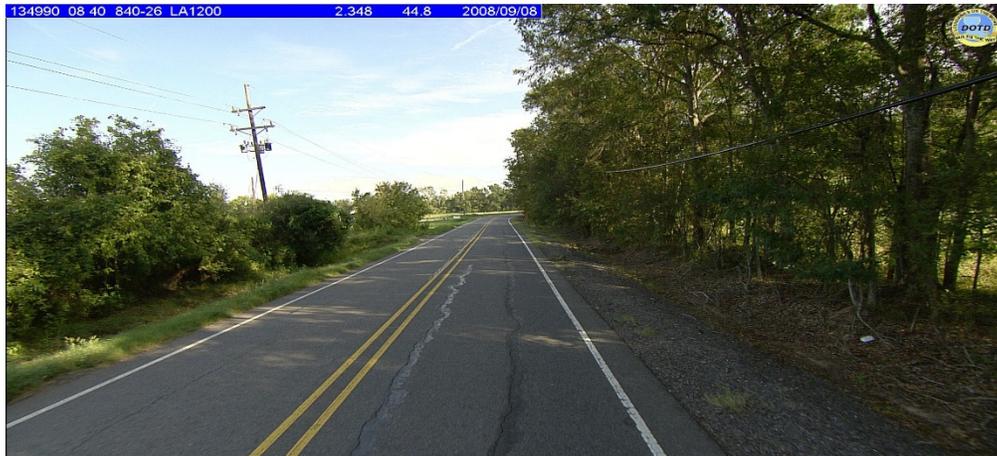
Figure 1

Longitudinal cracks: LA 1200: CSLM 2.348

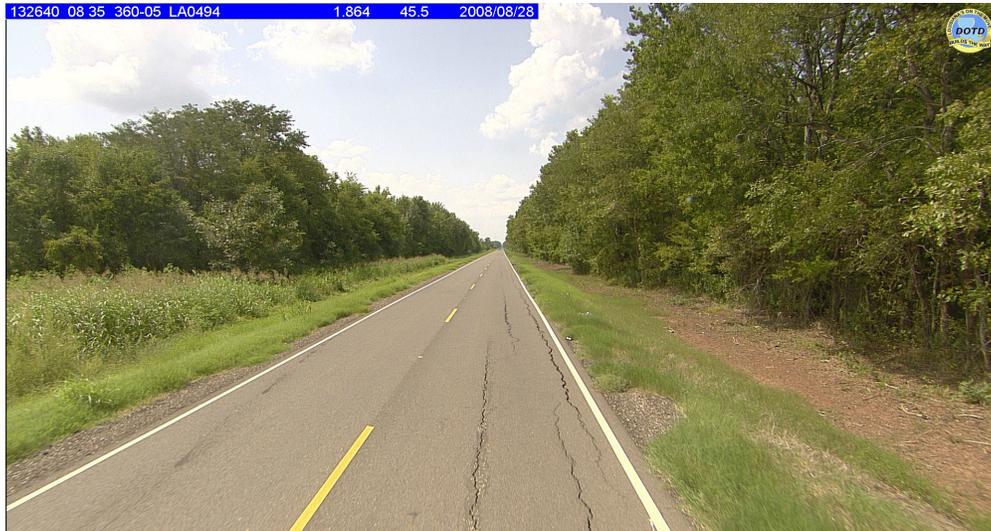
Figure 2
Multiple Longitudinal cracks: LA 494: CSLM 1.864

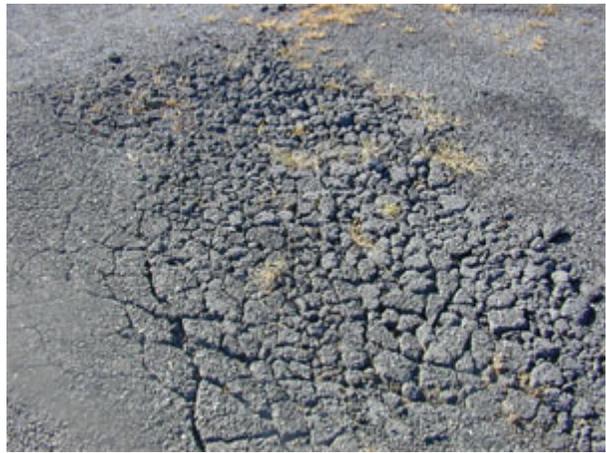
Figure 4
Alligator cracking in AC surface

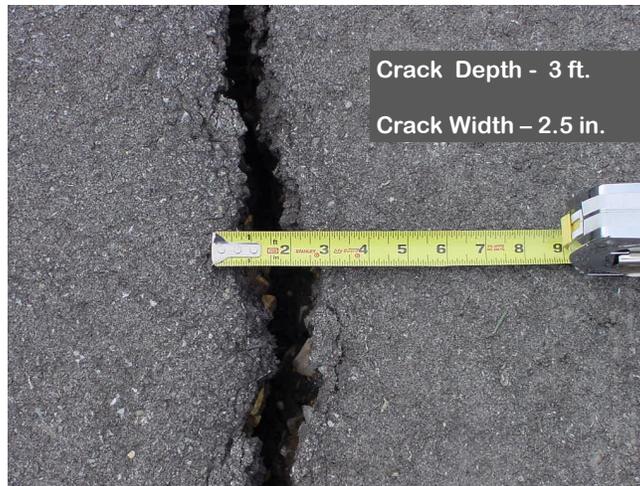
Figure 5
Parish Road: St. Martin Parish

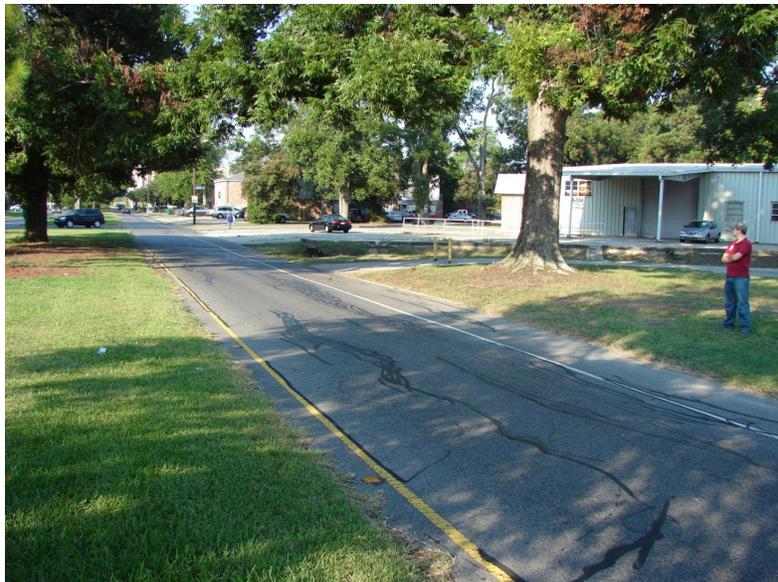
Figure 7
Multiple longitudinal cracks and subsidence: West Parker near LTRC

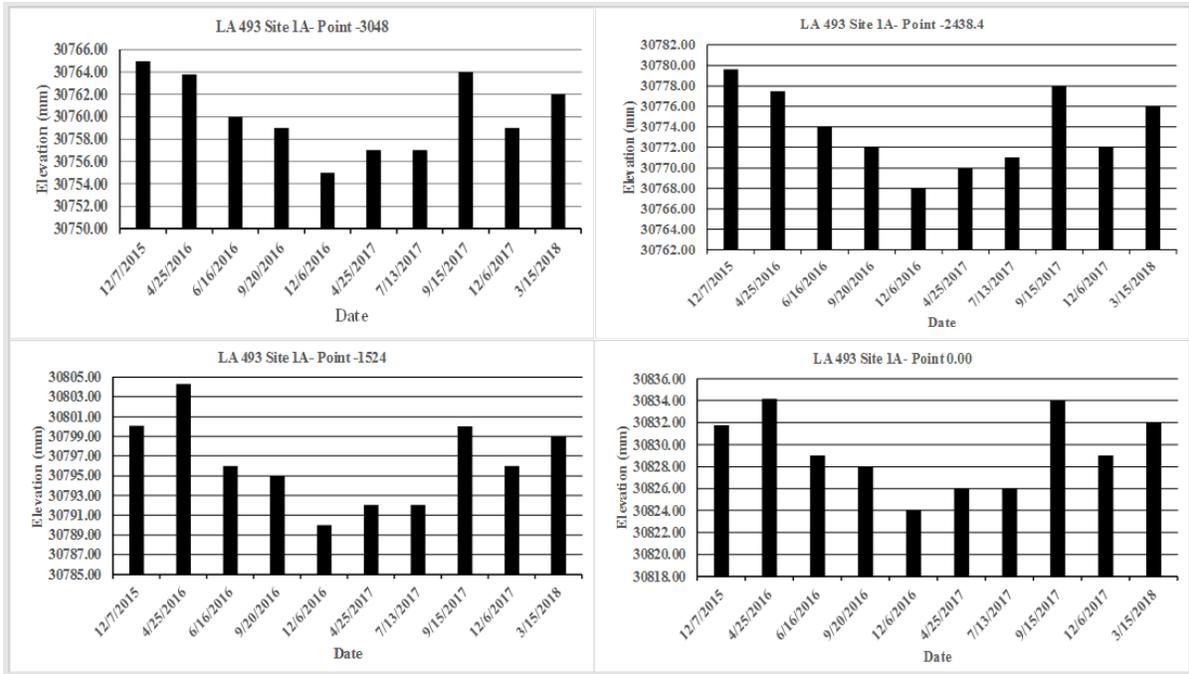
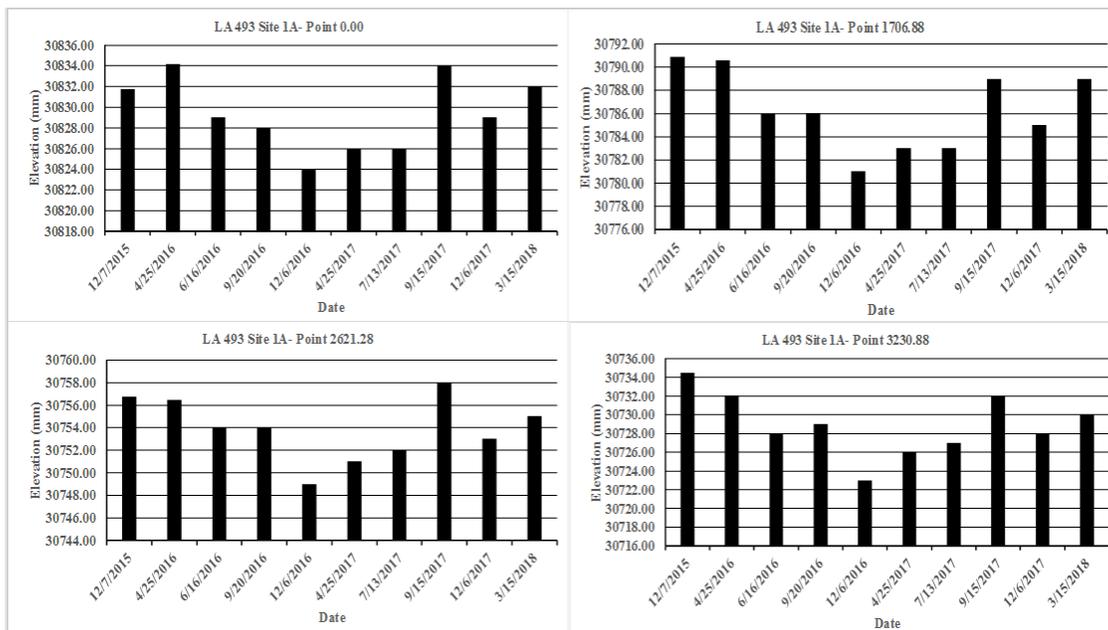
Further interesting observations from the survey measurements from Site 1A were that some points showed elevation increases while others showed elevation decreases across the roadway cross-section. One plausible explanation is that because of differential movement in the subgrade, semi-rigidity of the soil cement base course, and partial rigidity of the AC layer, an upward movement at one location may cause a downward movement at the adjacent location. A detailed finite element analysis, which is beyond the scope of this report, could validate this. This phenomenon though does fortify the notion that differential movements are occurring at roadway surface and those movements will induce stress into the AC layer which will eventually if not immediately lead to damage. In fact, careful examination of the values in Table 6 and Figures 12-13 reveal the obvious movements of each point as well as the differences of movement of each point over the course of the cross-section surveys (12/7/2015 to 3/15/2018) as well as the effect of submergence.

Figure 12
Charts of cross-section points for Site 1A (point -3048.00 to point 0.00)

Figure 13
Charts of cross-section points for Site 1A (point 0.00 to point 3230.88)

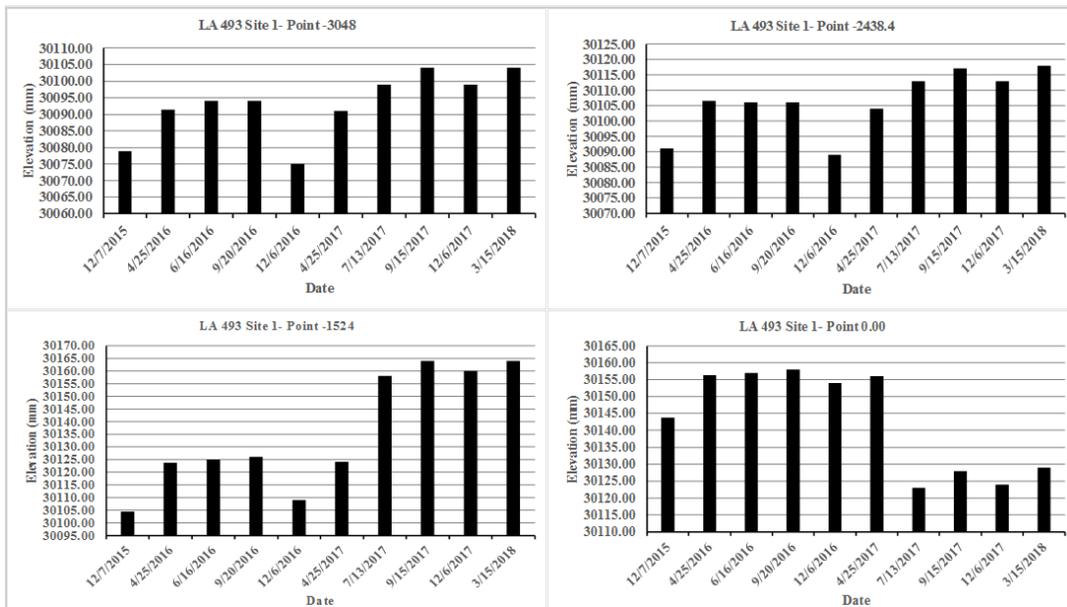
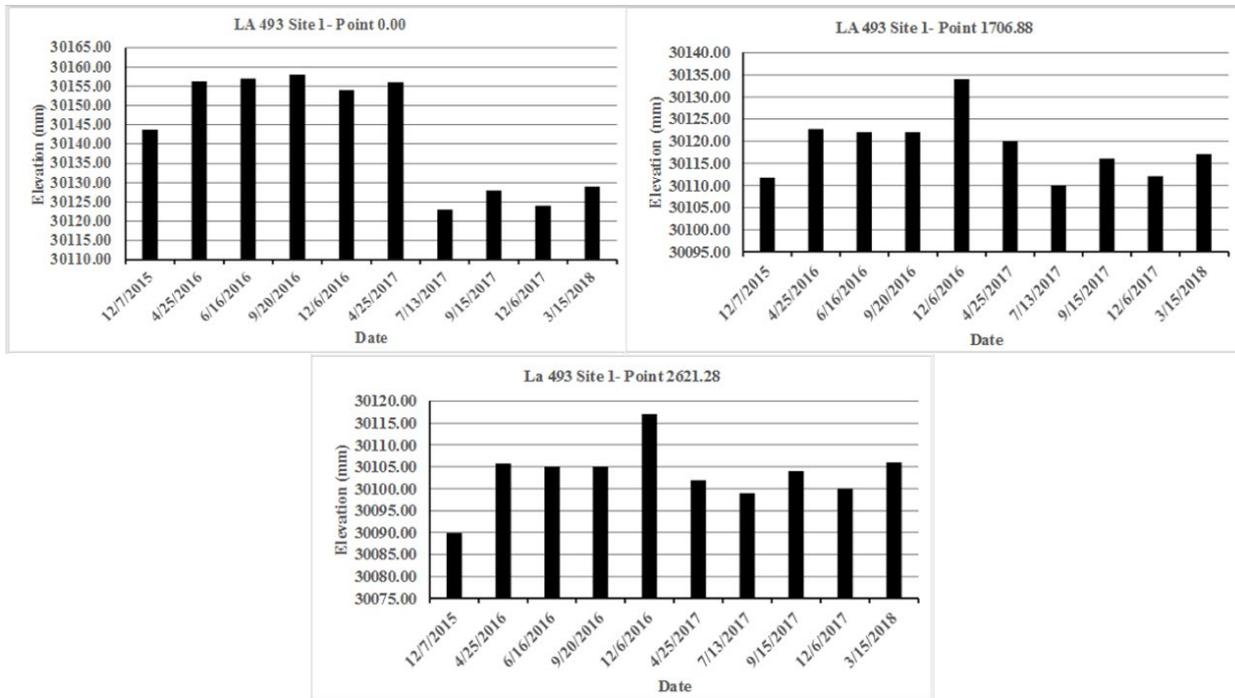
Tables 7-8 and Figures 14-15 present the results for the cross-section surveys. For this cross-section, no data is reported for the point 3230.88 because the edge of the road where this point was originally taken was damaged by heavy machinery. The elevation of the cross-section points (4/25/2016) all increased after the first flooding event with elevation increases ranging from 19.20 mm to 10.97 mm. As with section 1A, no adjacent point increased with a similar magnitude indicating that bending stresses were induced into the AC pavement and underlying layers. The trend toward increasing elevations continued until 12/6/2016 at which time the centerline (0) and left side of the roadway (- distances) reduced in magnitude while there was a general increase in magnitude on the right side (+ distances) of the roadway. The reasons for these differences between the left side and right side of the roadway is unknown. However, the reasons for the decreases in elevation (shrinking) can be explained because no flooding occurred between the 4/25/2016 and 12/6/2016. This trend generally reversed (increasing elevations) in the period between 4/25/2017 and 3/15/2018 which is probably the result of the two flooding events February 2017 to April 2017 and July 2017 to August 2017. It should be noted that on 3/15/2018, the AC surface was 59.51 mm (2.34 in.) higher than the time of the first cross-sectional survey on 12/7/2015 and that no point measured on the cross-section had the same magnitude.

Figure 14
Charts of cross-section points for Site 1 (point -3048.00 to point 0.00)

Figure 15
Charts of cross-section points for Site 1 (point 0.00 to 2621.28)

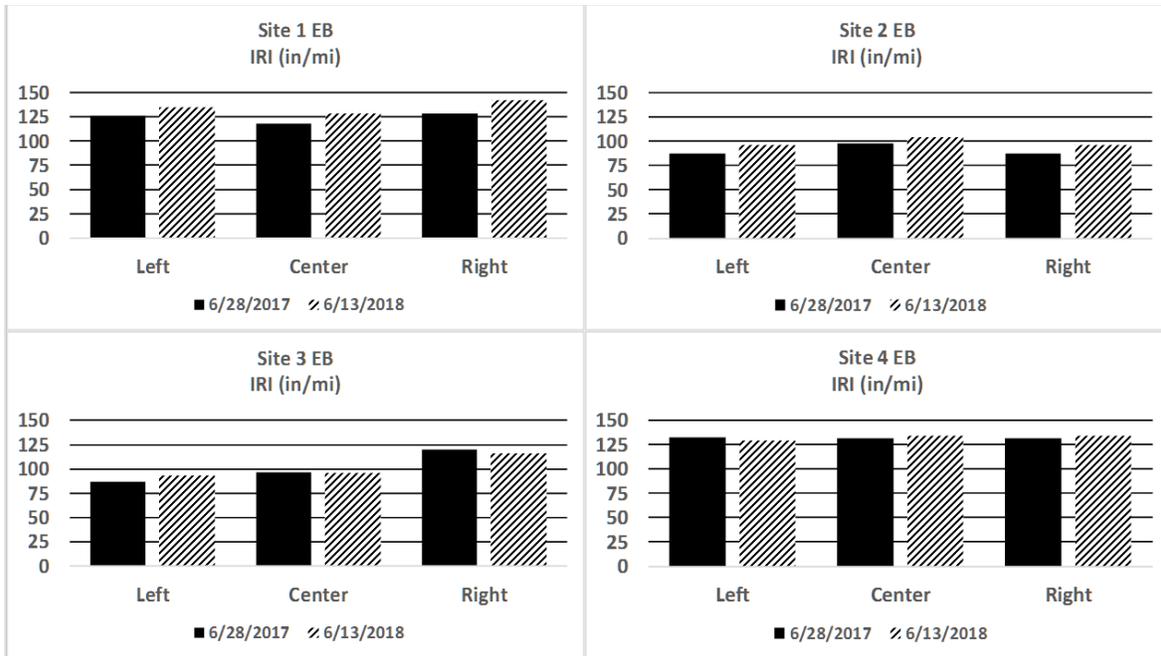
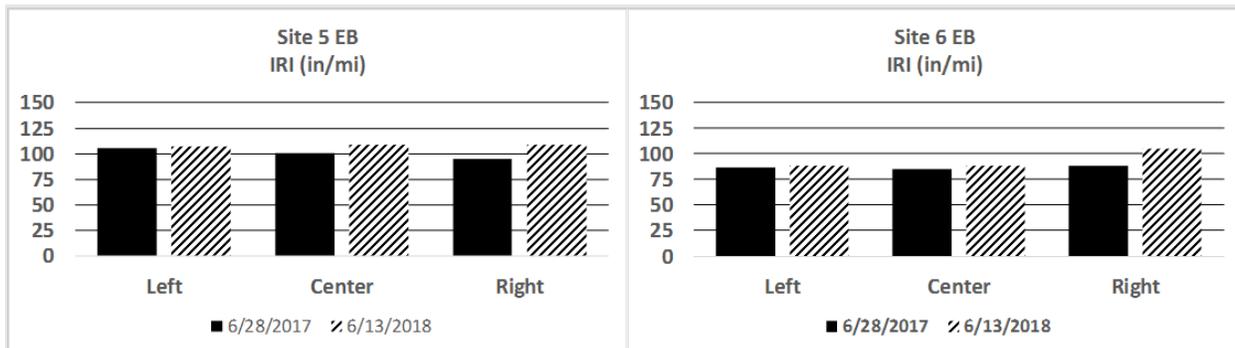
The IRI measurements for the six sites are presented in Figures 26 and 27. Regarding the EB direction assessment, there was only approximately 300 ft. on roadway available for the vehicle to begin its assessment. Because of that, the profile data may not represent the conditions of the roadway surface for Site 1. The profile measurements on the remaining sites (2-6) should not have been affected. IRI values for all sites exceeded 75 on the June 2017 collection date indicating that the roadway is rougher than it should be for the amount of time that it has been in service.

For Site 6, the IRI values for the LWP and RWP were higher than the CLP for the June 2017 collection date. On the June 2018 collection date, the LWP and CLP had similar IRI values and both were less than the RWP. The IRI values for the June 2018 collection date were larger than the June 2017 collection date.

Figure 26
EB IRI for Sites 1 to 4

Figure 27
EB IRI for Sites 5 to 6

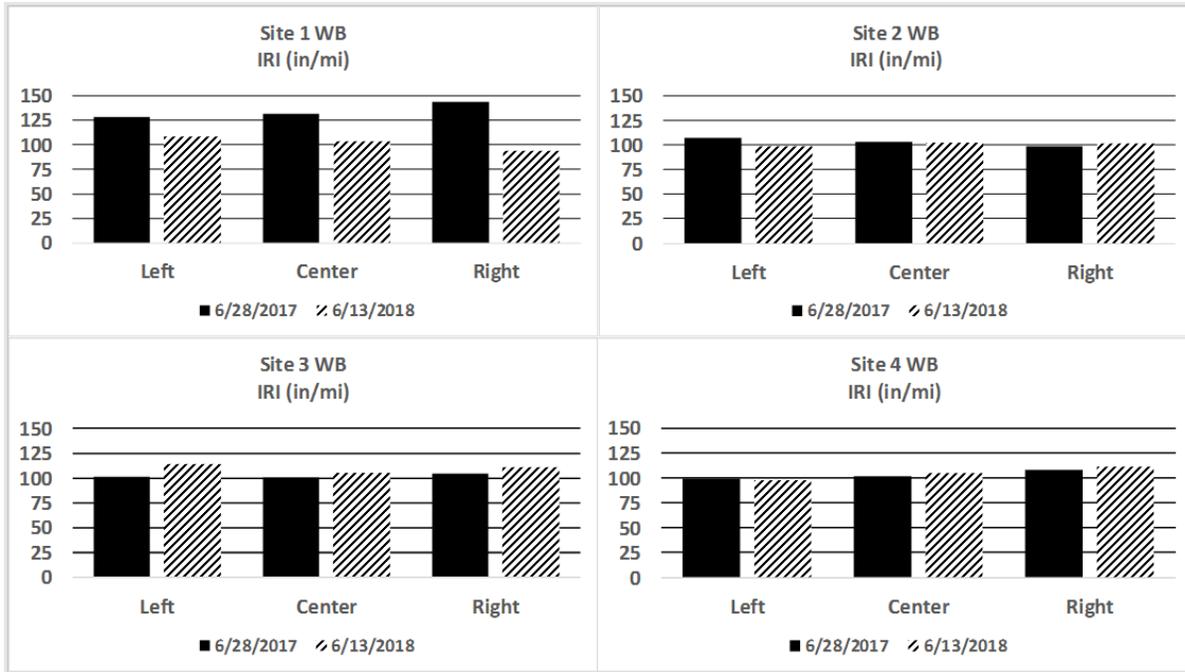
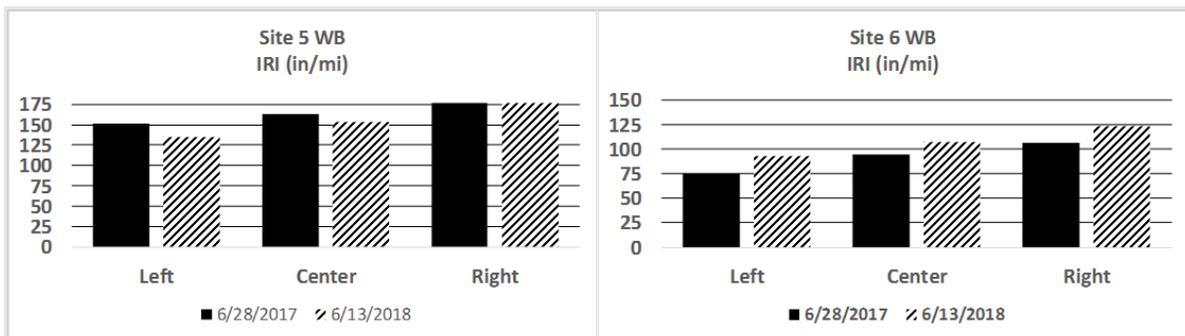
On Site 6, the IRI value on the RWP was greater than the CLP and both were greater than the LWP on the June 2017 collection date. The trend was similar in the June 2018 collection date and all the IRI values increased.

Figure 28
WB IRI for Sites 1 to 4

Figure 29
WB IRI for Sites 5 to 6

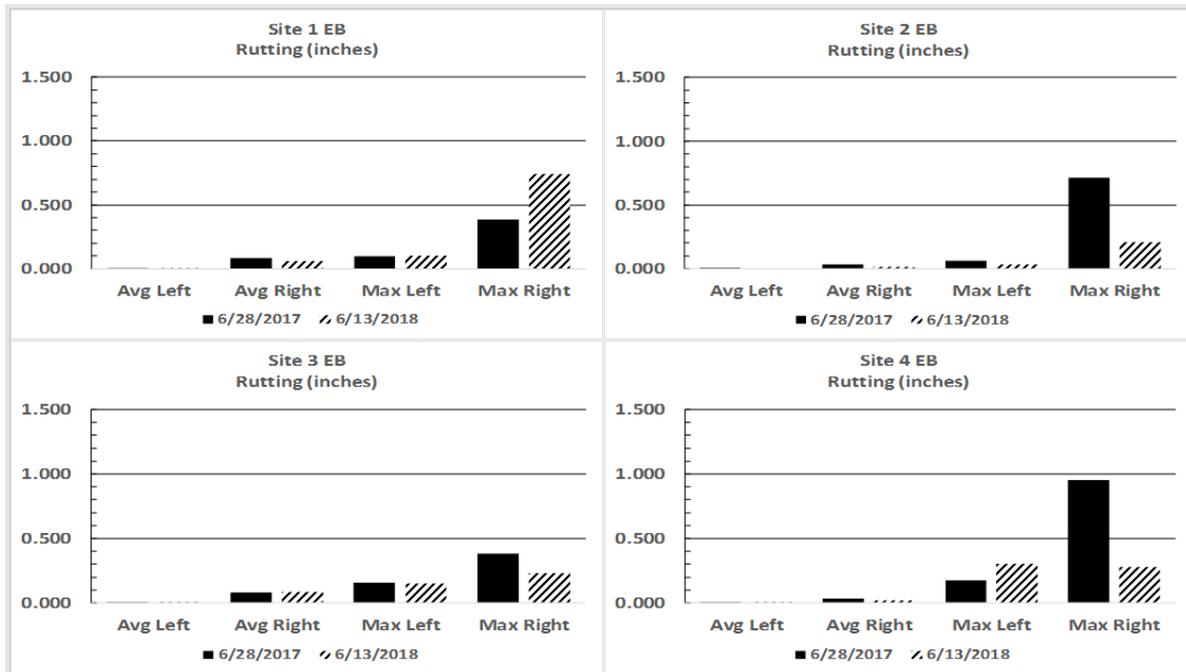
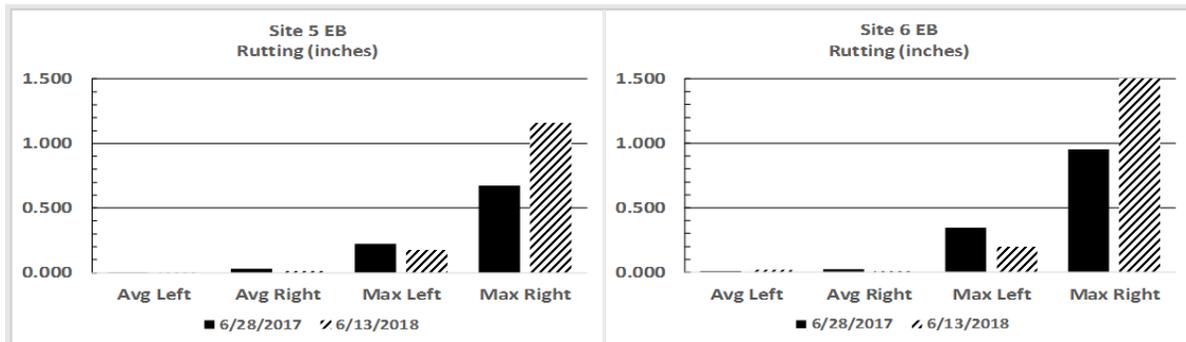
Figures 34 and 35 present the rutting measurements for Sites 1 to 6 on the assessment dates of June 2017 and June 2018. DOTD considers rutting greater than 0.5 in. to be significant and in need of mitigation. The average rutting depths for each site were very minor but there were significant maximum rutting depths at some locations within each Site. It is probable that the significant rutting at some locations were due to weakening of the pavement structure due to volumetric changes in the embankment as well as depressions caused by movements in the embankment. For Site 1, the maximum rutting in the RWP was 0.386 in. in June 2017 and 0.74 in. in June 2018 indicating that rutting in those locations are increasing. Site 2 showed a similar pattern with the maximum rutting in the RWP being 0.713 in. in June 2017 and 0.205 in. on June 2018. The reason for the decrease in the maximum rutting between June 2017 and June 2018 is unknown. The maximum rutting values for Site 3 in the RWP were 0.382 in. on June 2017 and 0.232 in. on June 2018. Site 4 had maximum rutting values in the RWP of 0.953 in. on June 2017 and 0.28 in. on June 2018. As with Site 2, the authors are uncertain of the decrease in maximum rutting between June 2017 and June 2018. The maximum rutting values in the RWP for Site 5 were 0.673 in. and 1.2 in. on June 2017 and June 2018, respectively. This site had the highest maximum rut depth in the EB direction. Site 6 had maximum rutting values in the RWP of 0.953 in. and 1.5 in. on June 2017 and June 2018, respectively.

Figure 34
EB rutting for Sites 1 to 4

Figure 35
EB rutting for Sites 5 and 6

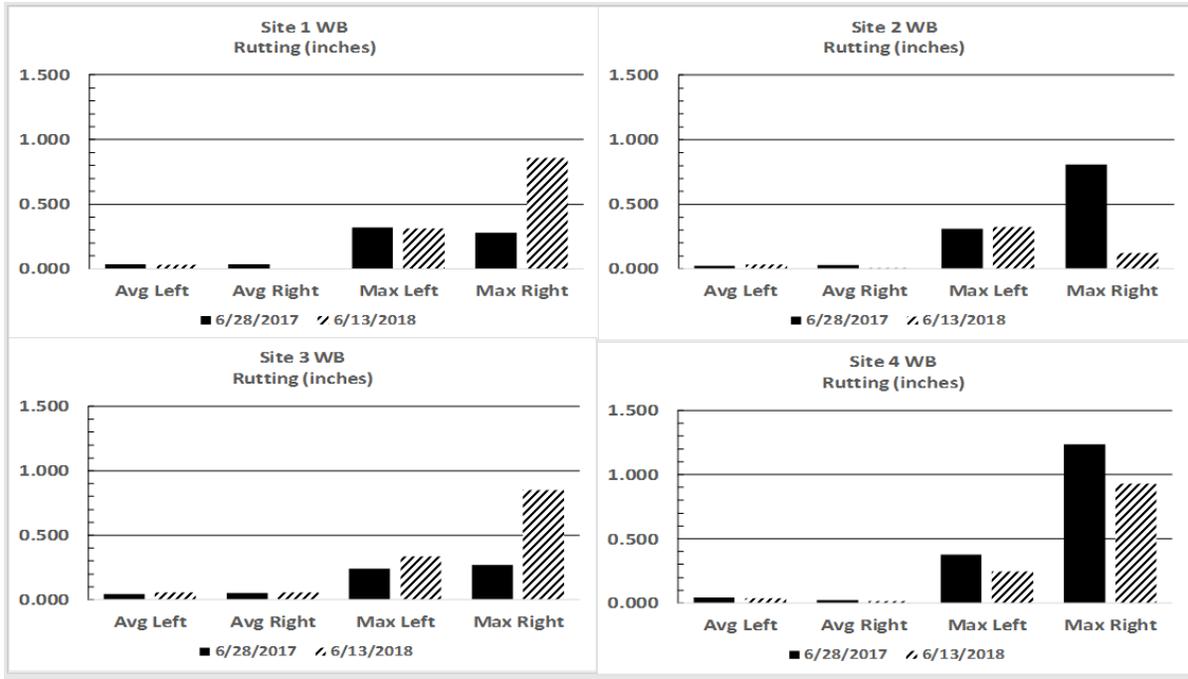
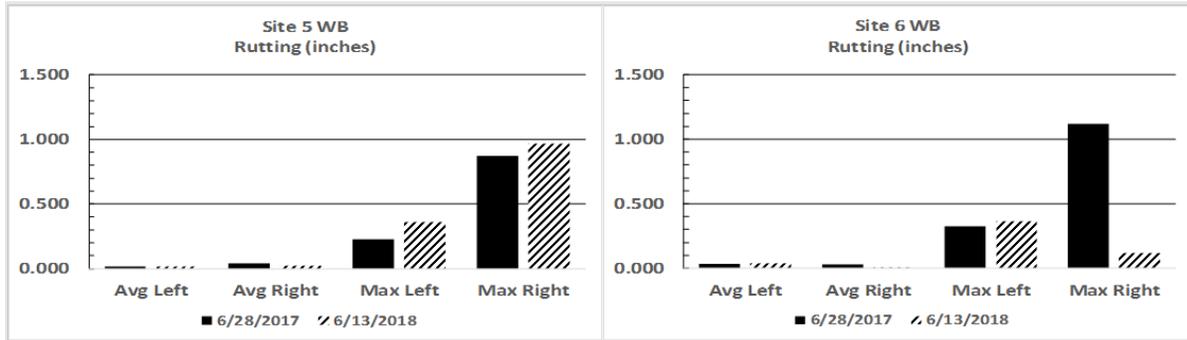
2017 and June 2018, respectively. Regarding Site 5, the maximum rutting depth in the RWP in June 2017 was 0.824 in. and on June 2018 it was 0.965 in. On Site 6, the maximum rutting depth on the RWP was 1.118 in. on June 2017 and 0.118 in. in June 2018.

Figure 36
WB rutting for Sites 1 to 4

Figure 37
WB rutting for Sites 5 and 6
