1. Title and Subtitle
**Forensic Evaluation of Pavement Structure:
Ponderosa Drive in East Baton Rouge Parish**
2. Author(s)
Qiming Chen, Ph.D., P.E., Nicholas Ferguson, P.E., Moses Akentuna, Ph.D., P.E., Saman Salari, P.E., Gavin Gautreau, P.E., Samuel Cooper, III, Ph.D., P.E.

5. Report No.
FHWA/LA.17/21-01TA-P
6. Report Date
January 2022
7. Performing Organization Code
LTRC Project Number: 21-01TA-P
8. Type of Report and Period Covered
Technical Assistance Report
August 2020-August 2021

Forensic Evaluation of Pavement Structure: Ponderosa Drive in East Baton Rouge Parish

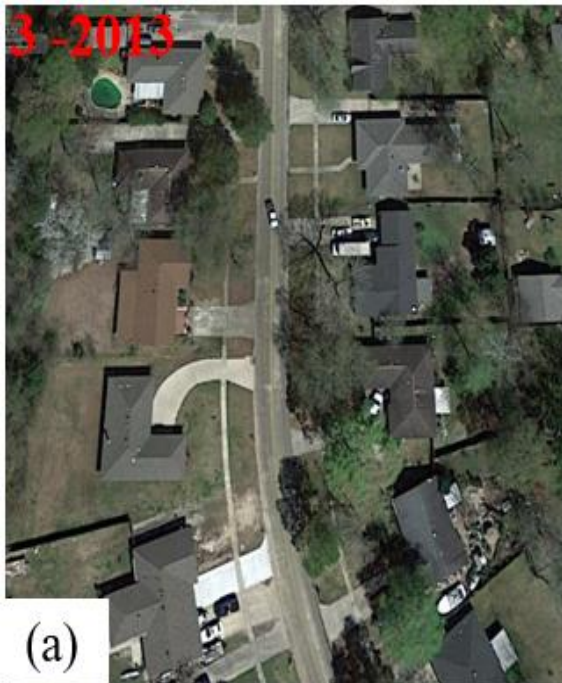
LTRC's roadway profiler and imaging vehicle (hereafter referred to as profiler) and falling weight deflectometer (FWD) were utilized for the pavement evaluation. Prior to performing the field evaluation of the pavement structure, the pavement research group obtained six years of Google Earth images of the pavement section to ascertain the progressive deterioration of the pavement section over the years; see Figures 3 and 4. Figures 3a and 3b show images of the road section before and during rehabilitation in 2013 and 2014, respectively. It is worth noting that the white spots, which are an indication of pavement deterioration and pumping failure, existed in 2013 before rehabilitation; see Figure 3a. Figures 4a, 4b, and 4c show the road section after rehabilitation (with some white spots appearing in January 2016, then followed by an apparent patching activity; see Figures 4b and 4c) and before the August 2016 flood. In addition, Figures 4d, 4e, and 4f present images of the road section after the August 2016 floods. It is noted that the white spots started appearing again on the road section from November 2017 and intensified in May 2019; see Figures 4e and 4f. Figure 5 shows detailed images of the deteriorated spots observed in May 2019, which are marked with red quadrilateral solid lines. Based on the preliminary analysis of the Google Earth images, the early deterioration of the road section may be attributed to the presence of weak spots in the pavement structure. This observation indicates that 2014 rehabilitation may not have improved the underlying weaker spots in the pavement. Additional causes of the early deterioration include weakening of the base and subgrade layers due to the August 2016 flood and the subsequent use of the road section by heavier waste disposal trucks to cart away flood debris.

Figure 3. Google Earth images of road section in (a) March 2013 and (b) March 2014

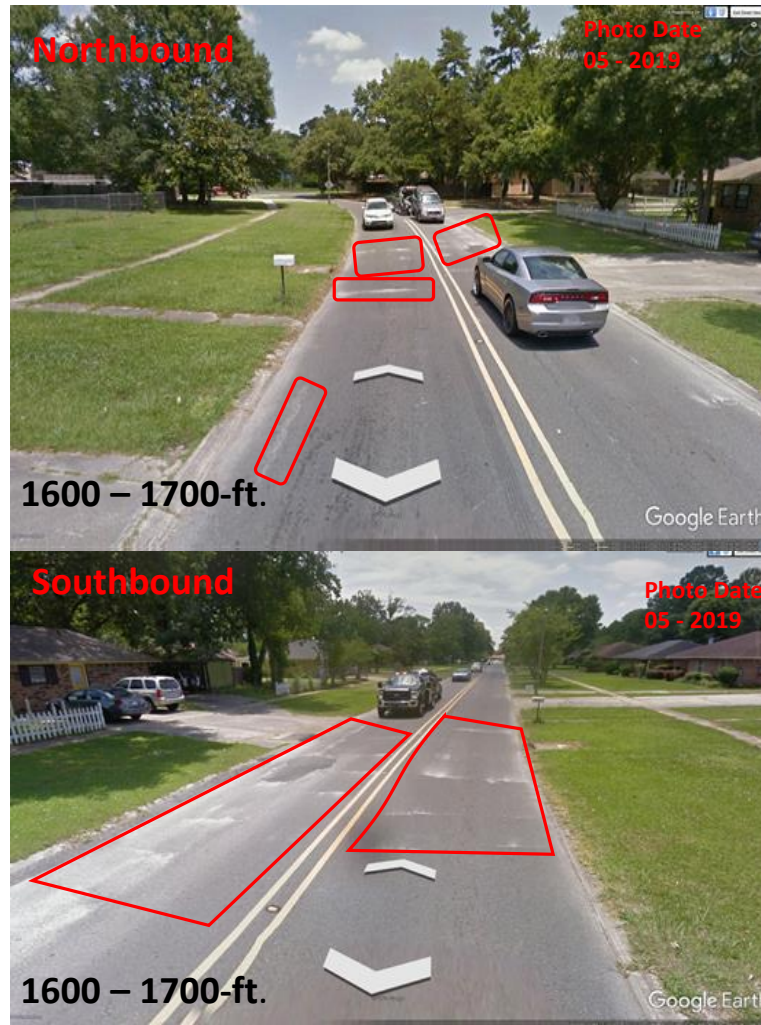
Figure 5. Distress locations in May 2019

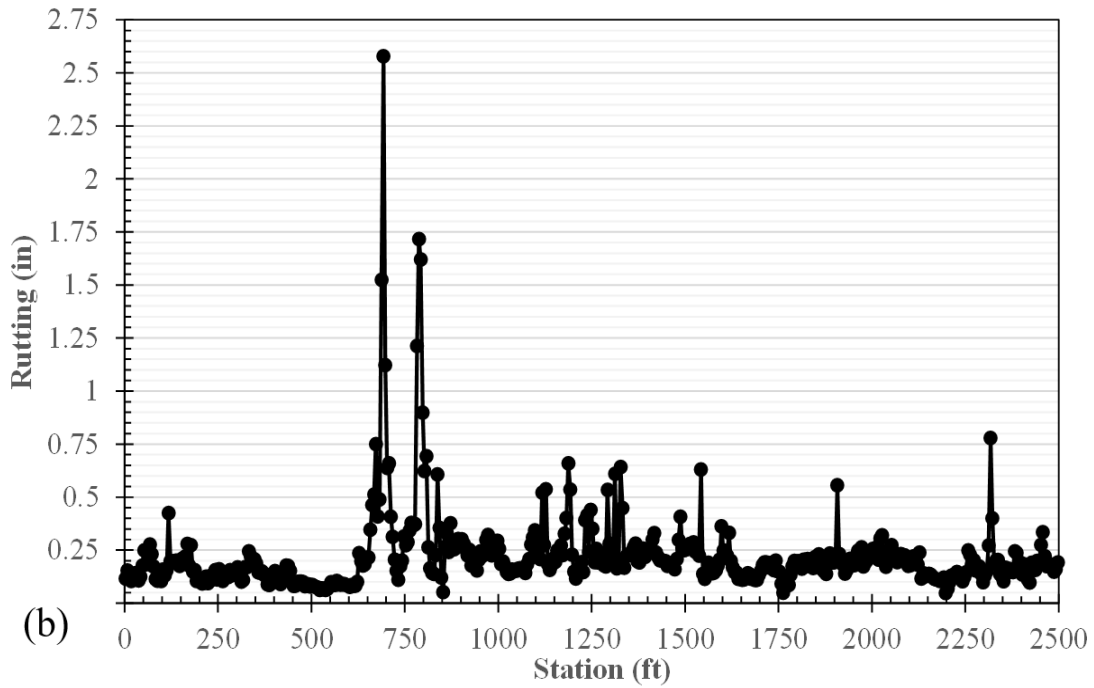
Rut depths were measured using LTRC's road profiler, which uses a 5-point rut bar system for pavement rut depth measurements. The rut depths were continuously measured as the survey van drove on the pavement section. The measured rut depths are presented in Figure 7. A couple of locations along the section exhibited rut depths greater than 0.75 in. The rut depths at a few locations were greater than 1 in. Such high rut depths are not typically observed in asphalt pavements with soil cement base. This observation may be attributed to a weakened base or subgrade layer.

Figure 7. Rutting values along (a) Northbound and (b) Southbound lanes

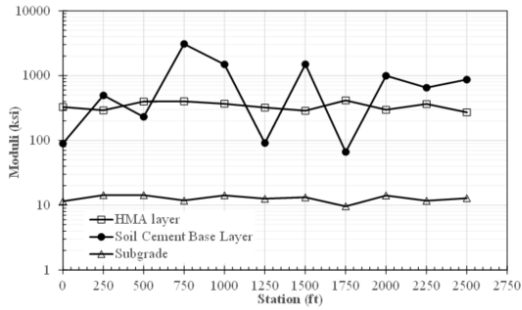
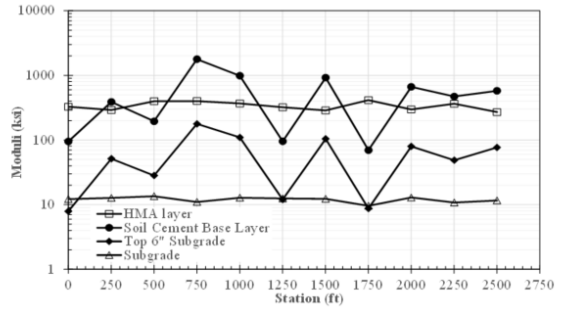
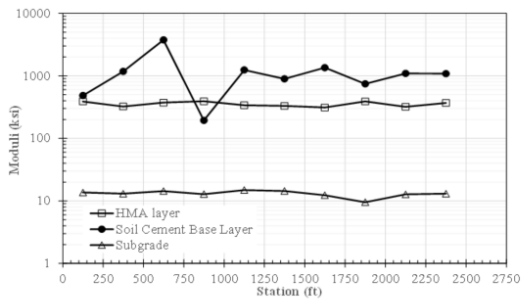
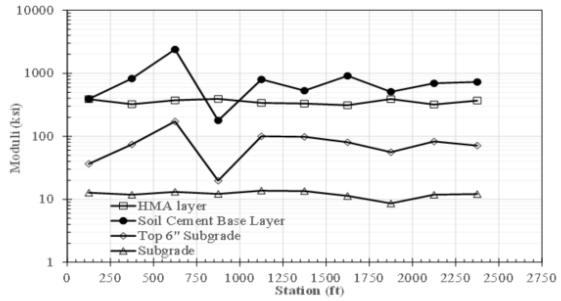
Figure 9 shows the backcalculation results for the various stations. Introducing a 6-in. top subgrade layer generally led to lower and more reasonable soil cement base modulus values. However, its effect on the backcalculated base modulus at stations with low modulus values (i.e., station 0, 1250, and 1750 Northbound) is minimal (within approximately 8-percent difference). The backcalculated soil cement base values at these stations were below 100 ksi (200 ksi is a typical value for stabilized soil cement [2]).

Figure 9. Backcalculated moduli for different layer combinations along the section

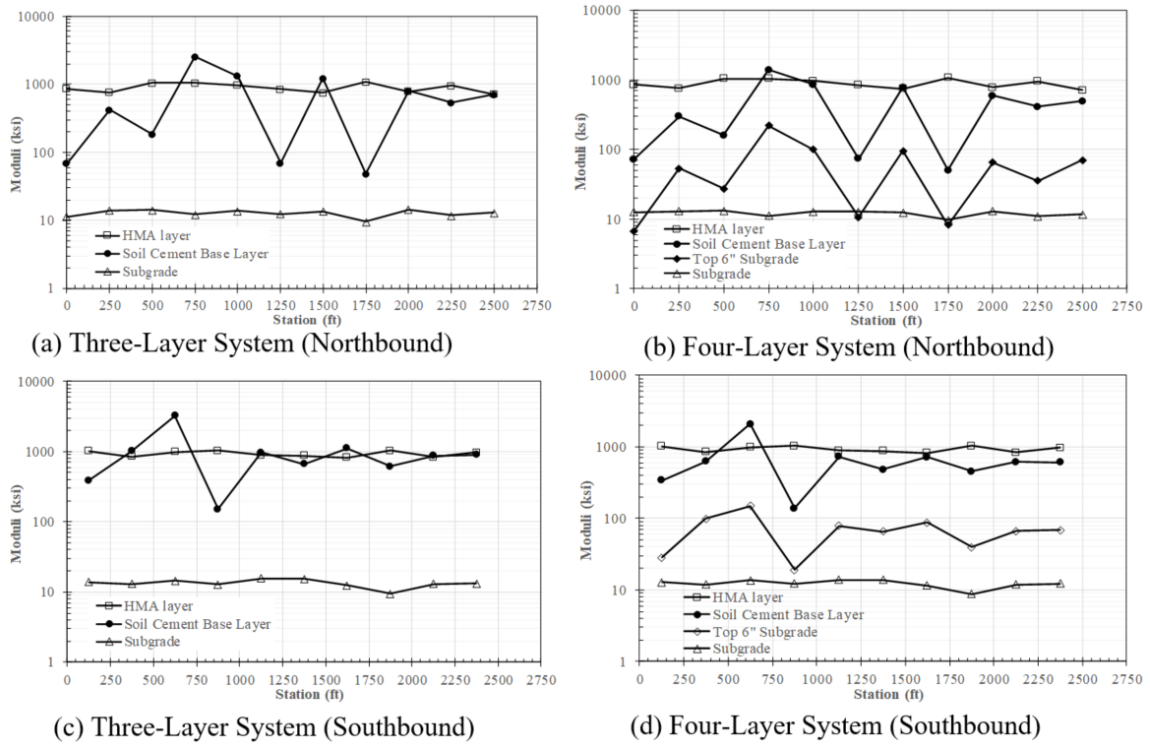
The backcalculation analysis was re-performed based on the recommended asphalt layer modulus value of 1180 ksi determined from the laboratory evaluation of field cores. Figure 10 illustrates the repeated backcalculation results for the various stations. Similar observations were made in the repeated backcalculation as compared to the initial backcalculation analysis; see Figures 9 and 10.

Figure 10. Repeated backcalculated moduli for different layer combinations along the section

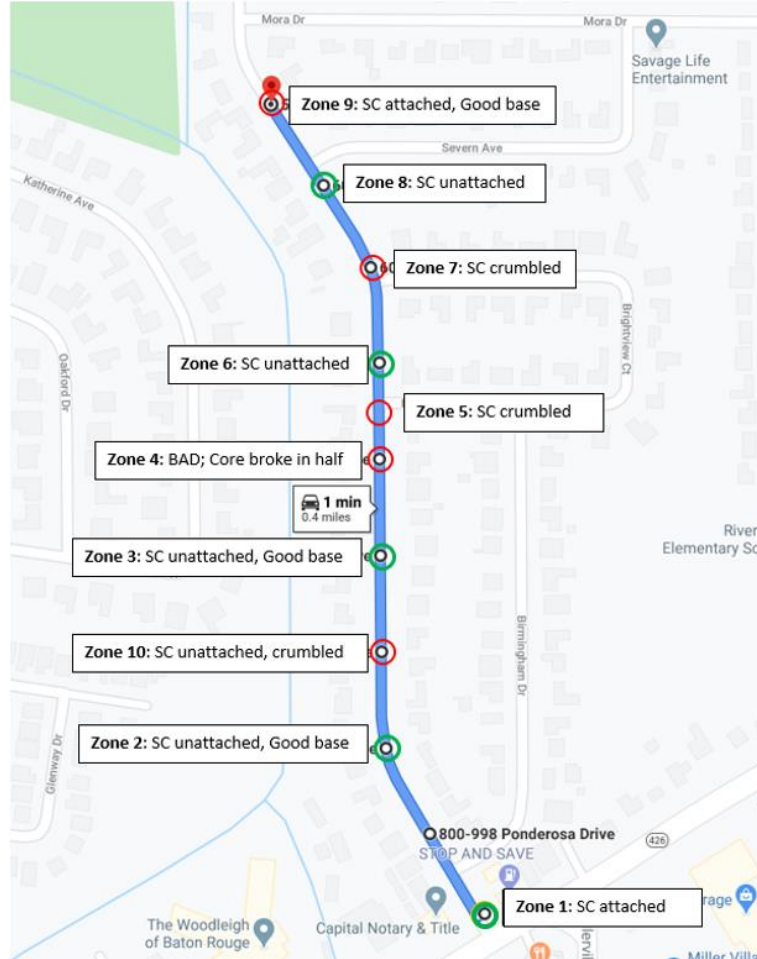
Prior to the geotechnical investigation, the asphalt crew performed 1-ft. coring operations at each of the 10 locations after ensuring that there were no underground utilities underneath the coring locations. Figure 12 indicates the asphalt core status (i.e., whether the soil cement base course was intact and attached to the asphalt layer). It is noted that the asphalt layer thickness varied from 1.5 to 2.8 in.

Figure 12. Core description map

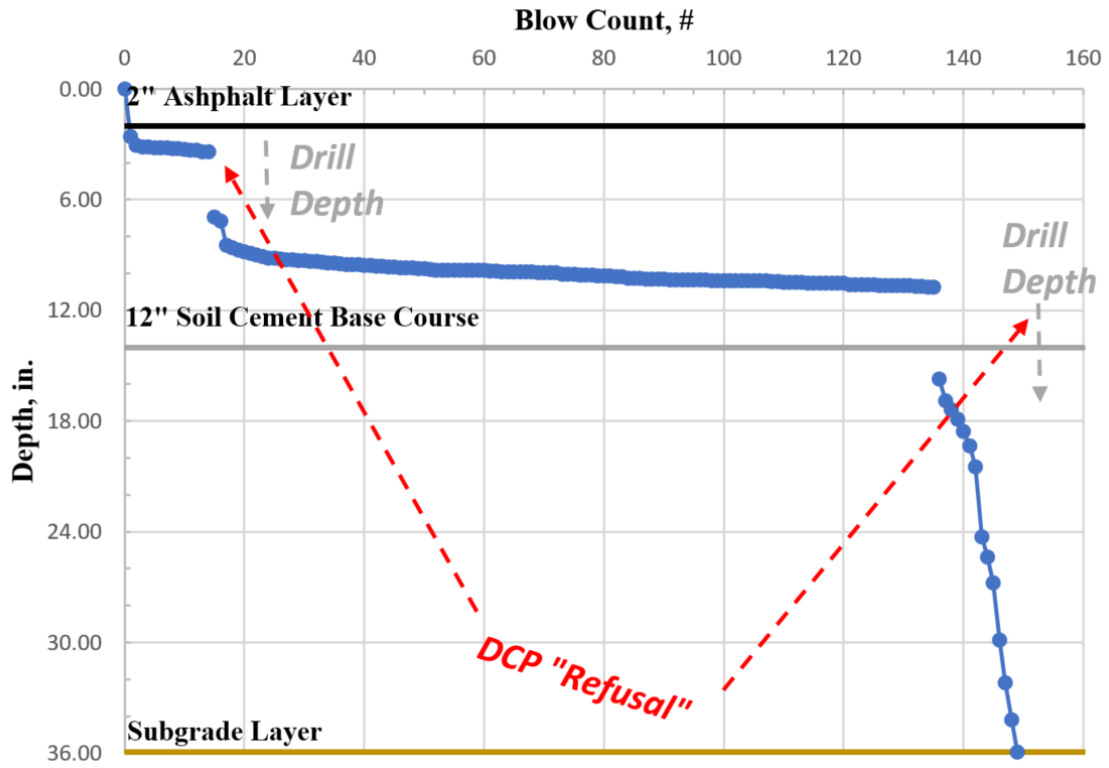
Zone 6 was initially deemed a “good spot” based on the FWD results. The DCP was performed within 2 ft. of the asphalt coring location. The soil cement base at this location was so stiff that it caused two DCP refusals. When the top of the soil cement reached refusal, the geotechnical group drilled to test the top of the lower half of the soil cement base course. When that also reached refusal, another hole was drilled to test the subgrade. Figure 17 presents a combination of three DCP tests plotted together on the same graph. The two steep sections/gaps represent drilling efforts.

Figure 17. Zone 6 blow count versus depth

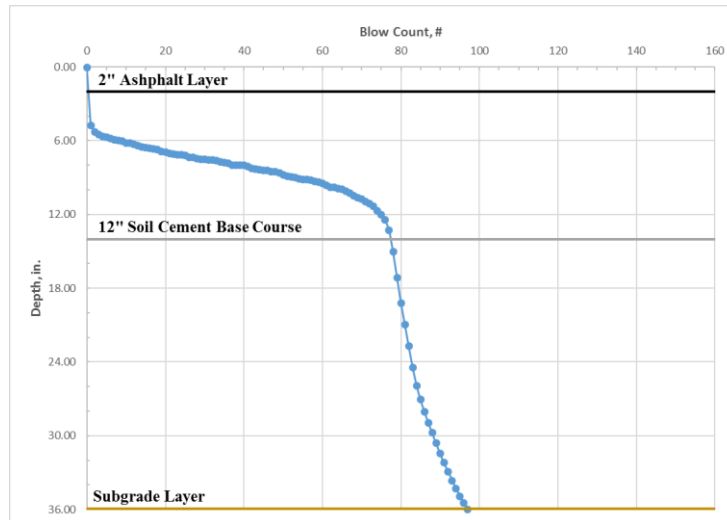
Zone 10 was initially considered a “bad spot” based on the FWD results. The graph of blow count versus depth for this zone can be found in the Appendix. The DCP was performed about 4 ft. away from the asphalt coring location in the deepest depression of the right wheel path rut as seen in Appendix. The soil cement base at this location was the weakest of all locations tested in this investigation. The DCP test was conducted to the full depth without reaching refusal. This test did not reach 100 blows in total and crossed from soil cement to subgrade in under 80 blows. In contrast, all other full-depth DCPs crossed over into the subgrade at over 100 blows; see Figure 18.

Figure 27. Zone 10 blow count versus depth

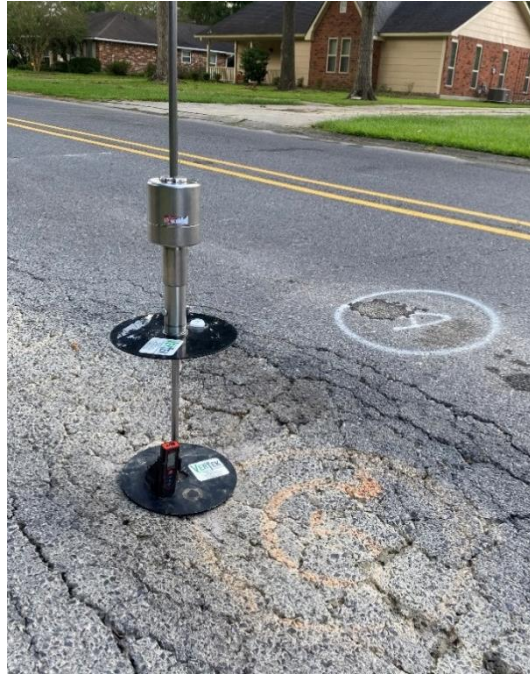
Figure 28. Photo of Zone 10 DCP and core location
