High Performance Concrete Bridge Deck Investigation

November 2009

FHWA Publication No. FHWA-HRT-10-028

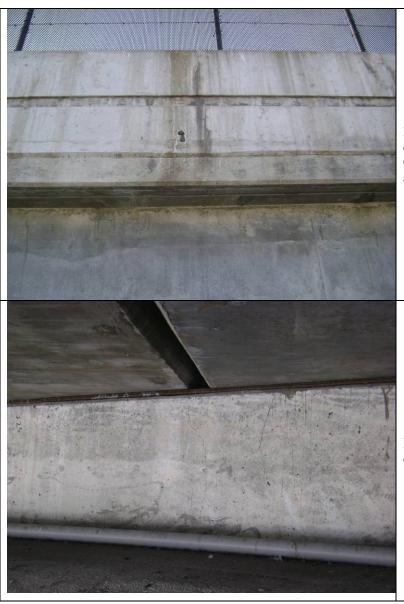
Photo 7: View showing typical cracks on the bridge parapet. Crack width is less than 1/32 in. and is categorized as hairline.

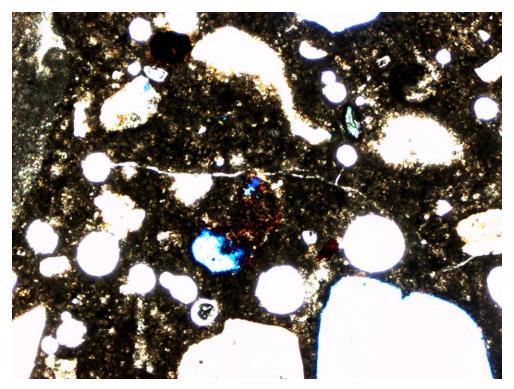
Figure D1-7: Cracks as seen in a thin section. Width of field is 1.6 mm.

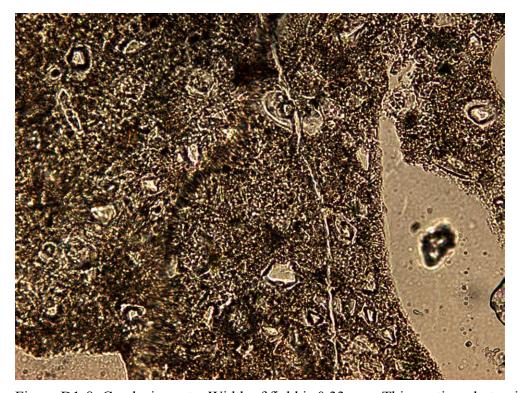
Figure D1-8: Cracks in paste. Width of field is 0.33 mm. Thin section photomicrograph.

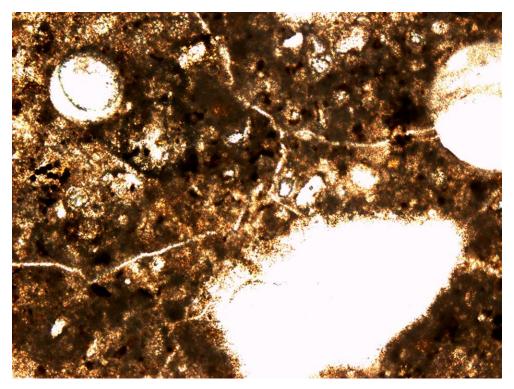
Figure E1-7: Cracks form a network. Width of field is 0.65 mm, thin section image.

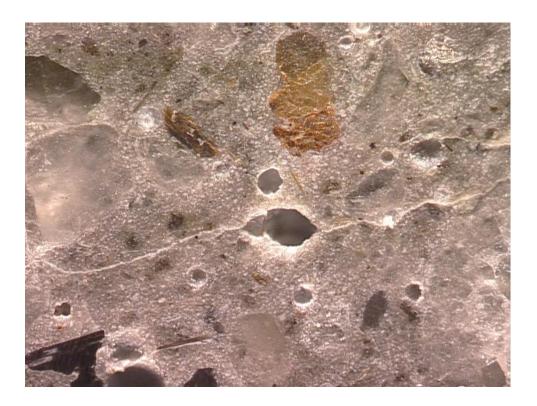
Figure F1-7: A crack in the paste. Width of field is 2.0 mm. Polished surface image.

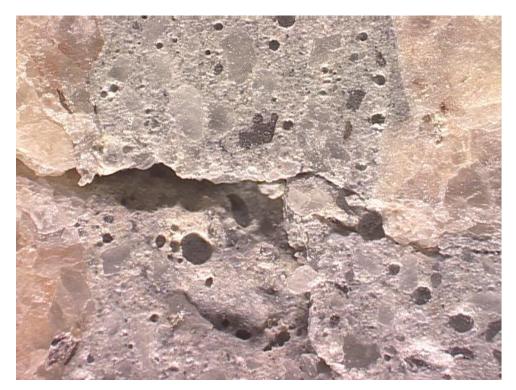
Figure I1-8. Another image of the major crack in core NC-5. Width of field is 6.5 mm.

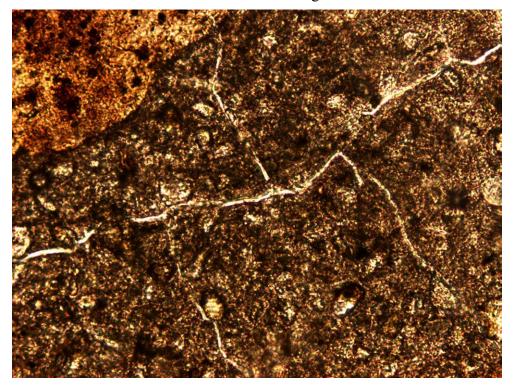
Figure J1-6: Cracks in the paste form network. Width of field is 0.33 mm. Thin section image.

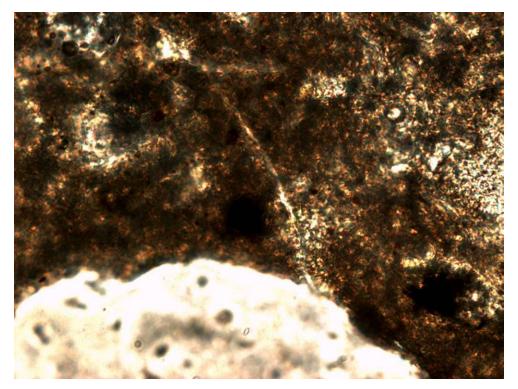
Figure K1-7: A crack in cement paste. Width of field is 0.165 mm. Thin section image.

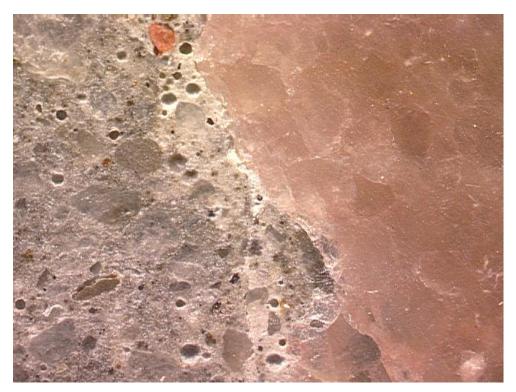
Figure K1-9: Cracks at the interfacial region between a coarse aggregate particle and paste. Width of field is 4.0 mm. Polished section image.

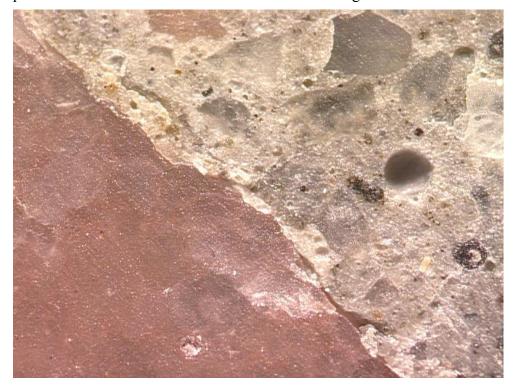
Figure K1-10: Another image showing cracking at the interfacial region between a coarse aggregate particle and the paste. Width of field is 2.0 mm. Polished section image.

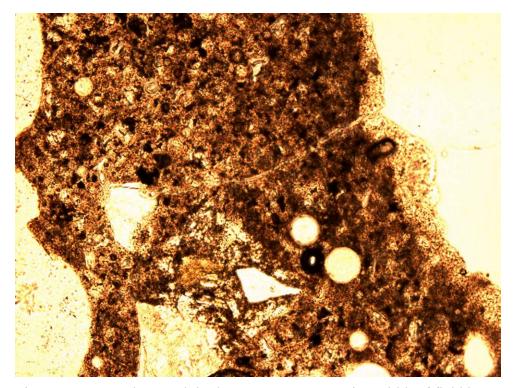
Figure L1-9: Another crack in the cement paste matrix. Width of field is 0.33 mm. Thin section image.

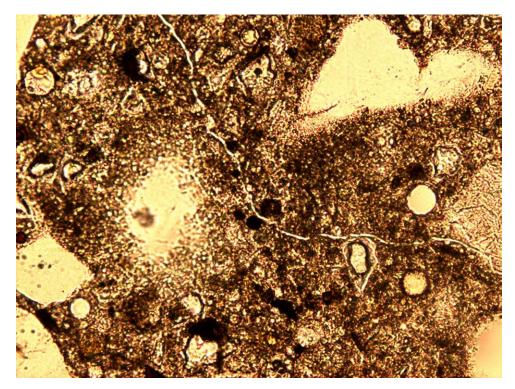
Figure P1-5. Crack in cement paste. Width of field is 0.33 mm. Thin section image.

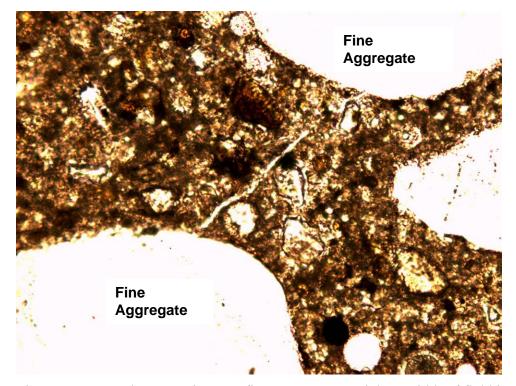
Figure P1-6. Crack connecting two fine aggregate particles. Width of field is 0.33 mm. Thin section image.

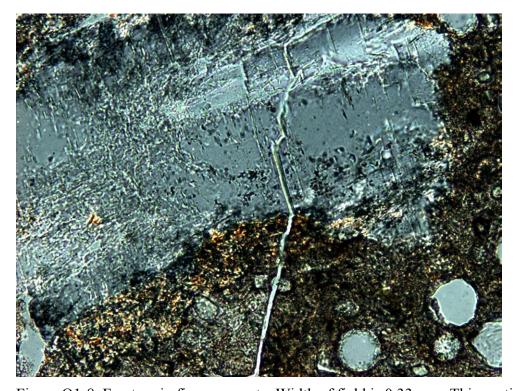
Figure Q1-8. Fracture in fine aggregate. Width of field is 0.33 mm. Thin section image.

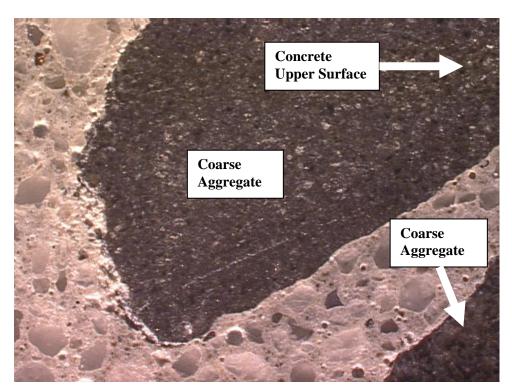
Figure R1-3: Gap and crack, as well as some air voids, line up around the coarse aggregate perimeter. Width of field is 4.0 mm. Polished surface image.
