# MONITORING LIVE LOAD FORCES ON 150 FOOT PRE-STRESSED BULB-T GIRDERS DURING TRANSIT AND INSTALLATION

*Louisiana Department of Transportation and Development  
1201 Capital Access Road  
PO Box 94245  
Baton Rouge LA 70804*

**BRIDGE DIAGNOSTICS, INC.**  
1965 57<sup>th</sup> Court North Suite 120  
Boulder, CO 80302  
303.494.3230  
[www.bridgetest.com](http://www.bridgetest.com)

January 2007

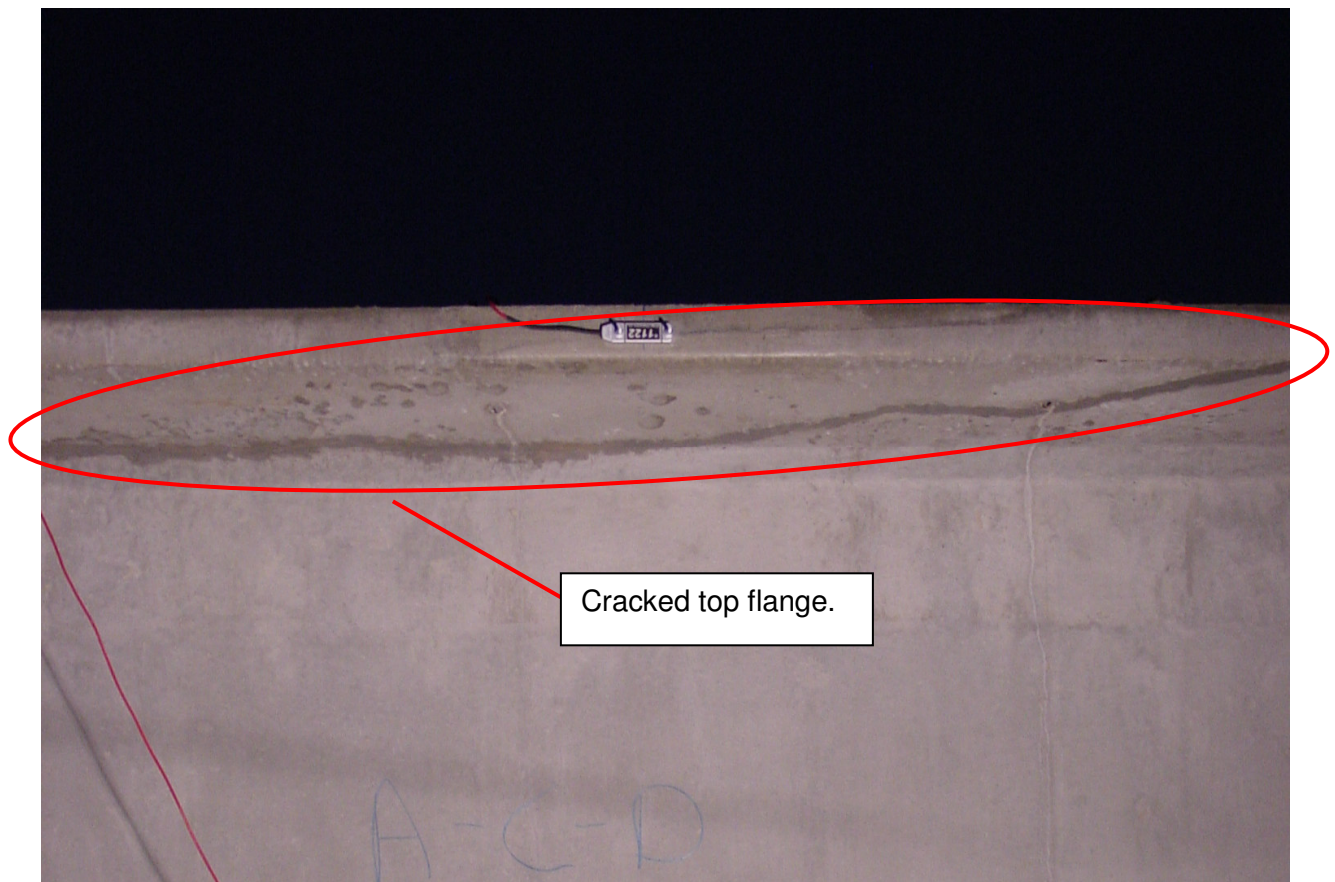
- During the gage installation procedures, it was noticed that the top flange of Girder A was severely cracked on the driver's side of the beam (see Figure 15). This crack was approximately 35 feet in length and spanned gage cross-sections C and D. As seen in the monitoring results, the strains were considerably higher in the cracked cross-sections on Girder A than in the same cross-sections on the uncracked Girder B. It is expected that this was the result of these cracked cross-sections being significantly more flexible.

**Figure 15 Cracked top flange of Girder A.**

Due to the high strains seen during the transportation of the girders, it is recommended that this span of the structure be load tested and rated. It has also been noted within this report that the top flange of Girder A was severely cracked around midspan (see General Observations in the Test Results section of a better description). Due to these two observations it is unknown whether the integrity of the structure was compromised during the pour or transportation of the girders. By performing a simple, one day load test, the effects of the higher-than-expected strains can be evaluated. These results can then be compared to the overall design calculations and decide whether the current design criteria is sufficient for a pre-cast girder of this size.

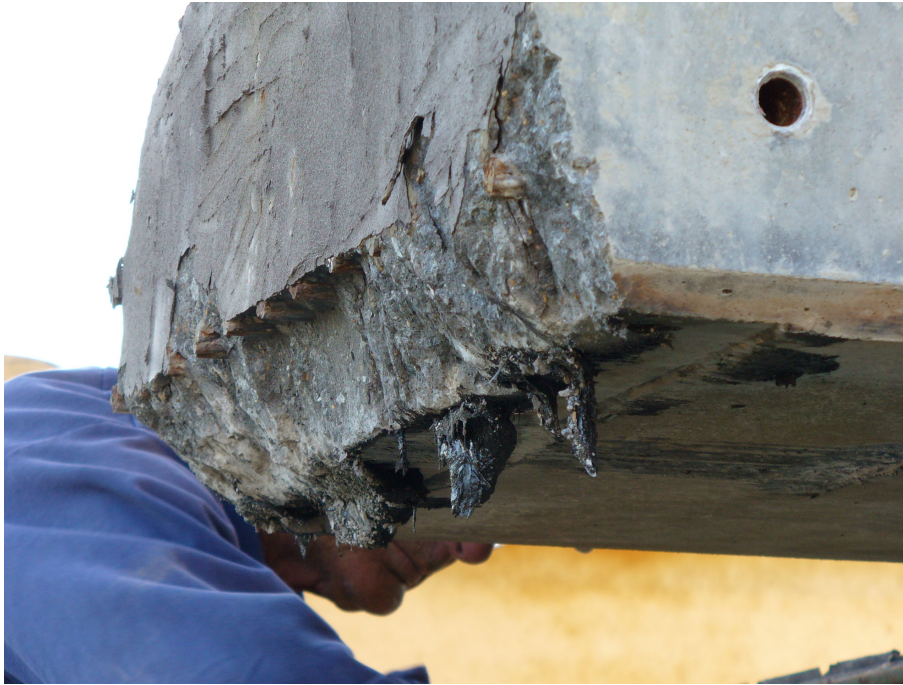
- During the loading process of Girder B, the pin that attaches the front portion of the trailer to the semi tractor became unlatched and the beam dropped about one foot. When this occurred, the front end of the beam was crushed but during a quick visual inspection the rest of the beam appeared to be undamaged. This inspection was performed simply to locate any visible cracking, but no non-destructive testing was performed to locate microscopic cracks, if any occurred. Figure 16 shows the damaged end of the girder immediately after it was reloaded onto the trailer. Note that the damaged end was patched during the night before the beams were transported to the job site in Columbia.

**Figure 16 Beam B damage.**
