# **US 84 Mississippi River Bridge**

U29 And U49 Pin Rehabilitation

Justin Walker, PE – MDOT Director Of Structures, State Bridge Engineer James Gregg, PE – HNTB Bridge Department Manager

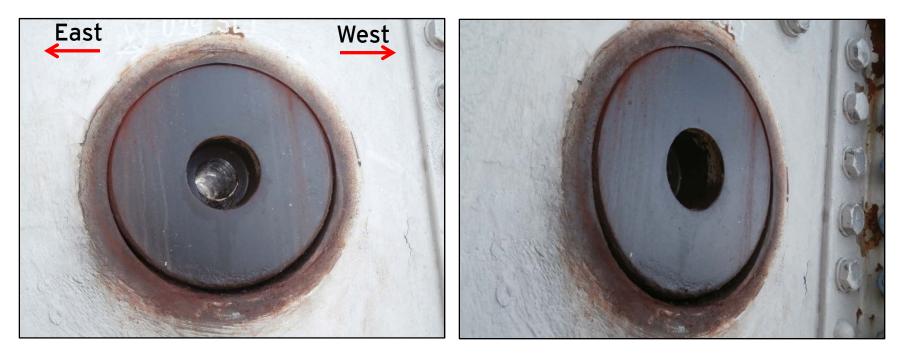
#### <u>U29 Downstream Truss (Upstream Side)</u>

1995	2010	2012
0.000" Rotated 2 ¾"	0.000"	-0.0625" (Ave.)

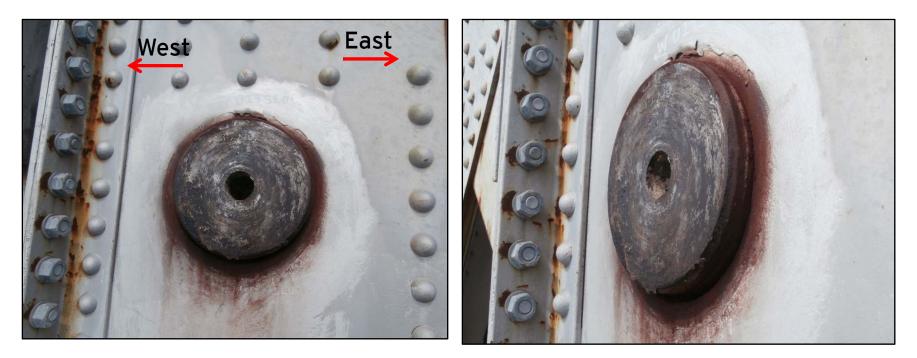
#### <u>U29 Downstream Truss (Downstream Side)</u>

1995	2010	2012
1.000" Rotated 2 ¾"	1.000"	1.0625" (Ave.)

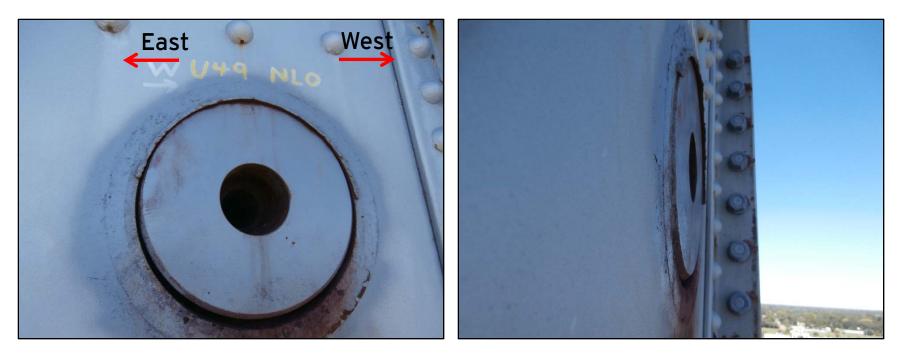
#### U49 Upstream Truss (Upstream Side)

1995	2010	2012
Not measured	0.0625″	0.028" (Ave.)

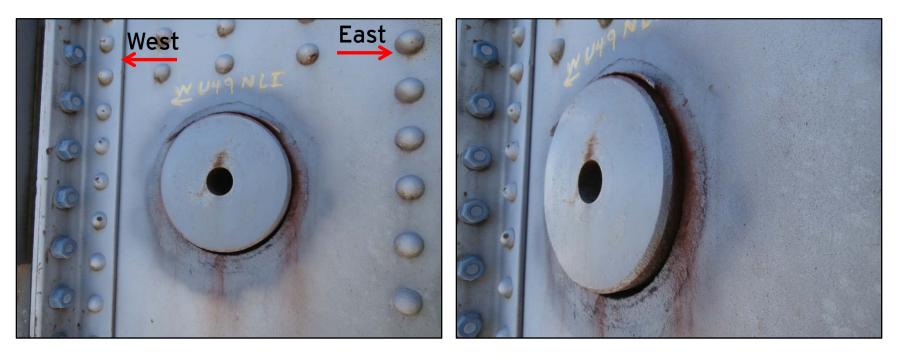
#### U49 Upstream Truss (Downstream Side)

1995	2010	2012
Not measured	0.8125″	1.008" (Ave.)

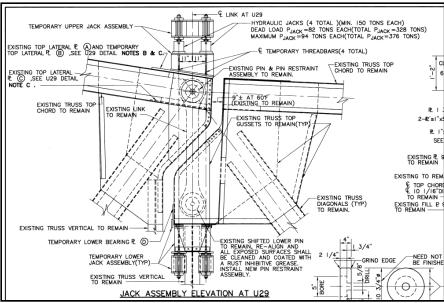
- O" extension observed
- HNTB advised MDOT that pin could move another 1/2" before adversely affecting the Factor of Safety
- MDOT decided to reset U29 Lower
  Pin

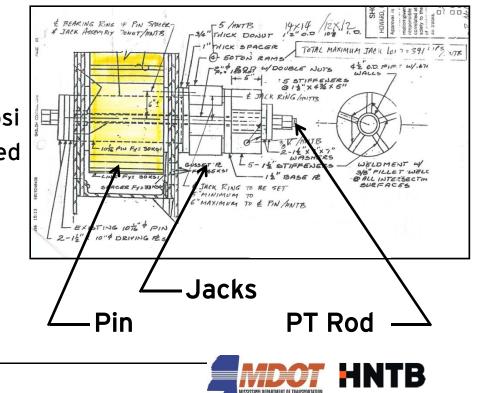
#### <u>1996 U29 Pin Rehabilitation Project (Contractor's Plan A)</u>

- Jacking assembly jacked to 6,100 psi
- 1<sup>st</sup> attempt, PT rods failed and landed in Mississippi River
- 2<sup>nd</sup> attempt, PT rods failed
- No horizontal movement in pin was noted

• Installed 2" PT rod though the pin, placing compression blocks on the rod and jacking the pin with 4 jacks

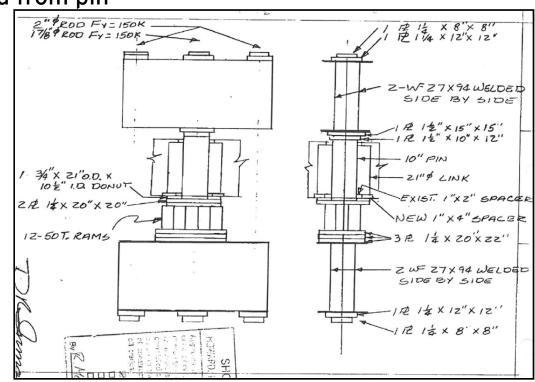
#### <u>1996 U29 Pin Rehabilitation Project (Contractor's Plan C)</u>

- Jacking assembly jacked to 10,000 psi
- (Horizontal force = 1,325 Kips)
- No horizontal movement in pin was noted

- Increase the number of jacking assembly to include 12 jack rams and 5 jacking rods
  - Vertical load not released from pin

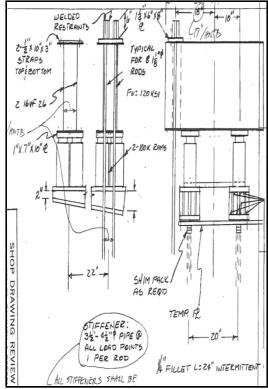
#### <u>1996 U29 Pin Rehabilitation Project (Contractor's Plan D)</u>

- Total Vertical Force = 733 kips to 830 kips (Design plan vertical dead load force = 656 kips)
- Total Horizontal Force = 727 kips
- Applied Horizontal Force > Estimated Vertical DL Therefore, assumed pin is jammed in the link

- Basic concept was same as shown in contract plans
- 8 Jack rams and 8 Jack rods in vertical position and 7 Jack rams and 3 Jack rods in horizontal position
- Relieved dead load stress in the pin-link system
- Horizontal re-alignment of pin was unsuccessful
