# Longitudinal Joint Construction Study

**David Allen  
Kentucky Transportation Center  
University of Kentucky**

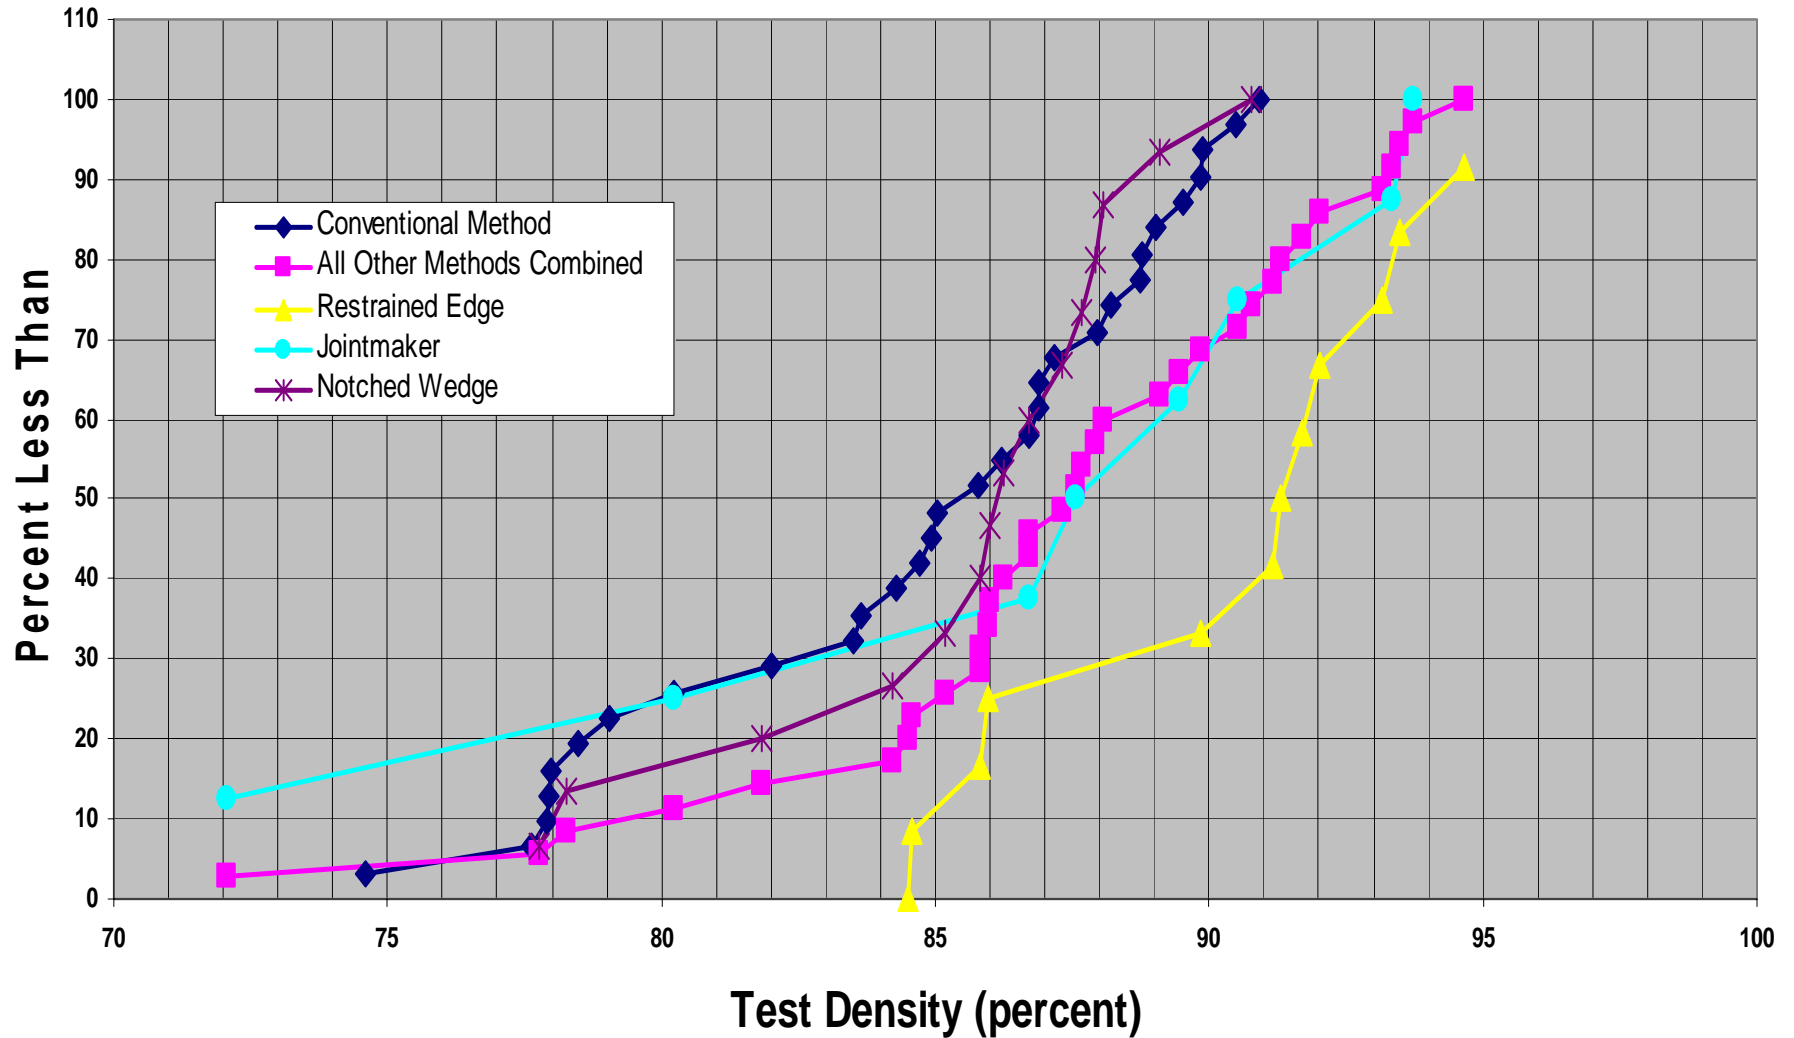
# Accumulative Distributions of Test Densities for Conventional Construction Method Versus Other Methods

( At the Construction Joint )

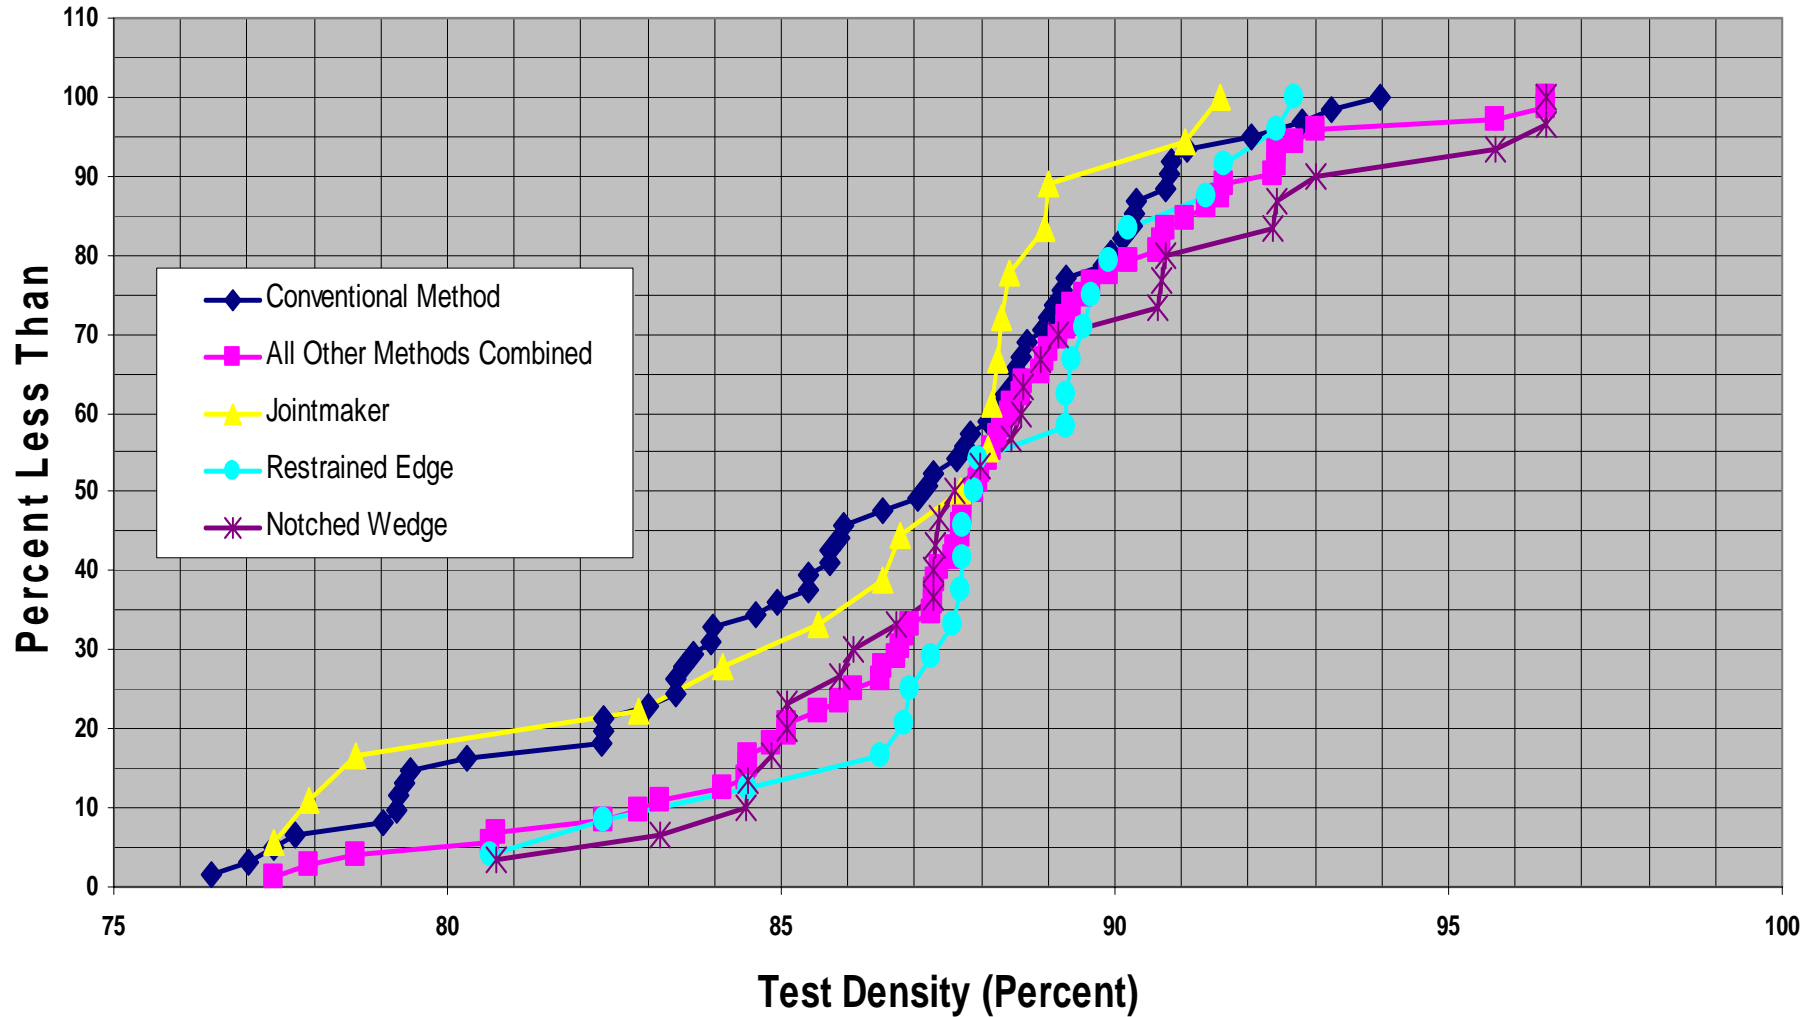
# Accumulative Distributions of Test Densities for Conventional Construction Method Versus Other Methods

(At Six Inches from the Construction Joint)
