EDWARD J. BRECKWOLDT PAVEMENT RESEARCH ENGINEER

Research Report No.38

Final Report

Research Project No. 68-1M(B) Louisiana HPR 1 (6)

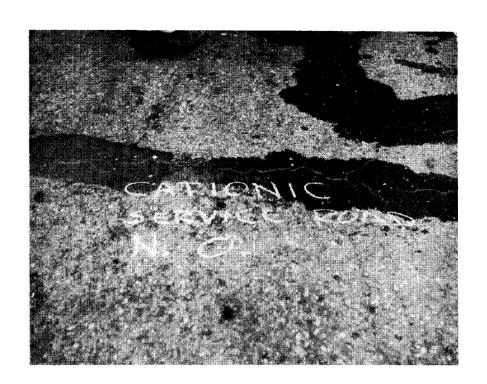
Photograph No. 1: RS-3K Treated Crack on New Orleans Service Road During September 1968

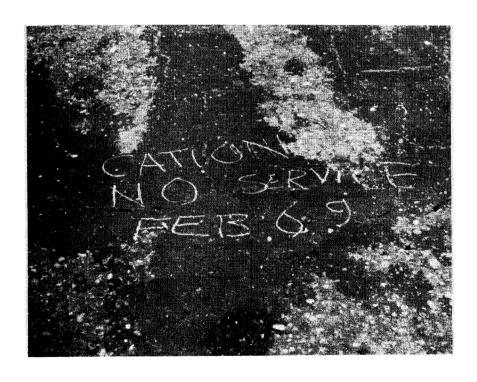
The application of the Reclamite material to these cracks brought the effectiveness of the seal to 100%, whereas the RS-3K only increased this effectiveness to 90%. (Photograph No. 2). Review of the data (Figure 9) showed that the cracks in the Reclamite section had possibly been better sealed initially by foreign matter than were the cracks in the RS-3K section.

Photograph No. 2: RS-3K Treated Crack on New Orleans Service Road During February 1969

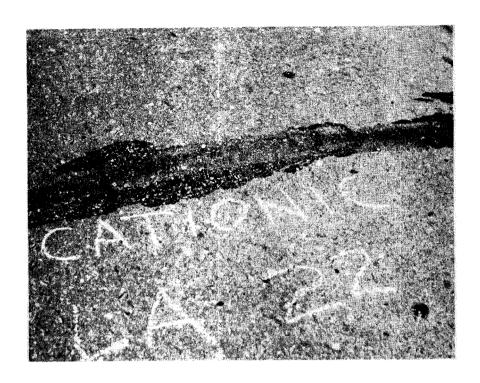
Photograph No. 3: RS-3K Treated Crack on La. 22 During September 1968

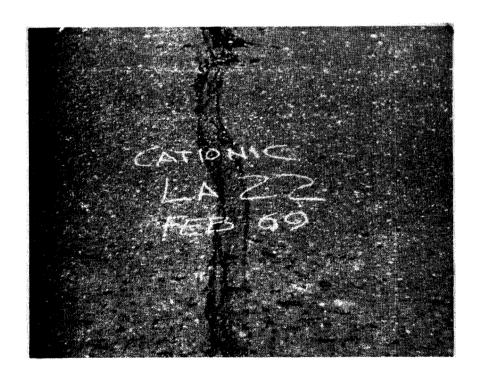
When the projects were visited during cold weather it was observed that all cracks on all projects had opened to the extent that it was impractical to even continue running the field water penetration tests. After running 54 tests the results showed that none of the cracks were effectively sealed against water penetration during cold weather. (Photograph Nos. 4 and 9).

Phylograph No. 1: RS-A Treated Crack on La. 22 During February 1969

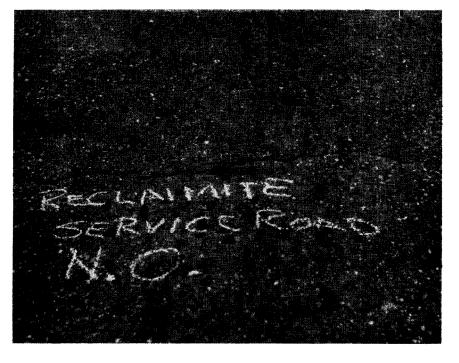
Photograph No. 5: Reclamite Treated Crack on New Orleans Service Road During September 1968

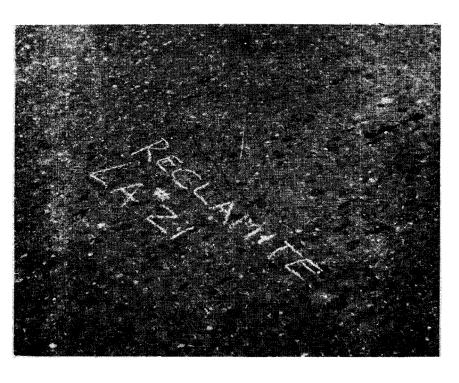
Photograph No. 6: Reclamite Treated Crack on La. 21 During September 1968

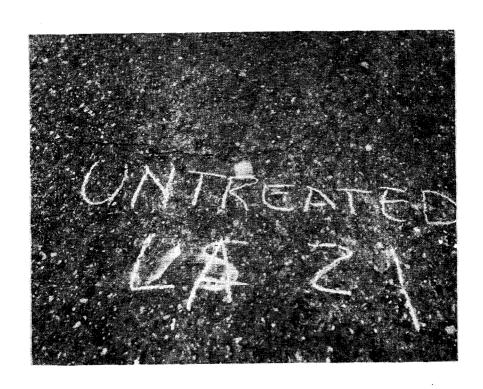
When the sections were first observed during warm weather it appeared that both Reclamite and Cationic Emulsified Asphalt (RS-3K) were performing as desired. The initial warm weather field water penetration tests showed (Figure 1) that the RS-3K had 91.7% effectively sealed the reflection cracks against water (Photograph Nos. 1 & 3). Reclamite had sealed only 81.2%, however the wheel paths for both Reclamite and RS-3K were 100% sealed. This indicates that Reclamite is 100% effective only in the wheel path where a kneeding action is present. The untreated sections were only 46.7% sealed even under ideal conditions of warm weather (Photograph No. 8).

Photograph No. 8: Untreated Crack on La. 21 During September 1968

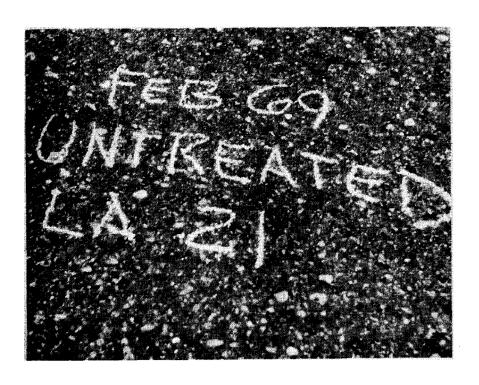
Photograph No. 9: Untreated Crack on La. 21 During February 1969

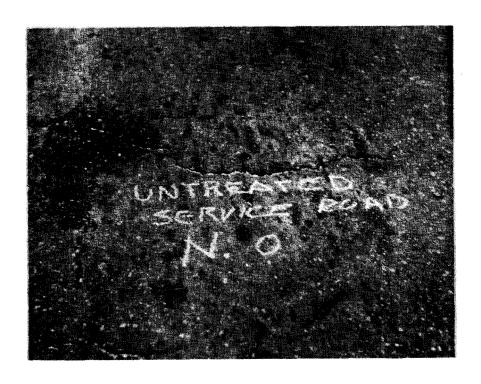
It was interesting to note (Figure 8) that the reflection cracks on the two eight (8)

year old projects were tightly packed and almost sealed (78% not penetrated by water) with foreign matter even prior to placing any sealant material. (Photograph No. 10).

Photograph No. 10: New Orleans Service Road - Untreated Crack During September 1968
