Roller Compacted Concrete: South Carolina DOT Experience

Andy Johnson, Ph.D., P.E.

Pavement Design Engineer

Portland Cement Association – SE Region

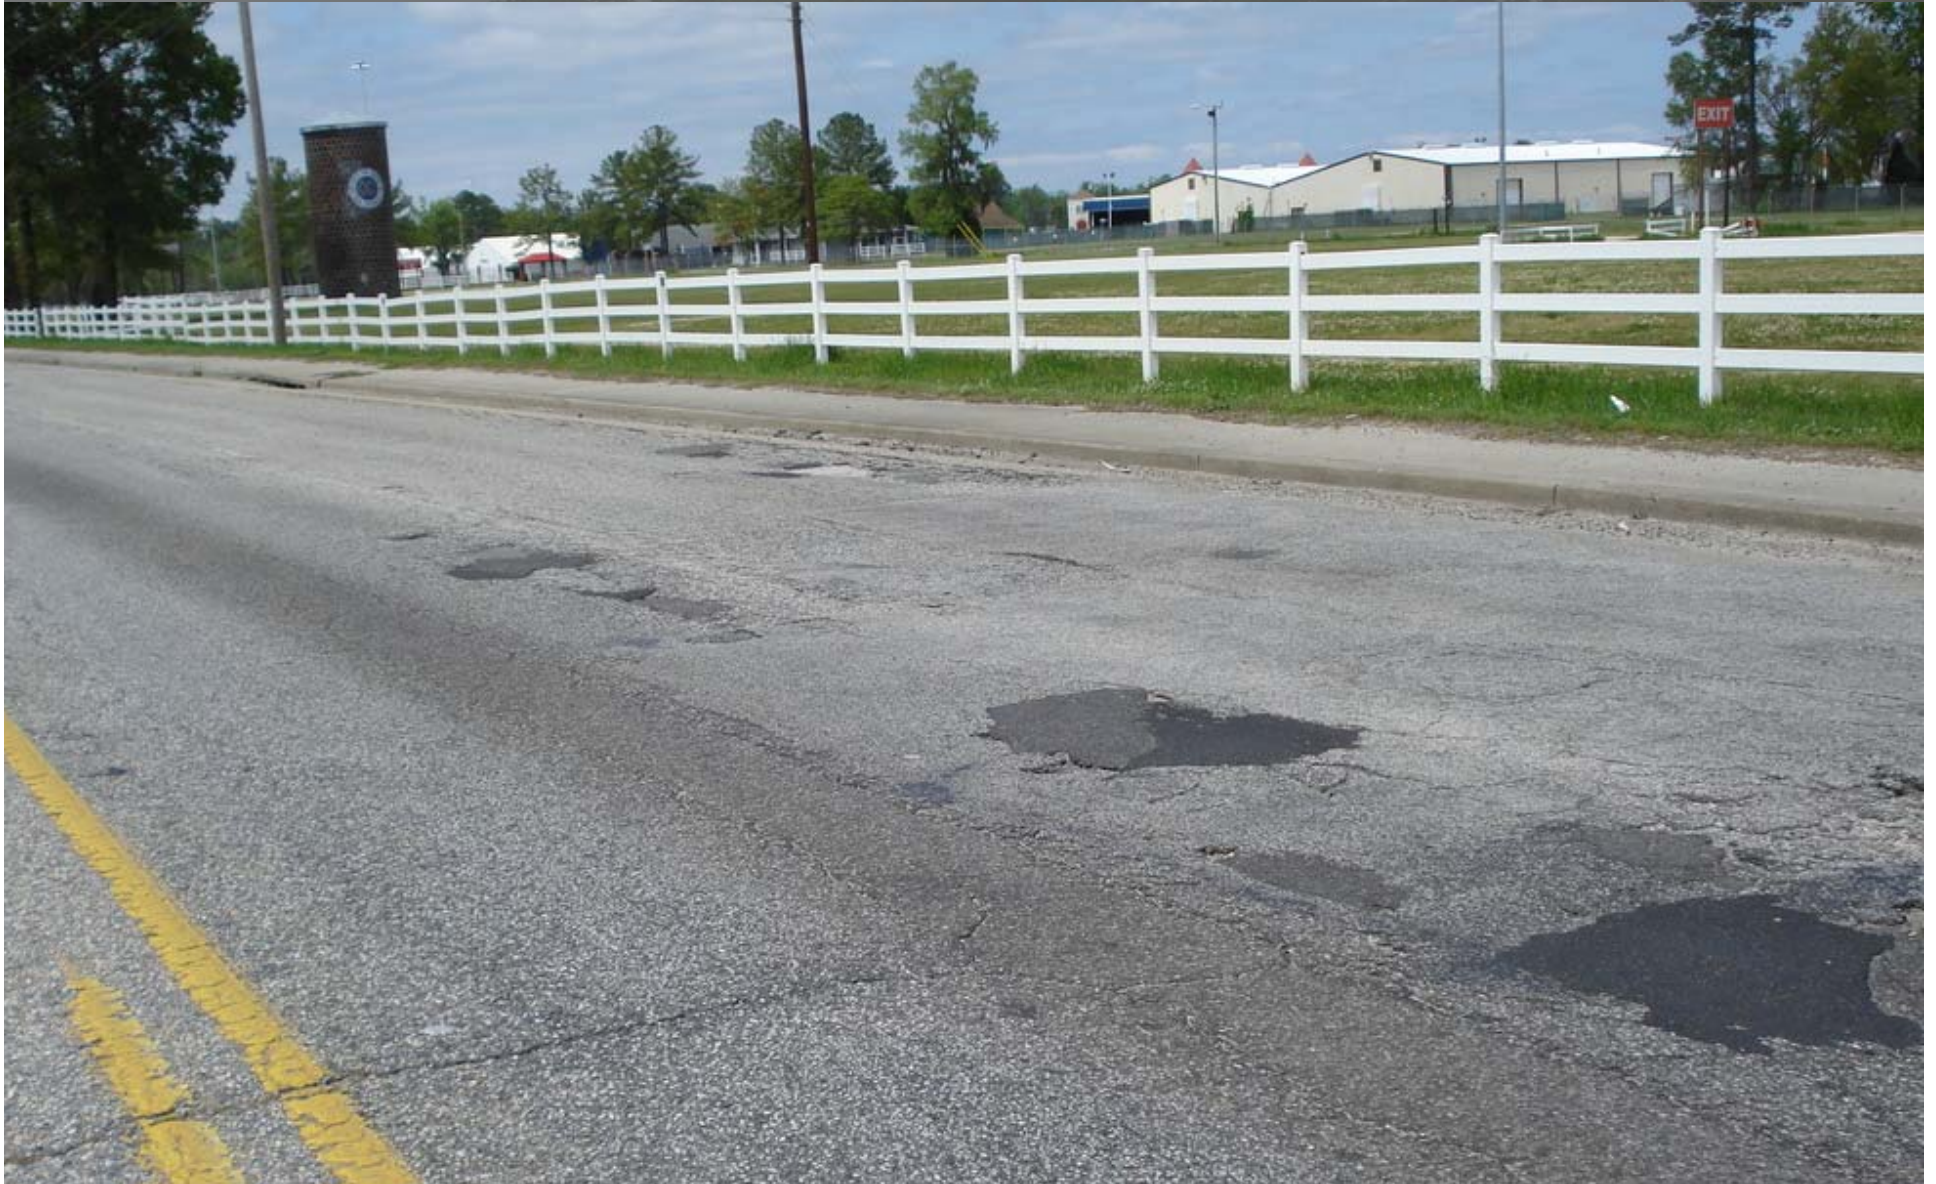
US 78, 2007

- US Route 78 widened from 2 lanes to 5 in 1984.
- Pavement design was 3.8 inches HMA plus 8 inches aggregate base.
- Considerable difficulty was encountered during construction due to unstable subgrade.
- By 2005, pavement was in very poor condition.

- In 2008, existing pavement was removed to a depth of 12 inches and replaced with 10 inches RCC and 2 inches HMA.
- Project length was approximately 0.9 miles, four lanes wide.

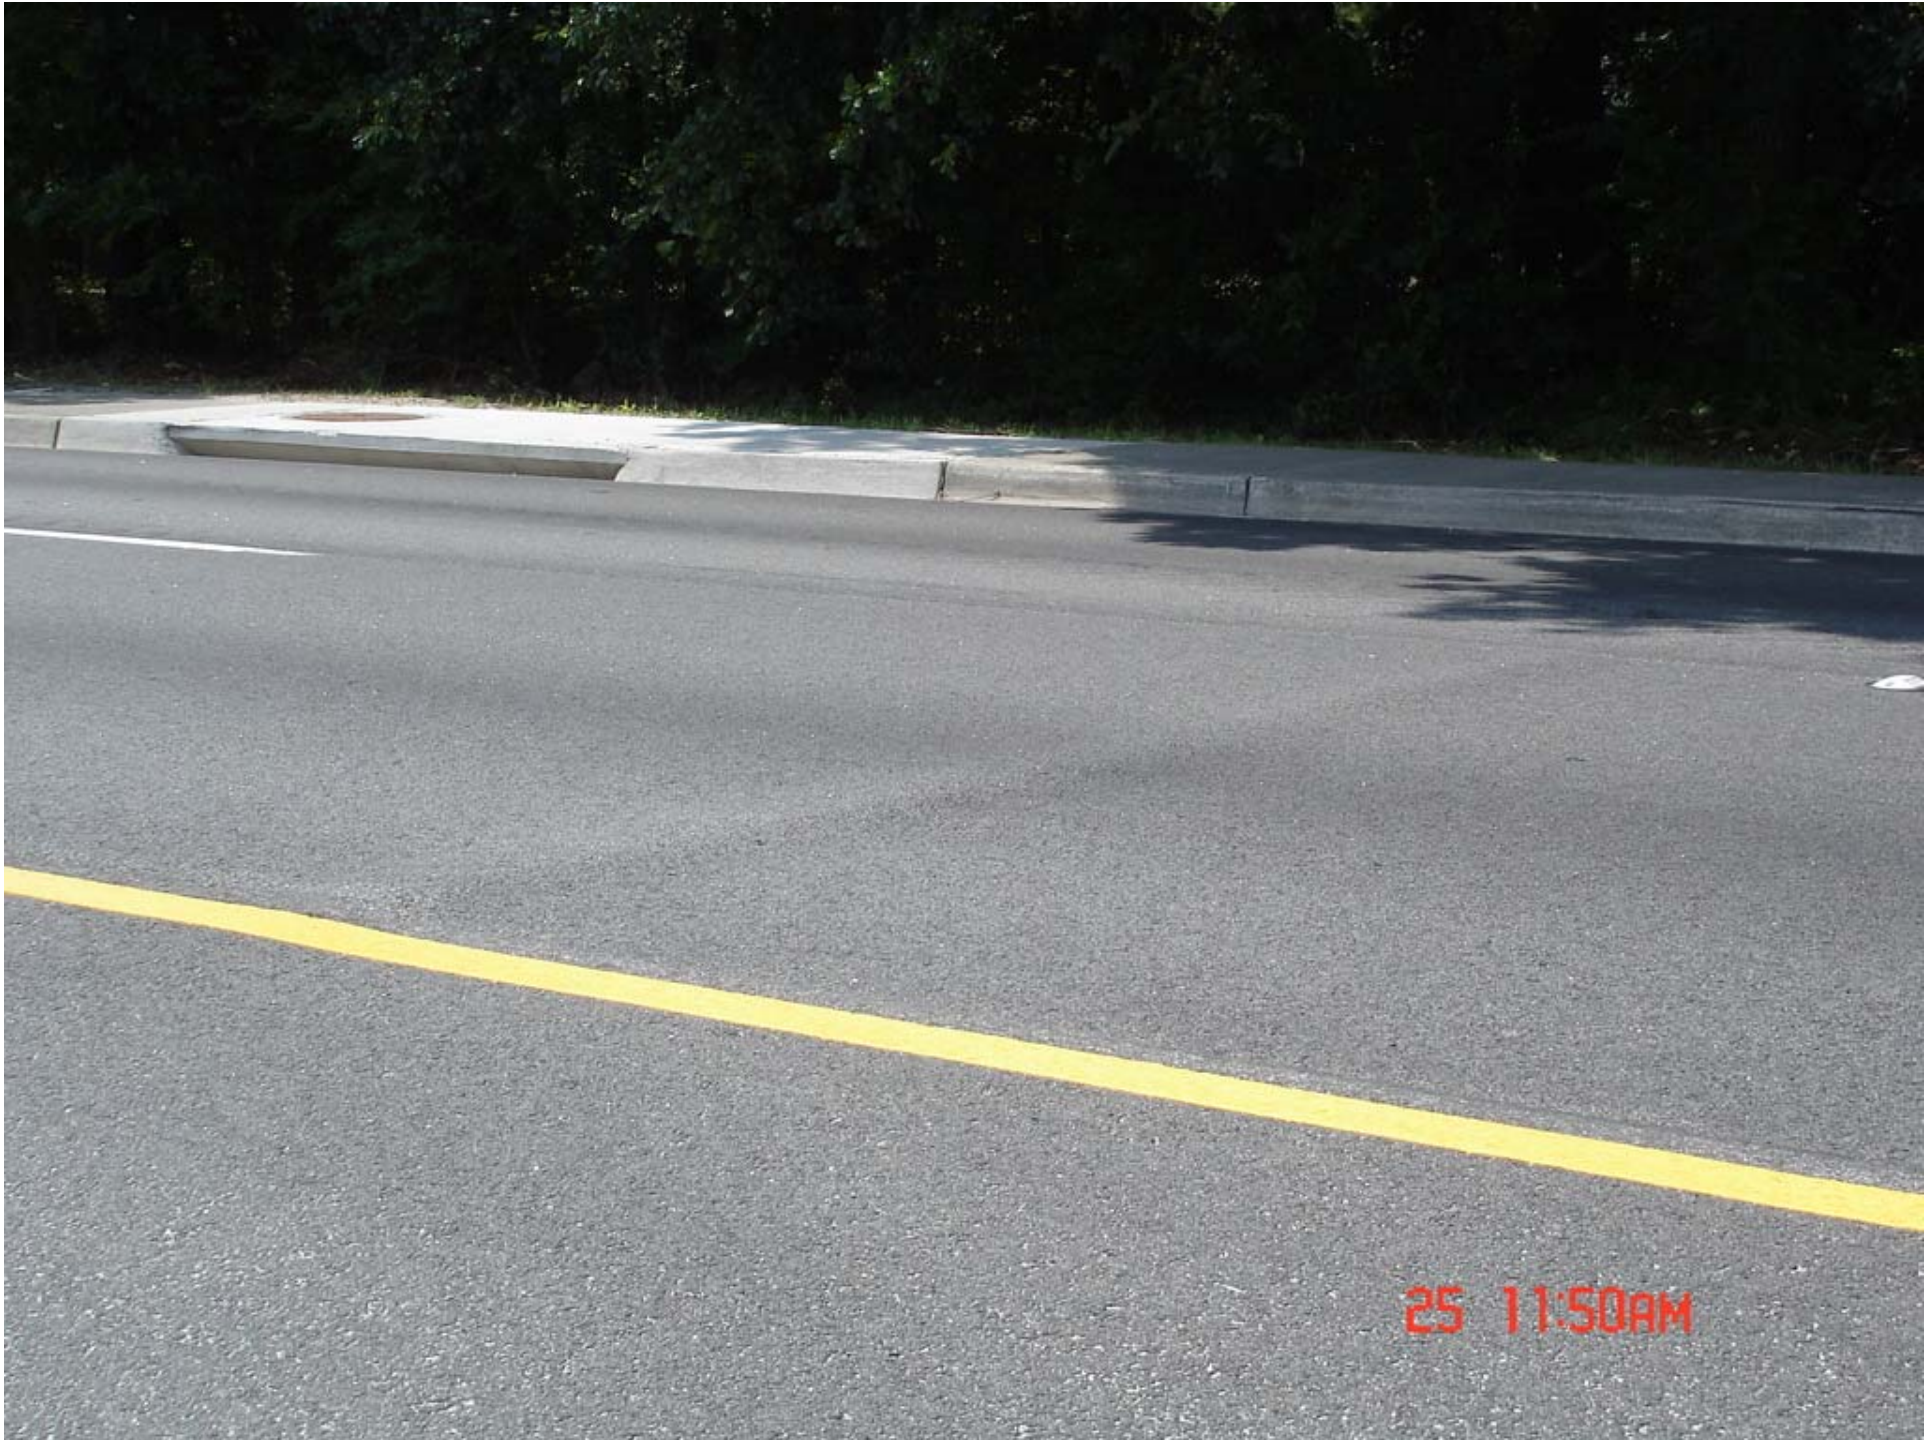
- In 2008, existing pavement was removed to a depth of 12 inches and replaced with 10 inches RCC and 2 inches HMA.
- Problems were encountered with the subgrade as in the 1980s.
- Overall, project went smoothly.
- Construction joint issues were encountered in 2009 after a week of +100° temperatures.

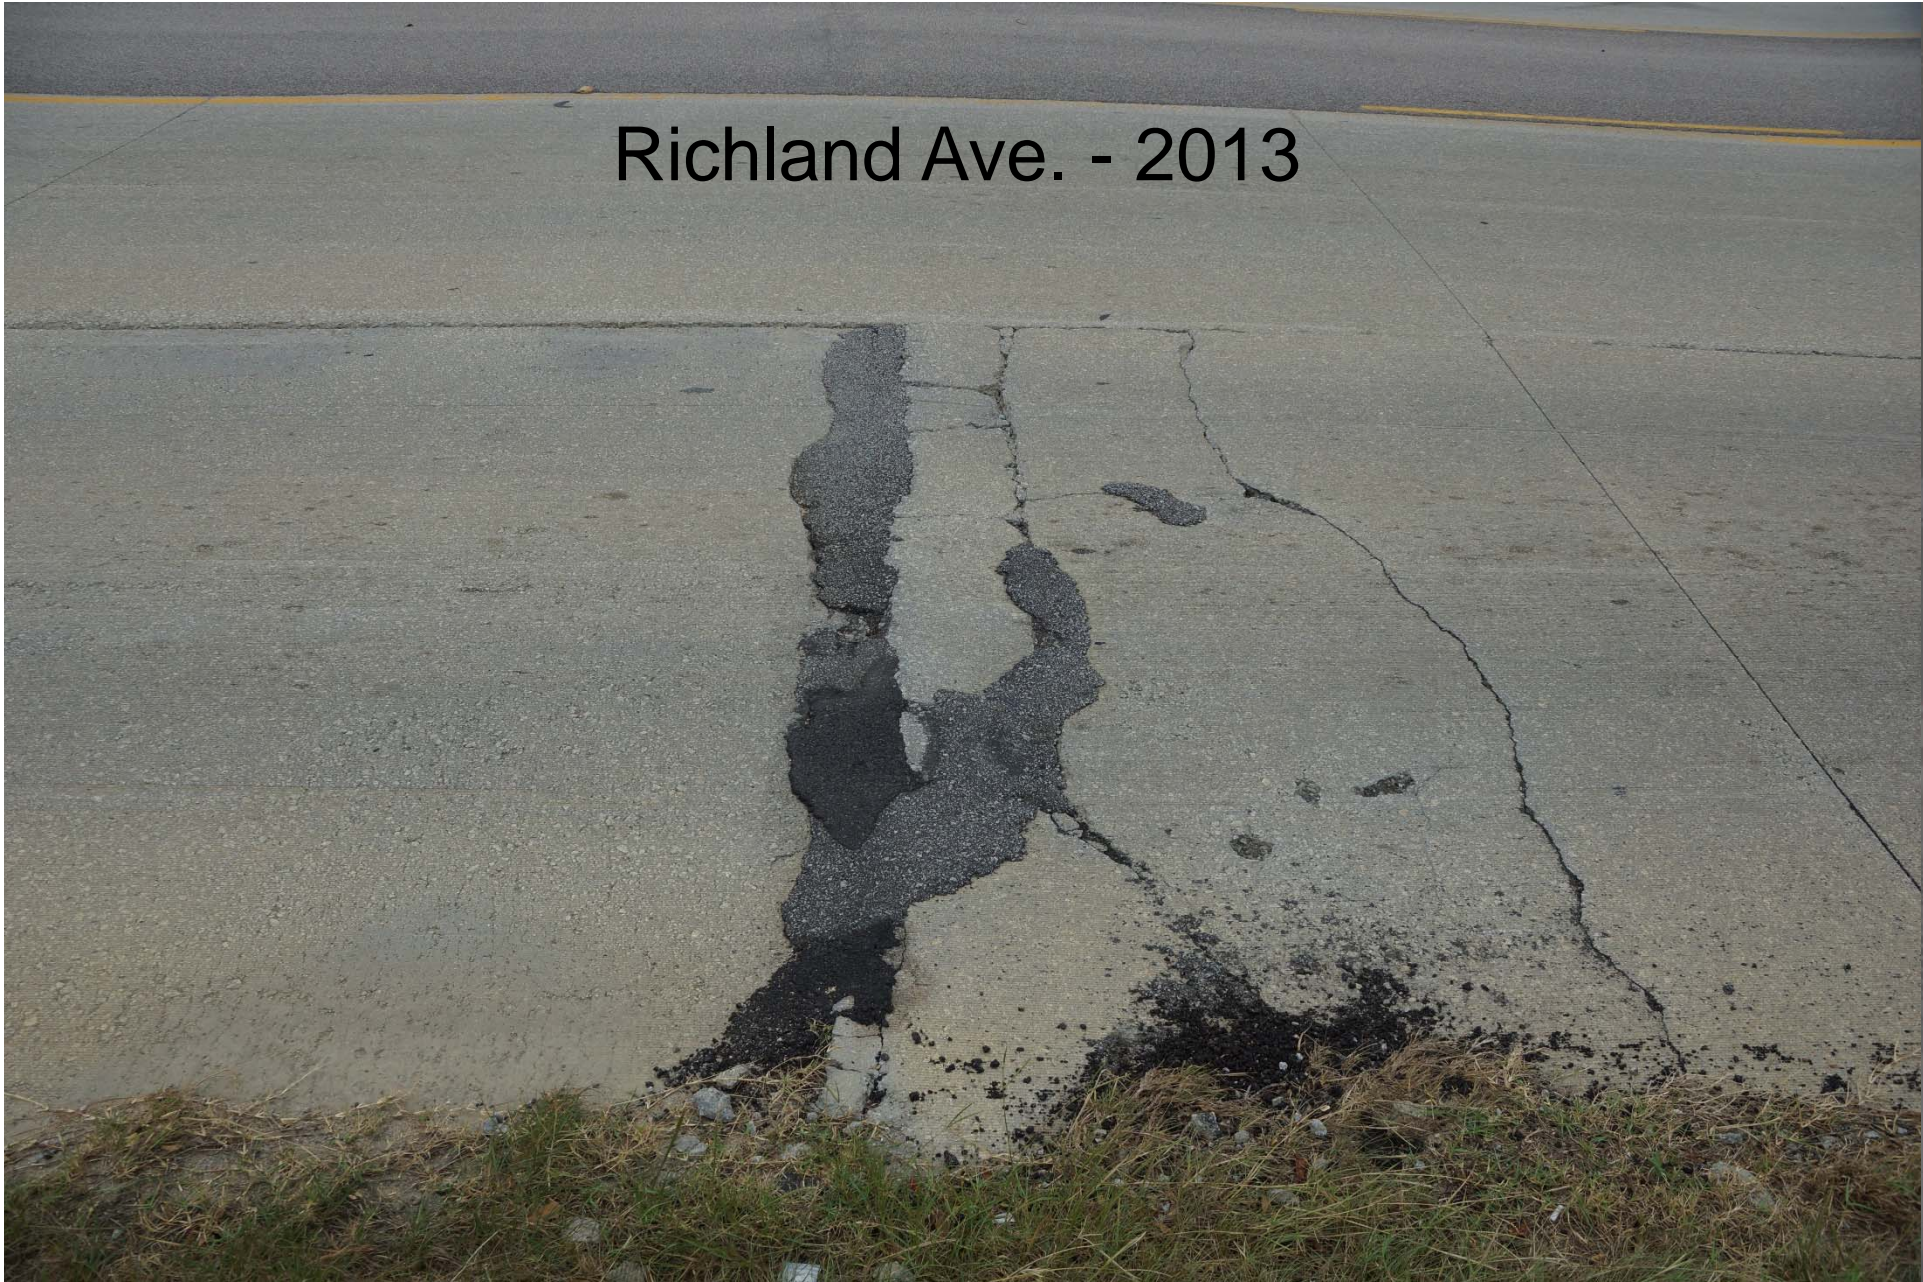
Richland Ave. - 2013

- Dark staining at joints does not appear to be a subsurface drainage problem; has not caused premature deterioration yet.
