Louisiana Transportation Research Center

Technical Assistance Report 16-03TA-C

Evaluation of Cores from Jefferson Highway Near Airline Highway

Petrographic Investigation of Concrete Cores Extracted from Cracked
Pavement Slabs on Jefferson Highway in Baton Rouge, Louisiana
(RE: LTRC Project 16-1TA-C)

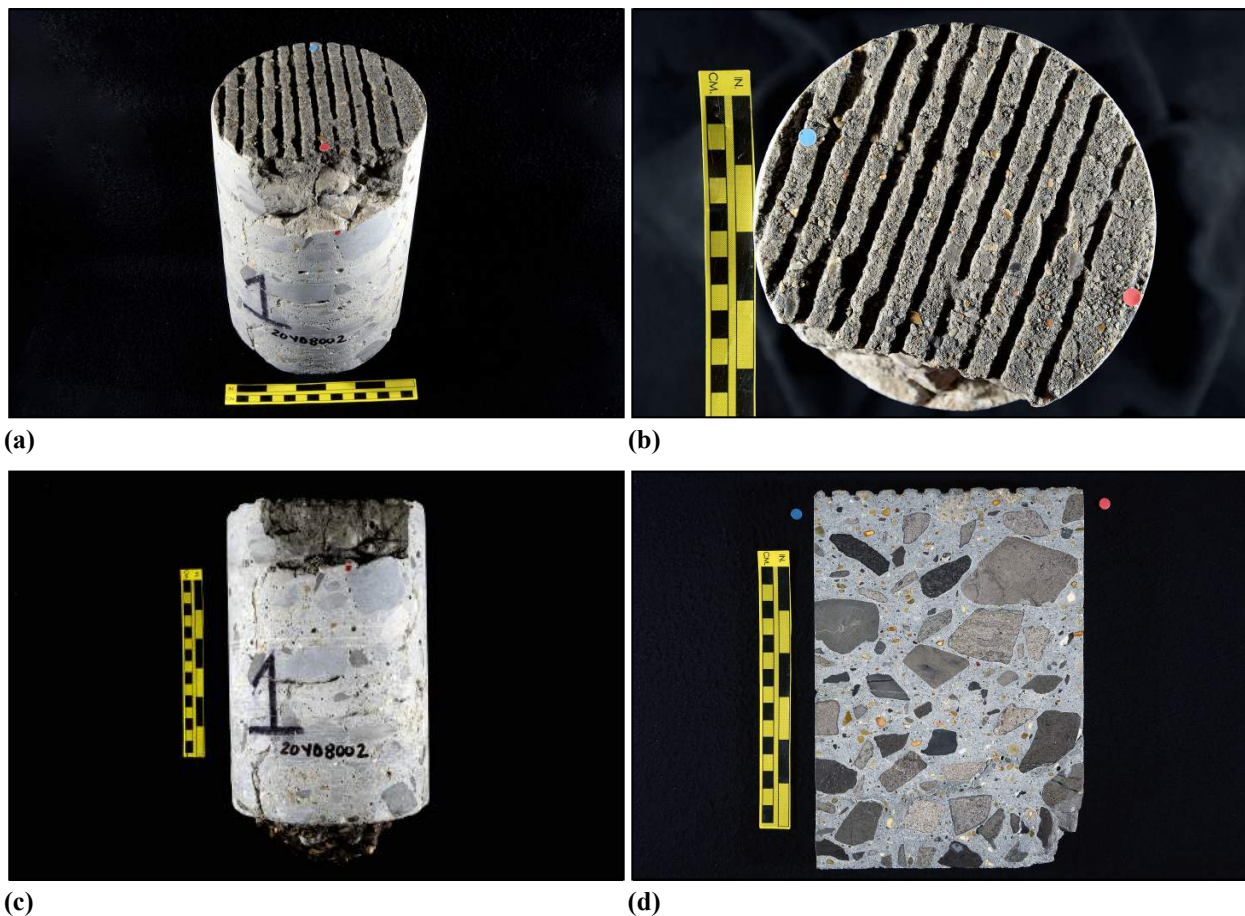
Figure 1. Photographs of Core 1. (a) Oblique view of the top and side of the core. (b) View of the top surface of the core. (c) View of the side of the core; note spalled area. (d) View of the polished surface of the core. Note that both sides of the core were polished. The yellow scale bar is ~ 150 mm (6 in.) long.

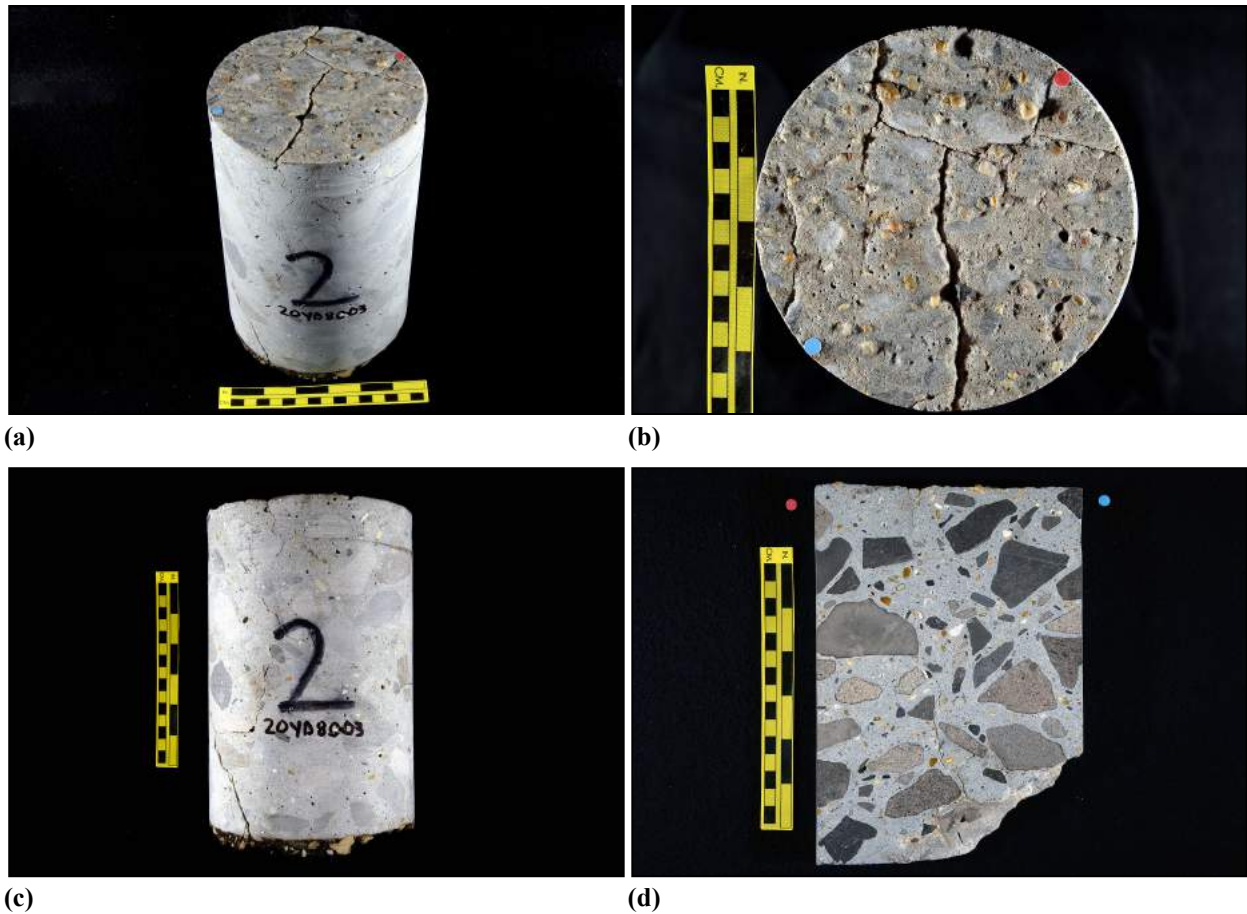
Figure 2. Photographs of Core 2. (a) Oblique view of the top and side of the core. (b) View of the top surface of the core. (c) View of the side of the core. (d) View of the polished surface of the core. Note that both sides of the core were polished. The yellow scale bar is ~ 150 mm (6 in.) long.

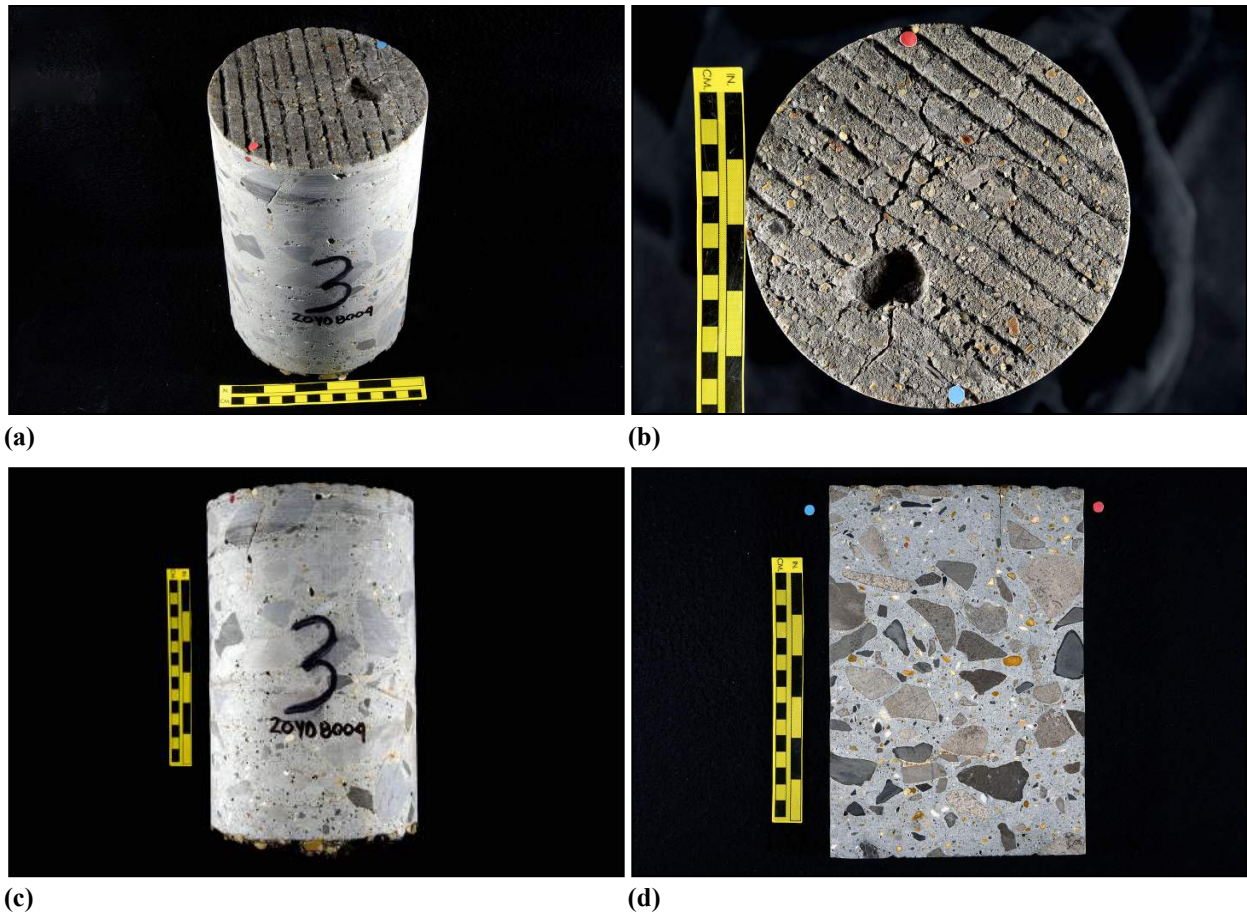
Figure 3. Photographs of Core 3. (a) Oblique view of the top and side of the core. (b) View of the top surface of the core. Note large pit. (c) View of the side of the core. (d) View of the polished surface of the core. Note that both sides of the core were polished. The yellow scale bar is ~ 150 mm (6 in.) long.

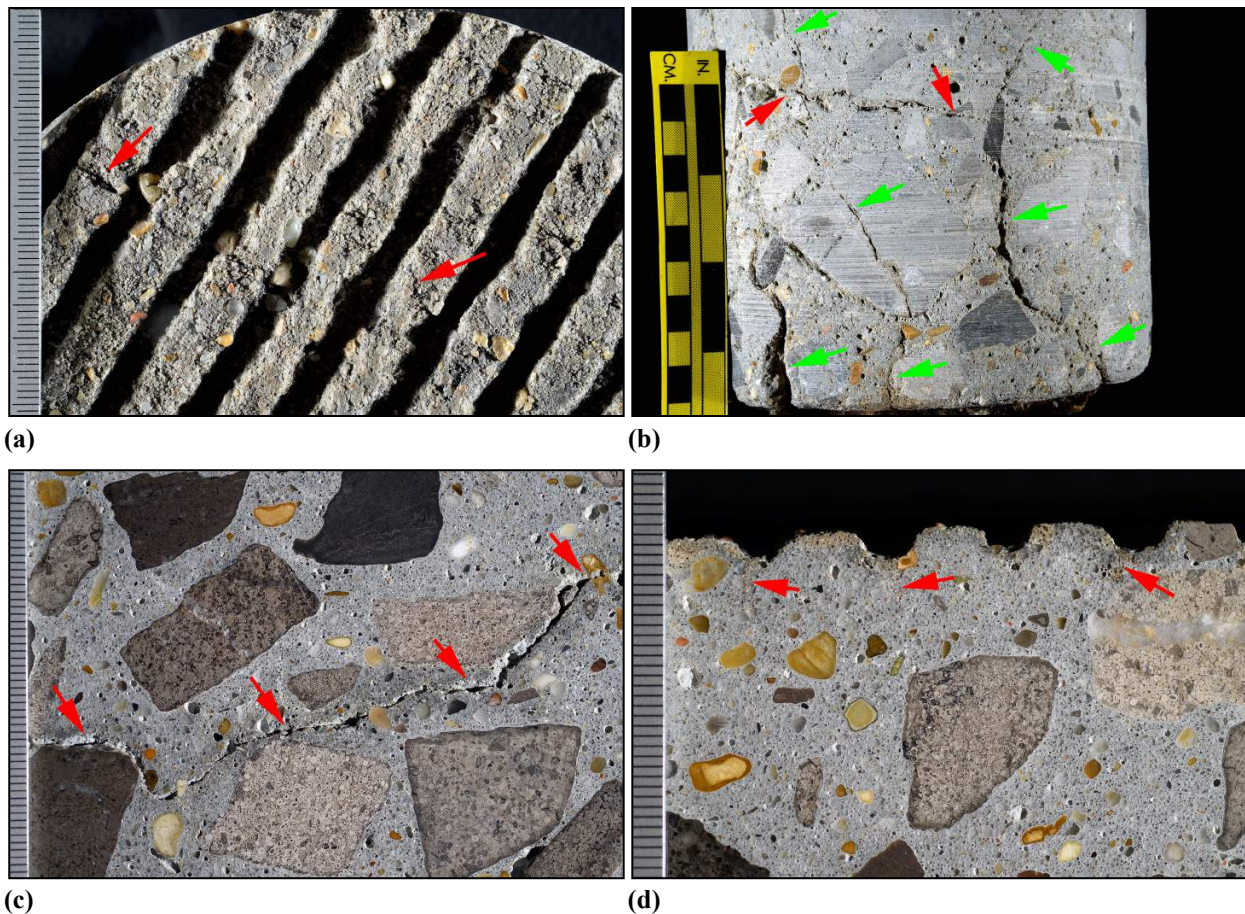
Core 1 Core 1 shows cracks up to 250 μm (10 mil) wide that cut across the the top surface and cracks up to 1.5 mm (60 mil) wide and 70-200 mm (2 $\frac{3}{4}$ - 8 in.) long on the side of the core. On the polished surface major sub-horizontal cracks up to 2 mm (80 mil) wide that cut across the full width of the core were observed at 75 mm (3 in.), 110 mm (4 $\frac{3}{8}$ in.) and 145 mm (5 $\frac{3}{4}$ in.) below the top surface. Some of the cracks contain deposits of ASR gel and ettringite was observed along segments of the cracks. Microcracking was relatively minor in the core. Several microcracks cut sub-vertically from the top surface to 6 mm ($\frac{1}{4}$ in.). Minor microcracking was observed in reaction rims in some coarse aggregate particles. Occasional microcracks filled with gel cut from limestone particles into the paste (see section on AAR below for more detail).

Figure 8. Photographs of cracking in Core 1. (a) Linear cracks (red arrows) on the top surface. (b) Sub-vertical cracks (green arrows) and sub-horizontal cracks (red arrows) near the bottom of the core. (c) Sub-horizontal crack (red arrows) about 75 mm (3 in.) below the top surface. (d) Sub-vertical microcracks (red arrows) at the top of the core. Scale in millimeters in all photos except (b).

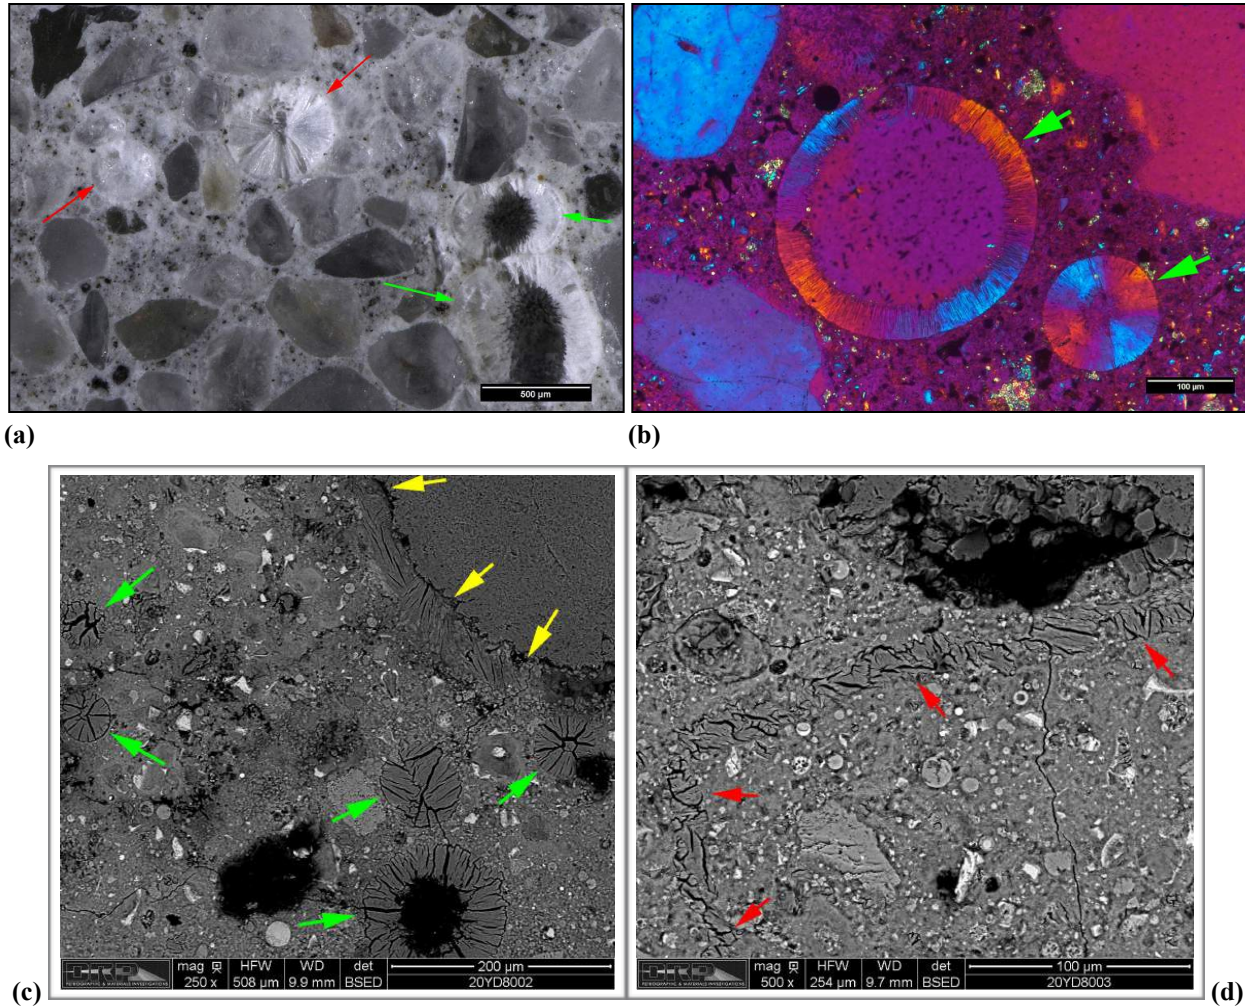
3.7 Secondary Deposits—Ettringite Ettringite was observed in all three cores but is more abundant in Core 1 and Core 3 than in Core 2. The ettringite occurs primarily in air voids but was also observed lining and filling segments of cracks and microcracks as well as discrete deposits in the paste (**Figure 12**). No cracking or microcracking due to ettringite mineralization was observed.

Figure 12. (a) Reflected light photomicrograph of the polished surface of Core 1 showing ettringite filling air voids (red arrows) and lining air voids (green arrows). (b) Cross-polarized transmitted light photomicrograph of thin section from Core 3 showing voids lined and filled with ettringite (green arrows). (c) BSE micrograph of polished surface from Core 1 showing voids with ettringite (green arrows) and ettringite in the interfacial transition zone (yellow arrows) between an aggregate particle and the paste. (d) BSE micrograph of the polished surface from Core 2 showing microcrack filled with ettringite (red arrows).

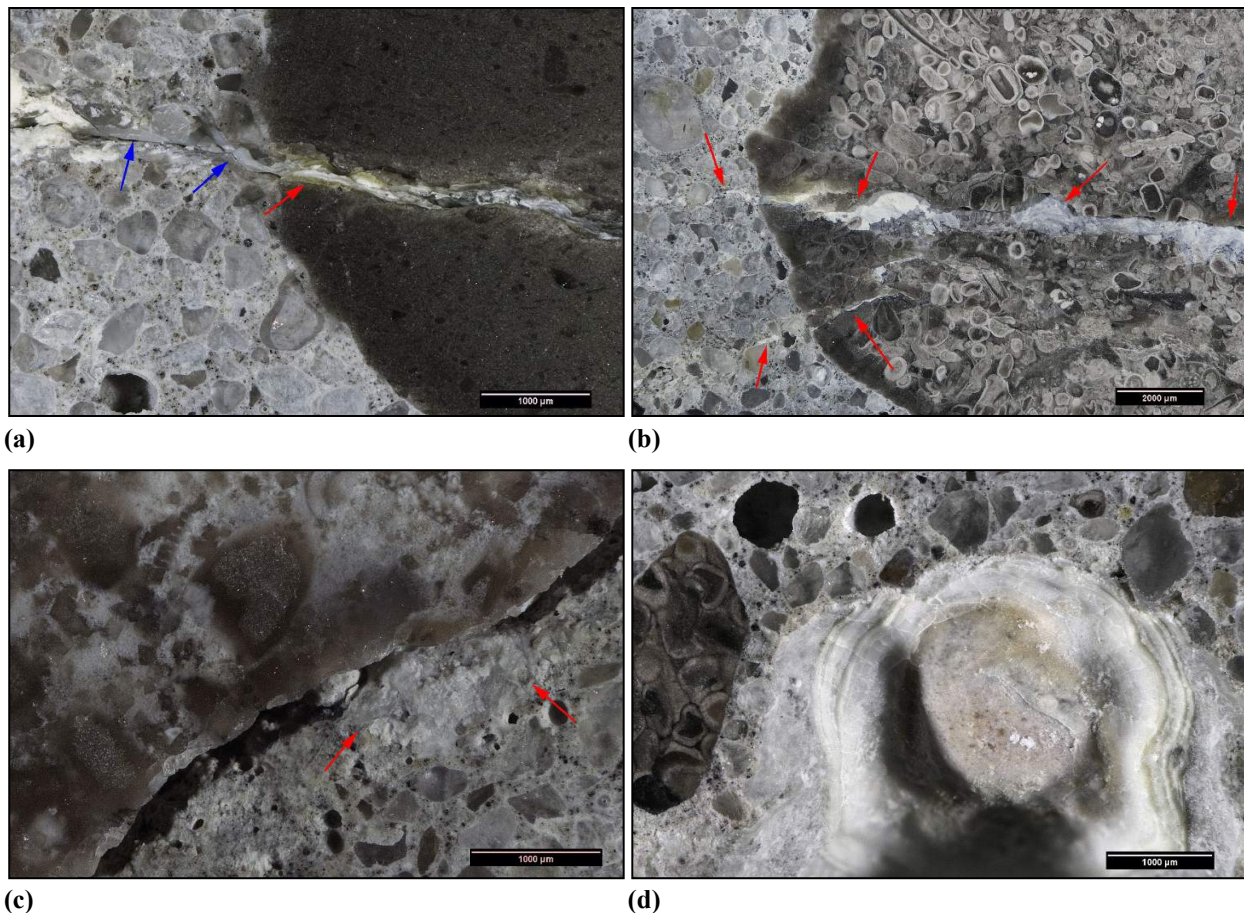
3.7 Secondary Deposits—ASR Gel Deposits of gel were observed in all three cores (**Figure 13**) but they are most abundant in Core 1, followed by Core 3 and are relatively scarce in Core 2. In all three cores analysis of gel compositions by EDS indicated they consist primarily of calcium and silicon. This indicates the gels are fairly mature, as calcium tends to diffuse into gels over time. This also suggests that the concrete shows evidence of alkali cycling, which may promote continued AAR. The reactive components in these cores primarily involves fossiliferous and oolitic limestones, which also contain interstitial quartz and chert, some of which is chalcedonic. Minor reaction was also observed with chert particles in the fine aggregate.

Figure 13. Reflected light photomicrographs of the polished surfaces of (a), (b) Core 1 and (c), (d) Core 3 showing deposits of ASR gel. In (a) the red arrow indicates white gel in a dolomitic limestone particle about 110 mm (4 3/8 in.) below the top surface and the blue arrows indicate translucent gel in the paste. In (b) the red arrows show deposits of gel about 150 mm (6 in.) below the top surface. In (c) the red arrows show a deposit of gel in the ITZ of a limestone particle about 90 mm (3 1/2 in.) below the top surface. (d) Laminated gel deposit in void about 135 mm (5 3/8 in.) below the top surface. All of these deposits were analyzed by EDS and found to consist primarily of calcium and silicon (see Appendices for details).

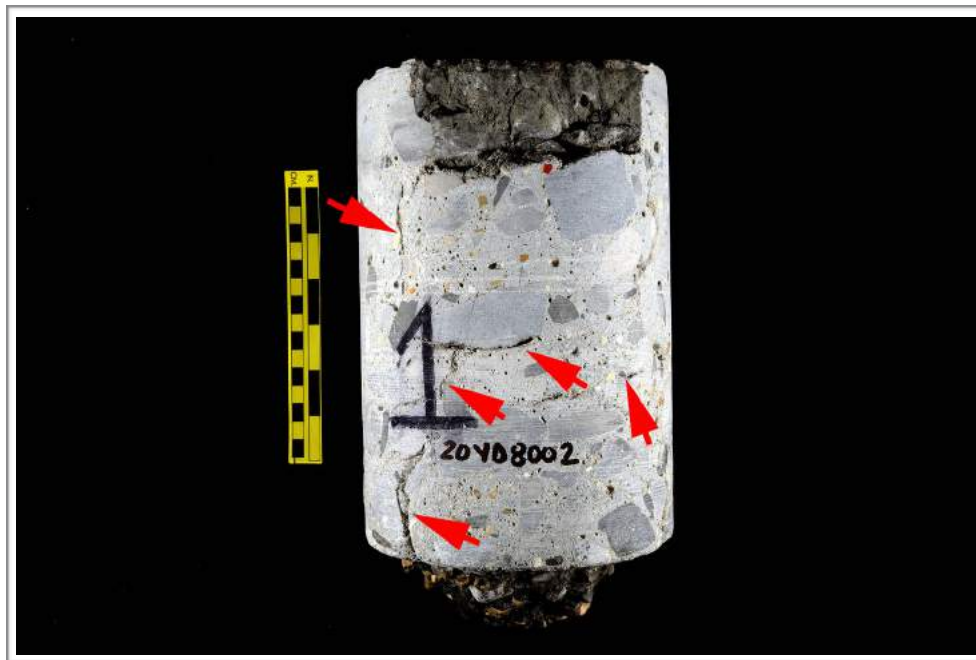
Figure A6. (a) Photograph of the side of the core showing overview of cracks (red arrows). The yellow scale is ~ 150 mm (6 in.) long.

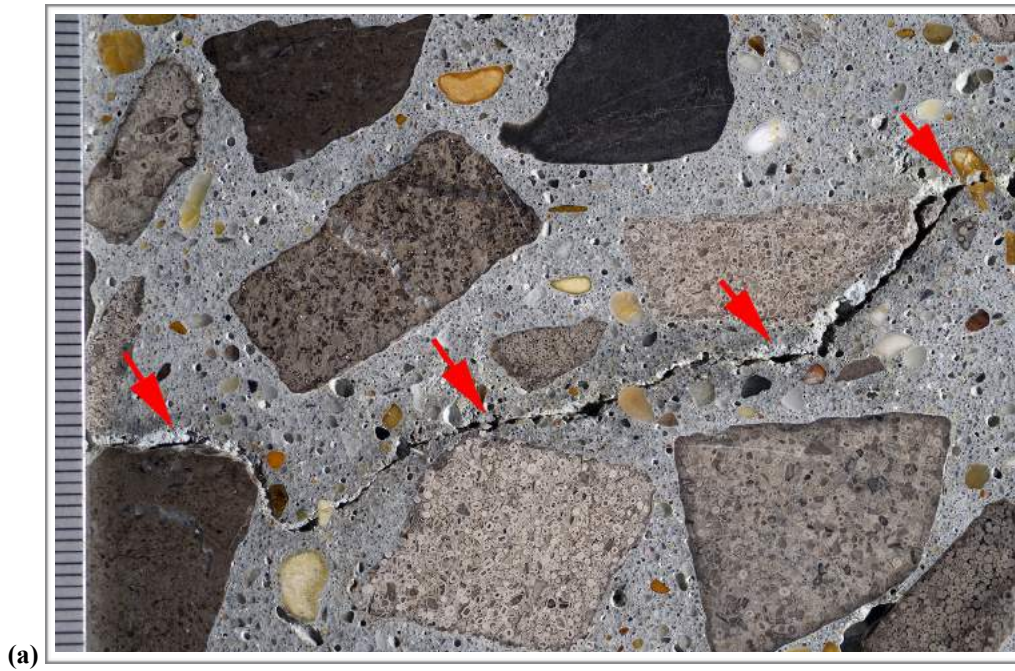
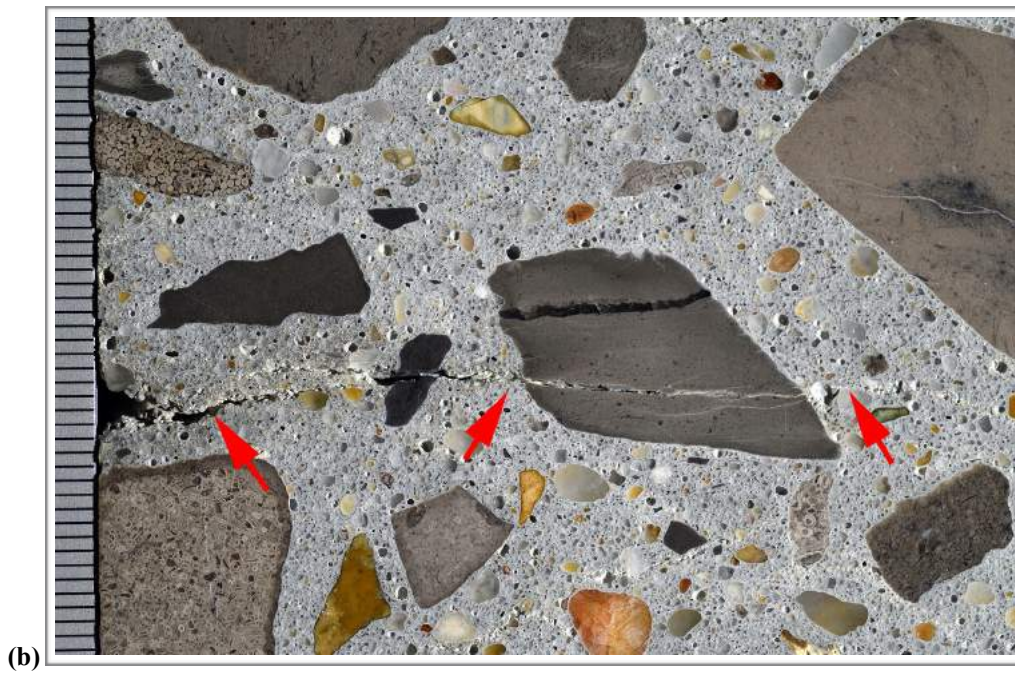
Figure A7. Photographs of the polished surface showing sub-horizontal cracks (red arrows) at (a) 75 mm (3 in.) and (b) 110 mm (4 3/8 in.) below the top surface.

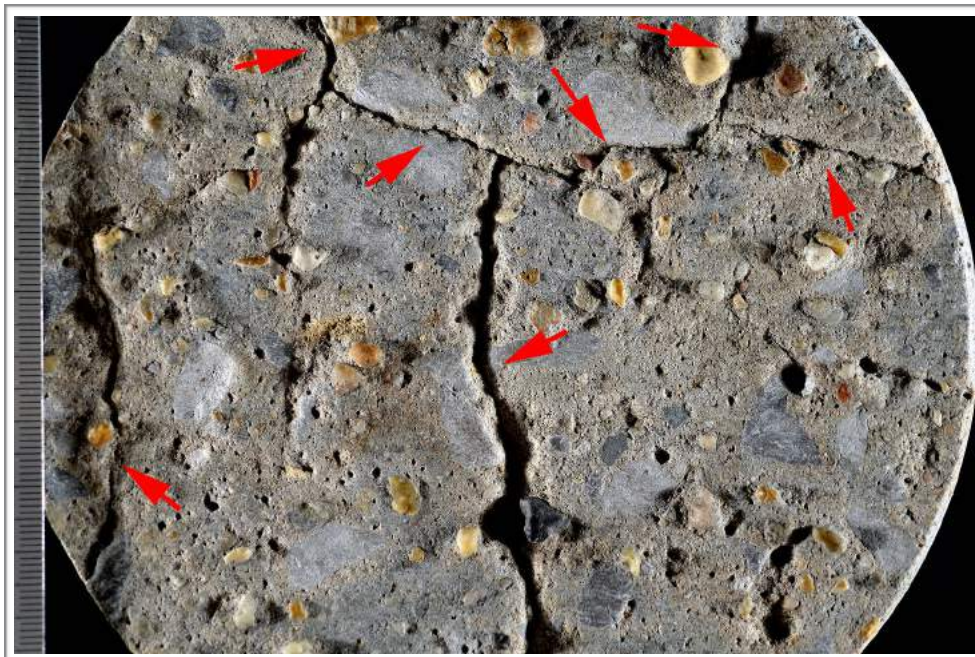
Figure B4. Photograph of top of core showing cracks (red arrows); scale in millimeters.

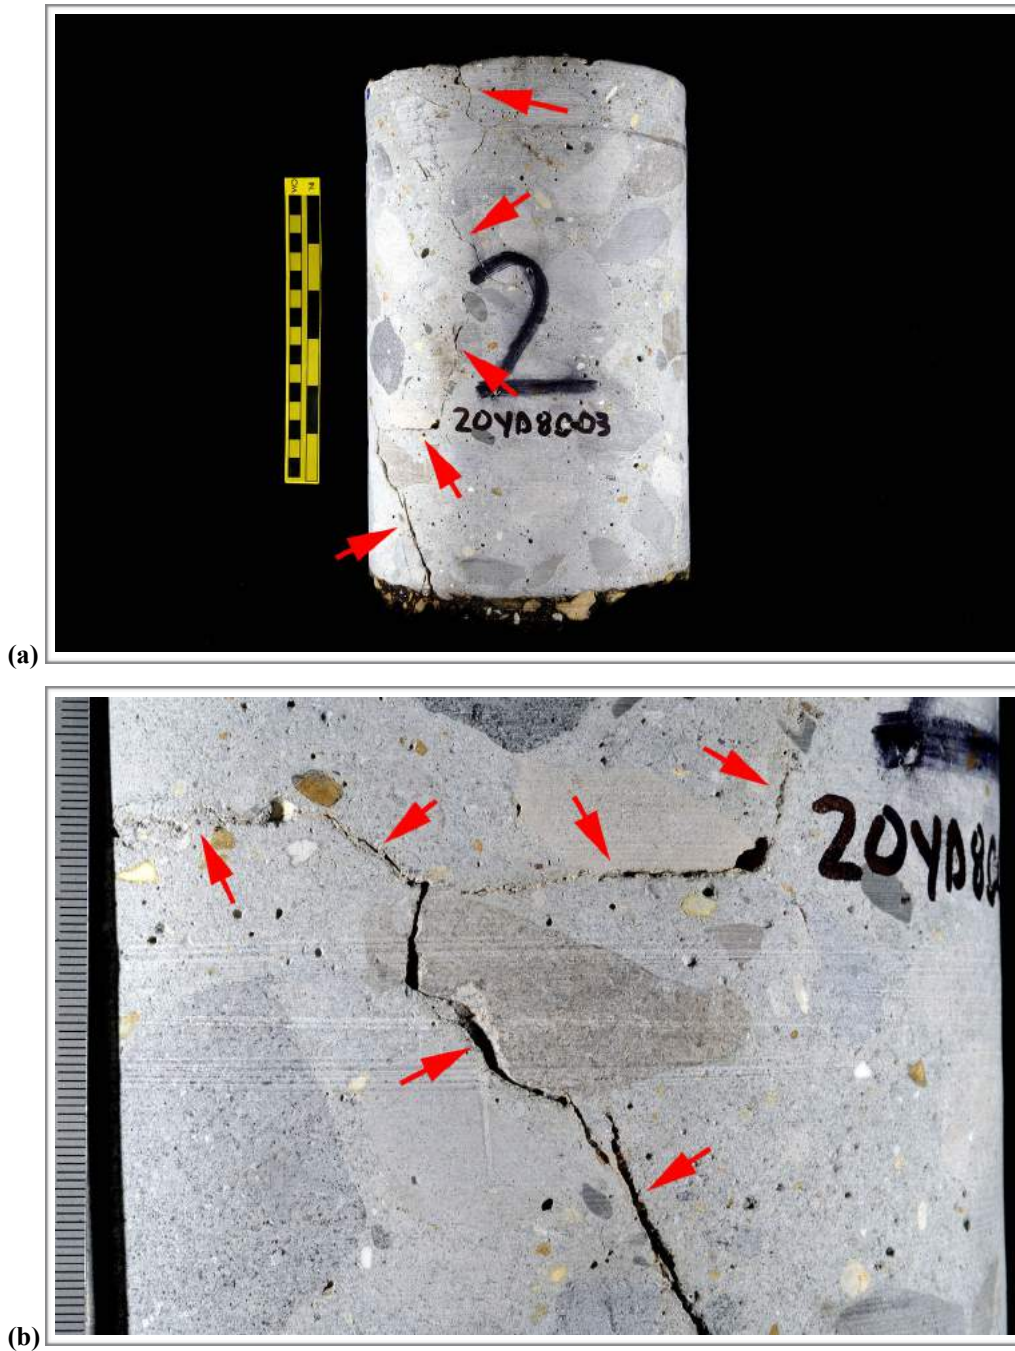
Figure B5. Photographs of the side of the core showing (a) overview and (b) detail of cracks (red arrows). The yellow scale is ~150 mm (6 in.) long.

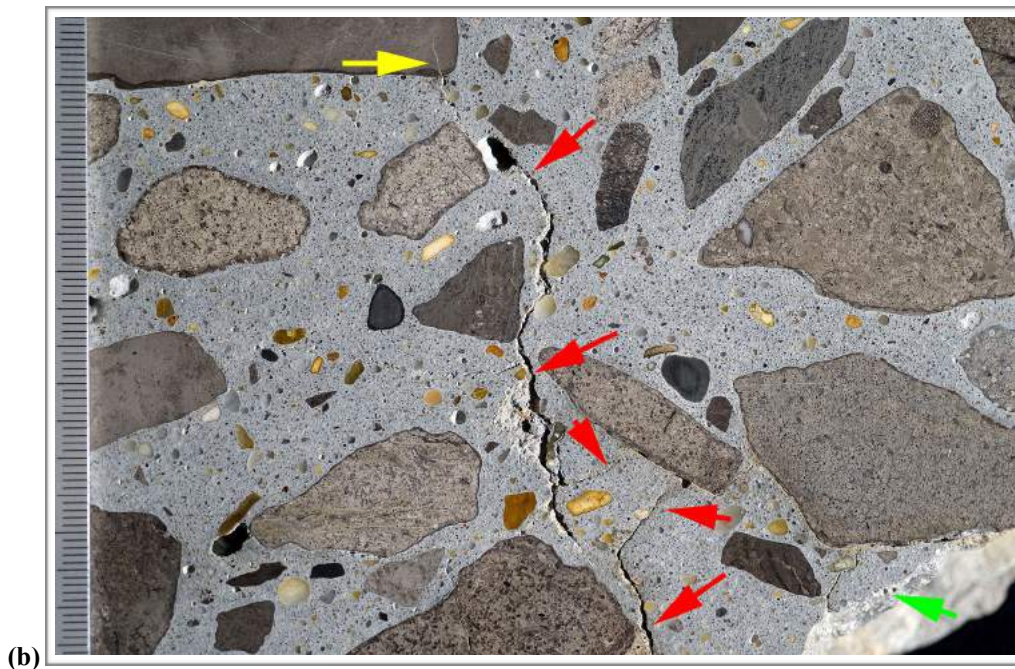
Figure B8. Photographs of the (a) side of the core and (b) the polished surface showing cracks (red arrows) at the bottom of the core (green arrow in (b)). In (b) the yellow arrow highlights a hairline crack in a dolomitic limestone particle and the scale is in millimeters.

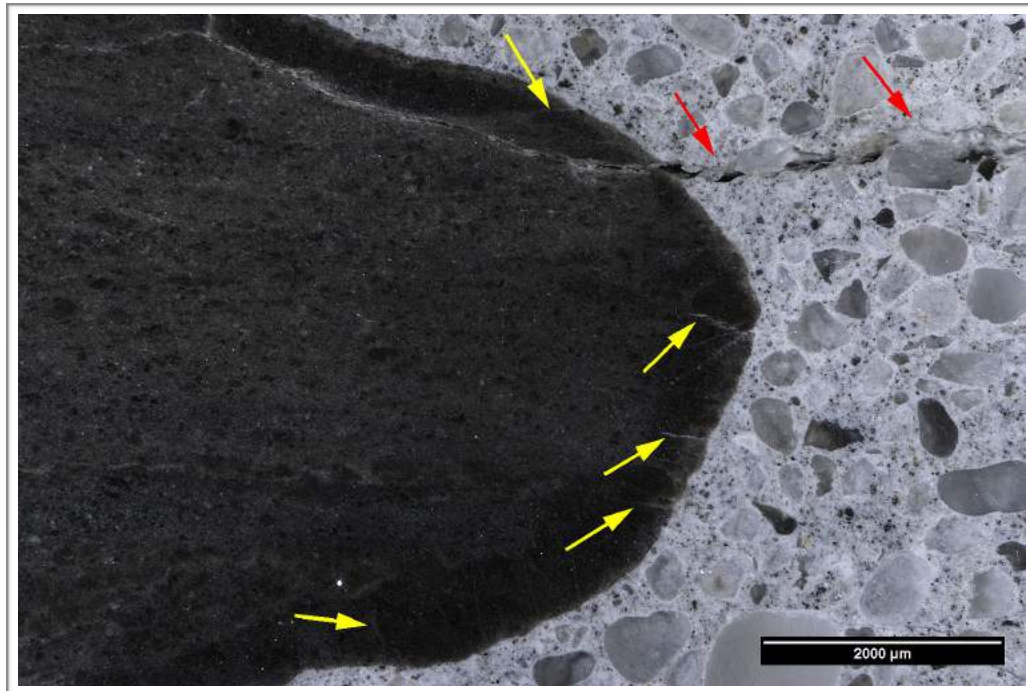
Figure B21. Reflected light photomicrograph of the polished surface showing hairline crack (red arrows) cutting from dolomitic limestone particle with microcracks in reaction rim (yellow arrows).
