Concrete Overlay Webinar Series Performance History of Concrete Overlays

November 2014 PERFORMANCE HISTORY OF CONCRETE **OVERLAYS IN THE UNITED STATES**

Case Histories

Highlights twelve concrete overlay projects across the US

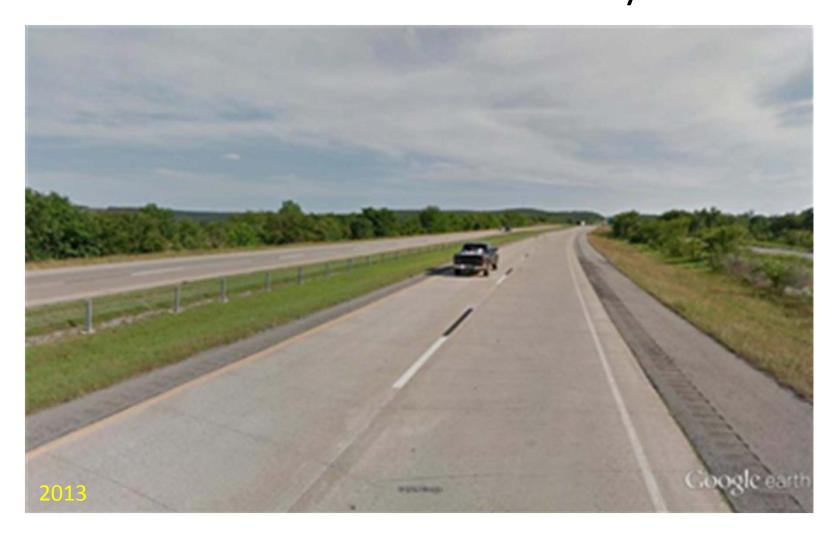
• Less than 1% cracked slabs after 9 years

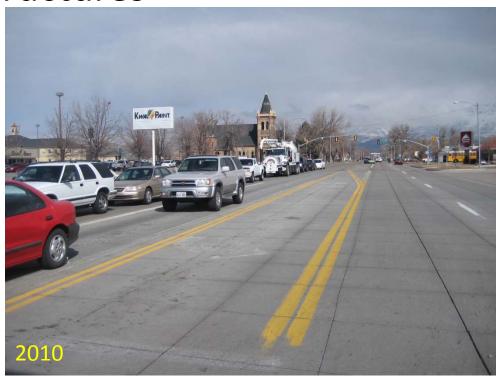
- Reconstructed during capacity widening project in 2012
- Early cracking and panel replacement around utility structures

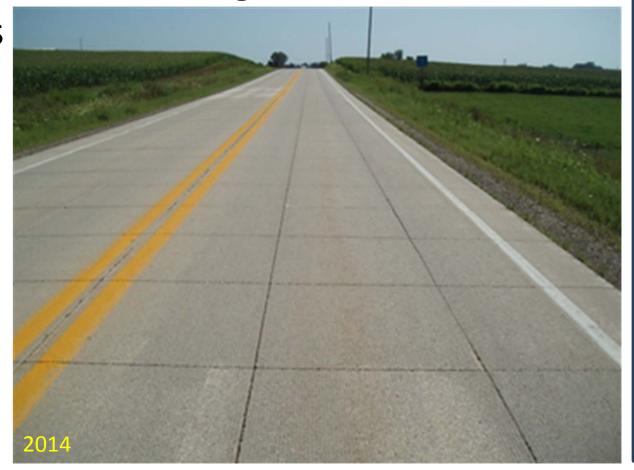
Minimal repairs after 12 years

Some longitudinal cracking attributed to

tooled joints

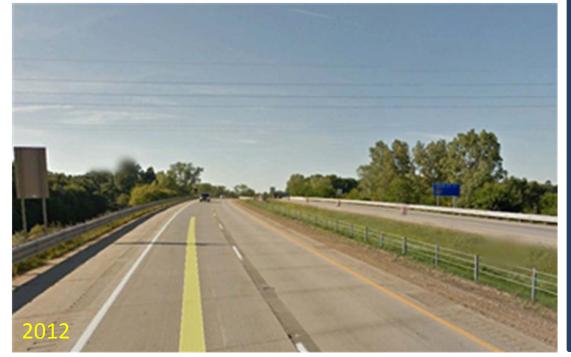
- Estimates based on 2012 imagery
 - 18 patches (0.3%)
 - 24 cracked slabs (0.4%) that have been sealed

0.8 mile section experienced early joint

deterioration
