Louisiana Transportation Research Center

Final Report 595

Evaluation of Dowel Bar Alignment and Effect on Long-term Performance of Jointed Pavement

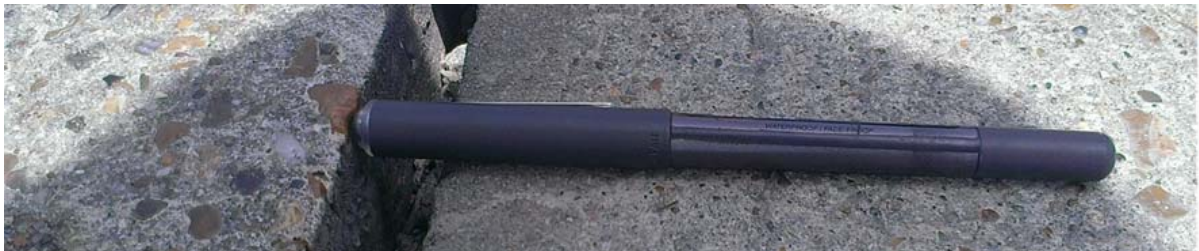
The 810-12 project showed significant faulting, as well as mid-panel cracking. The results were further analyzed and the contour map images shown in Figure 16 showed an “abnormal” dowel. Investigation by the authors uncovered that this pavement section was constructed using star lugs. Figure 17 and Figure 18 show magnitude of the faulting, in once case exceeding $\frac{1}{4}$ in.

Figure 17
Faulting of adjacent pavement slabs for the 810-12 project slightly less than 1/4 in.
