1. Report No. FHWA/LA.03/373		2. Government Accession No.		3. Recipient's Catalog No.	
4. Title and Subtitle Evaluation of the Effect of Synthetic Fibers and Nonwoven Geotextile Reinforcement on the Stability of Heavy Clay Embankments		5. Report Date April 2003

EVALUATION OF THE EFFECT OF SYNTHETIC FIBERS AND NONWOVEN GEOTEXTILE REINFORCEMENT ON THE STABILITY OF HEAVY CLAY EMBANKMENTS

LTRC PROJECT NO. 95-1GT
STATE PROJECT NO. 736-99-0760

April 2003

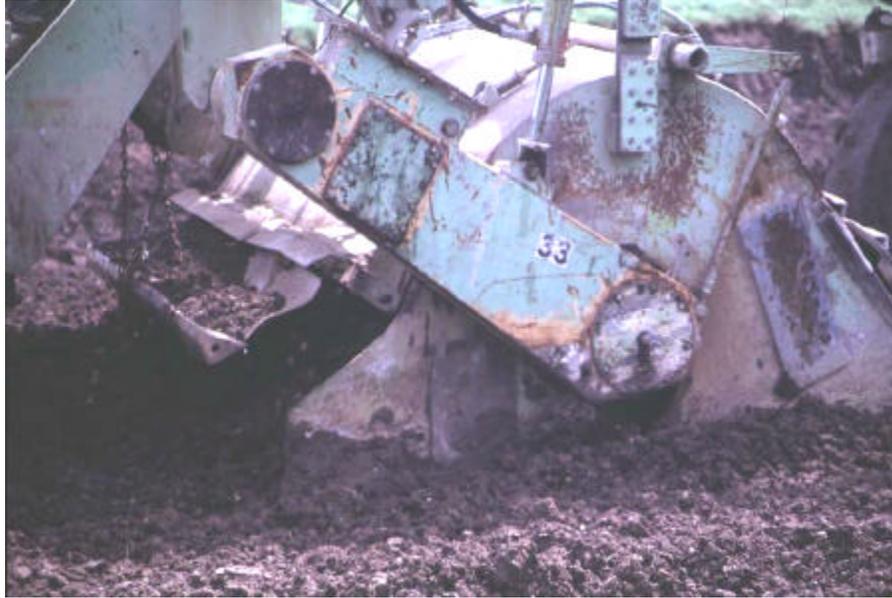
Figure 5
Fiber-soil mixing process in the field

Construction of Test Sections: The fiber-reinforced slopes were constructed with a general contractor as part of a roadway rehabilitation project. Three failed slopes, namely test sections 132, 213 and 224, were repaired using fiber-soil mix with a fiber ratio of 0.2% by dry soil weight. The mix was calculated and installed in the field based on soil volume. The excavated soils from the failed sections were spread over working areas at a maximum lift thickness of 12 inches. The bags of fiber were manually spread over the embankment lifts and fiber-soil mixing was achieved using a rotary pulverizer mixer. Figure 5 shows the fiber-soil mixing process with the stabilizer in the field. Figure 6 shows the dispersion of the fibers after the field mixing process. The fiber-soil mix was then compacted in layers parallel to the roadbed. The field compaction control was based on the soil-only compaction curve, not the fiber-soil compaction curve. In an attempt to mimic common maintenance practices, the test sections were constructed with various construction procedures and specifications in order to evaluate the effect of embankment construction controls on the long-term stability of the slopes.

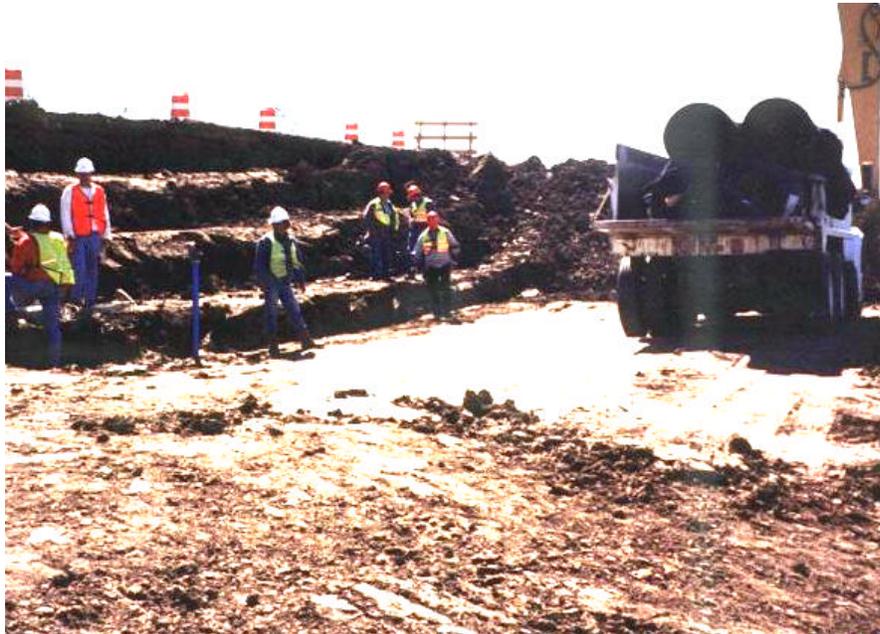
Figure 7 Field compaction with loaded dump truck

from the roadway to allow gravity drainage through the fabric. Soil was compacted using a loaded dump truck as shown in Figure 7. The fabric was placed on the top of each lift in one continuous sheet and was extended about two to four inches outside the slope facing. Figures 8 and 9 show a view of the fabric placement during construction. The field measurements of moisture and density are shown in Appendix B.

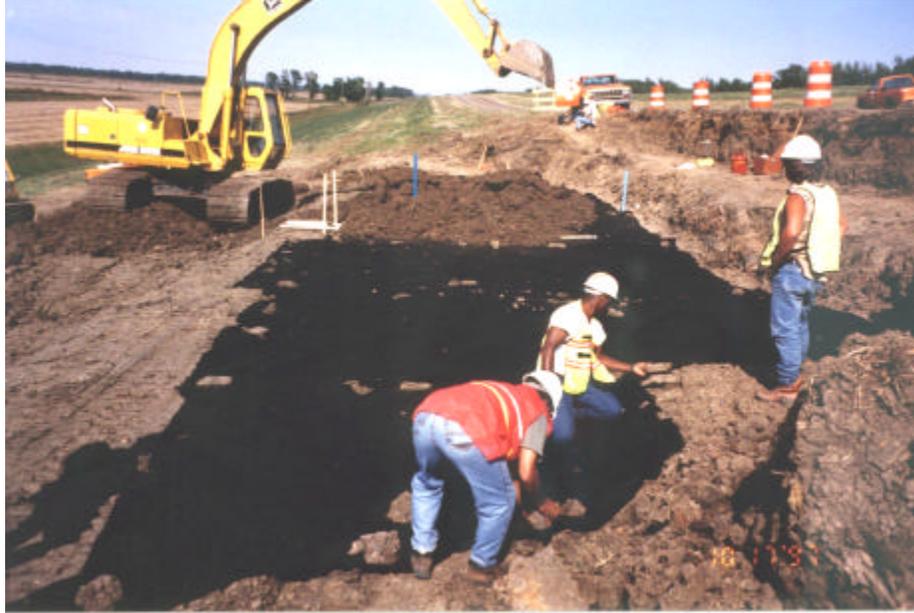
Figure 8
Placement of fabric during construction

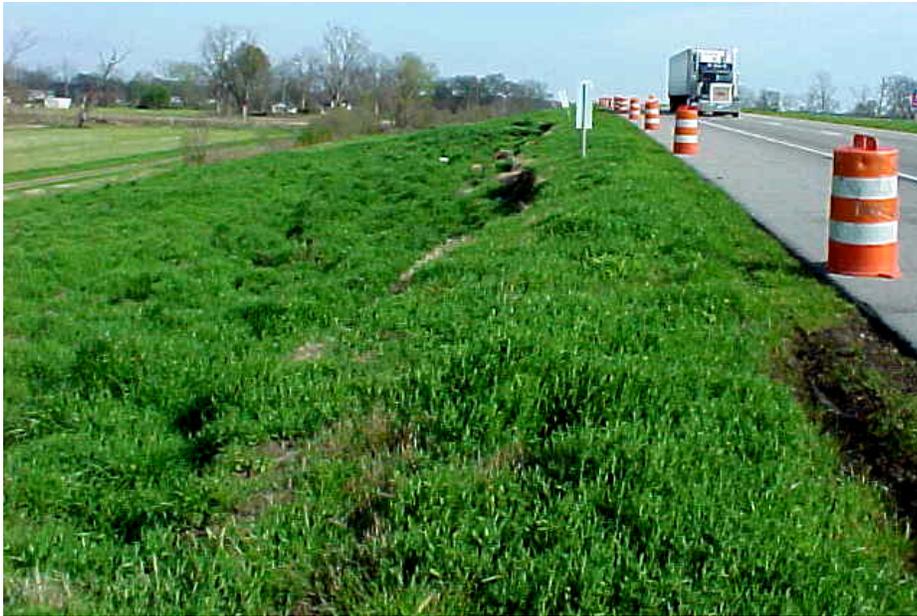
When the heavy clay in a slope is exposed to a wet- and dry-weather cycle, it expands and shrinks accordingly. This cycle of expanding and shrinking causes fissures and cracks to develop in the slope surface, thus allowing surface water to infiltrate. As the cycle repeats, the fissures and cracks become deeper. During a long wet season, the ground water will not only be trapped in these fissures and cracks, but it will also have enough time to soak the clay adjacent to these fissures and cracks. As the soil saturation increases, the shear strength decreases due to the interaction between the water and clay particles. As such, the soil will lose some of the initial shear strength established during the process of soil compaction at the optimum moisture content. The water molecules will change the fabric structure of the soil, breaking the bonds between clay particles. Slope failures most often occur in slopes when the soil becomes totally saturated causing a reduction of soil strength. This process is supported by the observation of the test sections and by other investigators [6,7]. Figures 18 and 19 show typical failures at sections in slopes constructed with heavy clay soil.

Figure 18
View of an Embankment Slope Failure on I-20

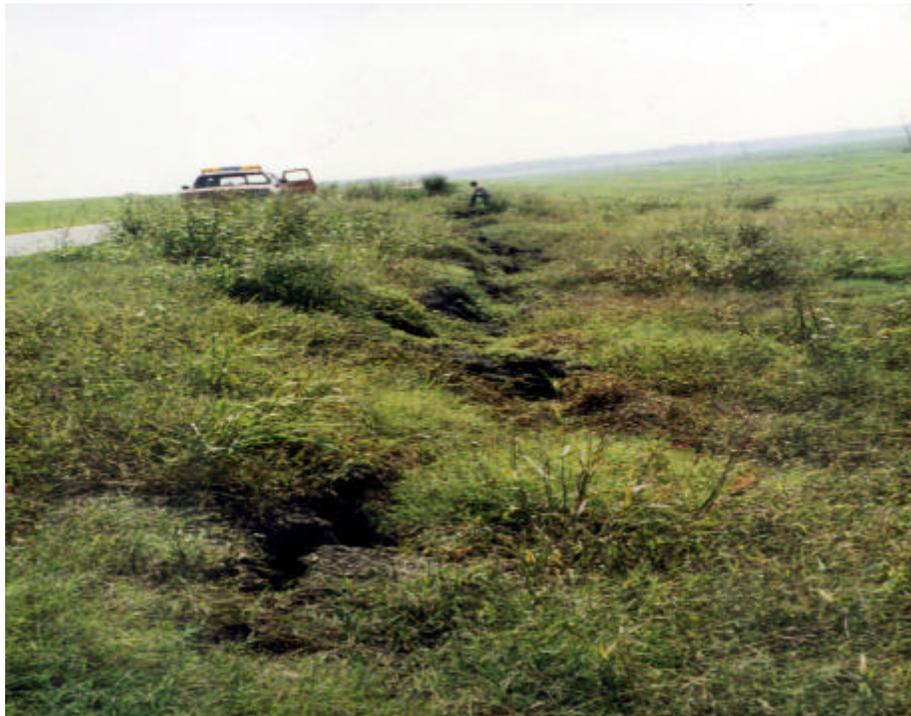
Figure 19
View of a Failure in a Slope Section in LA-15

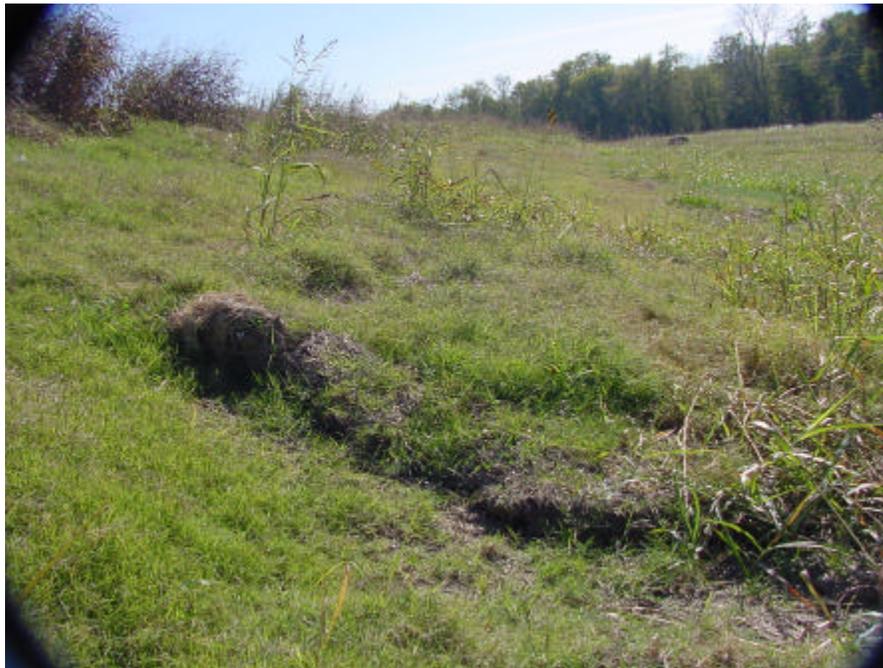
Several slope-sliding failures have been observed in the fiber-reinforced test sections since they were constructed in 1997. Most of these failures were visually observed. Only one slope failure in Section 132 (Fiber-Reinforcement–Standard Specifications) was detected by the vertical inclinometers. The results of the inclinometers in this section were used to estimate the location of the failure surface inside the slope. The location of the failure surface indicated that sliding developed in the wet clay soil below the repaired fiber-soil zone. Consequently, this section could not be used to evaluate the long-term performance of fiber soils. The other failures occurred in Test Section 224 (fiber reinforced at optimum moisture-minor compaction) in late fall of 2001. The cause of these failures was inconclusive since they occurred outside the instrumented zones and the sliding surfaces could not be identified with certainty. However, visual investigation showed that they appeared to be shallow failures passing through the fiber-reinforced zones. Figure 20 shows one of these failures.

View of Slope Failure in Fiber Section, Station 227+05

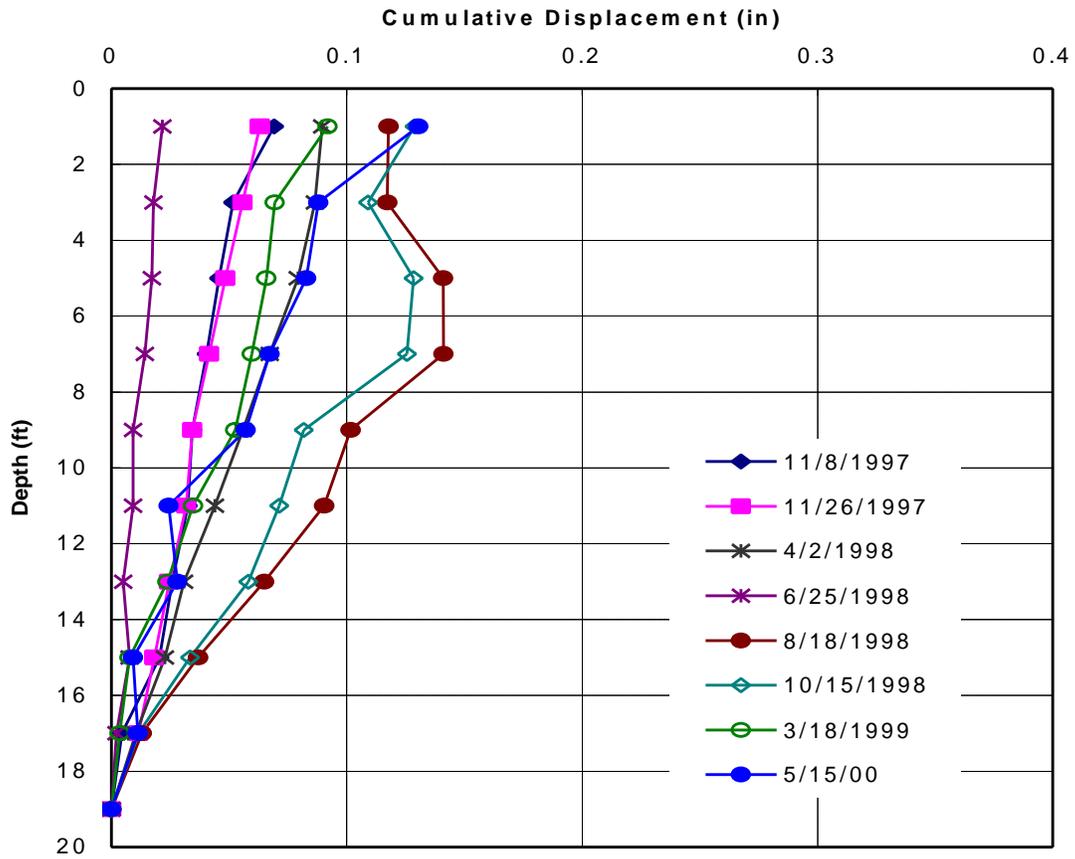
- The sections constructed at higher moisture contents experienced more deformations than the ones compacted at the optimum. Most of these deformations occurred during the wet season of the years 2000 and 2001 after relatively lower deformations during the earlier dry seasons of 1998 and 1999.
- There was no significant difference in performance between soil sections and fiber-soil sections.
- Fiber-soil section 242 did not show improvement in performance over soil section 213 (both compacted at the high moisture content using a lower compaction effort).
- Similarly, fiber-soil section 224 and soil section 244 showed similar deformation values. Both sections were compacted at the optimum moisture content. Although fiber-soil section 224 had a lower compaction effort, field measurements showed that its average dry density of 86 pcf was close to the measured densities of section 244.

The results of the measurements of the vertical inclinometers are shown in Appendix C. A typical inclinometer plot is shown in figure 21. The measurements of the maximum deformations at each section are also compiled in table 8.

Figure 21
Readings of the top inclinometer in section 224 [soil-fiber mix]

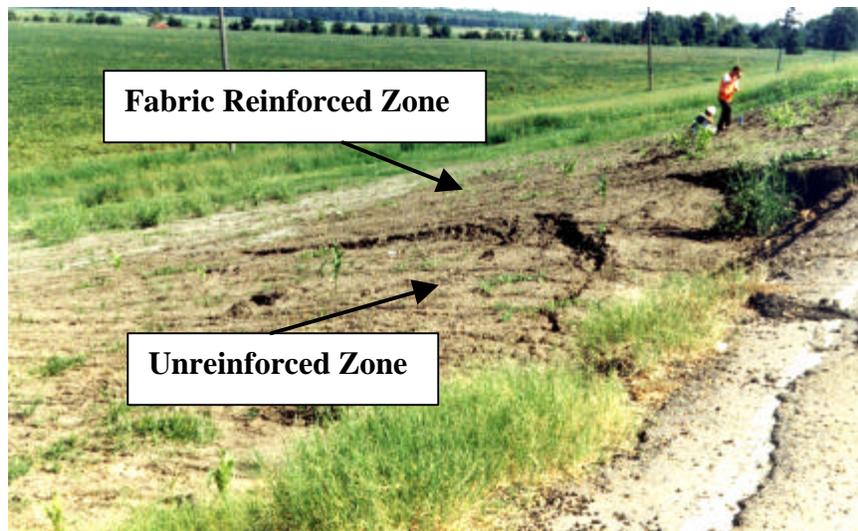
No slope failures have occurred in the fabric-reinforced test sections. Slope failures only occurred in soil sections adjacent to the fabric-reinforced zones at both sites. These failures did not progress into the reinforced zones. Figure 22 shows the slope failure in un-reinforced section adjacent to Fabric Site 2. The adjacent failures were subsequently repaired with fabric reinforcements.

Figure 22
View of slope failure in un-reinforced section adjacent to fabric site 2

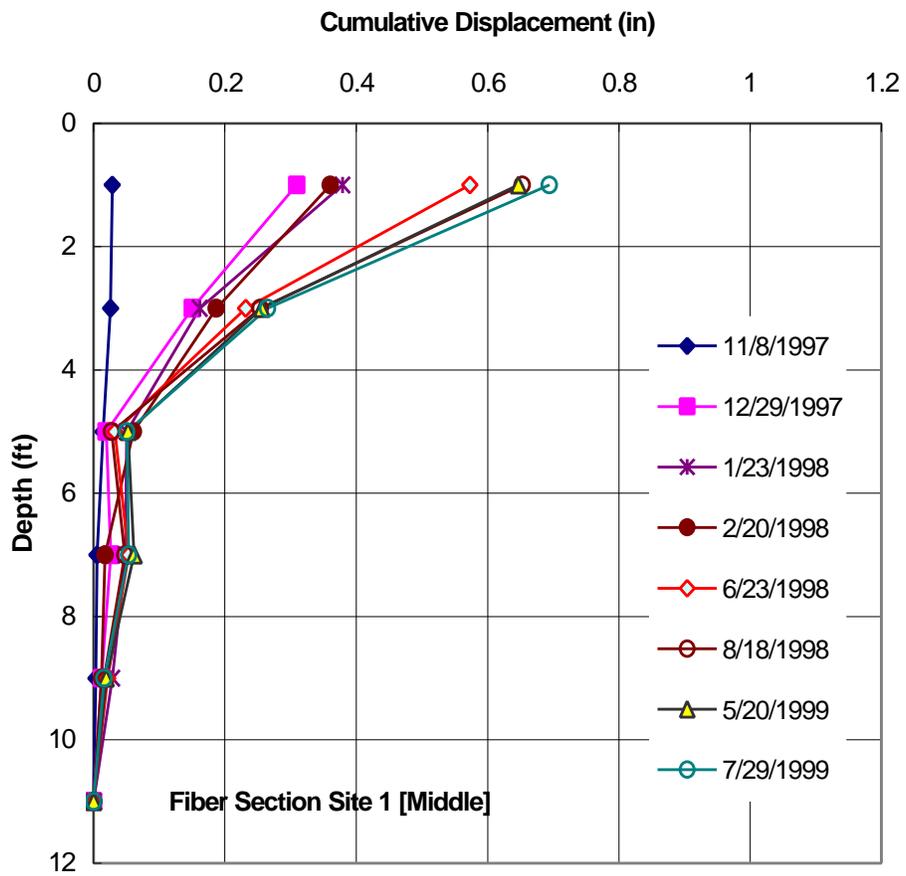
A typical inclinometer reading of the fabric sections is shown in figure 23. The measurements of the inclinometers in these sections are shown in Appendix D.

Figure 23
Readings of the middle inclinometer in fabric section 1
