1. Report No. FHWA/LA.03/378	2. Government Accession No.	3. Recipient's Catalog No.
4. Title and Subtitle Monitoring of the Bonnet Carré Spillway Bridge During Extreme Overload	5. Report Date October 2003

Monitoring of the Bonnet Carré Spillway Bridge During Extreme Overload

LTRC Project No. 03-6ST

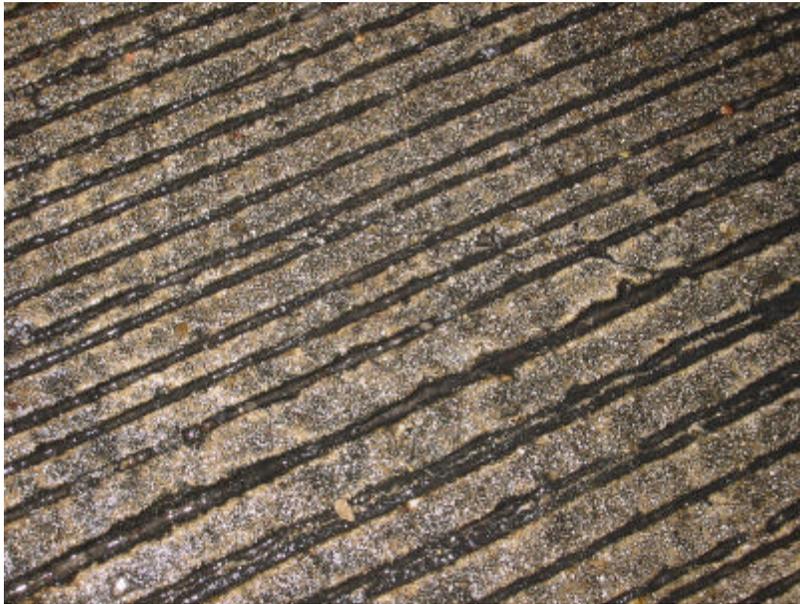
Figure 17
Photograph of cracks in concrete slabs

Visual inspection of the concrete deck was performed prior to the passage of the overload. It revealed cracks in the concrete deck in the negative moment region over the bents (figures 17 and 18). The cracks generally spanned the entire width of the bridge. Approximately five negative moment regions were inspected, and the cracks were observed in the deck at each region. The cracks were estimated to be approximately 1/32 to 1/16-inch wide. A crack width-measuring device was not available for a more accurate determination of crack width. The overload passed on the afternoon of Sunday, November 10. Time did not allow for another visual inspection of the cracks after the passage of the overload. Therefore, it is not known if the crack widths were increased by the overload.

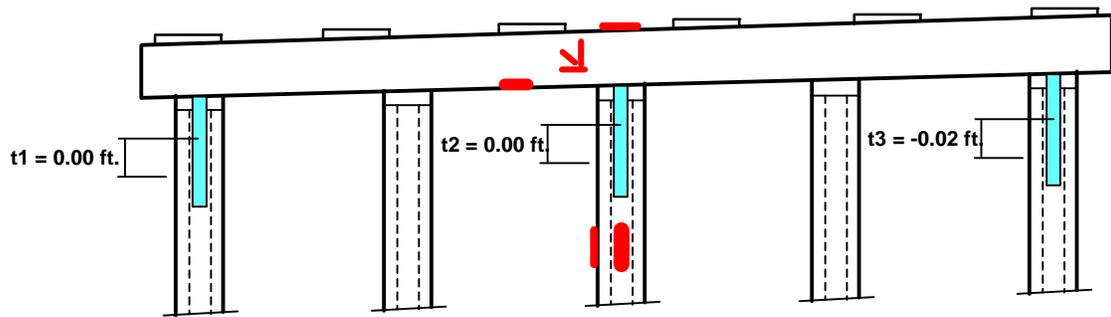
Figure 25
Deflection results for pier (bent 2)

Recorded deflection of the piles of bent 2 after the passage of the overload is shown in figure 25. These results indicate that two of the piles experienced no measurable deflection. The recorded deflection of the third pile was 0.02 feet downward. It is possible that this apparent deflection was due to improper reading or recording of the elevation prior to the passage of the overload. The readings taken prior to and after the passage of the overload were taken by different individuals.

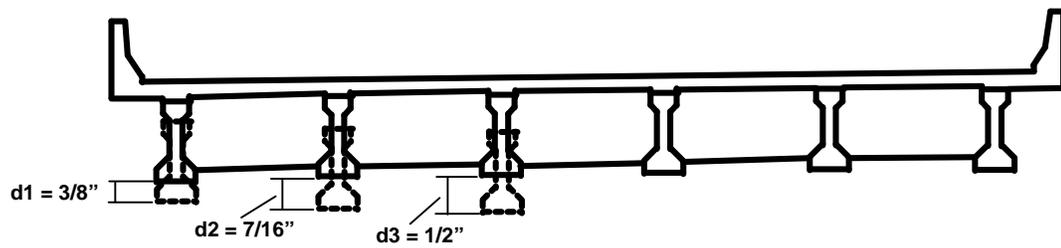
Figure 26
Deflection results for girders at midspan (span 1)

Deflection as recorded by the deflectometers after passage of the overload is shown in figure 26. This figure indicates that the deflection of the interior girders was greater than the exterior girders as expected for a load pattern of this type. The maximum recorded deflection was 1/2-inch.
