1. Report No. XXXXXX		2. Government Accession No.	3. Recipient's Catalog No.
4. Title and Subtitle Evaluation of Continuity Detail for Precast Prestressed Girders		5. Report Date December 2010

9. Performing Organization Name and Address Department of Civil and Environmental Engineering Louisiana State University Baton Rouge, LA 70803		10. Work Unit No.

11. Contract or Grant No. LTRC Project Number: 08-1ST State Project Number: 736-99-1513	
12. Sponsoring Agency Name and Address Louisiana Department of Transportation and Development P.O. Box 94245 Baton Rouge, LA 70804-9245		13. Type of Report and Period Covered Final Report March 2008 – September 2010

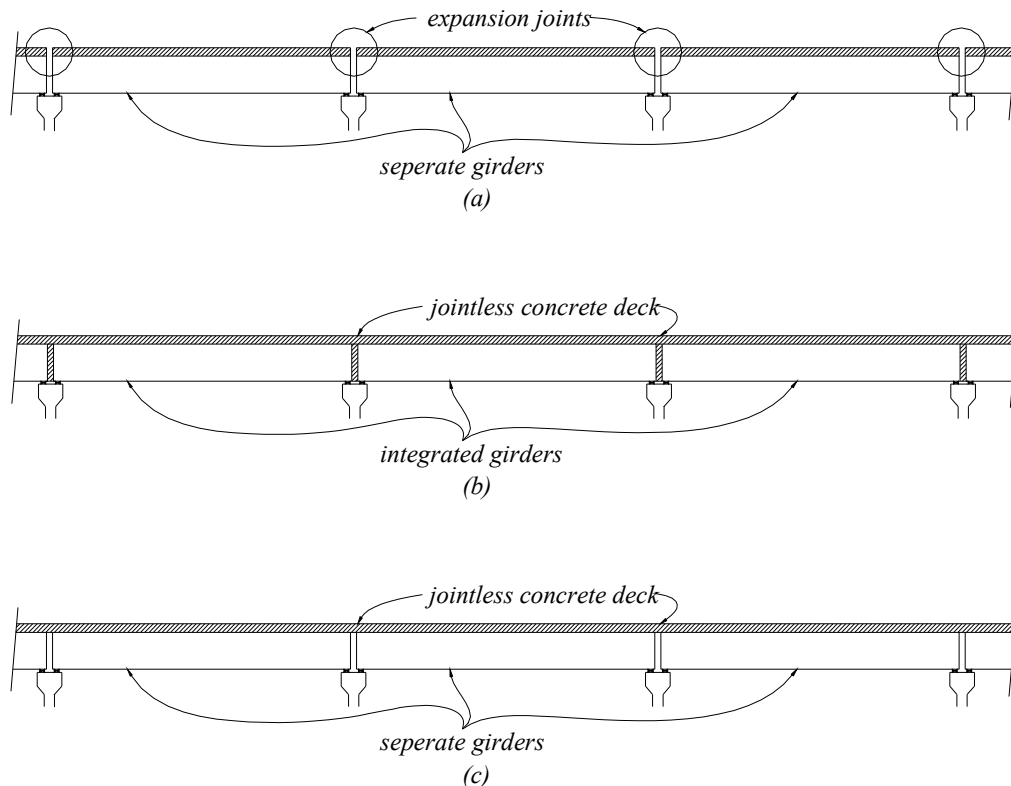
Figure 1
Typical continuity conditions in precast PSC girder bridges:
(a) simply-supported, (b) fully continuous, (c) partially continuous. (2)

Negative as well as positive moments develop over the continuous support once continuity is established in the system. Negative moments can be easily resisted by the abundance of tensile reinforcement in the deck and the ability of bottom flanges of precast PSC girders to transfer compression forces from one span to another through the diaphragm. The compression forces in the flanges of adjacent girders are transferred through the continuity diaphragm. Positive moments mainly develop in continuous bridge structures due to long term effects (e.g. creep) as can be seen in Figure 2. They cause compression in the deck over the support, which is not a problem because of the large deck area. However, the tensile forces developing in the girders' bottom flanges cannot be easily transferred from one span to the other. There are two solutions for the positive continuity moment problem. The first relies on providing additional bottom reinforcement at the girder ends that go through the continuity diaphragms to transfer the tensile forces between adjacent spans. This approach leads to *full integration* of the structure. Conversely, the designer may opt to relieve the

tensile force by separating girder ends and allowing some movement between the girder bottoms while maintaining the deck continuity. This option leads to a *partially continuous* structure.

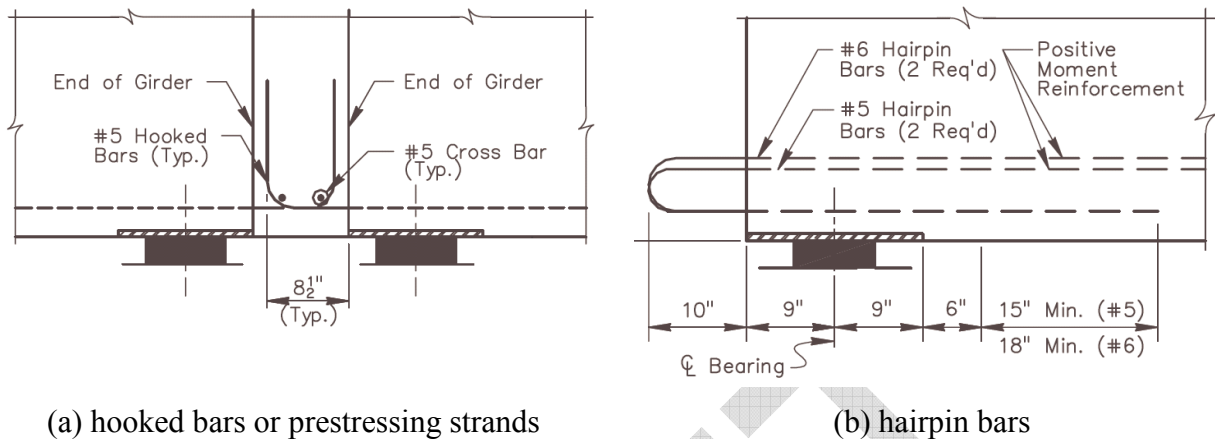
Figure 4
Alternatives for positive moment reinforcement (I)

Recently, NCHRP sponsored Project 12-53 (I) to survey current practices by different DOTs and to experimentally investigate the performance of positive moment continuity details. Design methods and tools were also developed for the design of live loads on bridges with the recommended continuity detail. Six specimens were fabricated and tested under cyclic loads until failure. Continuity details where positive moment reinforcement extends from the bottom flange at girder ends were investigated. Additional hairpin/hooked bars or prestressing strands can be utilized as can be seen in Figure 4. The conclusion from the study is that positive moment continuity details are not costly (\$200 per girder). It was recommended that positive moment connections should be designed for a capacity less than $1.2 M_{cr}$, since connections with higher capacities are not efficient. To reduce the applied moments, and therefore reduce the possibility of diaphragm cracking because of the concern that diaphragm cracking can lead to loss of continuity, the report recommends that the continuity be introduced after the 90 days or more after casting the PSC girders. The 90-day girder age limit was based on the response to the survey and from analytical results to. Experimental results showed that the loss of continuity was not seen until the connection was close to failure, and even then, the loss was about 30%. Furthermore, the authors of the report stated that positive moment continuity details also enhance the structural integrity of the bridge even if they do not reduce the total design moment. The authors of NCHRP Report 519 recommended further research to study the performance of the recommended positive moment continuity details in full-size specimens since the tested specimens were single line AASHTO Type II girders. The effects of bridge skew and thermal changes were not investigated.

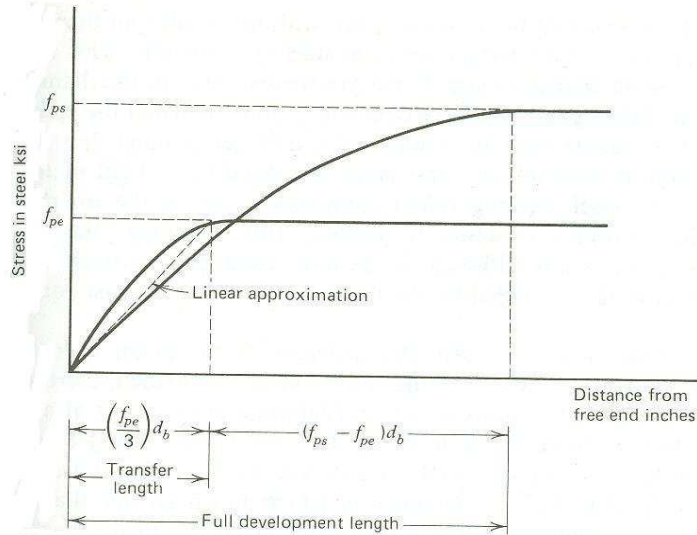
Figure 16
Transfer length model used in estimating M_{cr} at girder ends (Nilson 1987)

In determining M_{cr} for prestressed girders, the effective prestress value is calculated at a transfer length of 4 in. from the girder end, which corresponds to the face of the diaphragm assuming that the girders are embedded 4 in into the diaphragm as is the case for Bridge #2. The rate of prestress transfer is assumed to be linear for each case (Nilson 1987) as shown in the Figure 16.

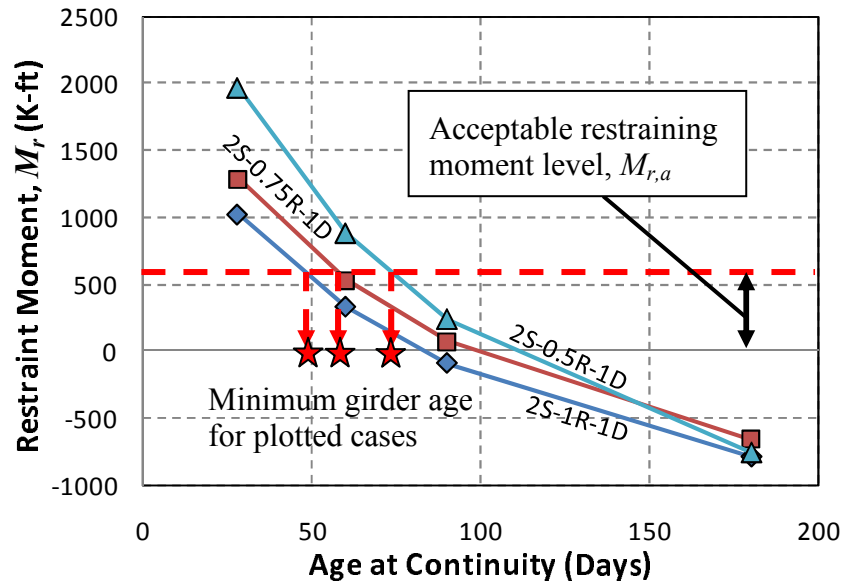
Figure 17
Determining girder age that achieves prespecified M_r criteria.

Once the cracking moment is determined, the preset acceptable positive restraint moment, $M_{r,a}$, is used to determine the age at which this moment level intercepts with a curve that represents the results for the same case with different continuity ages. This approach is shown in Figure 17. In the figure, three curves for the 2S-1R-1D, 2S-0.75R-1D, 2S-0.5R-1D cases are plotted. For an assumed $M_{r,a}$ value (horizontal dashed line), the horizontal line intercepts the three curves at approximately 48, 57, and 75 days (marked with a star on the x -axis). This approach is repeated for all analyzed cases. The results are then studied to evaluate the 90-day recommendation in NCHRP Report 322. More details about the approach and the results can be found elsewhere (35).

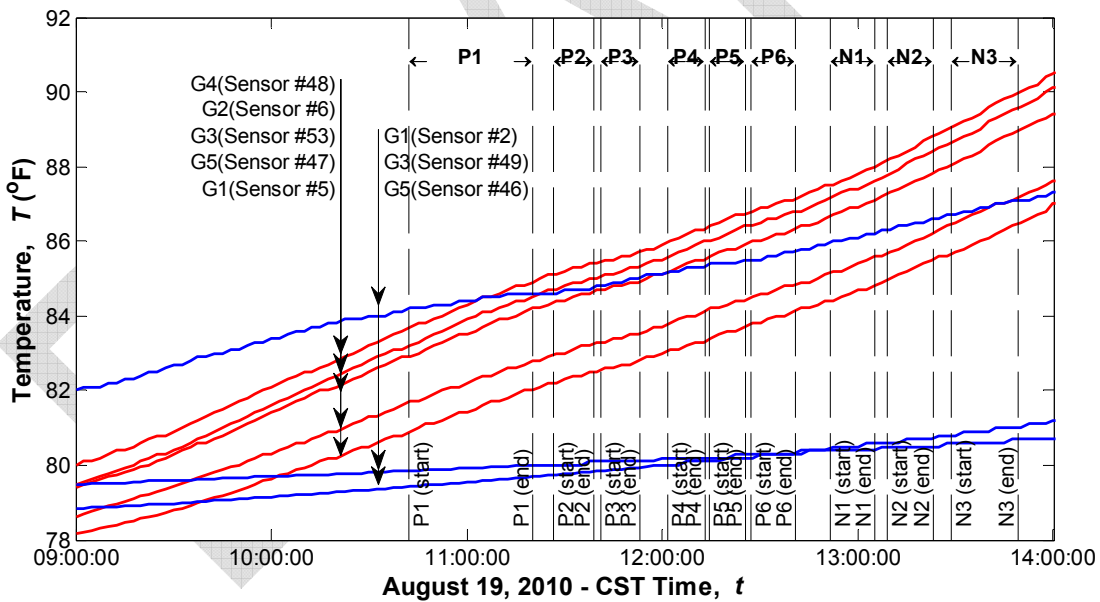
Figure 26
Temperature increase during the time of conducting static load tests.

During the course of the static load tests which started at 9:00AM and continued until about 2:30PM, the temperature at the bridge site rose about 10 °F. This rise in temperature affects both sensor readings and structural response. While the first is correctable using the temperature correction formulas provided by the sensor manufacturer, the second is real and will have to be discounted from the recorded readings. More important is the temperature gradient whose effect on the continuity detail is more severe since it causes the bridge to camber up, hence applying an opening action on the joint. In comparison to temperature gradient effect, uniform temperature change applies uniform extension or contraction on the bridge girders and hence the joint. Figure 26 shows a plot of the temperature rise from five deck sensors and three bottom girder sensors. It should be noted that the five deck sensors are at a depth of about 6 inches from the deck surface. Temperatures above 110 °F were recorded manually by the research team on the deck surface during the course of the static load test.

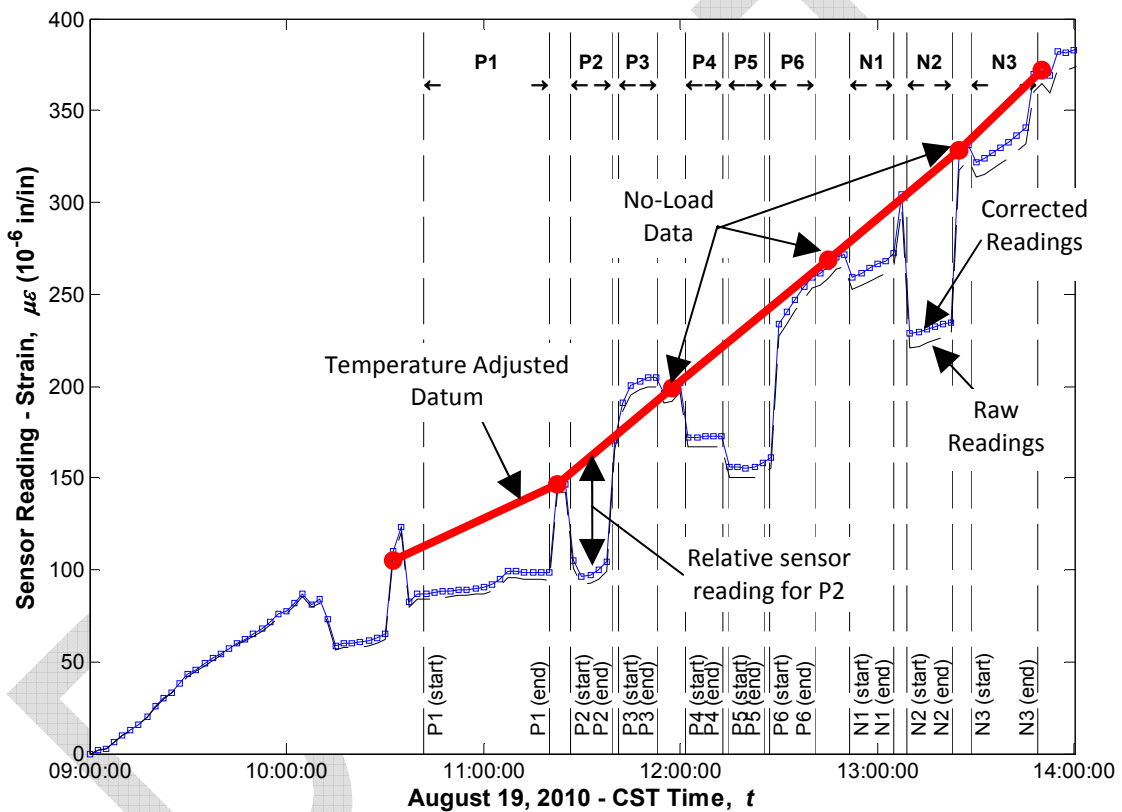
Figure 27
Sample sensor reading during static live load testing (Sensor #50 – G3, Span 23, hairpin bar).

The approach described in this section was used to interpret the live load static test readings for all sensors. The results are plotted in APPENDIX . A summary of the relative sensor readings are given in TABLE XXX, which shows that many of the readings are small because of the nature of the sensor location (close the neutral axis) or its proximity with respect to the loading position. To ensure the reliability of the interpreted data, a minimum threshold, $\epsilon_{\text{threshold}}$, was established. All sensor readings below this threshold were considered too small to warrant consideration in analyses. These readings are identified by '<<<' in Table XXX.

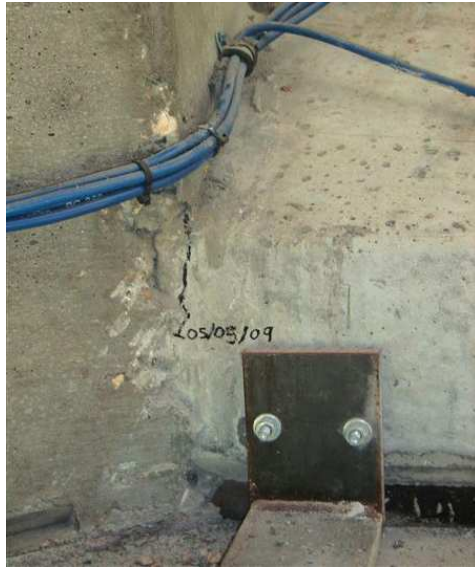
Figure 32
Observed crack at bottom flange of Girder G3 – Span 24.

The strains at the girder's bottom flanges were also investigated to understand the dissipation of these high strains in the hairpin bars 18 inches away from the continuity diaphragm's face, which is where the vibrating wire gages are installed (top, middle, and bottom). Figure 33 shows the strain records from the surface mounted gages on the bottom flanges on Girders G1, G3, and G5 on both sides of the continuity diaphragm; i.e. Span 23 and Span 24. It can be seen that the daily strain changes are about 30-40 $\mu\epsilon$ for all locations except for Girder G3 (both sides) and Girder G1 (Span 24) where the daily strain changes are about 70-80 $\mu\epsilon$. By comparison with the readings from the strandmeters on the hairpin bars, the changes are much less in all cases. The drop in daily strain changes at the surface-mounted VW gages can be attributed to the fact the tensile force in the hairpin bars has been distributed into a larger area of the girder 18 inches from the diaphragm face. At girder ends, the hairpin bars are the sole resistance of tensile forces. Because Girder G3 is cracked at the face of the diaphragm, the tensile force is still mainly resisted by the hairpin bars. However, because no further cracks took place in the girder, the tensile force is effectively distributed into the girder. The high strain changes from the surface-mounted VW gage on Girder G1 (Span 24) is also higher than G5 and G1 (Span 23), which may indicate that a crack has taken place at this location. Visual inspection has not revealed any cracks at this location.

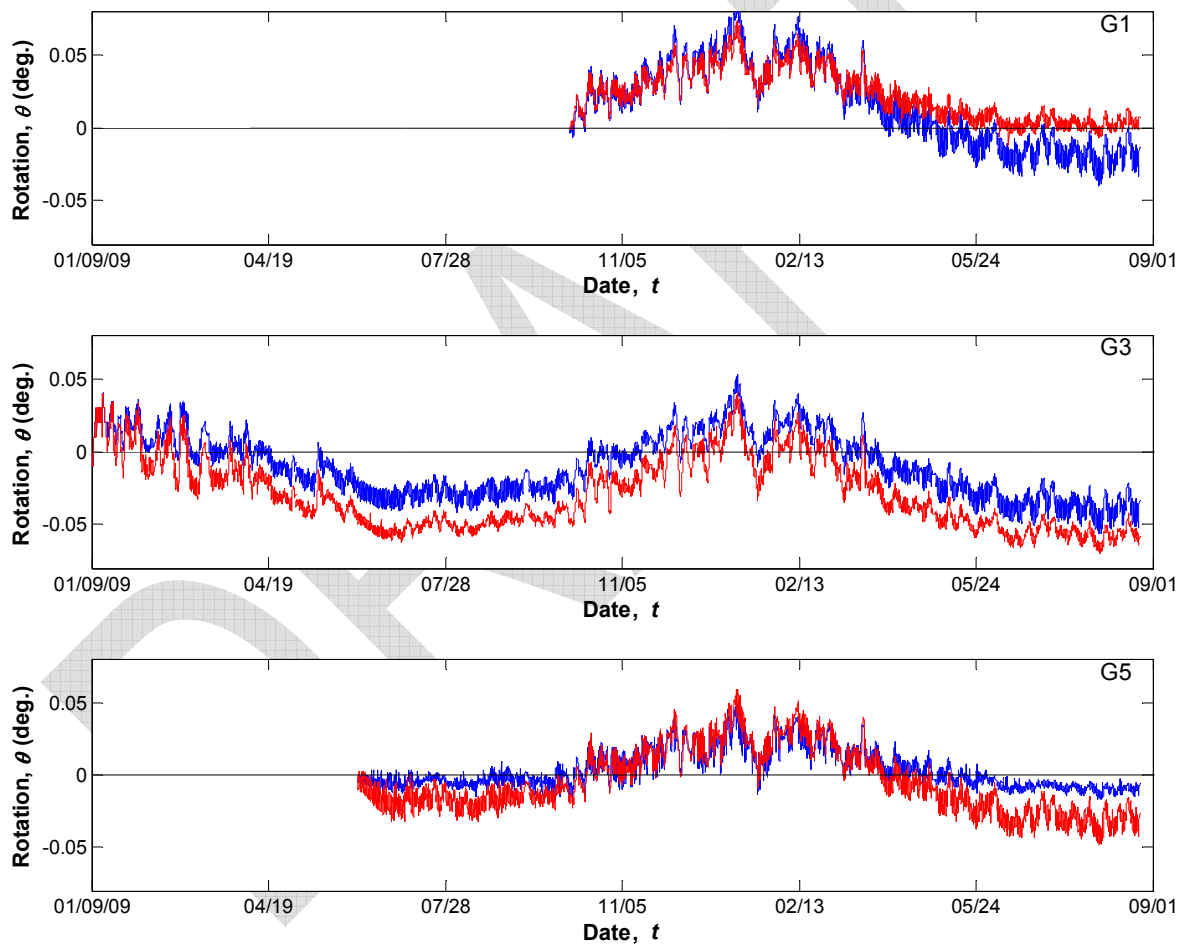
Figure 36
Rotation of girder ends (G1, G3, and G5).

that the continuity diaphragm is doing its job of providing continuity between the girders. Had there been an expansion joint between these girders, the camber of the girders (due to creep or temperature gradient) would cause opposite signs of girder end rotation as can be seen in Figure 37. In the case of an expansion joint, the rotation angles θ_r and θ_l are of opposite signs. This can also happen if a continuity diaphragm connects both girder ends, however, there is also the possibility that one girder's movement overcomes the other resulting in similar rotation signs on both side of the diaphragm. The records of girder end rotations show both cases for the continuity diaphragm detail. Most of the time, however, the sign for rotation angles θ_r and θ_l are similar.

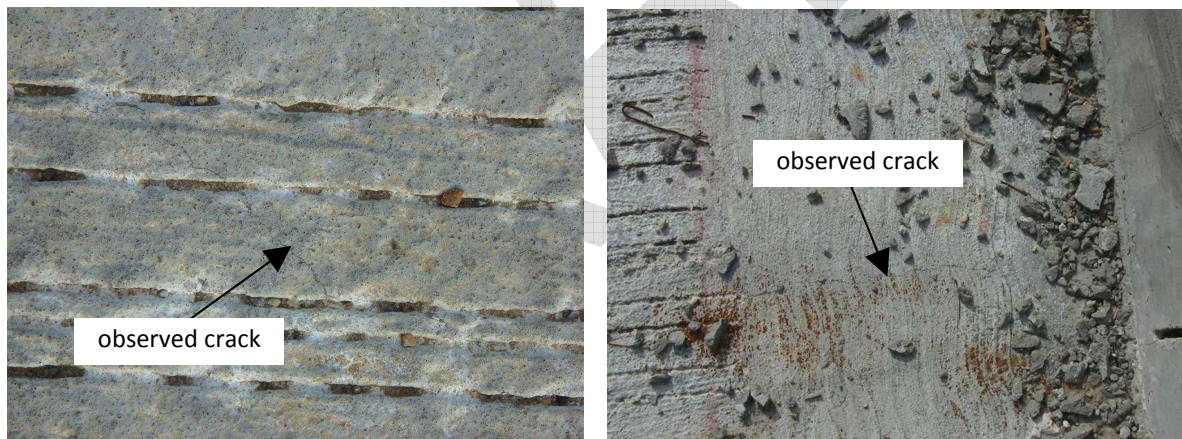
(a) in the middle of deck (skewed)

The research team visited the bridge site numerous time during the period of the project. During each visit a visual inspection of deck surface cracking was conducted. Hairline cracks were observed as early as May 2009 (4 months after establishing continuity). The cracks were very limited in width (0.001 inch) and location. They mainly ran across the deck at an angle equal to the skew angle of the bents; i.e. over the continuity diaphragm. Cracking is typical in bridge decks, especially continuous ones. Nevertheless, the likelihood of the having deck cracking over continuity supports is reduced if the detail relieves the movement of the girders (such as the case of continuous decks with no continuity diaphragms), which reduces the continuity moment between spans. Figure 39 shows two of the observed cracks in the deck of the monitored segment. In Figure 39-a, which depicts the deck in the middle of the roadway, the crack is at an angle with the deck grooving. Figure 39-b shows the crack over the support in the overhang part of the deck; i.e. outside the exterior girders. Since the continuity diaphragm is not extended outside the exterior girder, the deck crack in the overhang region is free from the diaphragm's influence, and therefore propagates along the shortest distance to the edge of the deck. This explains the crack orientation in Figure 39-b, which is parallel to the deck grooving.

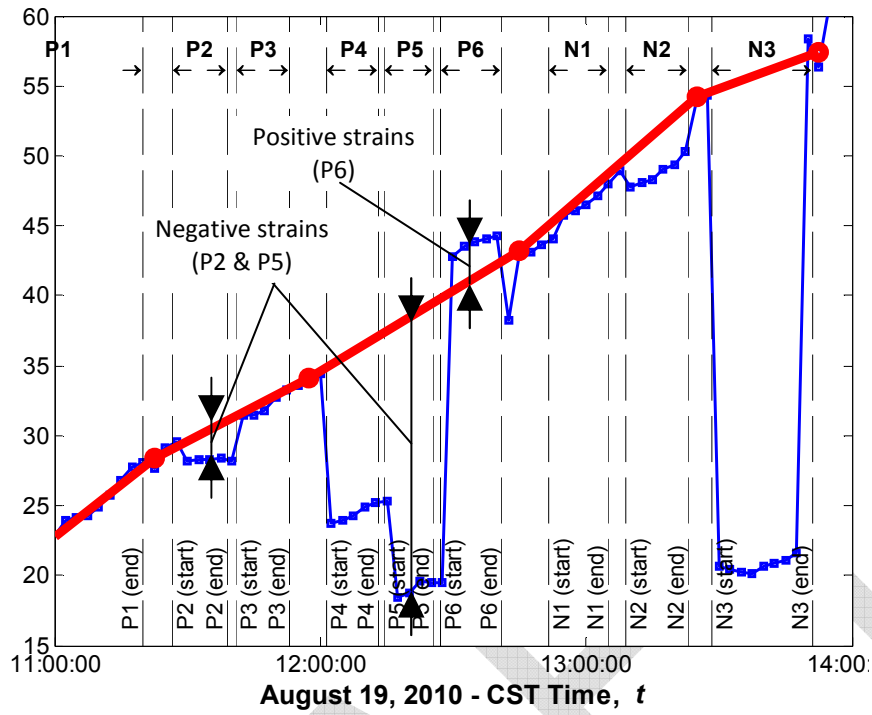
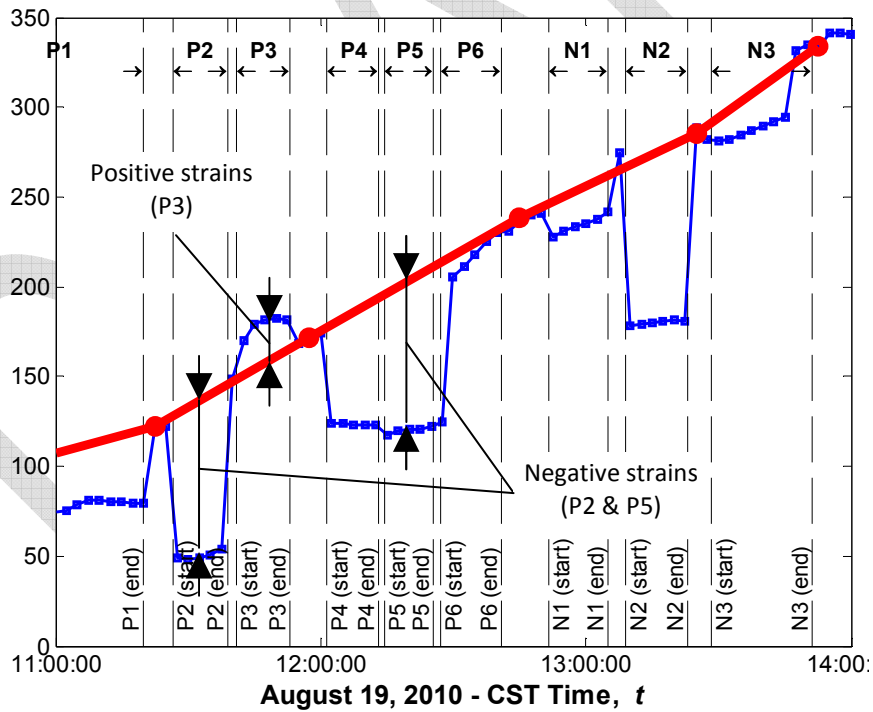
Figure 41
Strains in hairpin bars showing positive values for faraway load cases

One interesting observation is that the hairpin strain records confirm that forces were transferred from Span 25 (loaded span) to Span 23 (monitored span) for load positions P3 and P6. These two cases cause positive moments on the monitored continuity detail. Figure 41 shows the magnitude of the strains, which are larger for Girder G3 than G1. A similar observation is related to the recorded negative strains for load positions P2 and P5. Both are load cases that target positive moment in the middle of Span 24. Therefore, trucks are positioned over Span 24. They trucks would however, apply negative moments on the continuity diaphragm if it performs as intended. In both load positions (P2 and P5), the hairpin bars experienced negative strains that are, as expected, higher than the positive strains discussed earlier. Like the P3 and P6 load cases, the sensors are in one span and the loads act on another for these two cases. Hence, the ability of the new detail to transfer forces between spans is confirmed. It should be noted that Girder G5 was not instrumented on the hairpin bars and therefore a plot was provided.

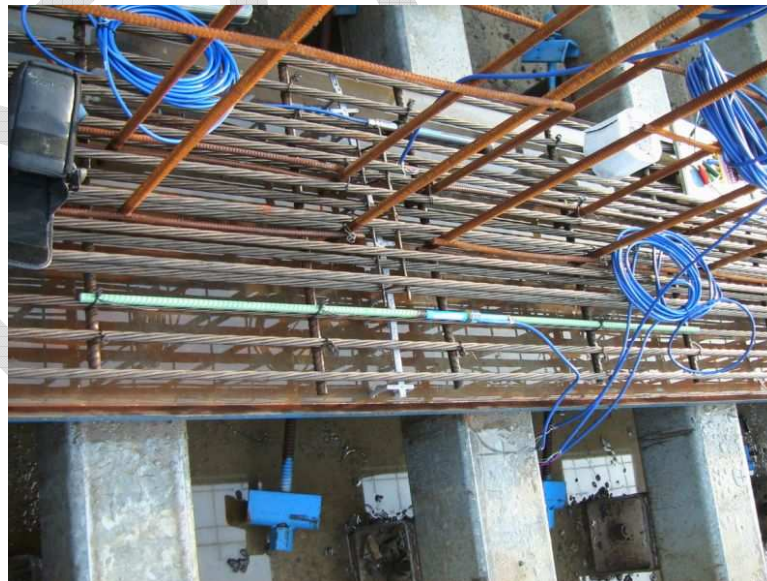
Figure A-2
Sisterbar installed next to a prestressing strand at midspan.

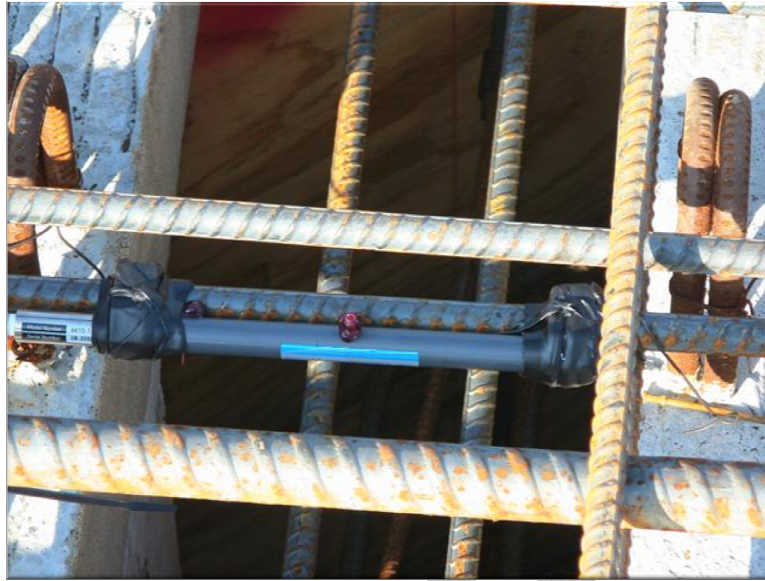
Figure A-3
Strandmeters installed on reinforcing bars in deck over continuity diaphragm.

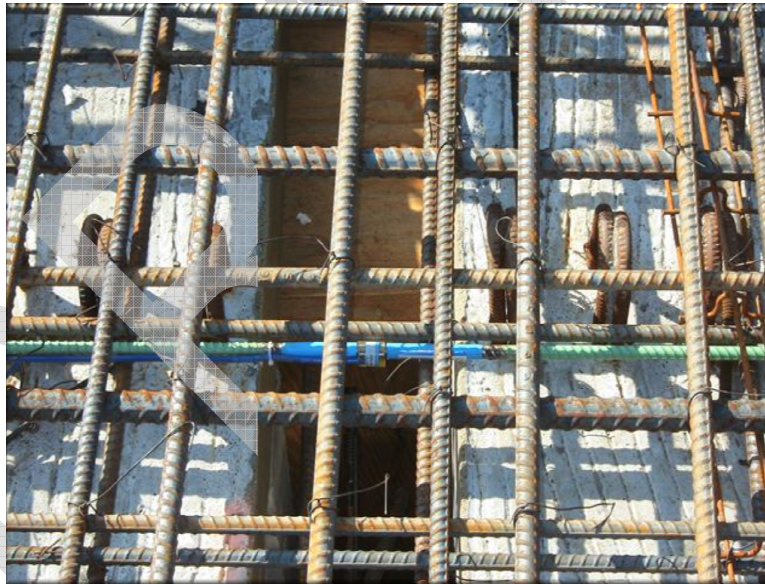
Figure A-4
Sisterbars installed next to reinforcing bars in deck over continuity diaphragm.

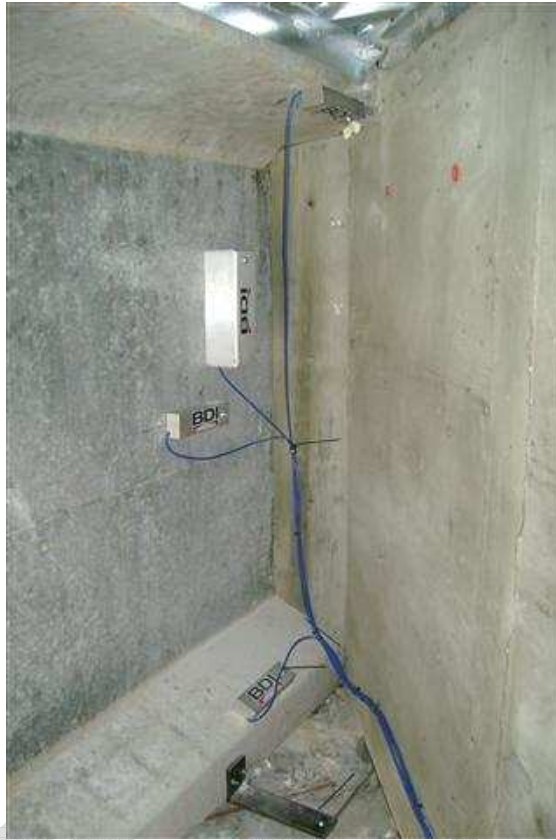
Figure A-5
Surface-mounted sensors (vibrating wire gages and tiltmeters) at girder ends.

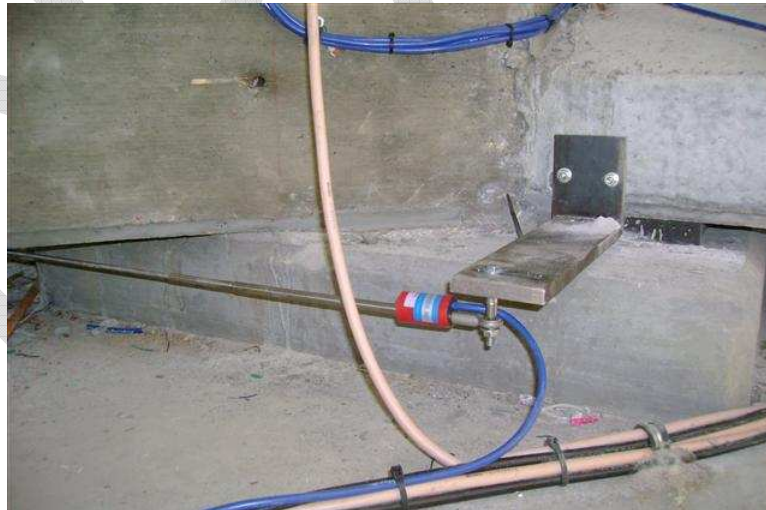
Figure A-6
Gap meter installed on brackets connected to girder ends at continuity diaphragm.

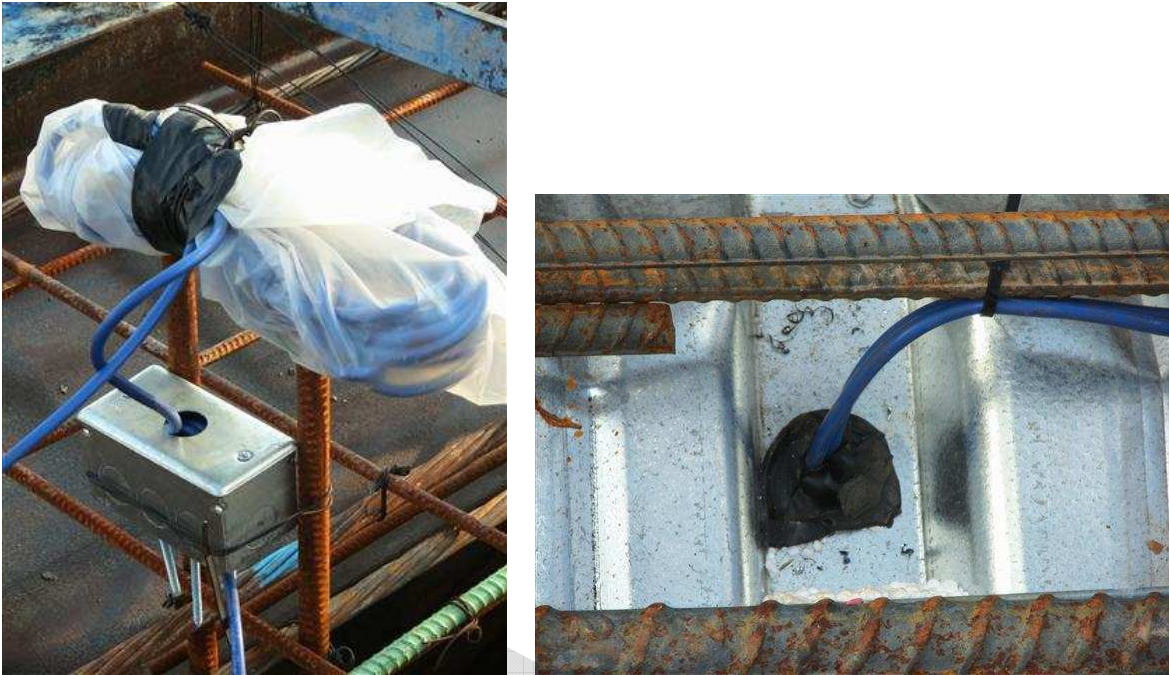
Figure A-7
Protection of wiring for embedded sensors prior to concrete casting.

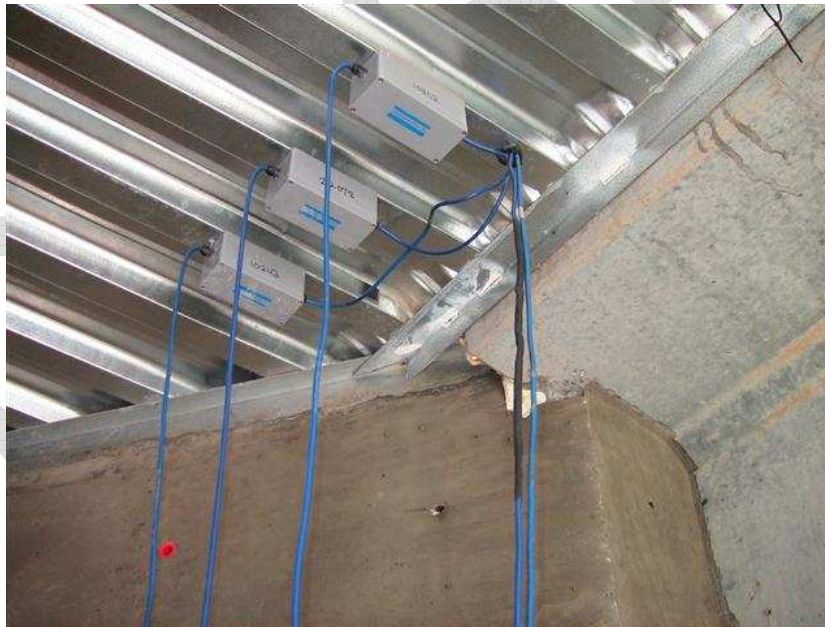
Figure A-8
Surge protectors installed on one of every two embedded sensors at the same location.

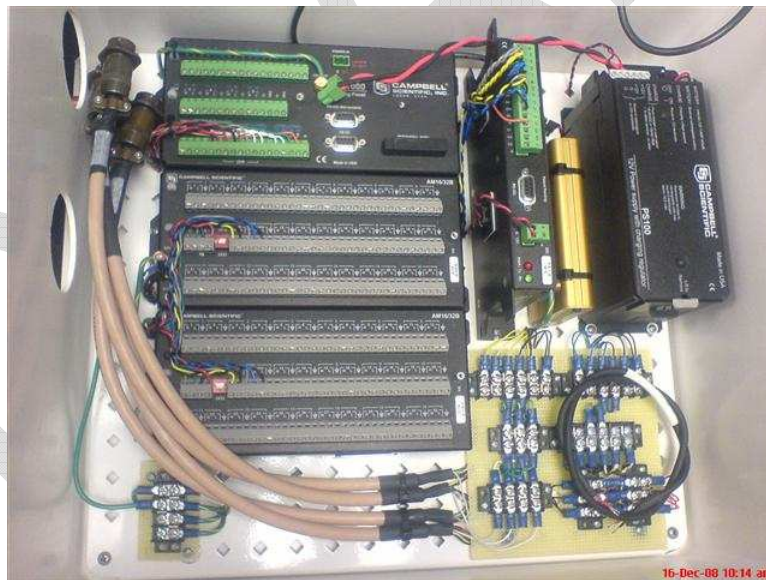
Figure A-10
Campbell Scientific datalogger.

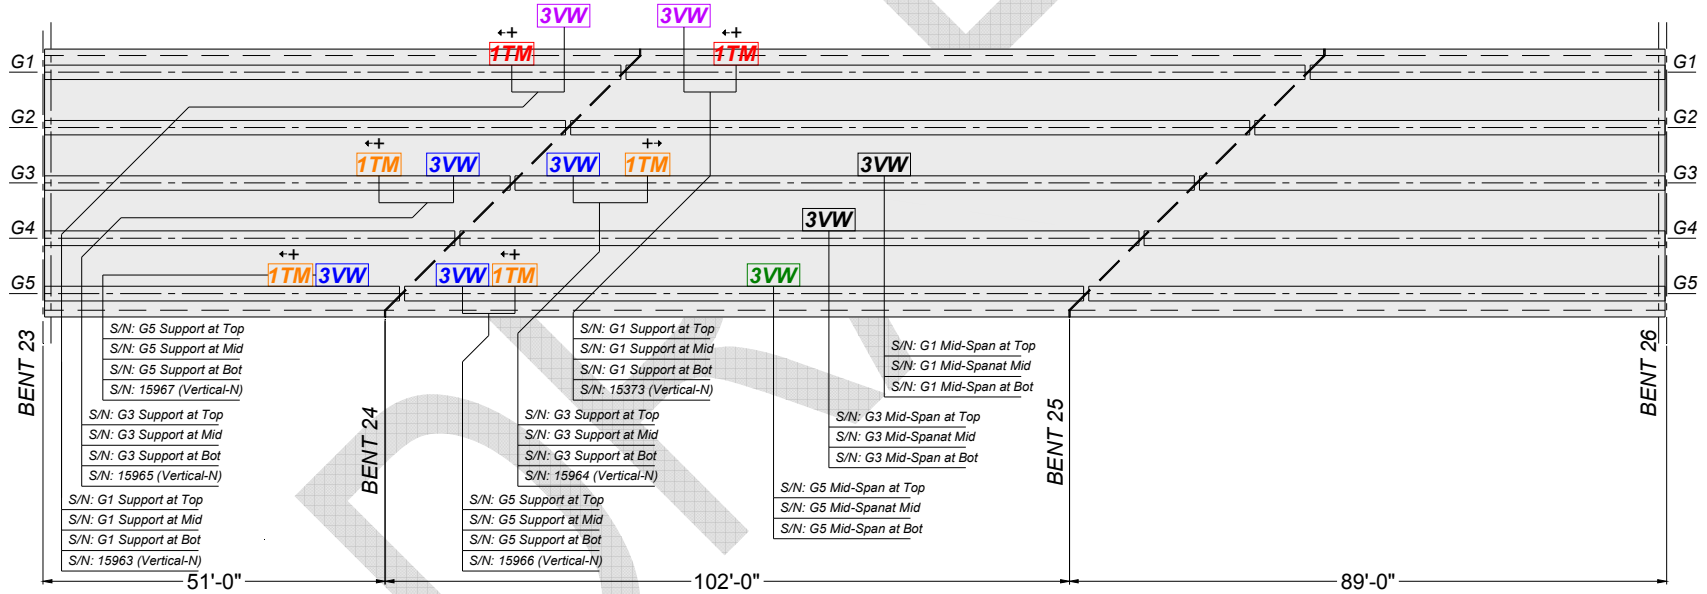
Figure A-17
Distribution of sensors on system multiplexers.

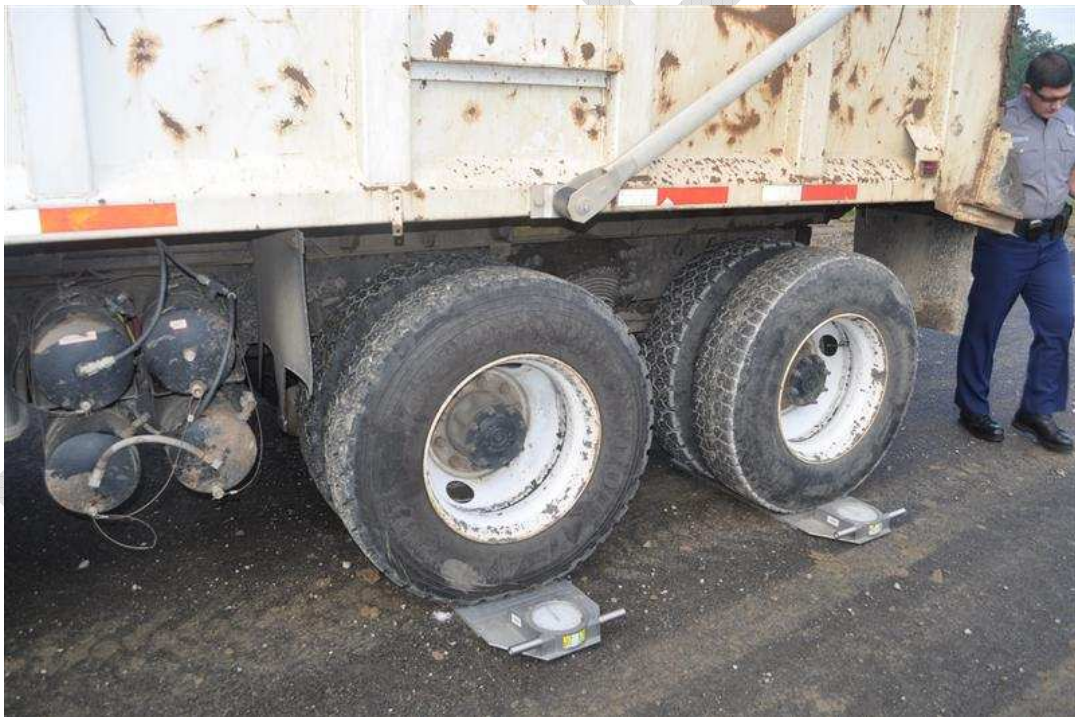
Figure D-1
Portable scales used in weighing individual truck axles.
