Assessment of the Urettek Process on Continuously Reinforced Concrete Pavement, Jointed Concrete Pavement, and Bridge Approach Slabs

Technical Assistance Report Number 03-2TA

LTRC Project No. 05-1TA
State Project No. 736-99-1282

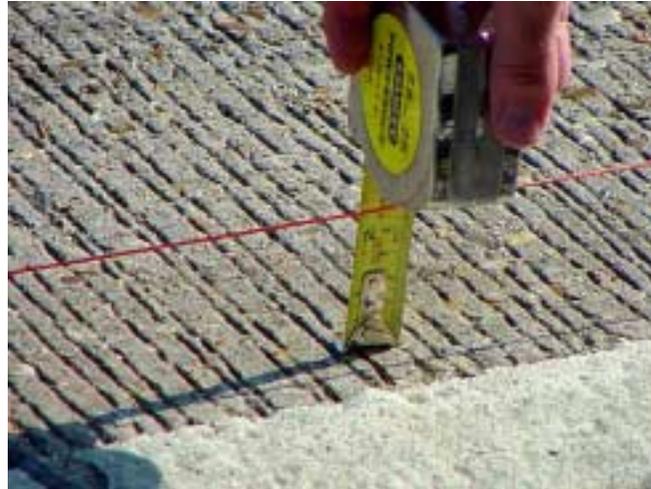
Figure 1
CRCP Depression

The CRCP evaluated was located at mile post 193.4, I-10, West bound in St. James parish. The embankment for this section of I-10 was constructed over an area with poor subgrade conditions using hydraulic sand fill. The pavement is approximately 35 years old, and its structure consists of 8 inches of CRCP, 5 inches of asphaltic concrete base course, and 12 inches of sand-shell base course. Pavement depressions have been observed over the years on this section of I-10, many of which are located at cross drain pipes. Embankment settlement and poor compaction around the cross drain pipes are believed to cause these depressions.

The location selected for this study had a measured pavement depression of 2.3 inches at the pavement edge and did not show signs of failure. Polyurethane injection area boundaries were located by holding a string line along the edge of the pavement. The locations where the pavement was visibly vertically departing from the string line were marked, as shown figure 1. Testing began approximately 10 feet before and after the depression. For details of all baselines, equipment testing, concrete coring, and Uretek injection locations, see figure 2.

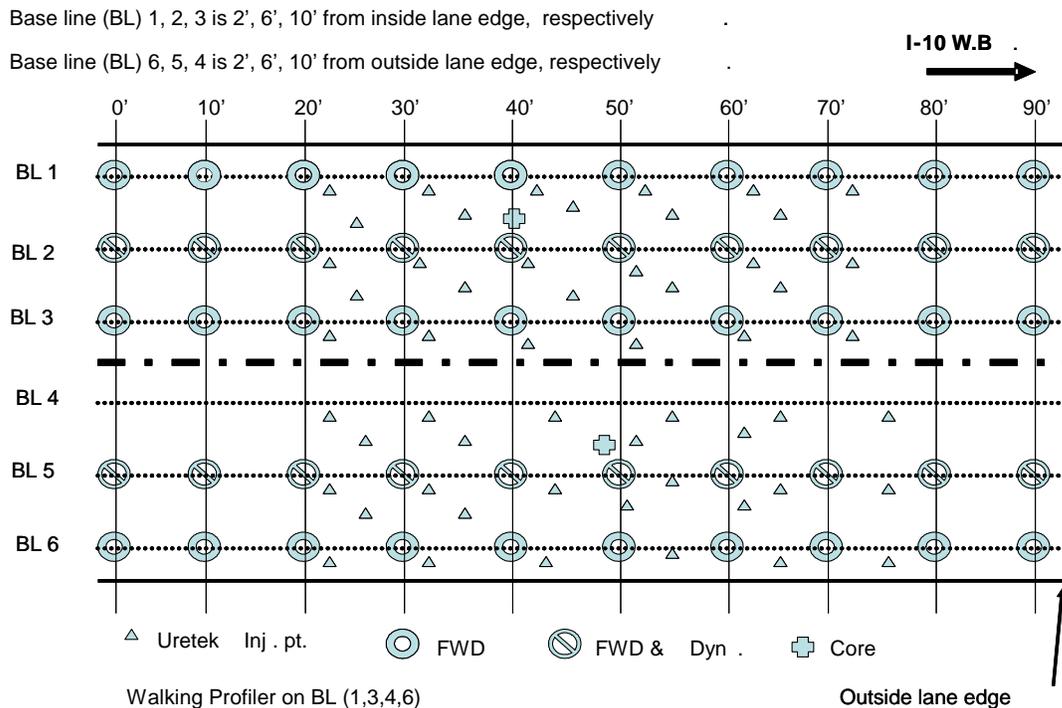
Figure 2

CRCP testing layout

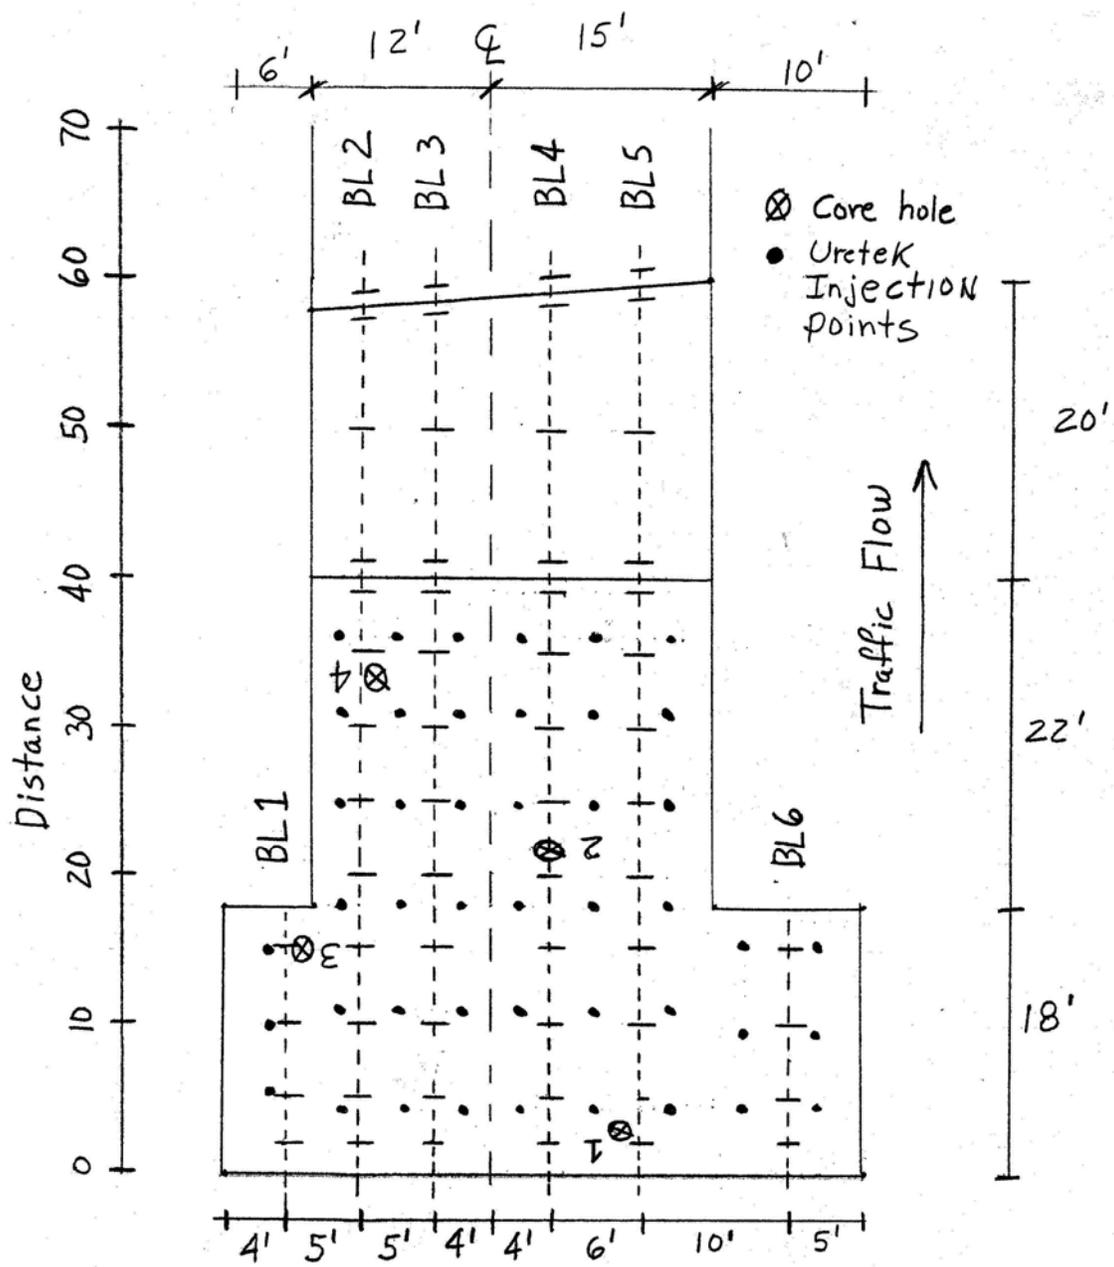
Figure 3
Testing layout for US 167 NB approach slab

These approach slabs have experienced settlement that caused pavement depressions. Depressions in concrete approach slabs are common in Louisiana. They have been mitigated by overlaying with asphaltic concrete, mud jacking, reconstruction, and polyurethane injection. District 03 asked LTRC to evaluate the polyurethane injection process and determine its effectiveness. The approach slabs and adjacent pavement are approximately 21 years old. The existing roadway typical section is 10-inch thick concrete pavement, 2-inch thick asphaltic concrete base course, and 6-inch thick treated soil. The existing bridge approach slabs had typical sections that consisted of 10-inch thick concrete pavement, 12-inch thick stone, and 6-inch thick treated soil. Figures 3 and 4 present the testing layout.

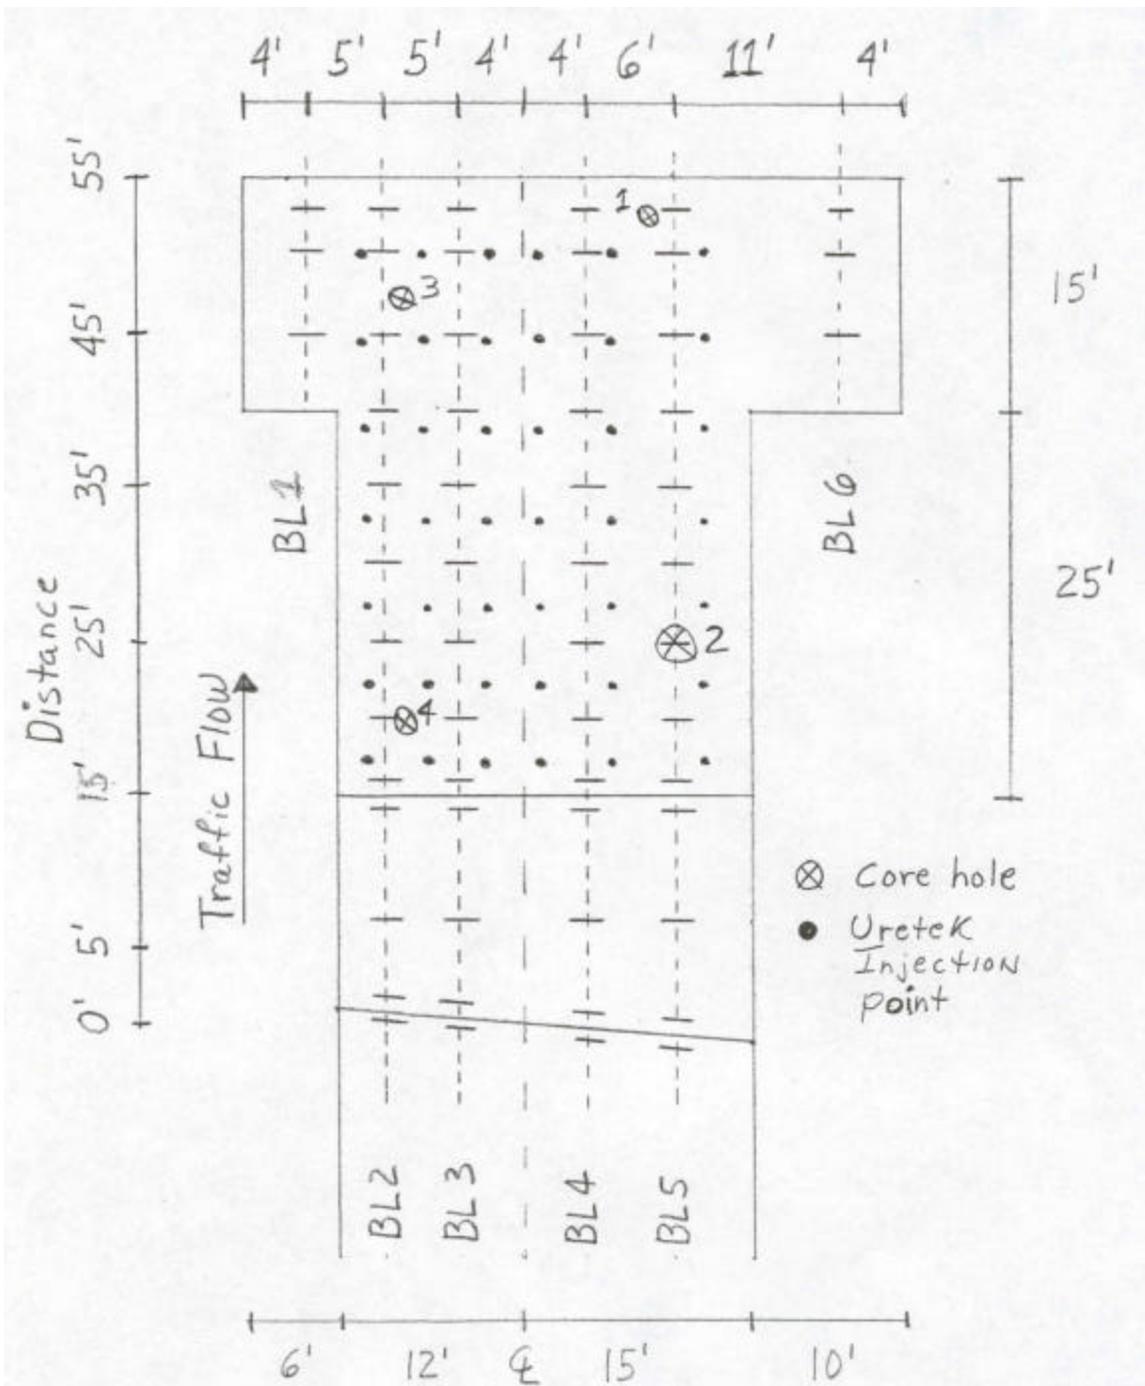
Figure 4
Testing layout for Bayou Duplente approach slab

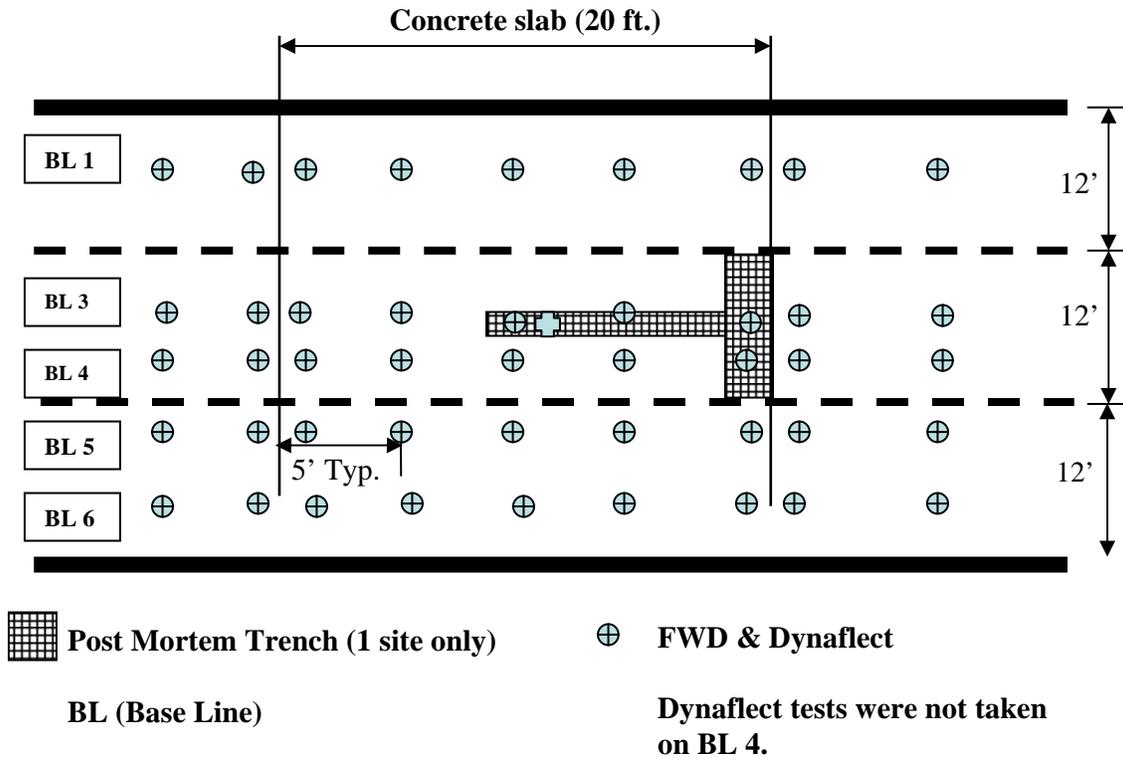
Figure 5
Typical diagram for trenching and testing

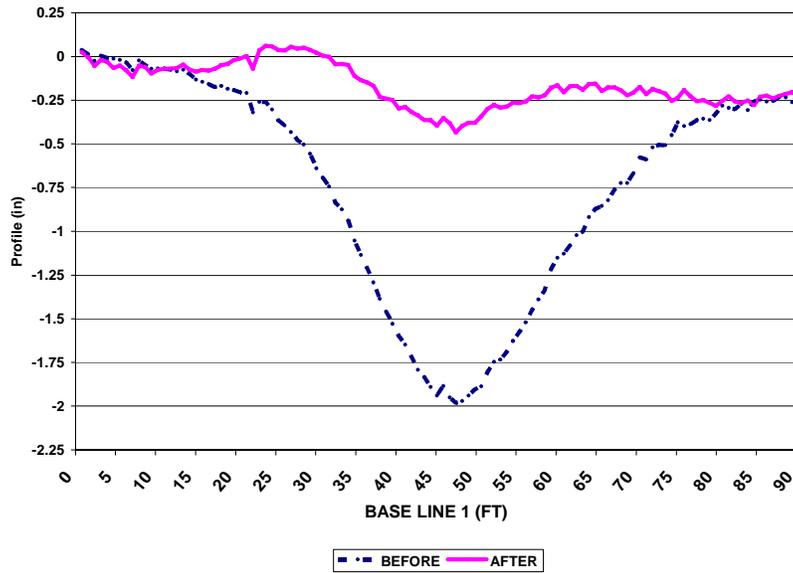
Figure 6
Walking Profiler base line 1

Figure 6 illustrates the profile and table 2 illustrates the IRI values before and after the polyurethane injection. The remaining walking profiler figures can be found in Appendix 3. Based on the point of maximum depression, the pavement was raised 2.019 inches on average. IRI was significantly reduced from 57 to 68 percent.

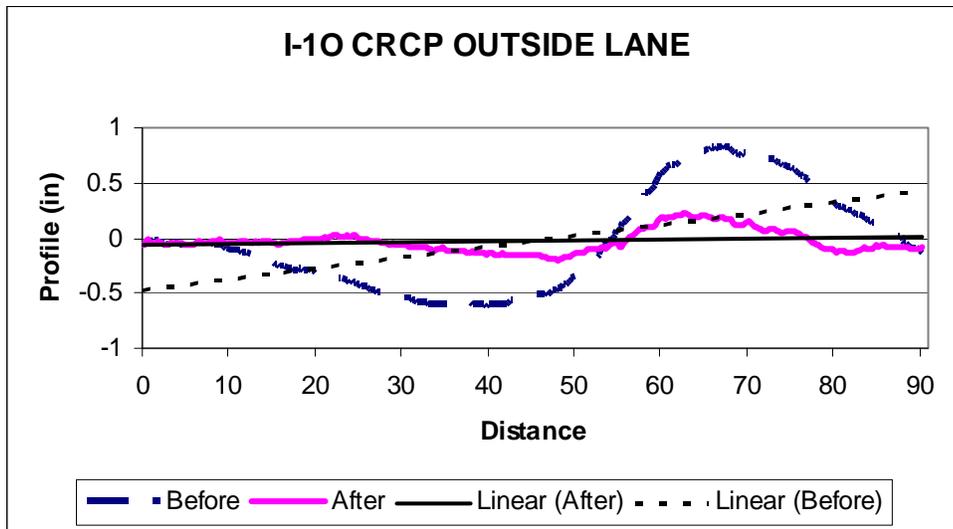
Figure 7
I-10 CRCP profile (outside lane)

Table 2 illustrates the IRI values before and after the polyurethane injection. IRI values were significantly reduced from 37 to 57 percent. Figures 7 and 8 illustrate the profiles before and after polyurethane injection. Linear regressions were taken through both profiles. Lesser slopes on the linear regression line indicate a smoother profile. It should be noted that the polyurethane injection process significantly lessened the slope, indicating an improvement.

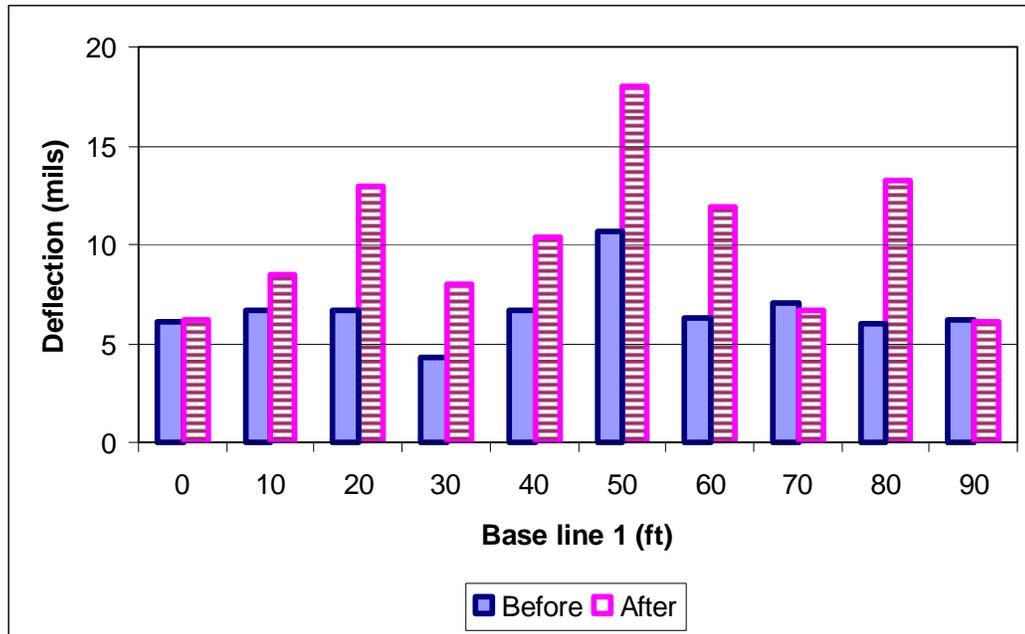
FWD first sensor deflections (14,500 lb load)

Figure 10 illustrates the deflections at the load plate (first sensor). The remaining figures can be found in Appendix 3. These deflections are based on a load of approximately 14,500 pounds. There is a trend towards higher deflections after the slabs were injected with polyurethane.

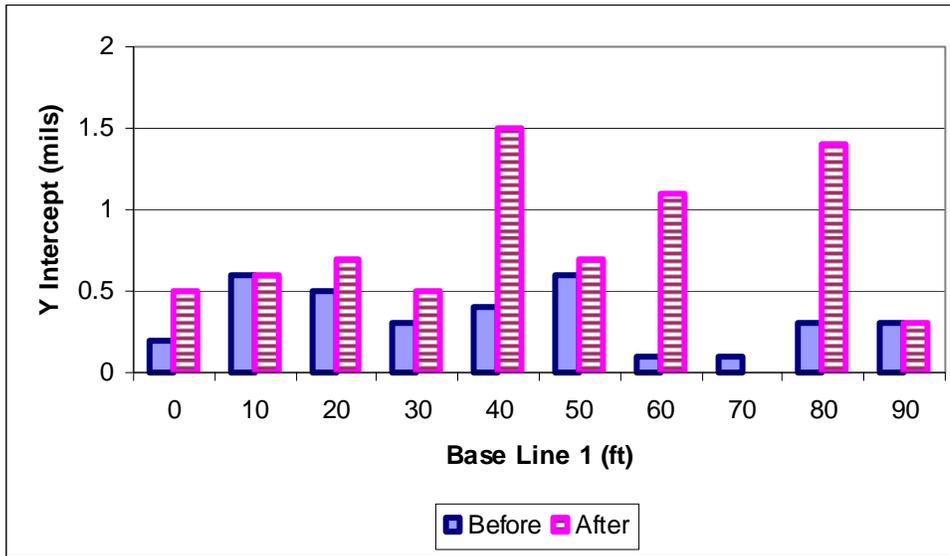
Figure 11
FWD void potential for base line 1

Figure 11 illustrates the Y intercepts. The remaining figures can be found in Appendix 3. There was a trend towards higher Y intercepts after the slab was injected with polyurethane.

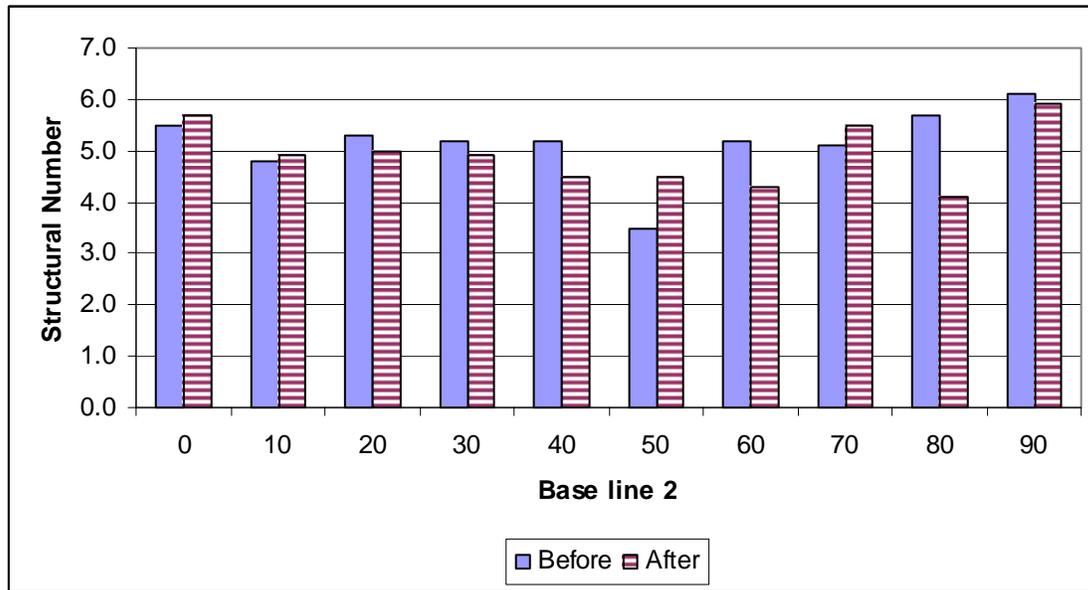
Figure 12

Dynaflect readings base line 2

Figures 12 and 13 illustrate the structural numbers obtained from Dynaflect tests.

The results indicated that the polyurethane injection did not adversely impact the structural number of the pavement.

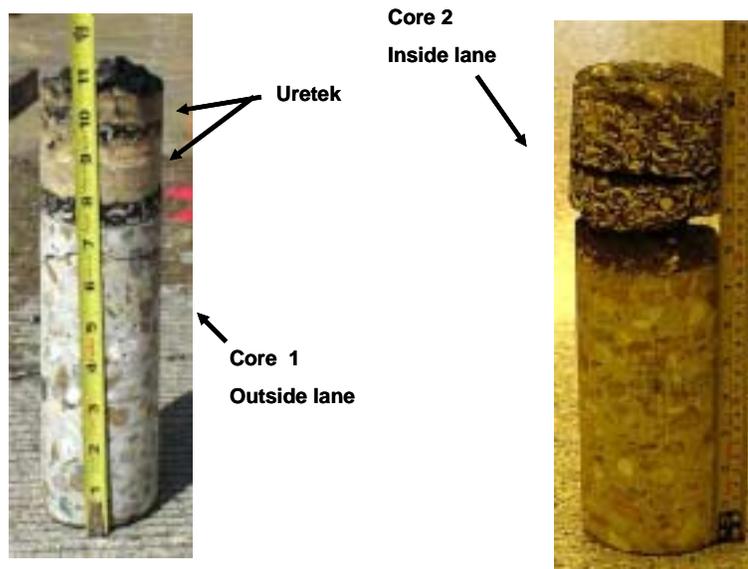
Figure 14
Concrete cores

Concrete cores were taken at the locations listed in table 3. The concrete pavement in core number 1 taken from the outside lane broke as it was being removed from the hole. The asphaltic concrete base course was permeated with polyurethane, as shown in figure 14. It is speculated that the asphaltic concrete in this area was stripped and weak which allowed the polyurethane to infiltrate it. The polyurethane specimens were so dense that a ball point pen could not be pushed into the specimen. Since the core hole was filled with water, the sand-shell base course could not be observed. The concrete pavement in core number 2, which was taken from the inside lane, was intact, but the asphaltic concrete base course in the core broke when it was removed from the core hole. The asphaltic concrete base course did not show any signs of being infiltrated as did core number 1. The sand shell base course was clearly visible and no signs of polyurethane foam could be seen, as shown in figure 15. Based upon visual inspection, it is unknown if a void was created by the polyurethane injection process. However, data from FWD tests did indicate a slightly higher intercept (0.5) after injection. Y intercepts less than 2.0 indicated that no voids were present.

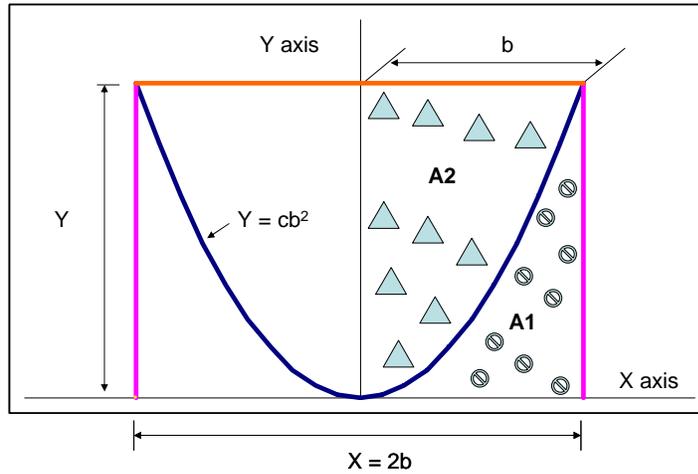
Figure 16

Parabolic equation diagram

As previously mentioned, the volume can be determined by several methods. In order to simplify the process as much as possible, the profile was simulated with a parabolic curve ($y = ax^2$) and straight lines. Since the area of the sections previously mentioned were known and represented true field conditions, they were used as a bench mark to evaluate the equations.

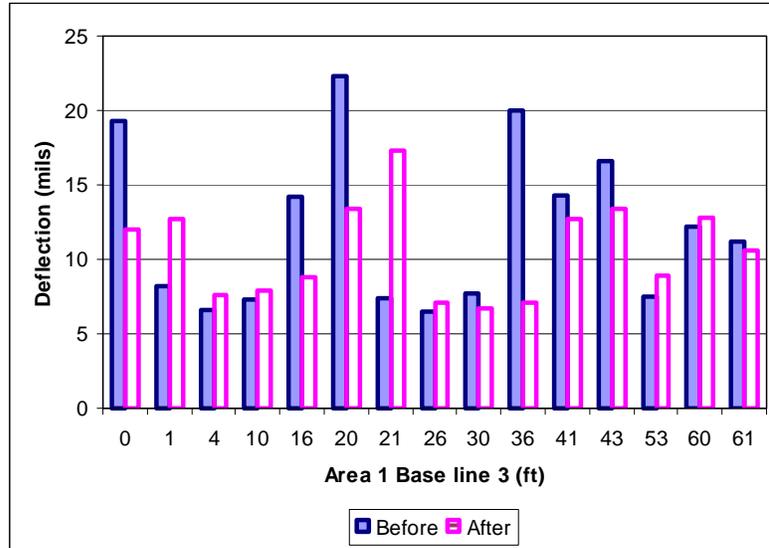
FWD first sensor deflections Area 1 Base line 3

Figure 19 illustrates the first sensor deflections. The remaining figures and tables can be found in Appendix 1. The deflection analysis that follows is based upon a review of all data points (joints, intermediate, and center) for the areas and base lines listed.

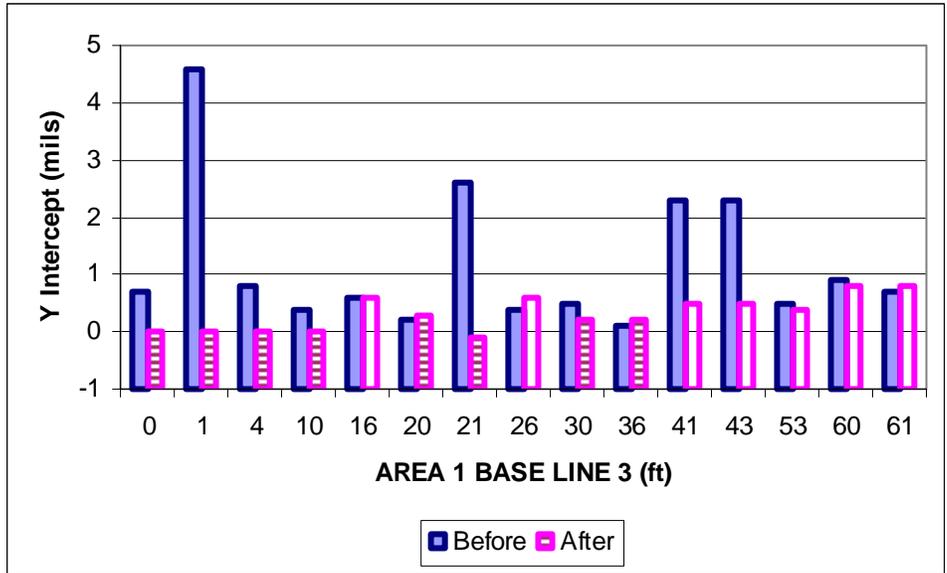
Figure 21
FWD void potential Area 1 Base line 3

Figure 21 illustrates the Y intercepts. The remaining figures and tables can be found in Appendix 1. The void analysis that follows is based upon a review of all data points (joints, intermediate, and center) for the areas and base lines listed.

Area 1 (Center and intermediate points): The average Y intercepts before and after polyurethane injection were 0.5 and 0.4, respectively.

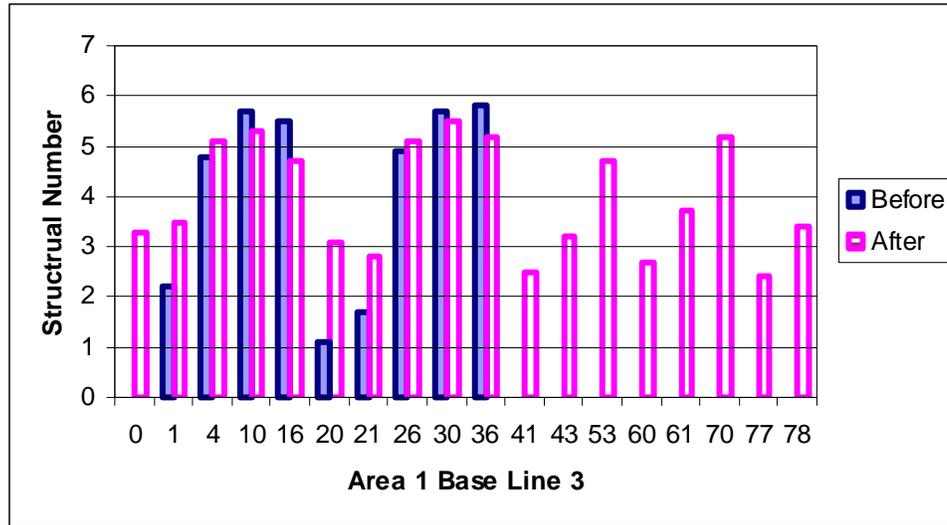
Figure 25
Dynalect Area 1 Base line 3

Figure 25 illustrates the first sensor deflections. The remaining figures and tables can be found in Appendix 1.

Area 1 (Base lines 3 & 5): The average SN values before and after polyurethane injection were both 3.6.

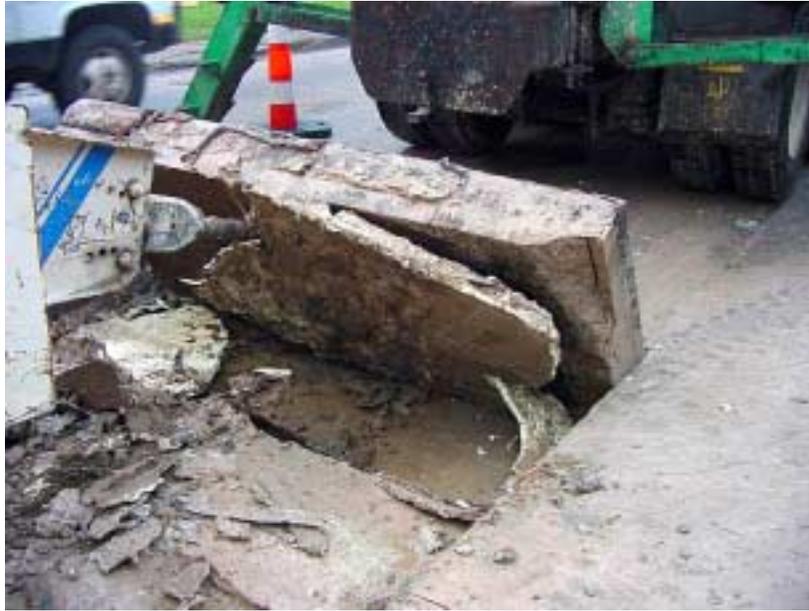
Figure 26
Polyurethane in trenched area (Area 3 Slab 74)

- Layers of varying stiffness were observed in the polyurethane sample acquired near the joint. The density of the polyurethane appears to be depend upon the confining pressure. The contractor's normal procedure is to inject a small quantity, wait for it to set up, and then inject again. This procedure is followed until the desired outcome is obtained. These layers could be observed in the sample. Having different densities in the polyurethane can be problematic, as shown in Figure 27. It should be noted that the injection process took place when the voids were filled with water present. Because the effect that this has on density is unknown, it should be researched further.

- When the adjacent left lane slab, 73, which had been injected with Uretek the previous year, was observed, the polyurethane between the base course and slab was clearly visible, as shown in figure 28. Even though polyurethane was present, water could be seen trickling out from the layer between the polyurethane and soil cement base course, as shown in figure 29. The joint at panel 73 could be seen deflecting under traffic loads. Whether the source of the pavement deflections was from the polyurethane, base course, subgrade, or a combination of the layers is unknown and warrants further investigation. The rainfall data for that month is shown in table 5, and 2.34 inches of rain fell the day previous to these observations.

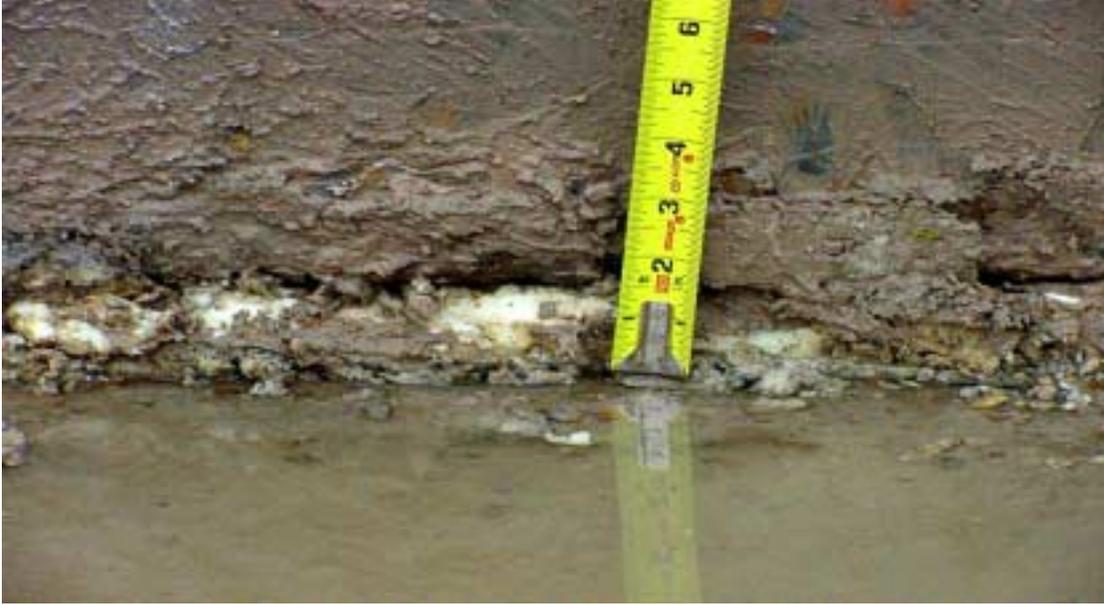
Figure 28
Polyurethane between slab and base course

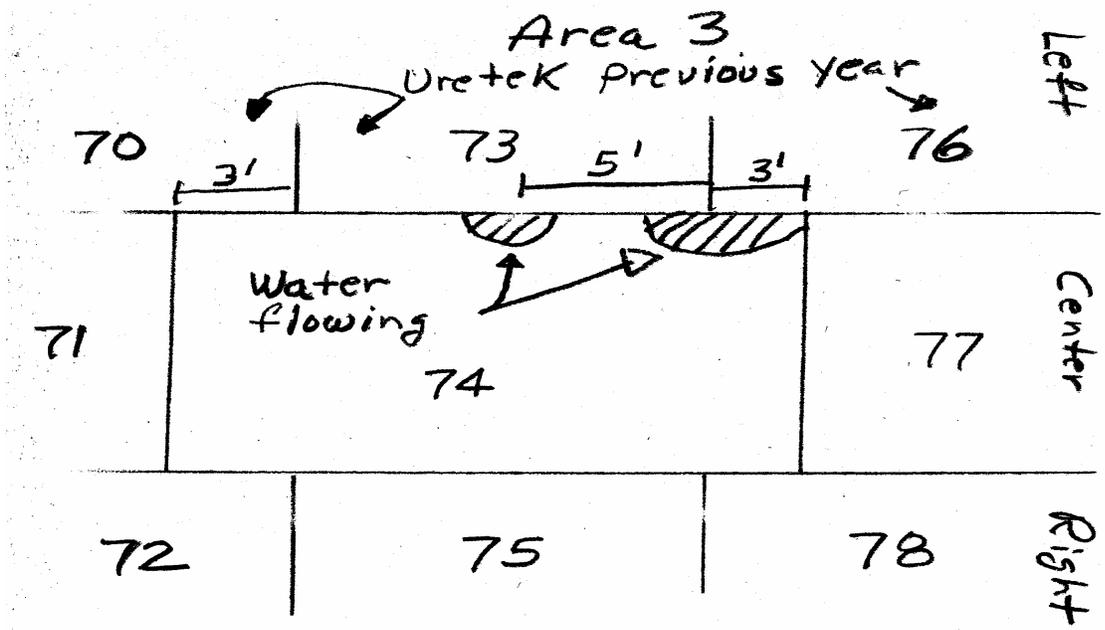
Figure 29
Area 3 pumping locations

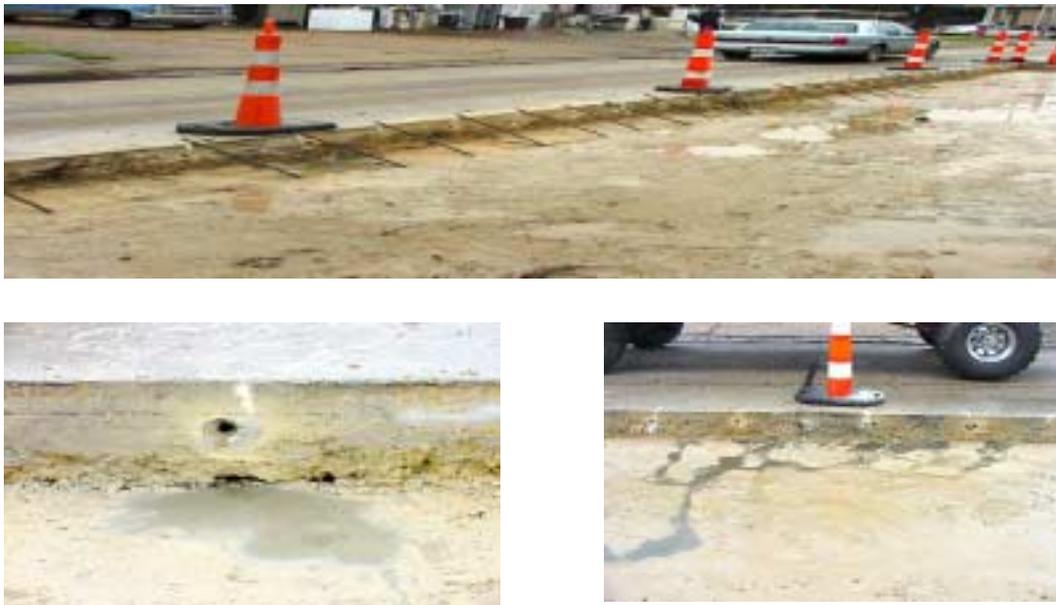
Figure 30
Pumping locations (Area 2)

Area 2: Because of patching in the center lane, left lane slabs 61, 64, and 67, which were injected the previous year could be observed and are shown in figures 30 and 31. As traffic moved across the slabs, the joints were observed deflecting, which indicates poor load transfer. As time progressed, water was observed pumping through the joints and flowing onto the subgrade. Similar to slab 73 (Area 3), previously injected polyurethane was observed at these locations. Whether the source(s) of the pavement deflections was from the polyurethane, base course, subgrade, or a combination of the layers is unknown and warrants further investigation.

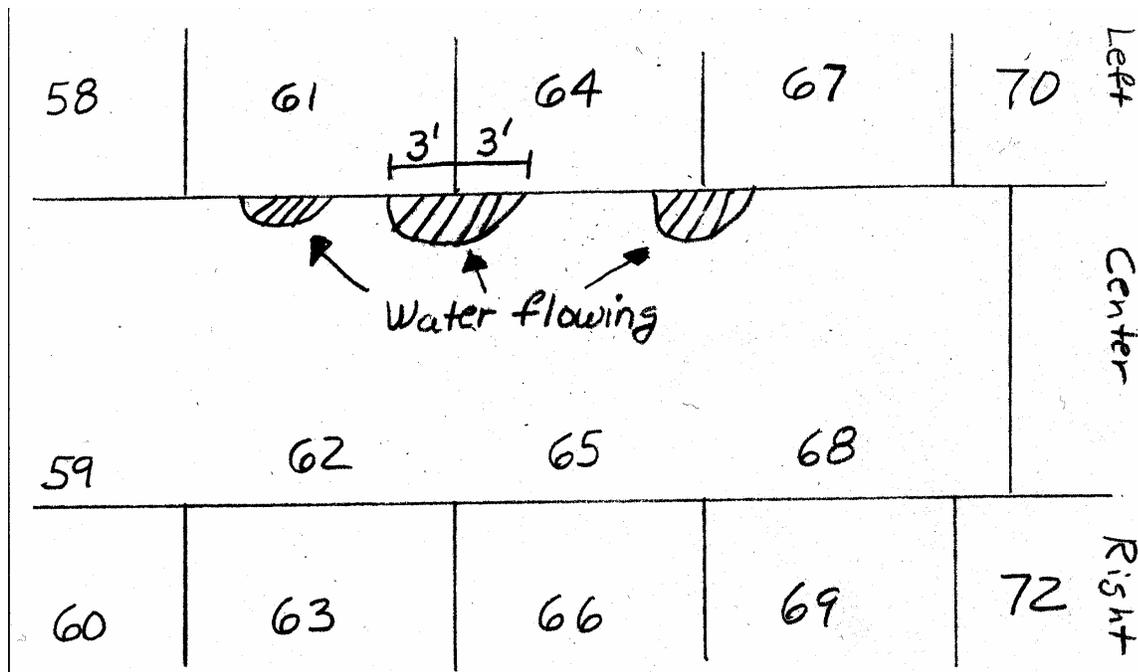
Figure 31

Sketch of area 2 pumping locations

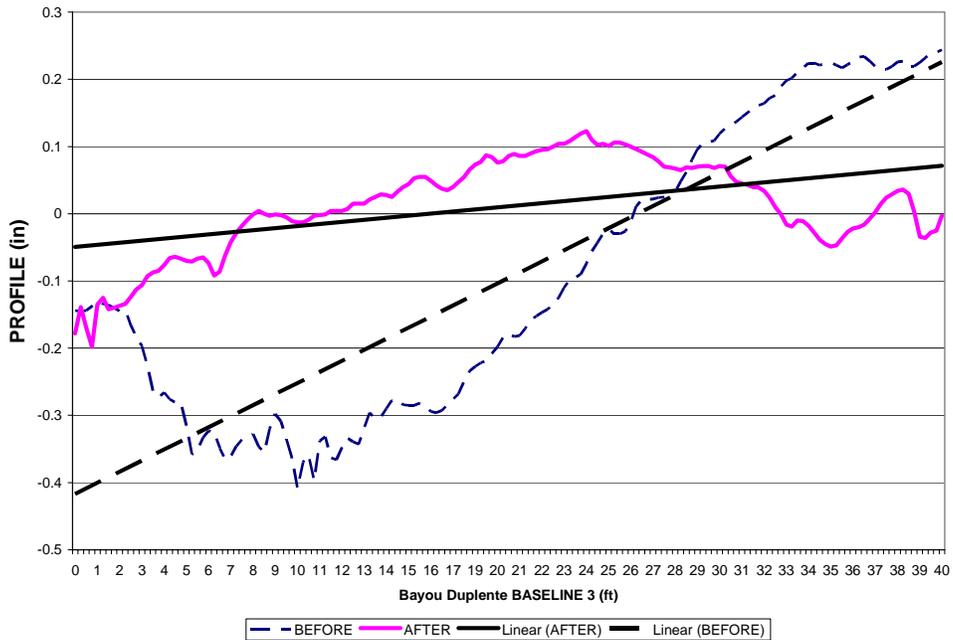
Figure 35
High speed profile for Bayou Duplente SB base line 3

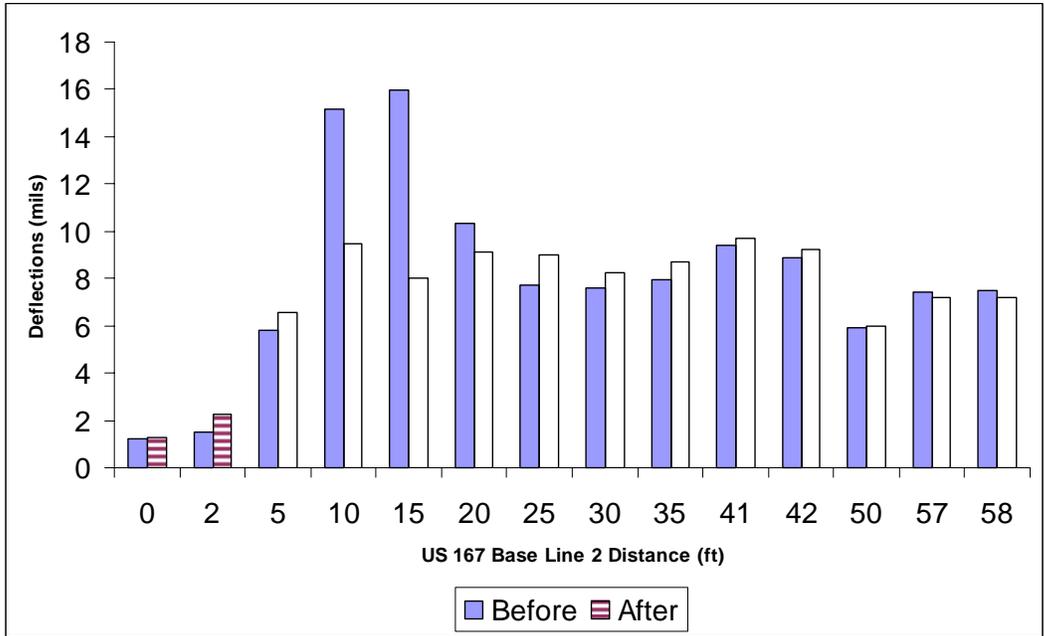
FWD first sensor deflections US 167 NB base line 2

Figure 36 illustrates the deflections at the load plate (first sensor). The remaining figures can be found in Appendix 4. These deflections are based on a load of approximately 16,000 pounds. The deflections were generally maintained or lowered as a result of injecting with polyurethane.

The deflections from the tests taken within the first five feet from the bridge end may be not be useful for this study. The deflections at these locations are less than 50 percent of the readings taken at 10 feet from the bridge end. The deflections are believed to be less since the steel-reinforced approach slab is anchored to a pile-supported abutment.

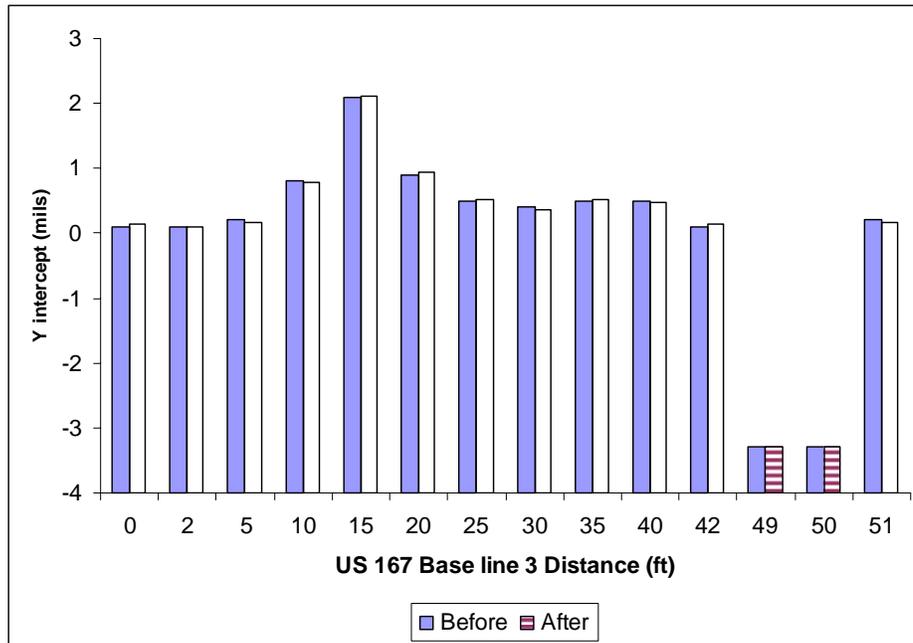
FWD void potential for US 167 NB base line 3

Figure 37 illustrates the Y intercepts. For further details about the cores, refer to section on core samples. It should be noted that polyurethane found in the core samples was dense throughout the specimen. The Y intercepts were generally maintained after injection with polyurethane. Out of 50 test points, 8 had Y intercept values near or exceeding 2.0 prior to injection. After injection, 4 out of the 50 test points had Y intercept values exceeding 2.0.

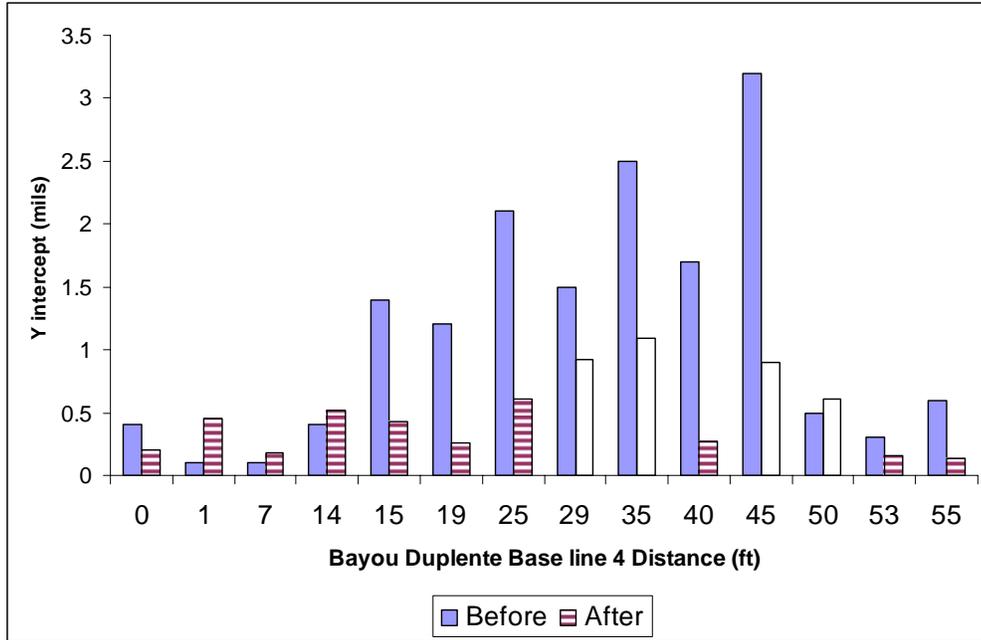
Figure 38

FWD void potential for Bayou Duplente base line 4

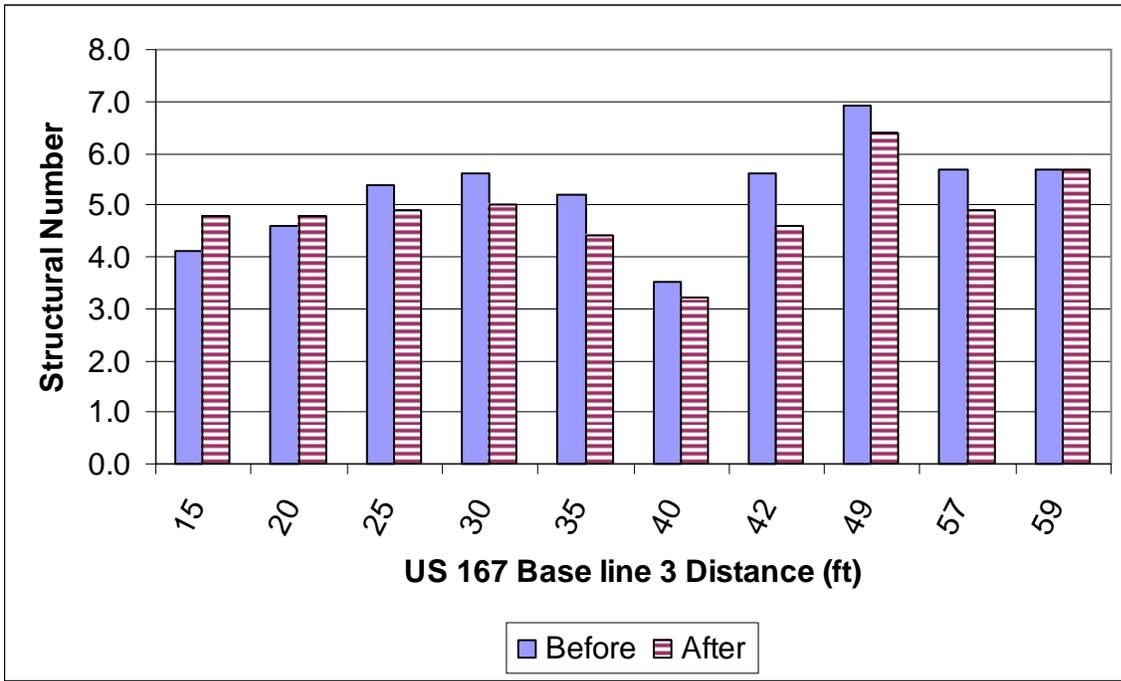
Dynalect results for US 167 Base line 3

The Dynalect readings showed that there was basically no change in the Structural number of the pavement before and after injection with polyurethane. The values could not be computed on some base lines because the Dynalect was not able to induce enough load to adequately deflect the pavement. Figure 39 illustrates the results. The remaining figures may be found in Appendix 4.

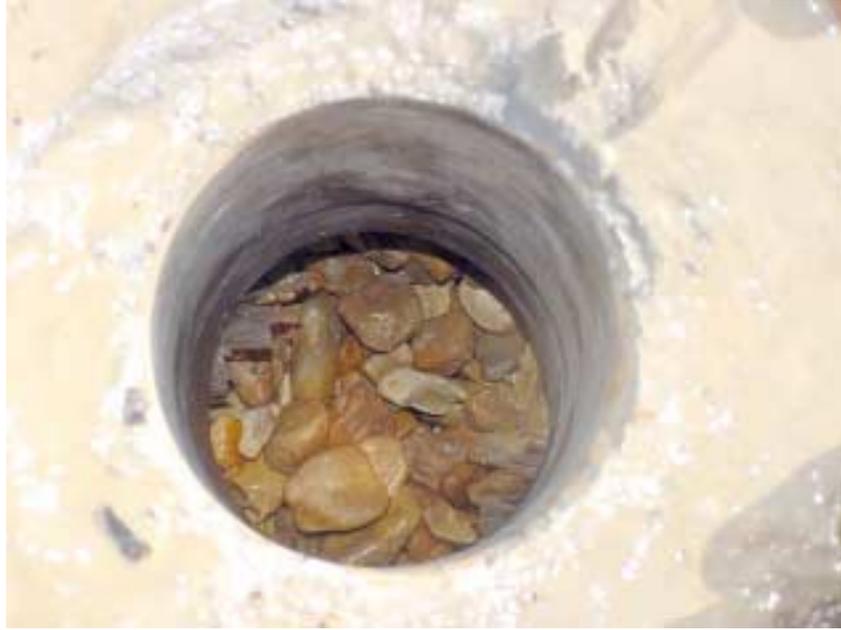
Figure 40

Concrete core hole (US 167 NB, Core N1)

- ❖ Core N1: The Y intercepts did not reveal any voids before or after injection. However, a 5-inch void was found between the concrete and stone base course. Polyurethane was not seen at this location.

Polyurethane was found at three out of the eight core locations. The polyurethane specimens were so dense that a ball point pen could not be pushed into the specimen. Though polyurethane was injected into the base course and subgrade on an approximately 4 x 4 feet grid pattern, it was found at only three locations. Perhaps the polyurethane is deeper than the core depths or it did not spread out to the locations cored. At core N1 (US 167 NB) , a 5-inch void was found. Core N1 is located about 2.5 feet from the bridge end and about 2 feet from

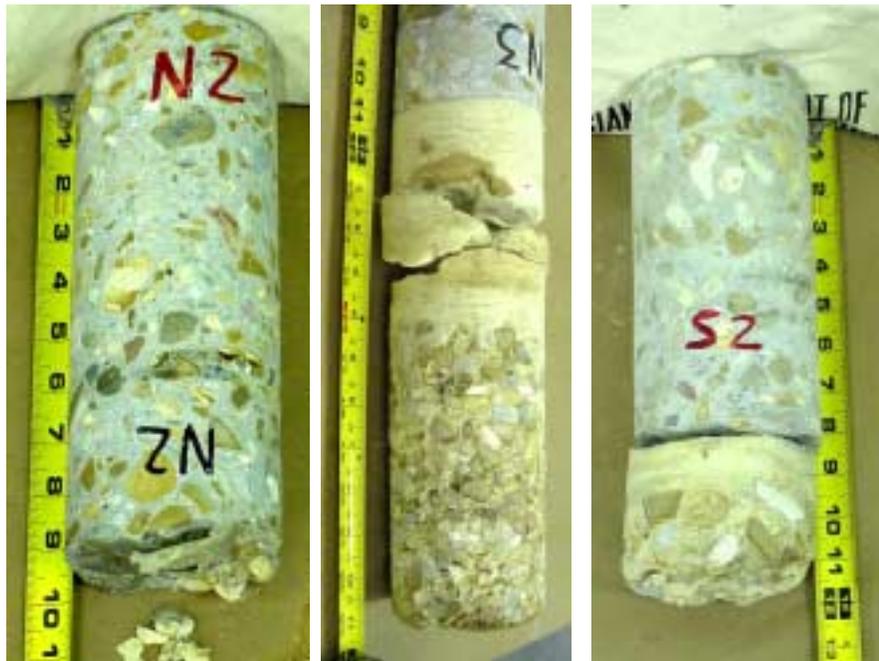
Figure 41

Concrete cores with polyurethane (N2, N3, and S2)

- ❖ Core N2: The Y intercepts did not reveal any voids before or after injection. One-half inch of polyurethane was observed on one side of the core.
- ❖ Core N3: The Y intercept revealed a void before and no void after the polyurethane injection process. Five inches of polyurethane plus seven inches of gravel-polyurethane core were found.
- ❖ Core N4: The Y intercepts did not reveal any voids before or after the polyurethane injection. Polyurethane was not found at this location. A 6-inch soil cement core was removed.

- ❖ Core S1: The Y intercepts did not reveal any voids before or after injection. Polyurethane was not seen at this location.
- ❖ Core S2: The Y intercept revealed a void before and no void after the polyurethane injection process. There was a 2.5-inch thick polyurethane core found.
- ❖ Core S3: The Y intercept revealed a void before and no void after the polyurethane injection process. Polyurethane was not found at this location.
- ❖ Core S4: The Y intercepts did not reveal any voids before or after the polyurethane injection. Polyurethane was not found at this location.

Concrete cores were taken. Table 7 presents the results, and figures 40 to 42 illustrate the cores in which polyurethane specimens were found.

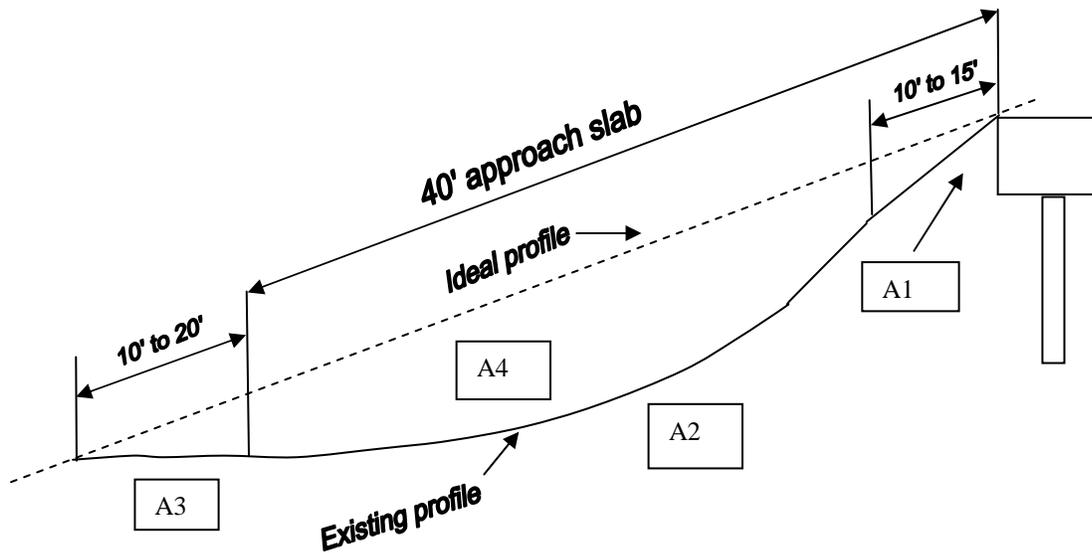
Figure 43
Typical approach slab profile

In order to accurately develop an equation to estimate quantities, the volume of the treatment area and the amount of polyurethane required to fill must be known. Unlike the CRCP, the approach slab pavement will not settle completely with the embankment. Bridge approach slabs are steel-reinforced concrete pavement that rests on pile-supported abutments. Even though the embankment settles at the bridge end, the approach slab at that location will rotate, but will not settle unless the approach slab fails. Because of this, developing an accurate equation to predict the void totally based on the string line and maximum vertical deflection method used on the CRCP may be difficult and will be subject to inaccuracies. It is impossible to determine the depth of the void near the bridge end without coring through the pavement or using some other method, such as ground penetrating radar. Figure 43 shows the typical profile seen at the approach slabs on the US 167 NB and Bayou Duplente SB locations.

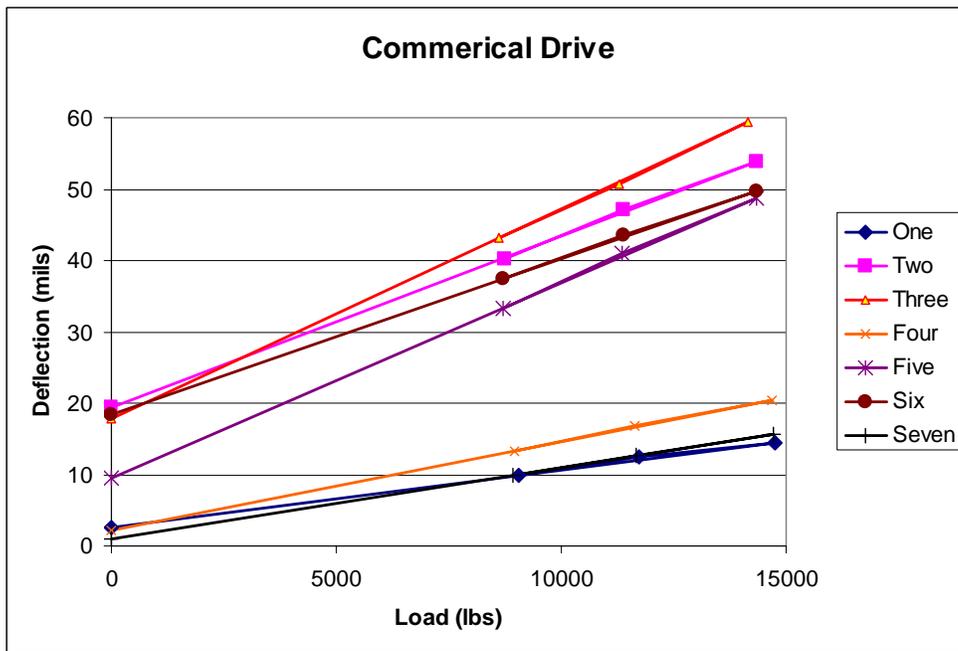
Figure 99
Y intercept diagram

The Y intercept refers to the linear regression of a line through three points. The point at which the line crosses the Y axis is the intercept value. For this study, the Y intercept is based upon deflection versus load. The loads used on this project were 9000, 12,000, and 14,500 pounds. The load and its corresponding deflection at the load plate were plotted and a linear regression was performed. The figures below illustrate this process. According to the AASHTO design guide, a Y intercept value greater than 0.002 inches means that there is either a void or loss of support.
