1. Report No. LADOTD/FHWA/06-411		2. Government Accession No.		3. Recipient's Catalog No.	
4. Title and Subtitle Evaluation of Narrow Transverse Contraction Joints in Jointed Plain Concrete Pavements		5. Report Date March 2006

16. Abstract This report presents the results of a research project conducted at the Louisiana Transportation Research Center (LTRC) to evaluate the performance of narrow transverse contraction joints to control cracking in jointed plain concrete pavements. In addition, the report also evaluated the early entry dry saw cutting method in crack control of jointed plain concrete pavements. Five test sections were established during the construction of a jointed plain concrete pavement on Northline Road in Port Allen, Louisiana. The first test section is 1200-ft long in which standard transverse contraction joints were created using the conventional wet double saw cut method. This section's joints were sealed. The second section is also 1200-ft long in which narrow transverse contraction joints were created using the early entry dry cut method. This section's joints were not sealed. The other test sections were 1000-ft long each in which the narrow joints were e

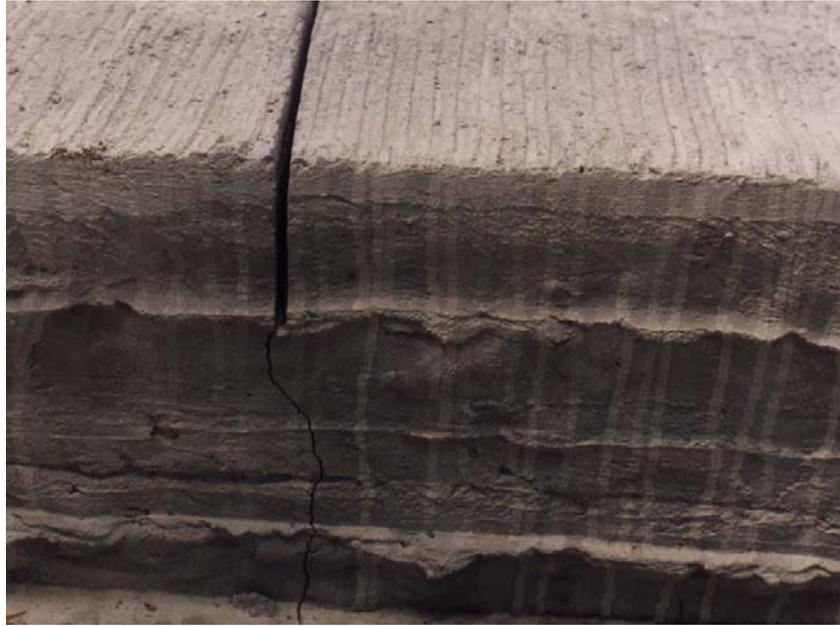
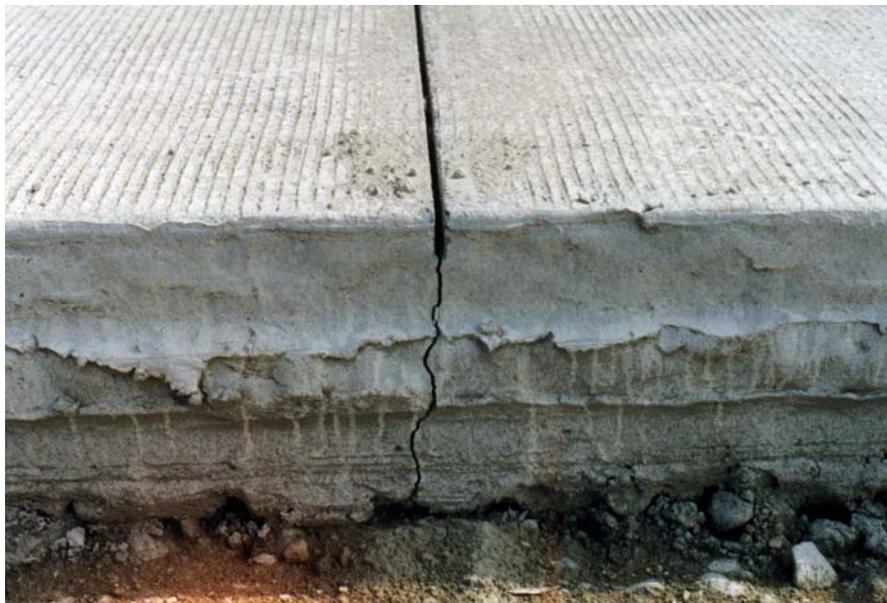
Figure 17

The visual survey conducted 24 hours after concrete placement showed that the controlled cracks did propagate along the transverse contraction joints in both sections S1 and S2 as expected. Photographs of the cracks are shown in figure 17, where the controlled cracks can be seen underneath the conventional wet cut standard joint (test section S1) in figure 17a and where they can be seen underneath the early entry dry cut narrow joint (test section S2) in figure 17b.

(a) Controlled crack developed underneath the standard contraction joint at test section S1 established using the conventional wet saw cut method

(b) Controlled crack developed underneath the narrow transverse contraction joint at test section S2 established using the early entry dry saw cut method

Development of controlled cracking in the investigated test section at Northline Road

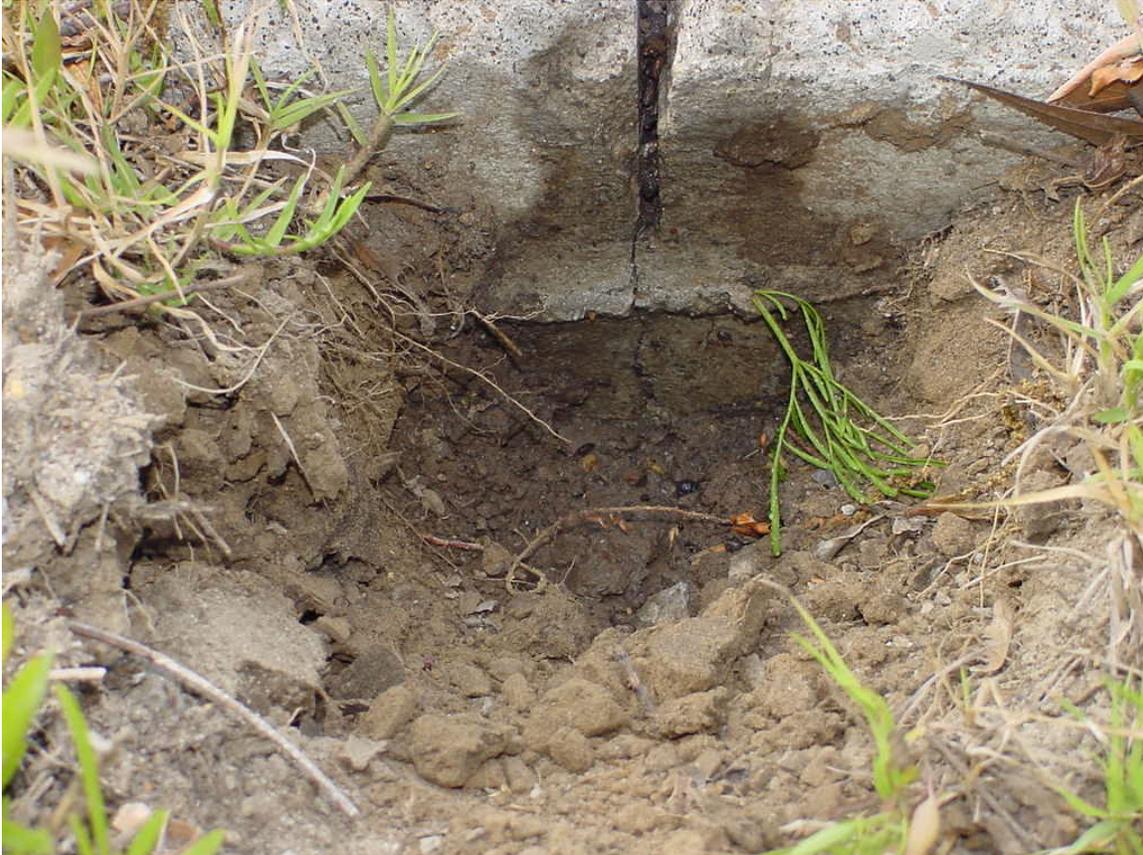
Figure 20
Verification of the development of the controlled crack across the narrow transverse contraction joints

The visual inspection conducted 6 six months after construction showed that the joints in the various sections had fully developed cracks. Figure 20 illustrates a controlled crack that developed across a narrow joint. This joint was exposed for the purpose of visually verifying crack development.

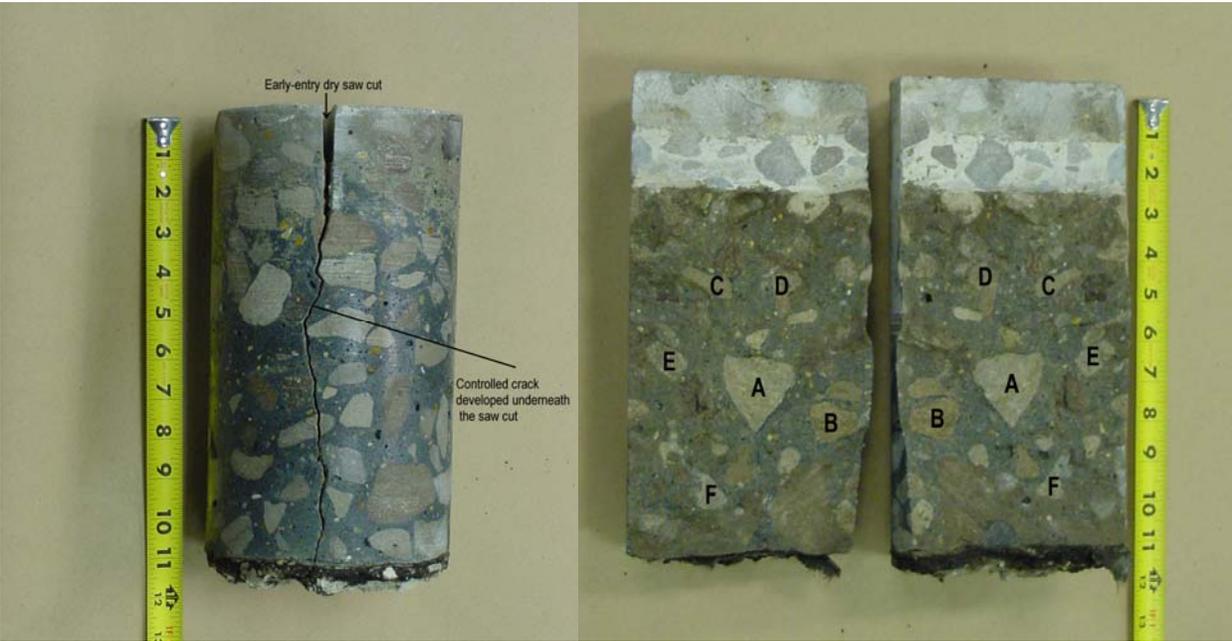
Another possible concern, related to the early entry dry cut method, was that using the diamond saw on fresh concrete might cause particle segregation in the concrete mix as the saw vibrated. In order to investigate this, core samples were taken from one of the joints on section S2. This joint developed a controlled crack 2 days after the initial 1.5 in. deep early entry dry saw cut had been made. As shown in figure 21, the controlled crack formed beneath the contraction joint and extended itself through to the bottom of the slab. It was also clear that the crack did not go around the aggregate particles but rather through them, as shown in figure 21b (aggregate particles A, B, etc.). Moreover, the aggregate particles, which were up to 2.5 in. diameter, were uniformly distributed within the concrete mass. These details provided enough evidence to show that the concrete had hardened enough at the time of diamond cutting to resist any form of particle segregation.

(a) Crack propagation underneath the early entry dry saw cut

(b) Uniformly distributed and split aggregates within the concrete mass due to crack propagation

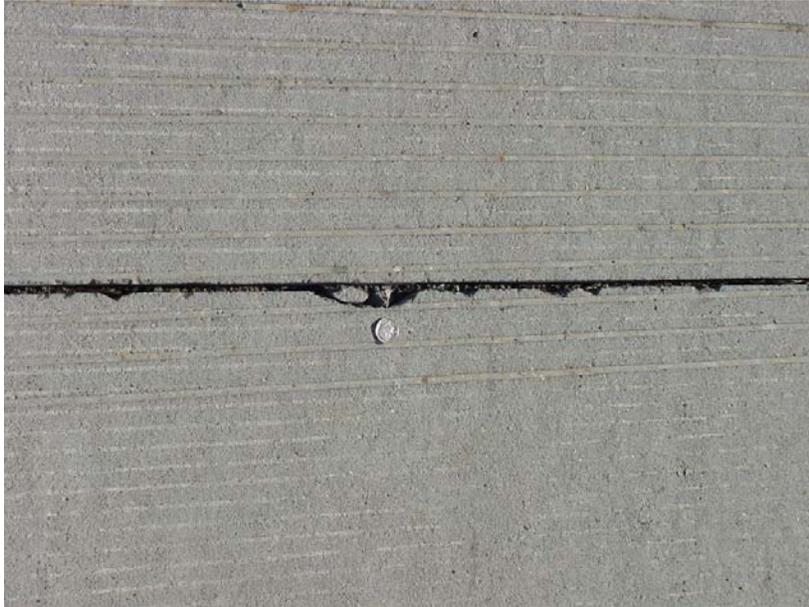
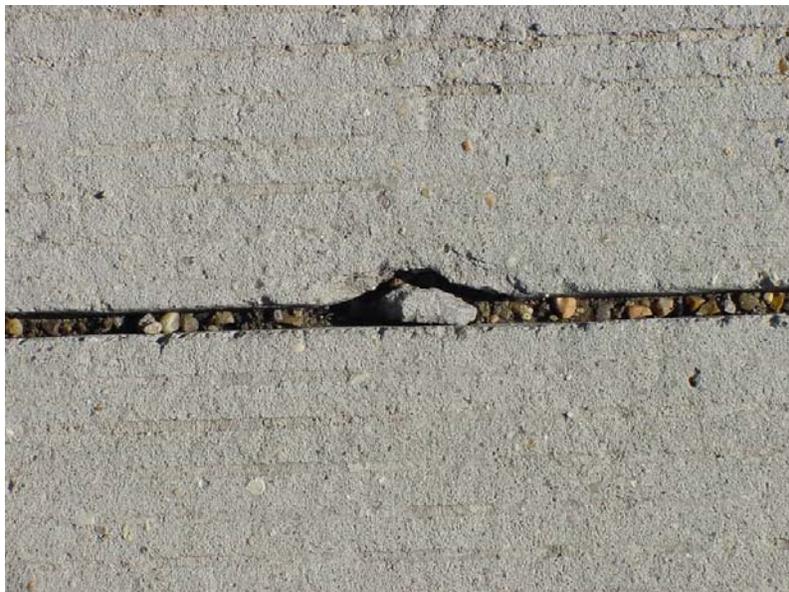
Figure 23
Low severity spalling of unsealed narrow contraction joints at test section S3

Other observed distresses recorded as part of the survey and associated with the unsealed narrow transverse contraction joints of section S3 included some isolated cases of low severity spalling, as shown in figure 23. In addition, the section S3 joints showed signs of intrusion by a large amount of granular debris. This debris will, likely, affect future pavement performance particularly during hot temperature periods when the joints are expected to close up.

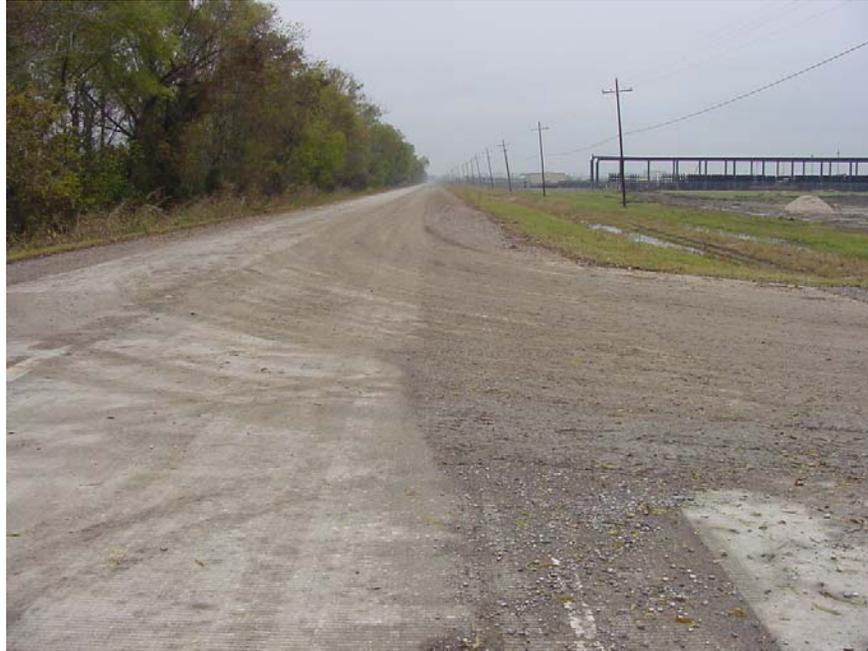
Figure 24
Debris tracked on pavement

Such intrusion by debris was related to the presence of many unpaved roadways in the area that serves industrial sites adjacent to the test pavement. The mud and gravel depicted in figure 24 was tracked onto the pavement by the heavy trucks that use these facilities and is likely to cause accelerated joint failure if the joints are not cleaned and sealed.
