EVALUATION OF RAISED PAVEMENT MARKERS

Research Report No. 60

Research Project No. 68-1T
Louisiana HPR 1 (9)

Conducted by
LOUISIANA DEPARTMENT OF HIGHWAYS
Research and Development Section
In Cooperation with
U.S. Department of Transportation
FEDERAL HIGHWAY ADMINISTRATION

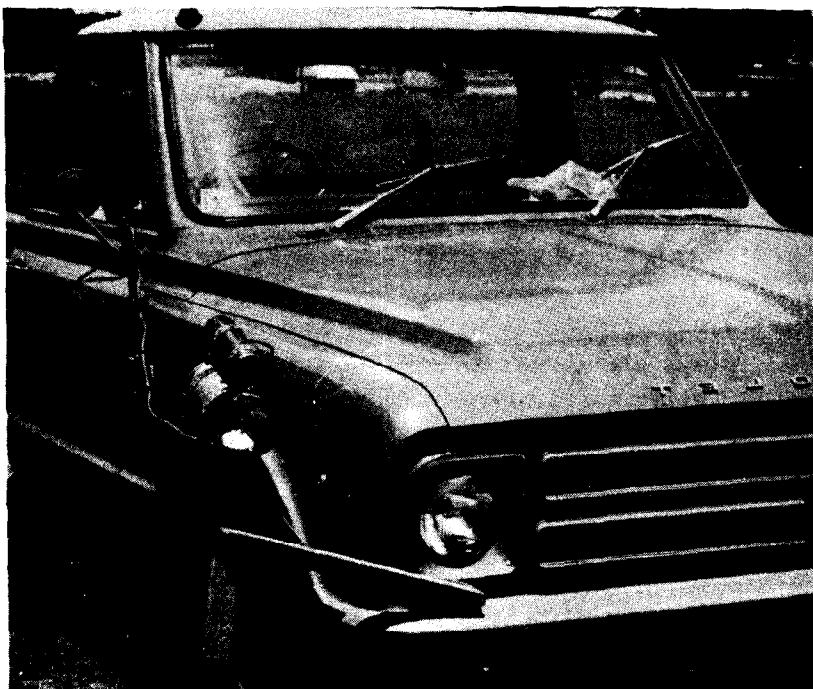
Vehicle Mounted Reflectivity Testing Device
FIGURE 13a

The device shown in Figures 13a and 13b was constructed for our use in a field evaluation of relative reflectance of markers in place on the roadway. The device consisted of a sealed beam spotlight and photocell assembly, a transistor amplifier, and a recording galvanometer. Before operation, the spotlight was pre-aimed at a spot on the ground about 15 feet in front and 3 feet to the left of the vehicle. It was then locked in-place and the photocell assembly aimed to achieve maximum pickup of reflected light from a luminous object placed on the ground in the brightest part of the light-spot.

With the device set up in this manner, it was possible to record relative reflectivity readings of pavement markers as the vehicle was driven along the roadway. Its major drawback was that extreme care had to be taken in driving the vehicle so that the brightest part of the spot stayed centered over the line of markers that appeared in the roadway.

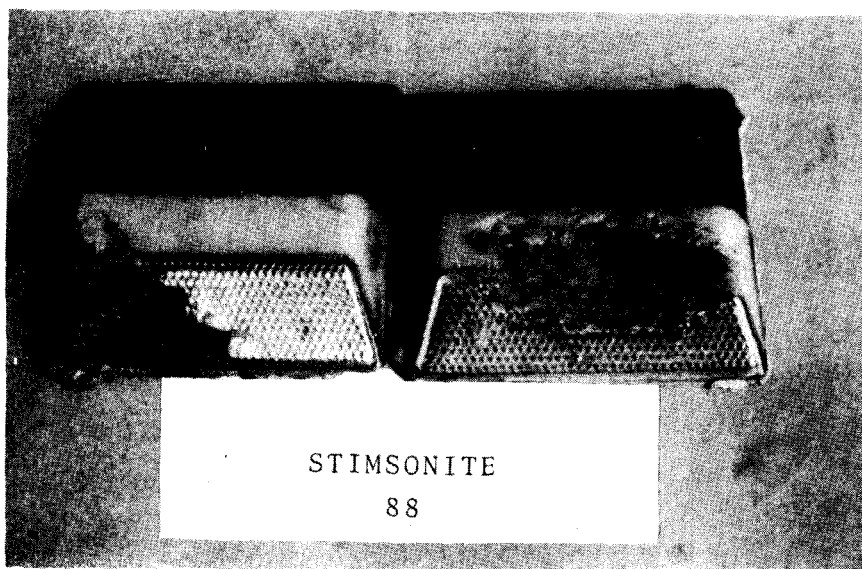
Stimsonite Markers from La. 1 with Severe Reflective Element Damage
FIGURE 23

- A. Number of markers losing bond to highway: 0
- B. Number of markers with small chip or crack on reflector: 17 or 9.7 percent (see Figure 21)
- C. Number of markers with a part of reflector or marker missing: 18 or 10.3 percent (see Figure 22)
- D. Number of markers with severe damage to marker and reflector: 4 or 2.3 percent (see Figure 23)
- E. The balance of the markers were in good condition physically (excluding five which were picked up during the year for testing purposes).

Brightness checks on new markers of this type averaged 176 foot lamberts. Markers in good condition maintained 58 percent of this average while those with severely damaged lenses averaged 32 percent of the hypothetical reading. Again, as with the case of the 3-M rods, the markers were cleaned with a brush and water prior to reflectivity readings being taken.

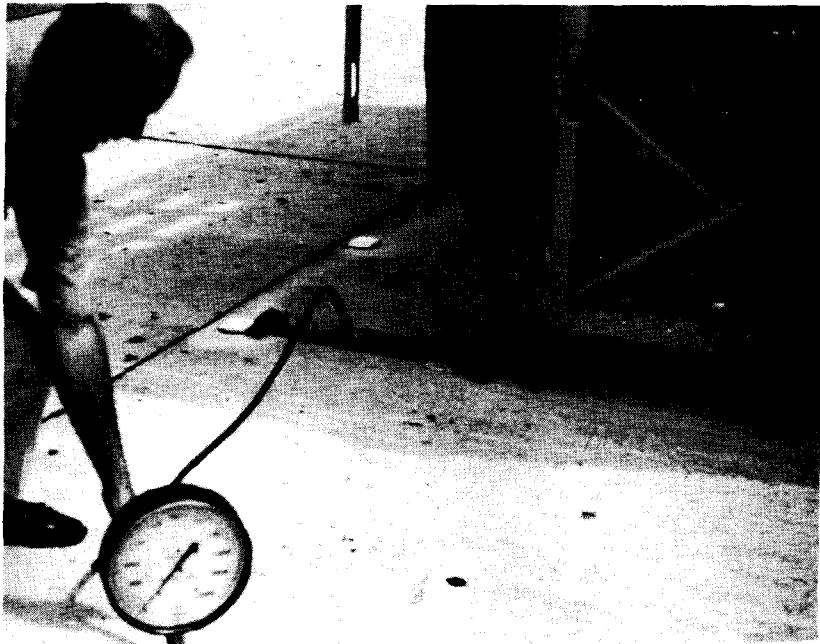
For field testing of problem areas in marker installations in the field, a heavy stake-body truck was modified to provide a "backstop" for the shear testing device. The device in operation can be seen in Figure 27. No systematic research was ever carried out involving use of this set up as its main use was that of a troubleshooting tool.

Rig Used for Field Testing of Epoxy Bonding
FIGURE 27
