GROOVING OF CONCRETE PAVEMENTS

FINAL REPORT

RESEARCH REPORT NO. 70

RESEARCH PROJECT NO. 67-1G
LOUISIANA HPR 1(11)

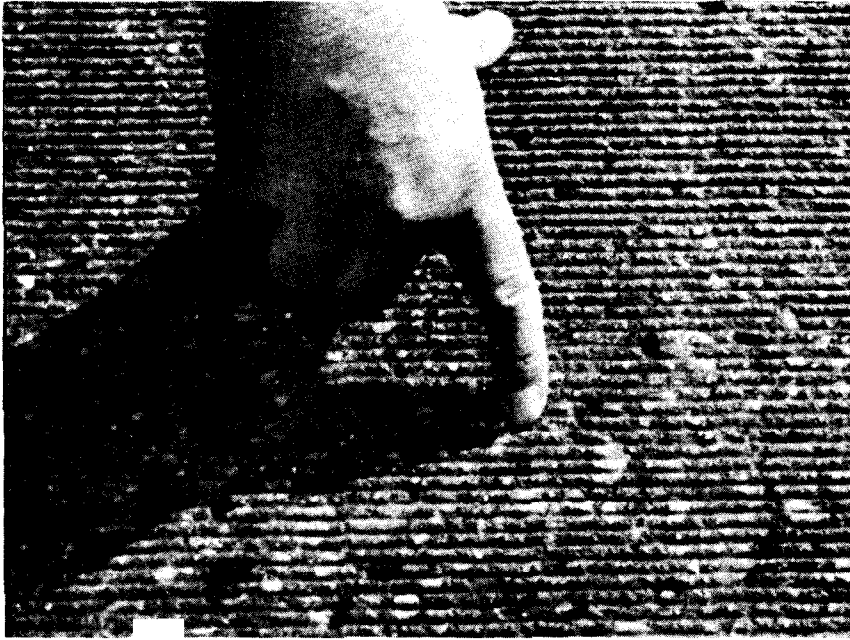
Christensen Diamond Services, Incorporated, of Salt Lake City, Utah, was the contractor that performed the grooving for this study. The grooves were cut by a special transverse grooving device especially designed for placing them while occupying only one traffic lane. The machine is mounted on a truck body, is completely self-contained, carries its own water supply and has a 36 inch cutting arbor which utilizes surface set cutters only. Christensen Style Number 7 grooving pattern was selected for application on all the sections under study. Christensen Style 7 consists of grooves cut .115 inch deep and .100 inch wide with the ridge between grooves .115 inch wide. The top corners of the ridges are also cut at a 60 degree angle (See Figure 1 and Figure 2).

Figure 2: Grooved Pavement Before Traffic

The other two sites are shown in Figures 10 and 13. The Florida Street Section is depicted by Figures 7 and 8, while the Scenic Highway site is shown in 12 and 13. All sections exhibit wear even though the pavement in Figure 10 does appear as worn as the others. The photograph in Figure 13 was taken outside the wheel path right at the intersection near the very end of the solid grooved section in the southbound lane. Except for the worn spot in the center of the photograph, probably created by vehicles turning to the right, it can be used as a basis of comparison - worn to relatively unworn grooving. However, the reader may also refer to Figure 2 for newly grooved pavement.

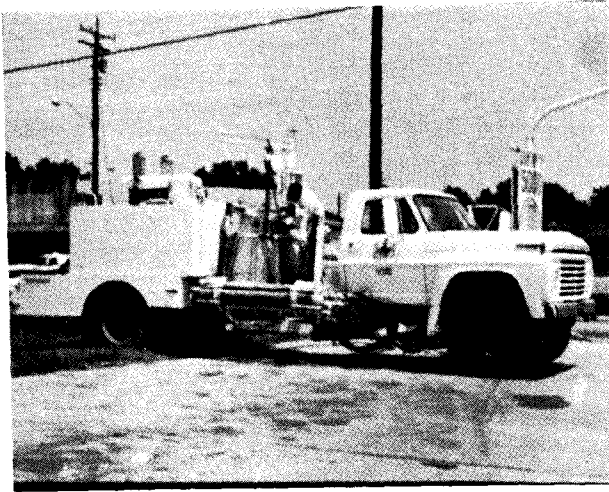
Figures 5, 6 and 7 are different views of the grooving truck and equipment. Figure 5 is an overall view of the truck. Figure 6 shows the diamond cutters with the diamond encrusted teeth showing rather than saws. Figure 7 shows the grooving truck in operating position with the diamond cutters on the pavement surface. Note the unique transverse alignment of the cutting rails underneath the truck. The cutting heads travel along these rails under the truck.

Figure 5: Overall view of the grooving truck with cutter in up position
