TEXTURING OF CONCRETE PAVEMENTS

(Interim Report No. 1)

Research Report No. 98

State Project No. 736-02-10
Research Project No. 72-3C(B)
Louisiana HPR 1 (13)

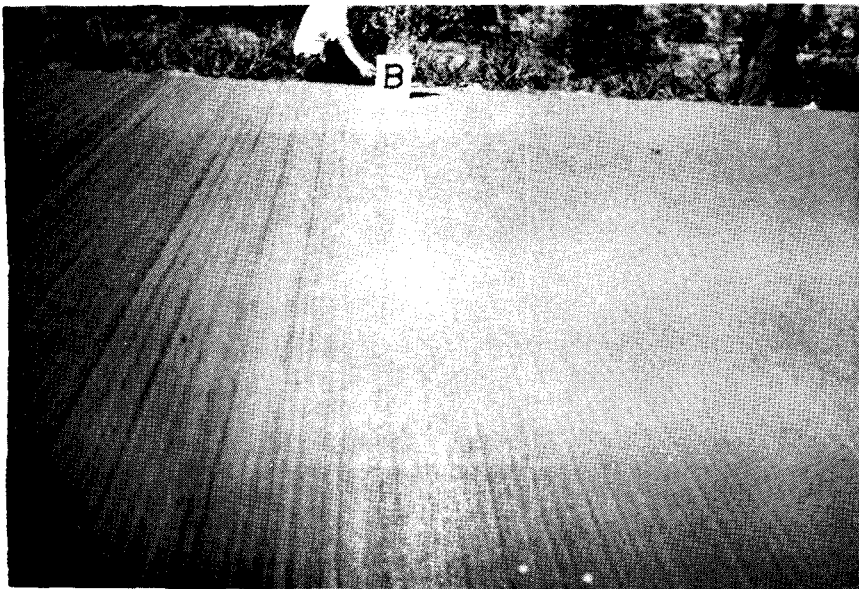
FIGURE 4
Mechanical Broom, Extra Heavy Nylon,
Transverse Texture

The initial average sand patch depth was 0.056 inch. With this broom, like all other brooms that were tried, the time of finishing was so critical that a few minutes would make a great difference on the final finished product. Generally, the surface had to be textured prior to the disappearance of water sheen from the surface of the pavement, otherwise balling of the grout or "popcorning" (see Figure 12) would occur and the result would be a poor surface texture with a low texture depth. This broom produced a texture superior to those produced by the soft bristle and heavy polyplastic brooms.

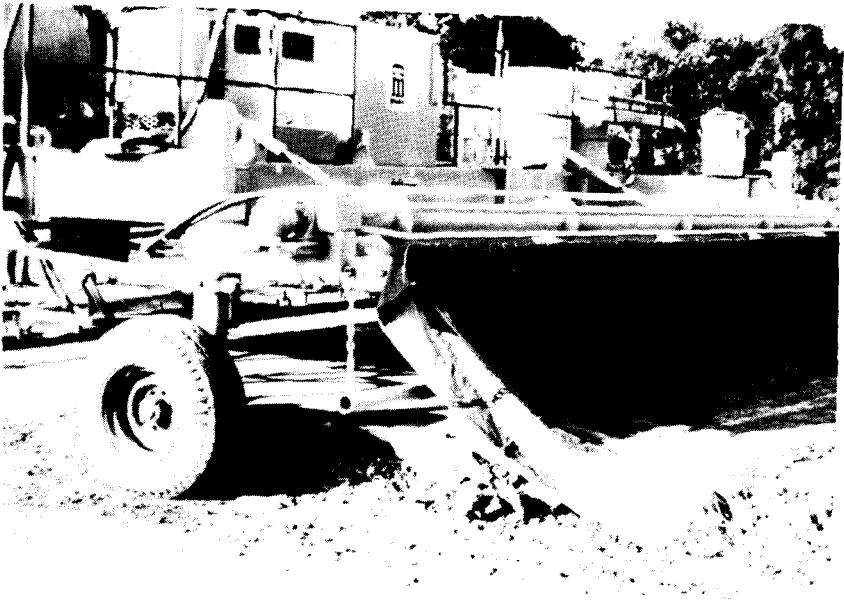
*FIGURE 9
Normal Burlap Drag
In Back of Float*

Two 24-ft. wide pieces of burlap cloth, each weighing 10 oz. per sq. yd., were hand sewed together so that one rested on top of the other. Each cloth was unraveled at one end approximately 6 inches, leaving trailing ends longitudinal to the pavement. The cloth was sufficiently long enough that when mounted onto the front of the texturing machine, 3 to 4 ft. of the burlap cloth would be in horizontal contact with the pavement to be textured (Figure 9 in the Appendix).

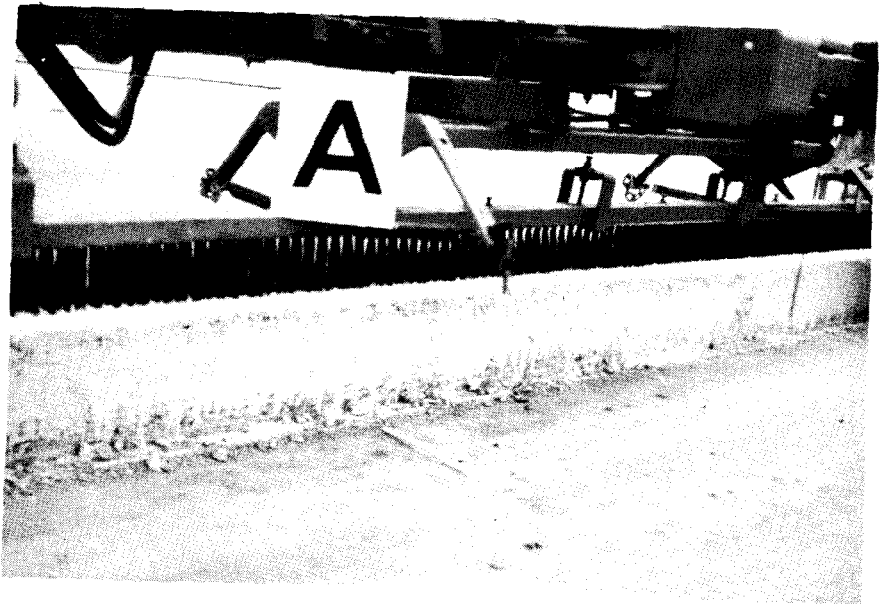
*FIGURE 10
Heavy Polyplastic Broom on
Transverse Texturing*

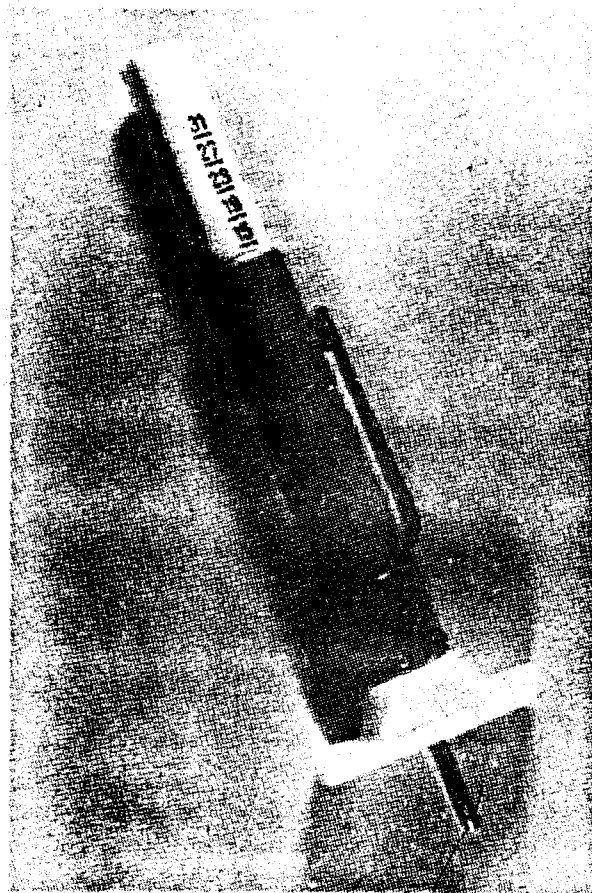
With the depth gauge guides in contact with the original concrete surface, the plunger is depressed until contact is made with the bottom of the groove in the concrete. The gauge is then removed

Figure 1
Depth Measuring Gauge

from the surface with care being taken to prevent the plunger from being disturbed. The texture depth is then read to the nearest 1/32 of an inch (1 mm) on the calibrated plunger. The plunger is then rezeroed and another depth measurement taken. This procedure is repeated until the necessary measurements are completed.
