EVALUATION OF EXPERIMENTAL
RUMBLE STRIP AREAS
IN LOUISIANA

Interim Report No. 1

Research Report No. 173

Conducted by
LOUISIANA DEPARTMENT OF TRANSPORTATION
AND DEVELOPMENT
Research and Development Section
In Cooperation with
U. S. Department of Transportation
FEDERAL HIGHWAY ADMINISTRATION

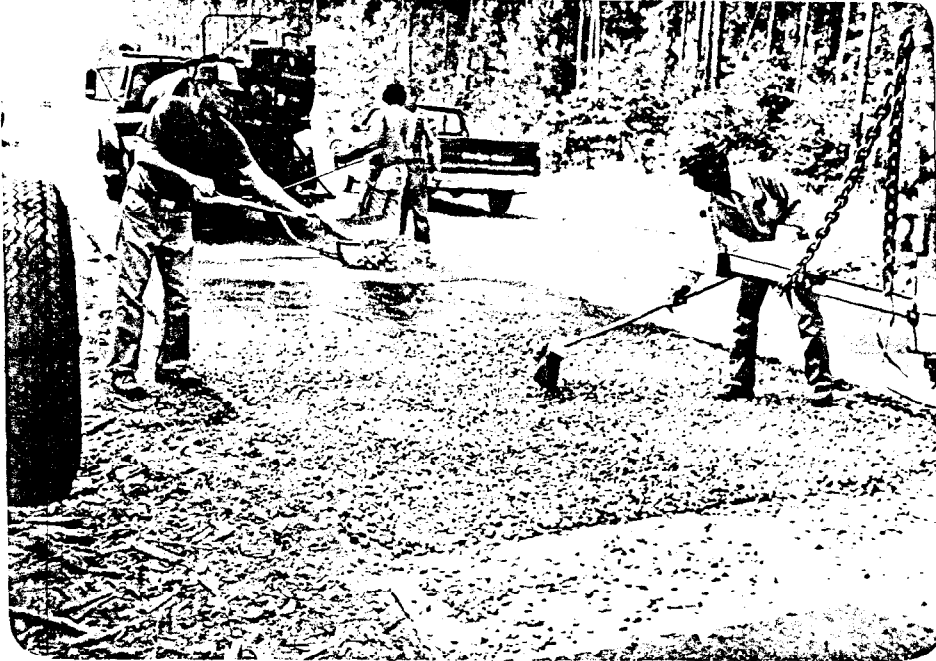
Figure 6

After application by either method, stiff push brooms were used to spread the aggregate uniformly to eliminate "bald spots" (Figure 6).

Distribution of Aggregate Prior to Rolling

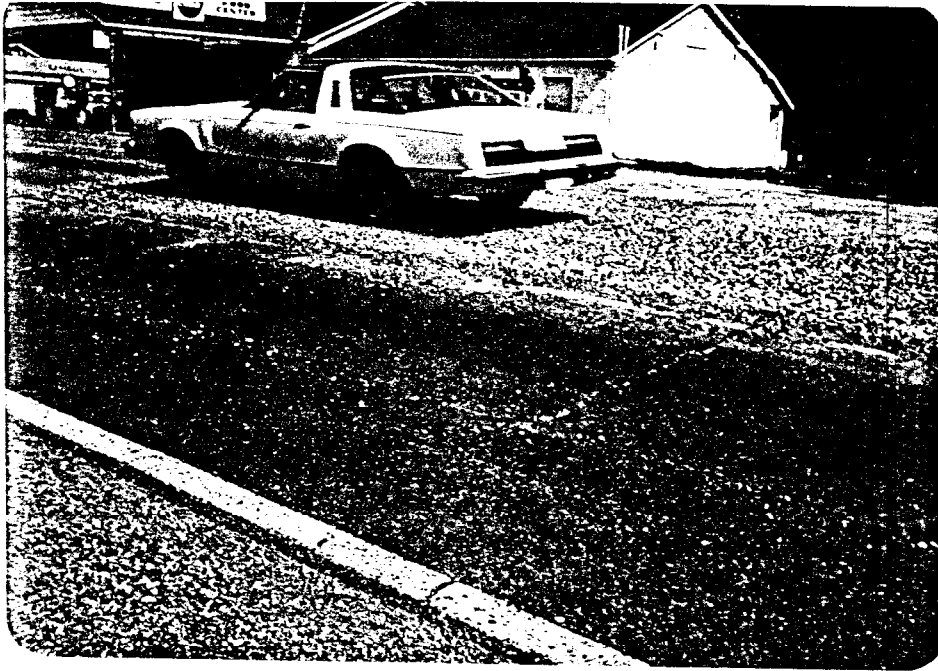
Figure 7

Application of excessive aggregate always contributed to rapid loss once opened to traffic, with approximately 5 - 10% being strewn onto the shoulder or into the opposite lane overnight (Figure 7). Experience gained to date can be utilized in the application of future installations to maximize coverage and minimize waste. Distribution of aggregate with excessive fines or deleterious material should be avoided. Stockpiles of materials should be maintained on paved areas wherever possible and used as soon after receipt from the quarry as is practical.

Initial Overnight Loss of Loose Aggregate

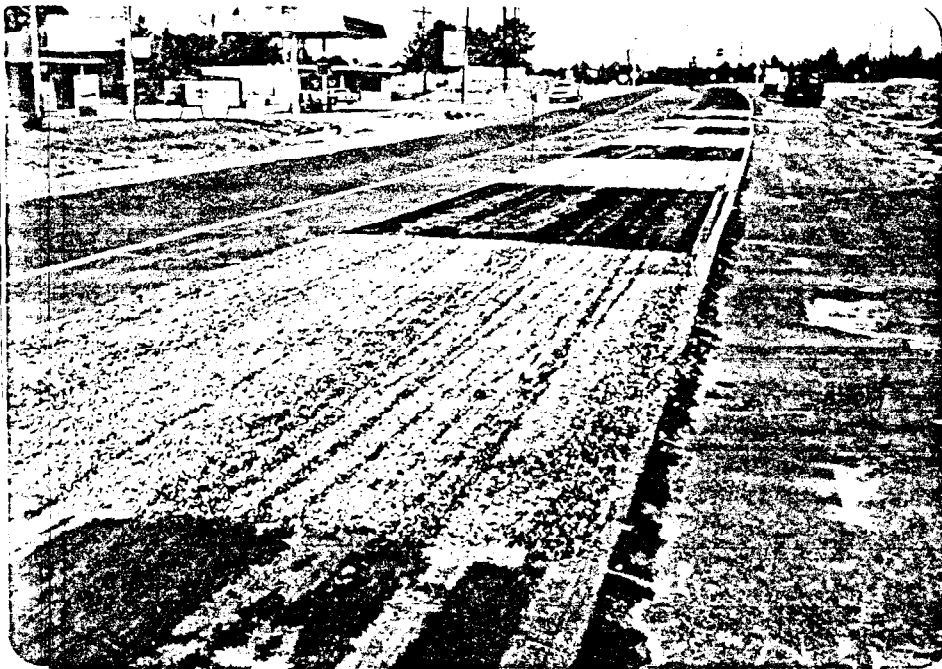
Figure 9

The first installation of rumble strip areas was on La. 3225 where it intersects with U.S. 167 in Alexandria, Louisiana (Figure 9).

Site No. 1 and 2 on La. 3225 at Alexandria

La. 3225 is a two-lane undivided city street (Figure 9) and is controlled with stop signs and an overhead flashing red light in the center of the intersection.

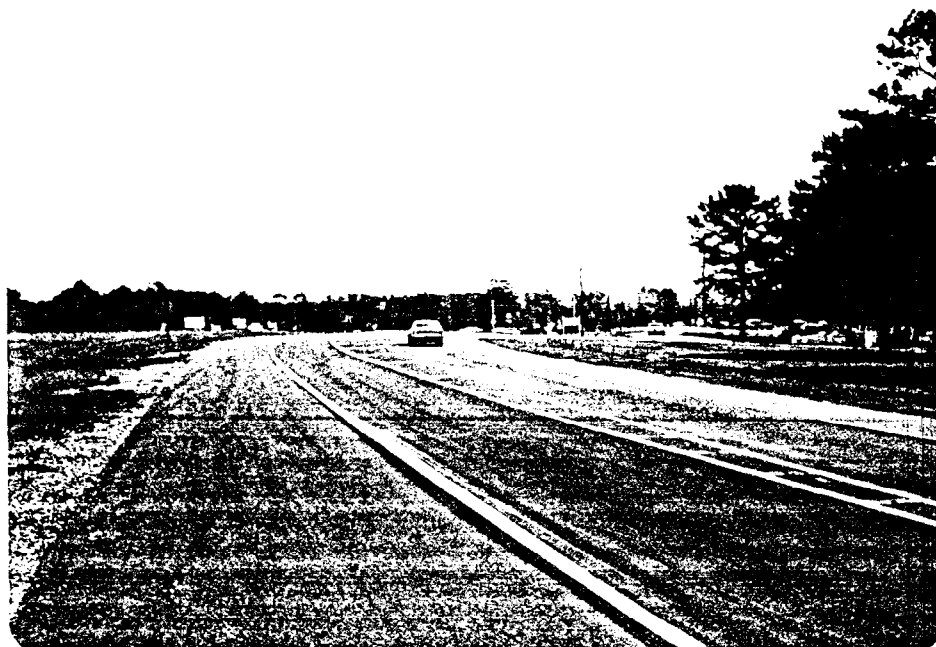
Figure 10

Although this same light has flashing amber for U.S. 167 through traffic, the intersection is situated on an elevated curve (Figure 10) and is partially obscured from view. The majority of accidents occur when the high speed through traffic disregards the amber caution light and collides with traffic ignoring the stop signs and flashing red light.

Elevated Curve of Eastbound Approach of La. 3225

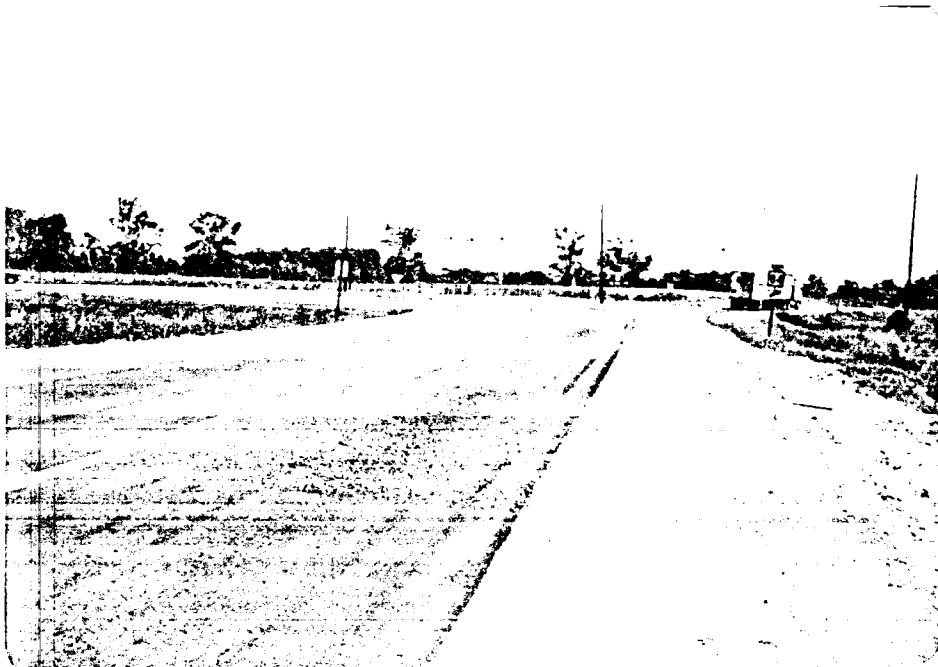
Figure 13

At this location (Figure 13), La. 28 is a moderately heavily traveled country road that terminates at its intersection with La. 84 adjacent to a levee. Although there are no sight obstructions, vehicles have a tendency to approach the intersection too fast and overshoot La. 48, coming to rest on the levee or overturning in the painted turn lanes.

Site No. 4 Intersection of La. 28 at Archie

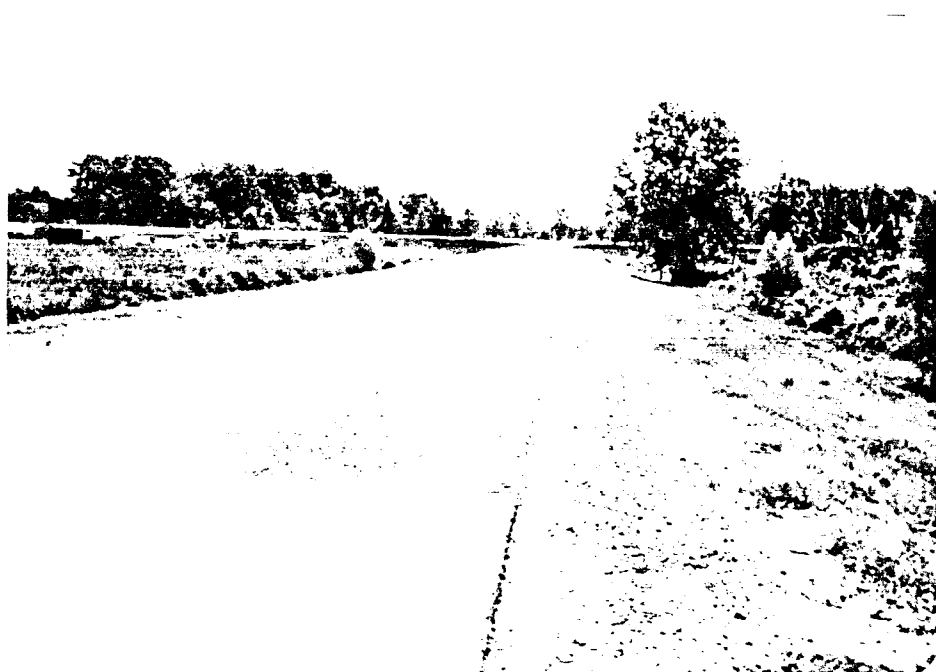
Figure 14

At the subject location (Figure 14), La. 126 is a country road that intersects La. 124 in a curve. At night this curve presents a sight obstruction for drivers on La. 124. The absence of advance warning lights to warn drivers of the impending stop situation on La. 124 was responsible for three right-angle collisions. A fourth accident at 2:00 a.m., involved a pick-up that overshot the intersection, was airborne for 60 feet and landed upside down in a ditch, killing the driver. There were no skid marks or other indication that the driver was aware of the intersection. This lightly traveled rural location is typical of the many intersections that do not warrant

Site No. 5 Intersection of La. 126 at Jonesville

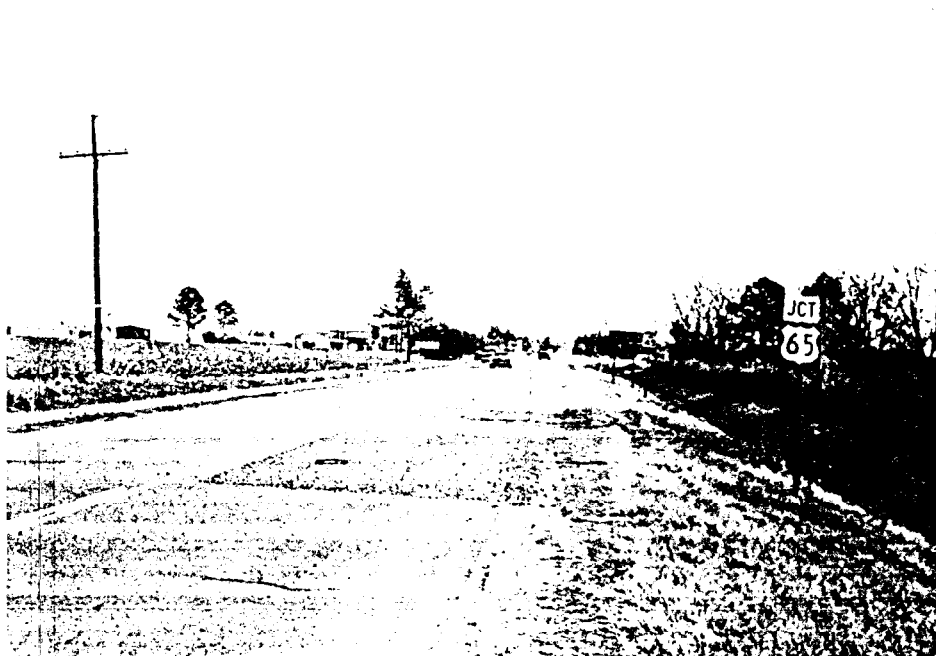
Figure 15

This site is on La. 4 at its intersection with U.S. 65 at Newellton (Figure 15). This busy intersection, with flashing amber warning lights, striping and turn lanes, has a history of many turning/collision accidents attributed to driver inattentiveness.

Site No. 6 Eastbound Approach of La. 4 at Newellton

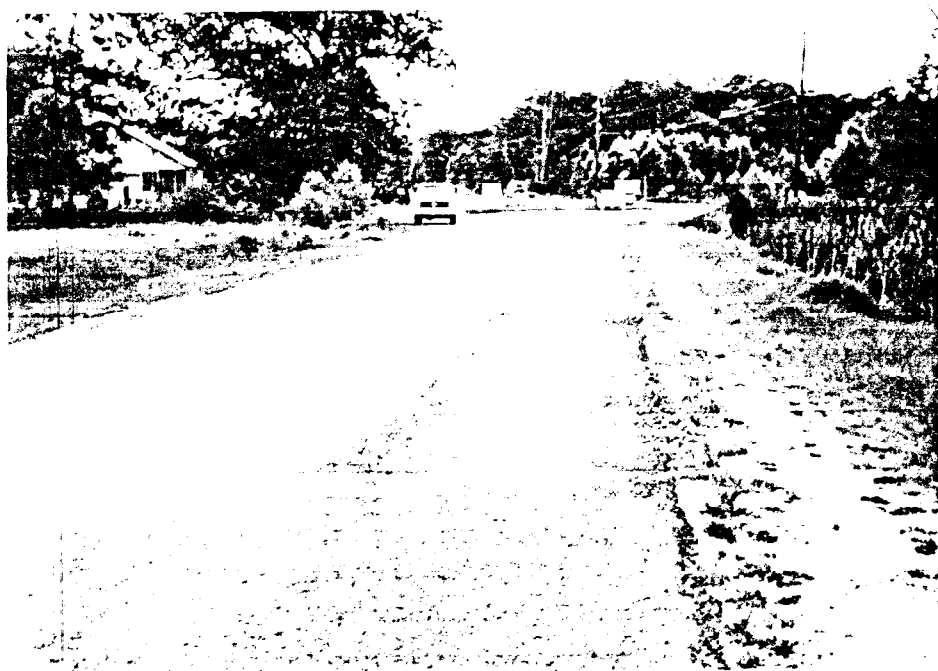
Figure 16

At this heavily wooded rural location, La. 662 is a narrow, winding and old asphalt road that intersects La. 398 with a sharp right-hand curve (Figure 16) with only a stop sign for traffic control. La. 398 is a long curve, and the dense swamp to the left provides a sight obstruction to the intersection of La. 662. Installation of rumble strip areas at this location were preceded by eighteen accidents in which there were eight instances of injuries reported.

Site No. 10 Route La. 662 South of Labadieville

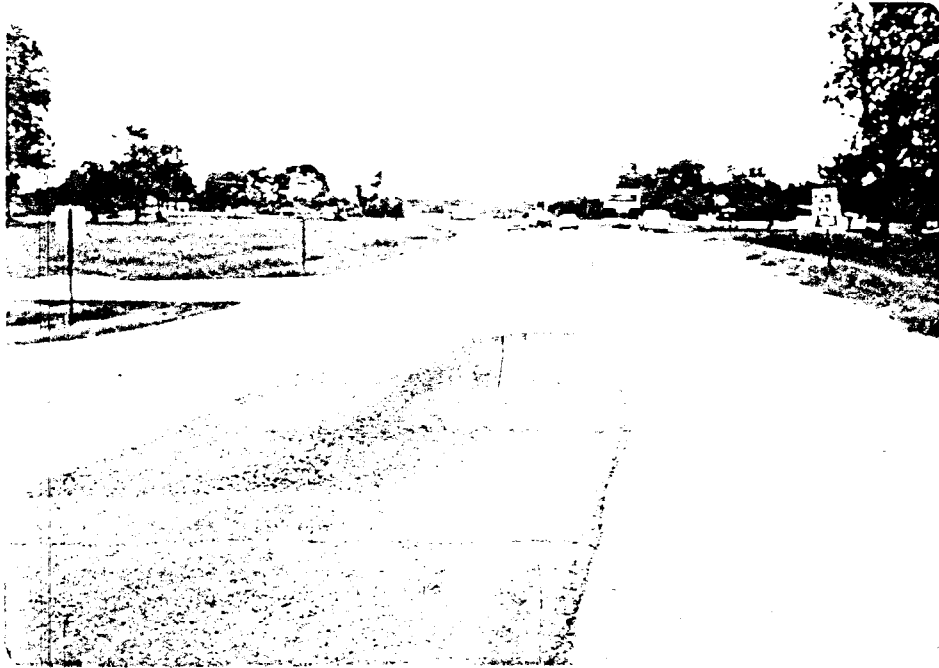
Figure 17

right-angle collisions due to driver violations, neglect or inattentiveness and failure to yield after stopping. Rumble strip areas were installed on the curved approach of Spur La. 70 (Figure 17) in an effort to reduce speeds and increase driver awareness.

Site No. 11 Spur La. 70 at Plattenville
