APPLICABILITY OF THE RAINHART PROFILOGRAPH AS A
SPECIFICATION TOOL FOR LOUISIANA PAVEMENTS
(PARTIAL REPRODUCTION -- MASTERS THESIS)

A Thesis

The Department of Civil Engineering

By
David Oren Cox
B.S., Oregon State University, 1970
December 1984

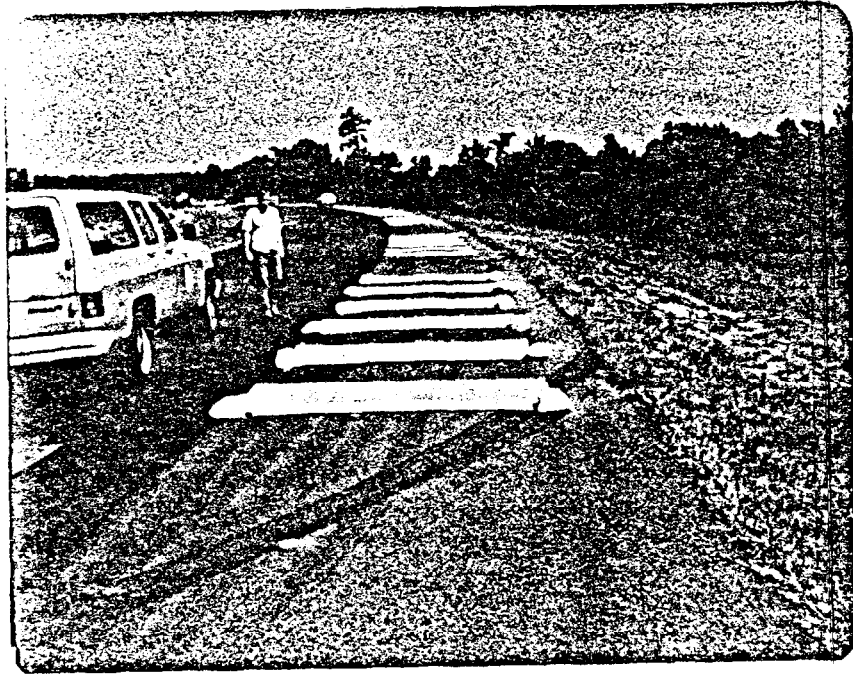
FIGURE 10

The purpose of these tests was to determine the response of the profilograph to a series of grouped deviations. As in the previous test, these deviations range from 1/8 inch to 5/8 inch in height in 1/8-inch increments. However, in these tests six deviations of each height, each four feet wide, were spaced in a group with four feet between deviations. This resulted in several test patterns each 44 feet in length, a distance sufficiently long so as to engage all of the averaging wheels at the same time. The individual groups of deviations were however, sufficiently separated so as to allow the profilograph to completely disengage from one set

INDUCED ROUGHNESS TEST PATTERN NO. 2

prior to encountering the next set (see Figure 10).
