ROAD PROFILE STUDY

FINAL REPORT

STEVEN L. CUMBAA  
PAVEMENT EVALUATION RESEARCH ENGINEER  
LOUISIANA DEPARTMENT OF TRANSPORTATION  
AND DEVELOPMENT

Research Report No. 185

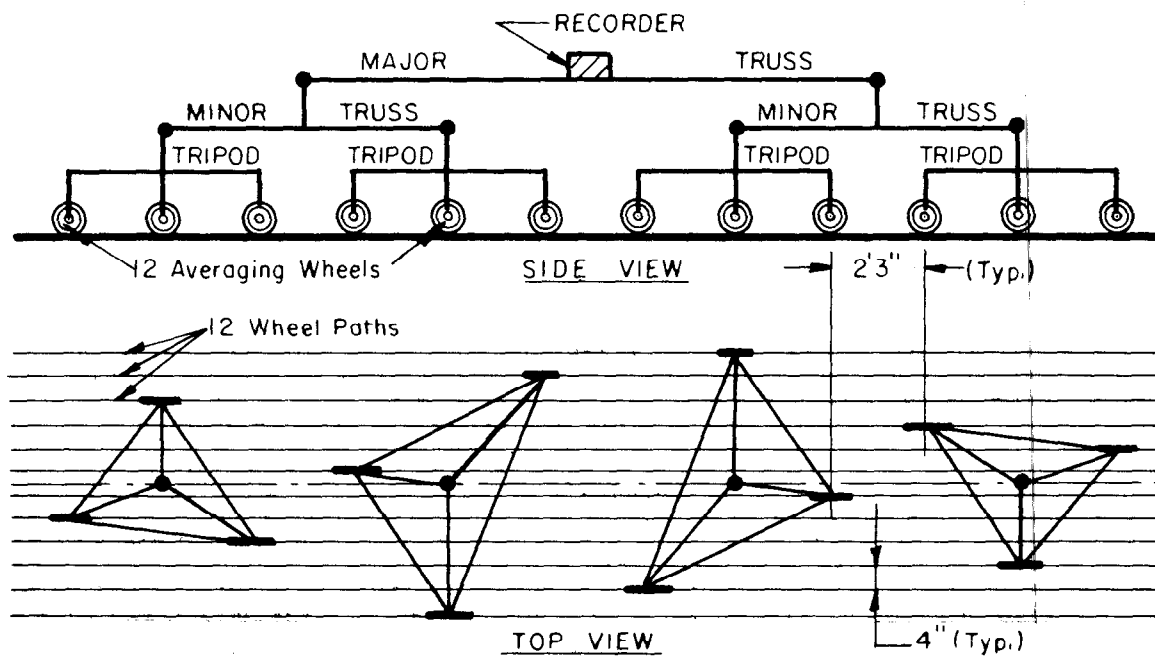
FIGURE 1

The Rainhart profilograph is a 26 ft. long device composed of a major truss which is supported at each end by two minor trusses. The minor trusses are supported at each end by a tripod, each supported by 3 small wheels. The instrument that records roughness is centered on the device and is located at the top center of the main truss. The minor trusses are pinned to the main truss and the tripods are connected to the minor trusses with a ball and socket arrangement allowing partially independent movement of each major component of the device. The 12 small wheels that support the device are called averaging wheels, and each traverses a different path as the profilograph is pushed longitudinally along the roadway. Due to the geometrics of the profilograph, 1/12th of the vertical movement of an individual averaging wheel is transmitted mechanically to the center of the main truss where the recording instrument is located. A schematic diagram of the Rainhart profilograph is presented in Figure 1 on page 6 .

The roughness recording instrument is actuated mechanically during vertical distance changes between the recorder and a 5 ft. circumference recording wheel which rides on the pavement surface below the recorder. The recorder is a strip chart recorder which is also equipped with a digital longitudinal distance counter and two vertical roughness counters. As the 5ft. recording wheel moves longitudinally and vertically along the pavement surface it mechanically drives the chart paper, pen carriage and counters.

The profilograph truss and averaging wheels are designed to provide a relatively consistent vertical frame of reference to the recorder

*Schematic of the Rainhart Profilograph*

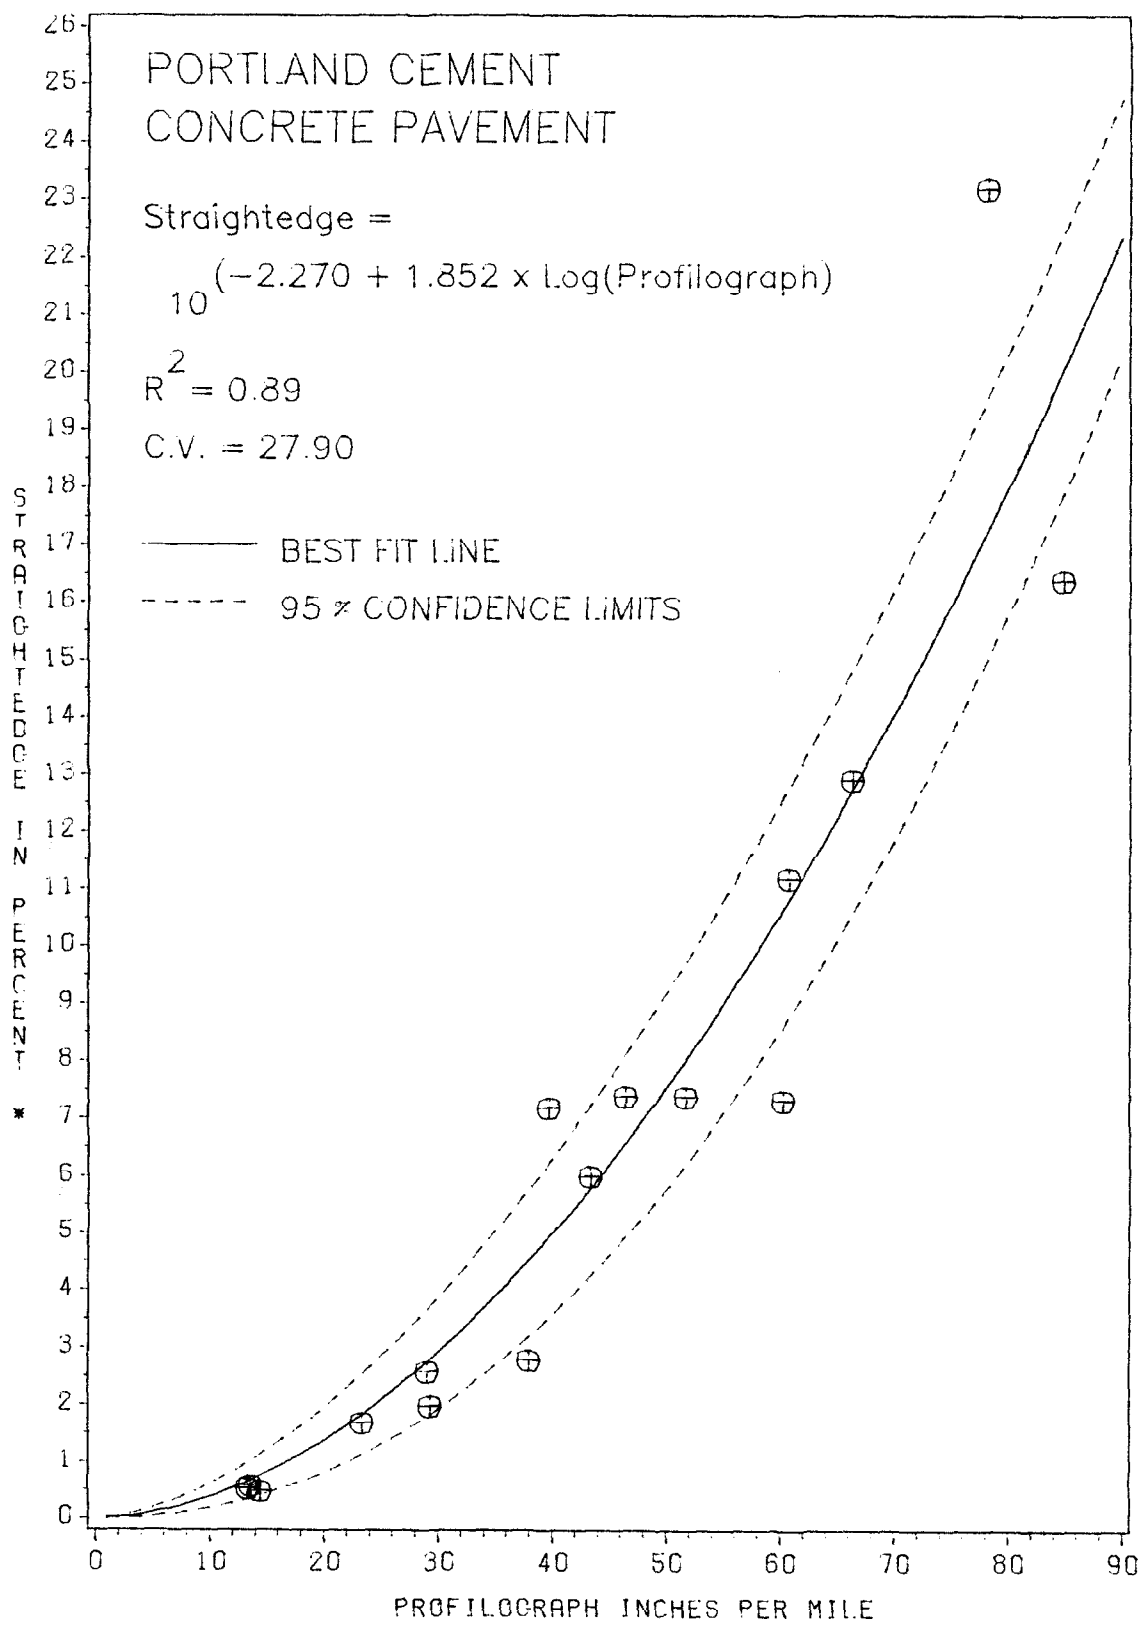
\* - LINEAR PERCENT EXCEEDING 1/8" TOLERANCE

*Graph of Best Fit Curve  
 (Straightedge vs. Profilograph) PCC  
 FIGURE 6*

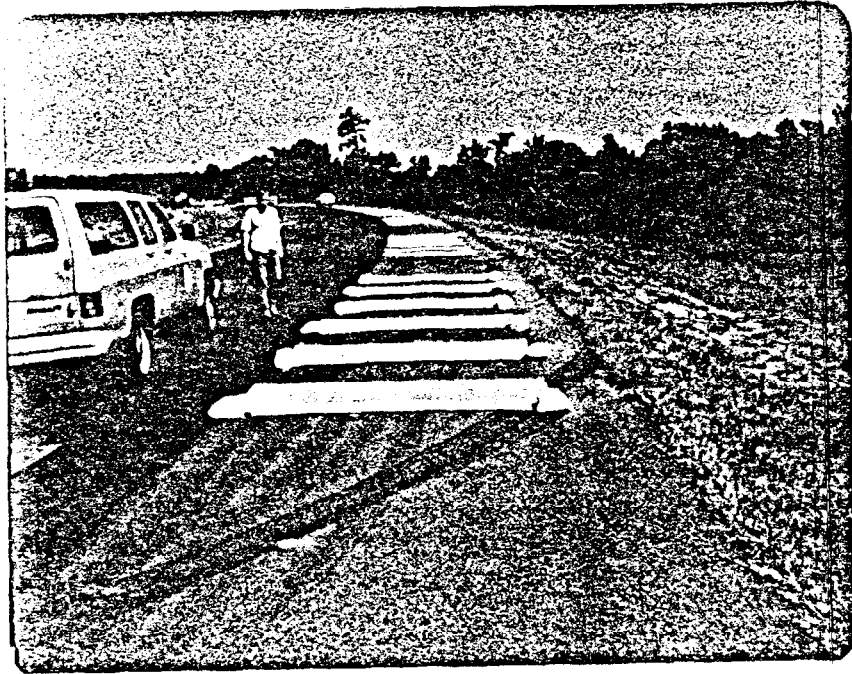
FIGURE 10

The purpose of these tests was to determine the response of the profilograph to a series of grouped deviations. As in the previous test, these deviations range from 1/8 inch to 5/8 inch in height in 1/8-inch increments. However, in these tests six deviations of each height, each four feet wide, were spaced in a group with four feet between deviations. This resulted in several test patterns each 44 feet in length, a distance sufficiently long so as to engage all of the averaging wheels at the same time. The individual groups of deviations were however, sufficiently separated so as to allow the profilograph to completely disengage from one set

INDUCED ROUGHNESS TEST PATTERN NO. 2

prior to encountering the next set (see Figure 10).
