EVALUATION OF SURFACE MODIFICATION METHODS  
TO MITIGATE RUSTING AND PITTING  
IN WEATHERING STEEL BRIDGES

FINAL REPORT

RESEARCH REPORT NO. 197  
STATE PROJECT NO. 736-09-06  
RESEARCH PROJECT NO. 84-1ST

LOUISIANA DEPARTMENT OF TRANSPORTATION AND DEVELOPMENT  
LOUISIANA TRANSPORTATION RESEARCH CENTER  
*in Cooperation with*  
U. S. Department of Transportation  
FEDERAL HIGHWAY ADMINISTRATION

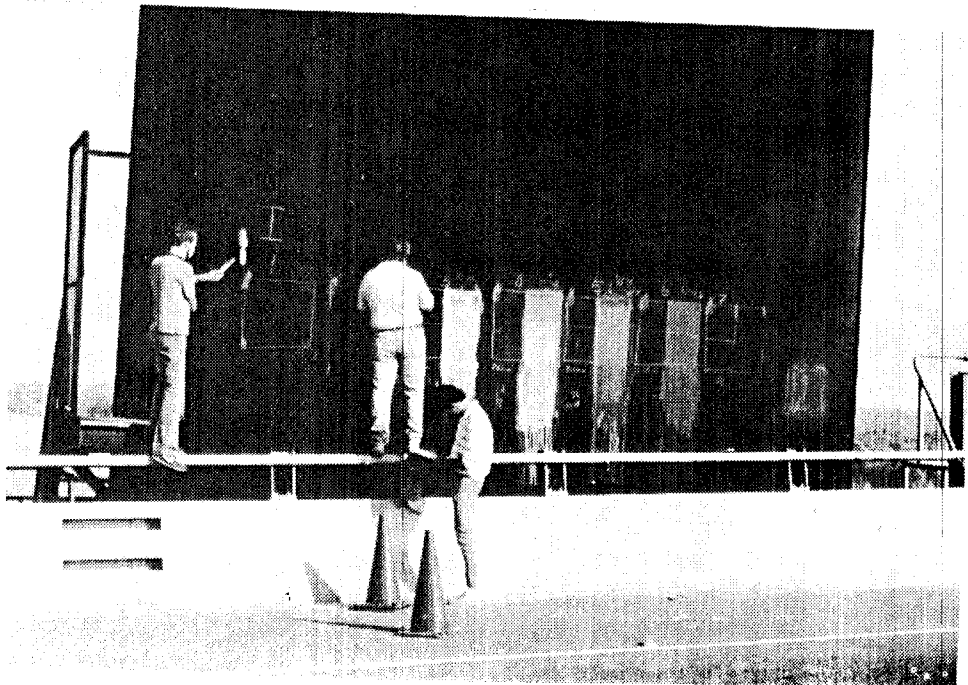
33

- (33) The investigators are taking the thickness readings. This shows the readings being taken at LU after 1 year from the first time readings were taken. An ultrasonic thickness gauge was used.
