# RESEARCH PROJECT CAPSULE [12-3ST]

## Repair of Morganza Spillway Bridge Bent Pile Cap Using Carbon Fiber Reinforcement (CFR)

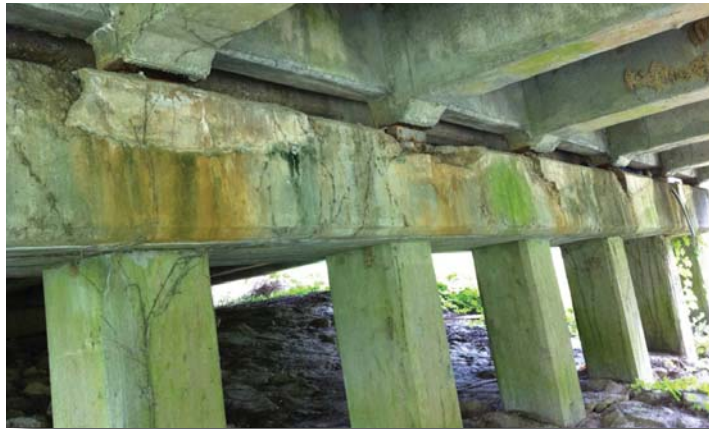
The pile cap of an end bent of the Morganza Spillway Bridge suffered extensive damage at the girder bearing locations on one side, due to the pounding of the girders at these locations by the adjacent concrete deck located on the approach side of the bent. The lack of a gap or an expansion joint between the two adjacent bridge decks contributed to the distress in the pile cap. The pounding caused heavy spalling of the concrete on the west face of the pile cap at the girder bearing locations and the spalling extended all the way to bearing plates. In conjunction with a major repair that was being undertaken on the bridge, the repair of the damaged pile cap (Bent 458) is proposed using the latest technology.

Figure 1  
Spalling of concrete at bearing locations

The primary repair of the damaged pile cap and the replacement of the bearing plates were completed by the contractor working on the project. Structural grade high-adhesive material, epoxy concrete, was utilized to patch the damaged areas of the pile cap. In the proposed effort, the repaired areas of the pile cap, namely the bearing plate locations, will be strengthened by preventing delamination of the repair material by confining it with high modulus carbon composite wrapping. An inorganic polymer coating that provides UV protection and prevents mold and mildew growth will be utilized. This coating also has self-cleaning properties. The project is conducted to demonstrate the application of high strength composites for rehabilitation of the transportation infrastructure.
