1. Report No. FHWA/LA.10/472		2. Government Accession No.	3. Recipient's Catalog No.
4. Title and Subtitle Development and Performance Evaluation of Fiber Reinforced Polymer Bridge		5. Report Date March 2014

11. Contract or Grant No. LTRC Project Number: 05-5ST State Project Number: 736-99-1370	
12. Sponsoring Agency Name and Address Louisiana Department of Transportation and Development P.O. Box 94245 Baton Rouge, LA 70804-9245		13. Type of Report and Period Covered Final Report Nov. 2005-Nov. 2010

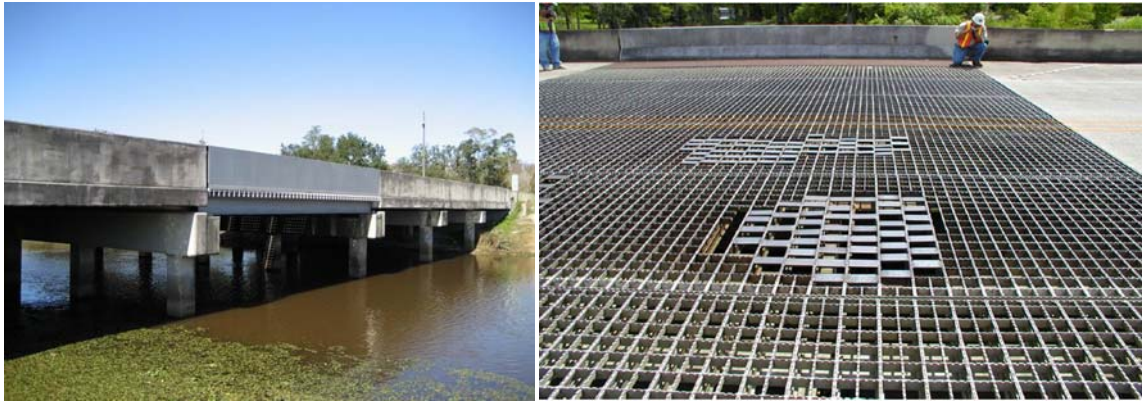
Figure 1
Pierre Part bridge

The bridge selected for this study is the Pierre Part Bridge on Route LA 70 in Assumption Parish. The bridge was built in 1988 with a design load of HS20-44 and an average daily traffic (ADT) of about 6000. The bridge, with a total length of 145 ft. (44.2 m) and a roadway width of 46 ft. (14 m), consists of six 20-ft. (6.1-m) spans and a 25-ft. (7.6-m) span. The 20-ft. (6.1-m) spans are concrete structures and the 25-ft. (7.6-m) span consists of a steel grid deck supported on steel girders. The height of the superstructure from the top of concrete pedestal to the top of roadway is about 20 in. (0.51 m). The 25-ft. (7.6-m) steel span is designed for being lifted for river navigation when needed. Figure 1 shows the damaged grid deck that needs to be replaced in the 25-ft. (7.6-m) span. The requirement of being movable, the appropriate span length 25 ft. (7.6 m), and the existing height of the superstructure 20 in. (0.51 m) make this steel span a good candidate to be replaced with a FRP slab system.

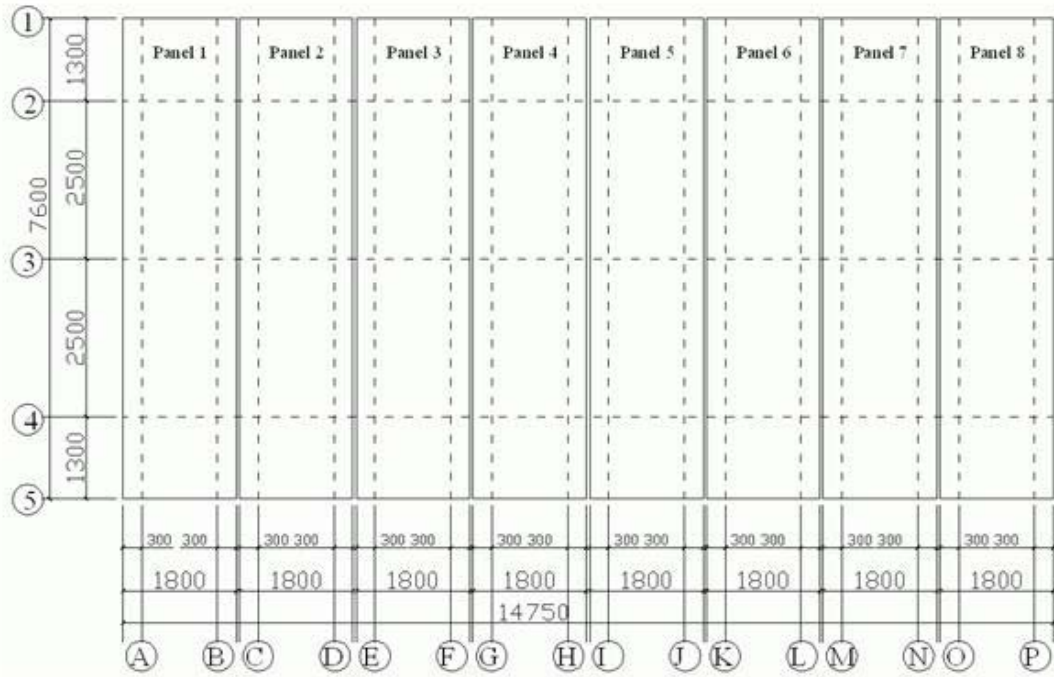
Figure 2
Bridge deck plan view

The span to be replaced has eight 299.21-in. x 70.86-in. (7600-mm x 1800-mm) deck panels across the traffic direction, as shown in Figure 2. The FRP deck panels that will be bonded on the I girders have the same dimensions as the steel grid deck panels. Labels A through P in Figure 2 stand for the girder positions, and 2 through 4 are the reference lines where sensors are located. In this project, the issues of interest for the bridge's long-term performance monitoring are: (1) integrity of the FRP-wrapped balsa wood bridge deck system, (2) the strains in the transverse direction of the deck and the longitudinal direction of the individual girders, and (3) bridge deck–girder interface bond integrity.

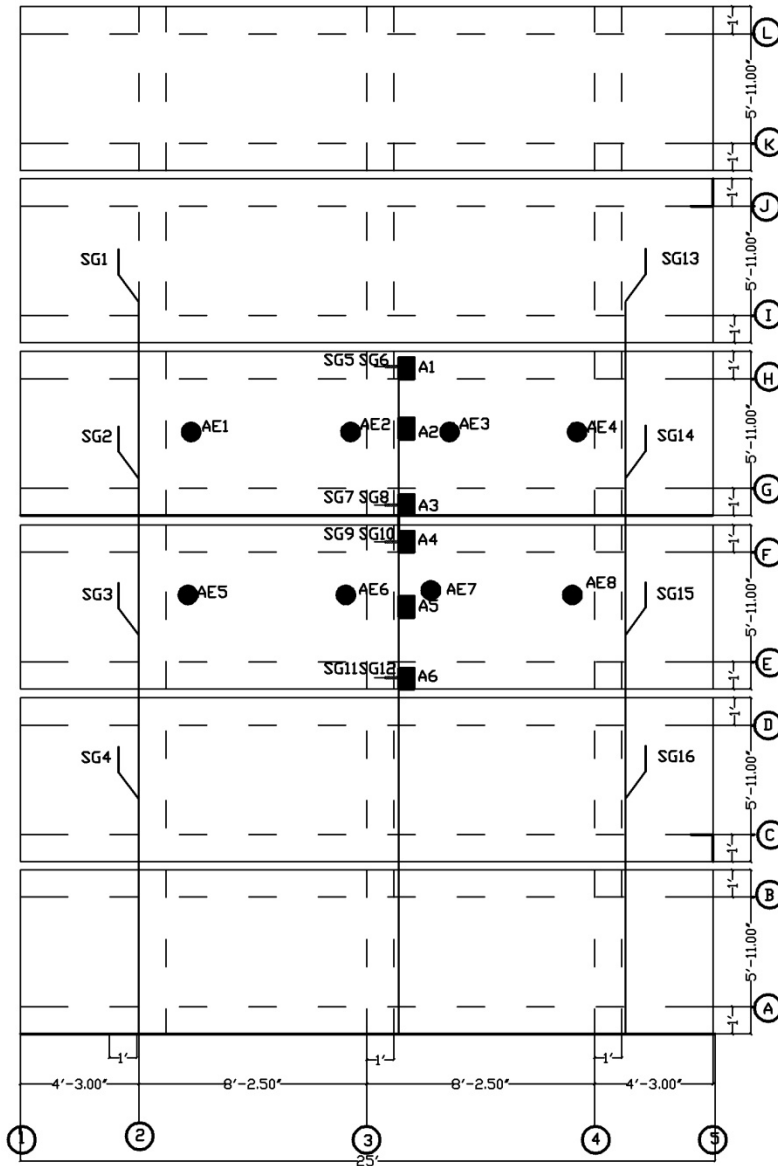
Figure 12
Traditional strain gauge, accelerometer, and AE sensor layout on bridge

From Figure 12, it is clear that strain sensors (SG1- SG16) were attached to the bottom of the FRP deck assembly along the centerline between two girders, while sensors attached to the steel girders were located at the mid-span. Sensors on the girders were attached to both the bottom flange and top flange to identify extent of composite action between the deck and girder.

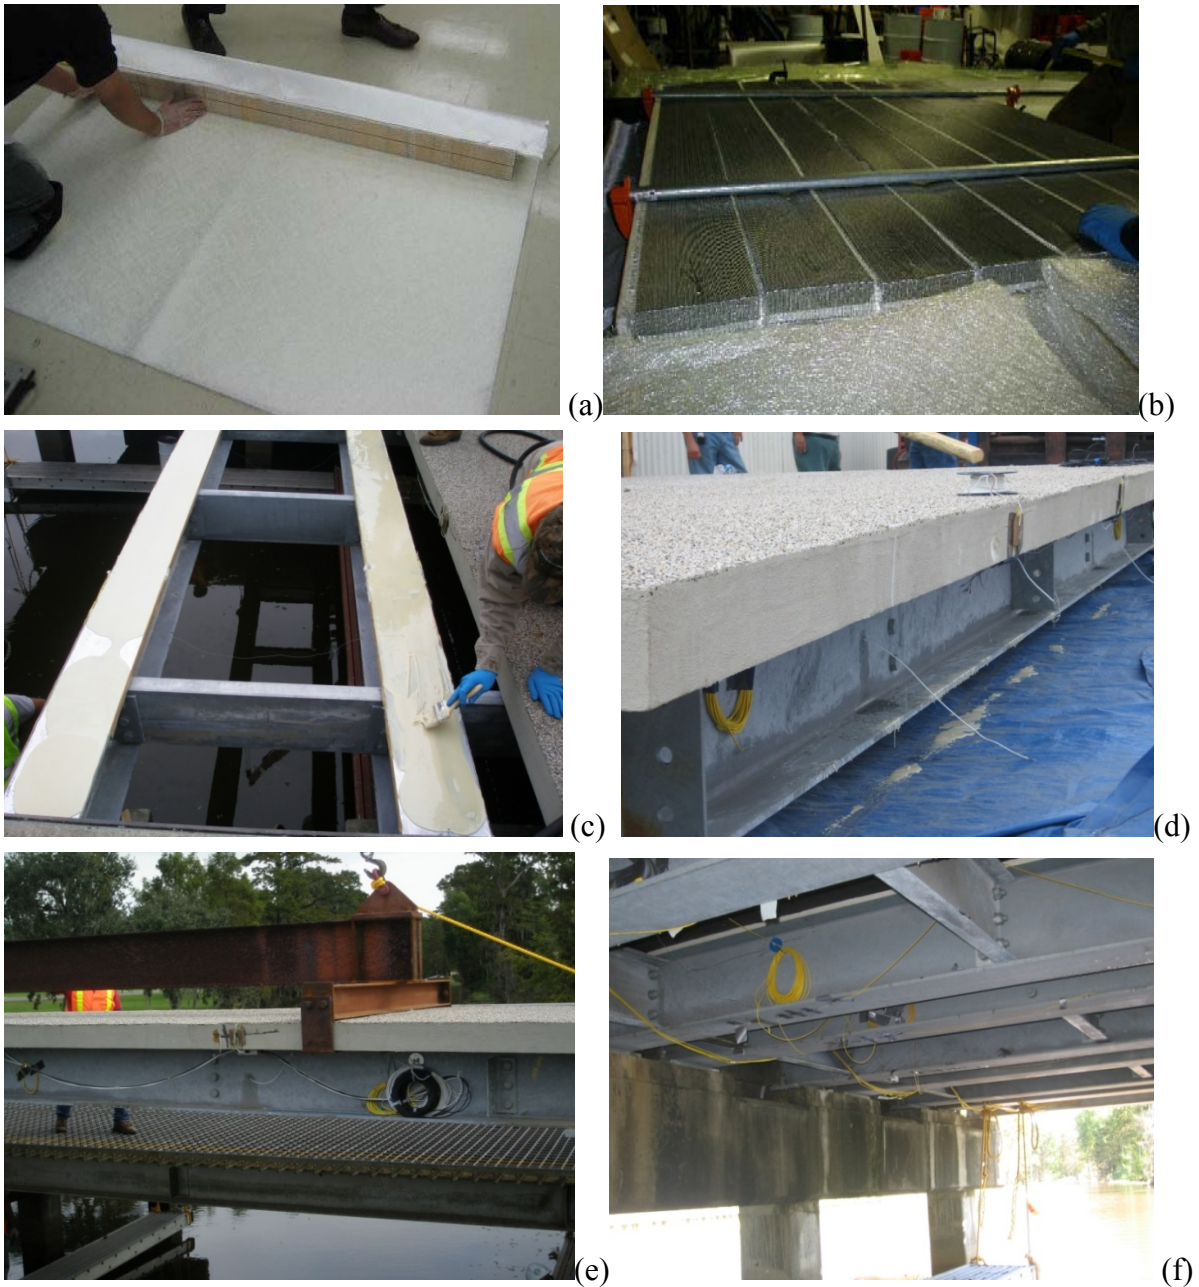
Figure 14

The new bridge deck consists of pre-fabricated FRP-wrapped balsa wood units. The fabrication sequence of the bridge deck units and final installation are illustrated in Figure 14(a) that shows the balsa wood beam being wrapped with glass fiber reinforced polymer (GFRP) sheets. In Figure 14(b), a single panel is being assembled using several of the wrapped balsa wood beams and hardware layers. The deck was adhesively bonded to the steel girder using customized epoxy [Figure 14(c)] and a bonded panel is shown in Figure 14(d). The panels were transported and placed on site as seen in Figure 14(e) and finally all sensors required for performance evaluation of the newly constructed bridge were installed as shown in [Figure 14(f)].

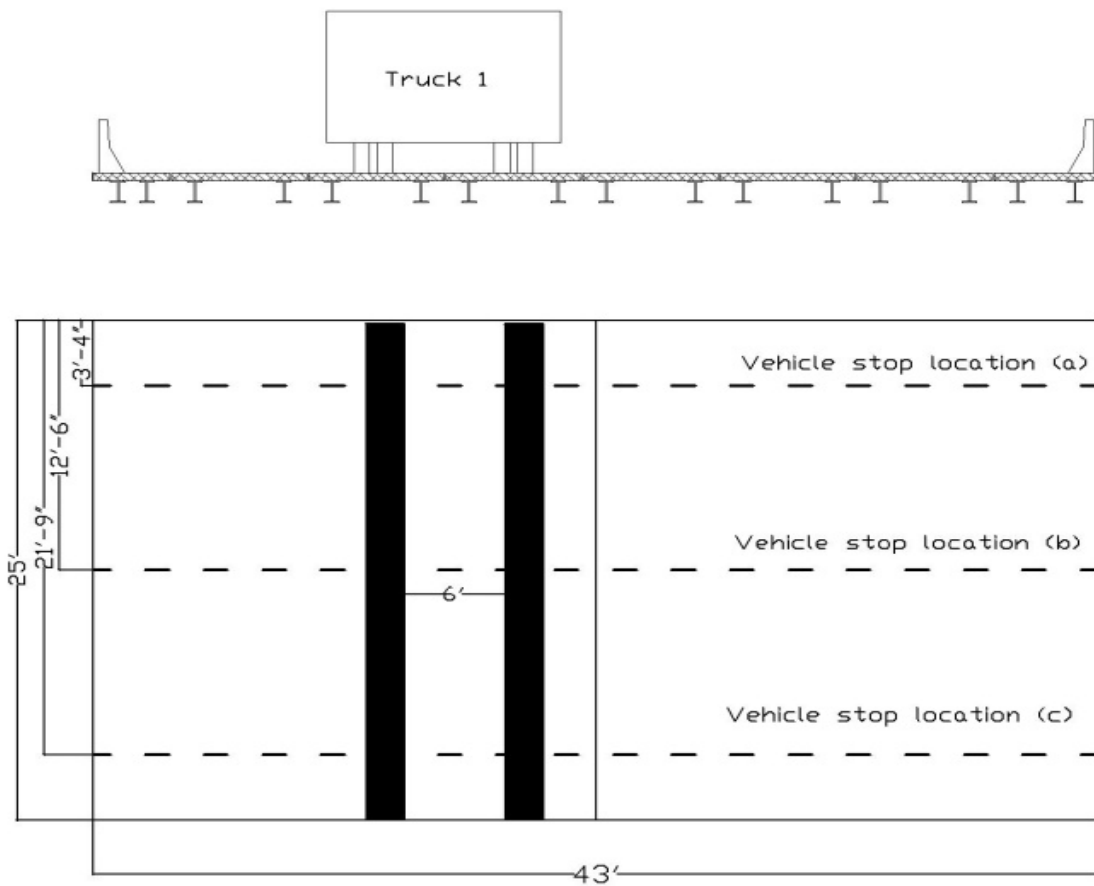
Figure 17
Static and dynamic truck loading path for north bound traffic lane

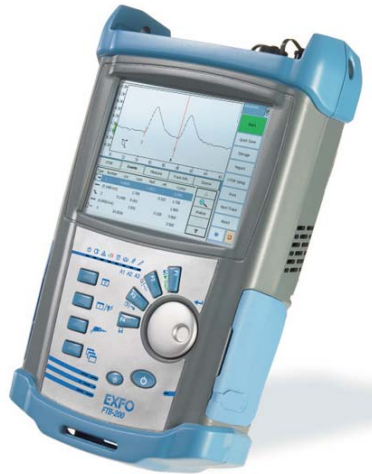
Figure 19
EXFO FTB-200

The FTB-200 Compact Modular Platform (Figure 19) by EXFO is the acquisition system that measures optical backscatter as a function of linear position in an optical fiber. The fiber characteristics such as attenuation of the link, loss trends, and length of fiber are deduced from the backscattered light. Thus, this principle of the OTDR sensors aids in locating the existence of any debonding in the monitored interface.

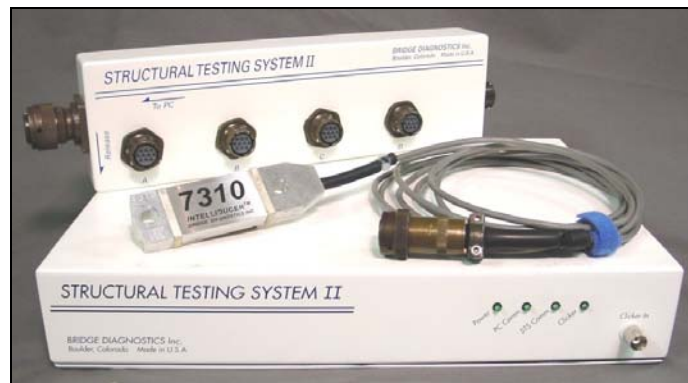
Figure 20
STS II data acquisition system and intelligiducer

Traditional strain gauges used in this project are manufactured by Bridge Diagnostics, Inc. The 16-channel Structural Testing System II (BDI-STS II) shown in Figure 20 is used in conjunction with the intelligucers/strain gauges to monitor strain profiles during live load tests.

To supplement and cross-check the strain information collected from the FBG sensors, a few traditional strain gauge transducers were also placed at coincident locations on both deck panel and girder surfaces. The traditional transducer chosen for this project was a Bridge Diagnostics, Inc. (BDI) intelliducer (shown later in Figure 20).

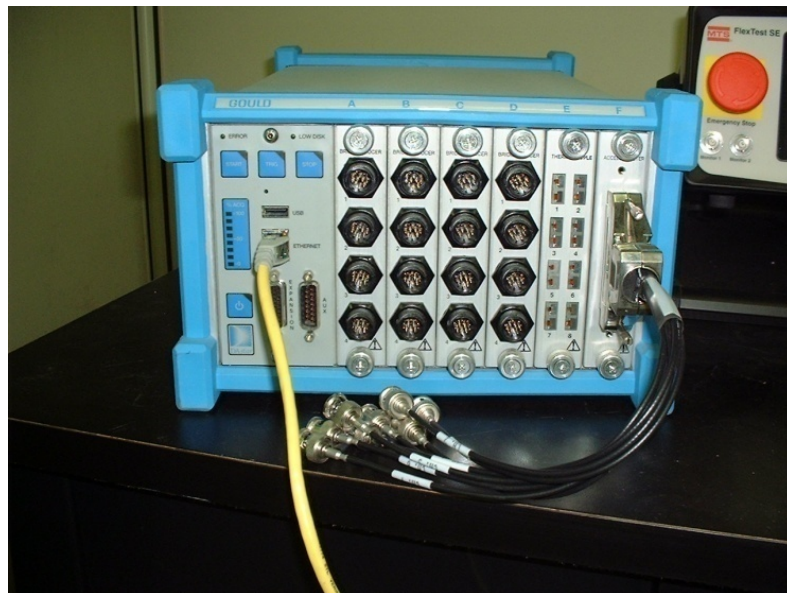
Figure 22
Gould data acquisition system

The structures vibration frequency information was traced by mounting six accelerometers and collecting the data using Gould DAStarNet data acquisition system shown in Figure 22.

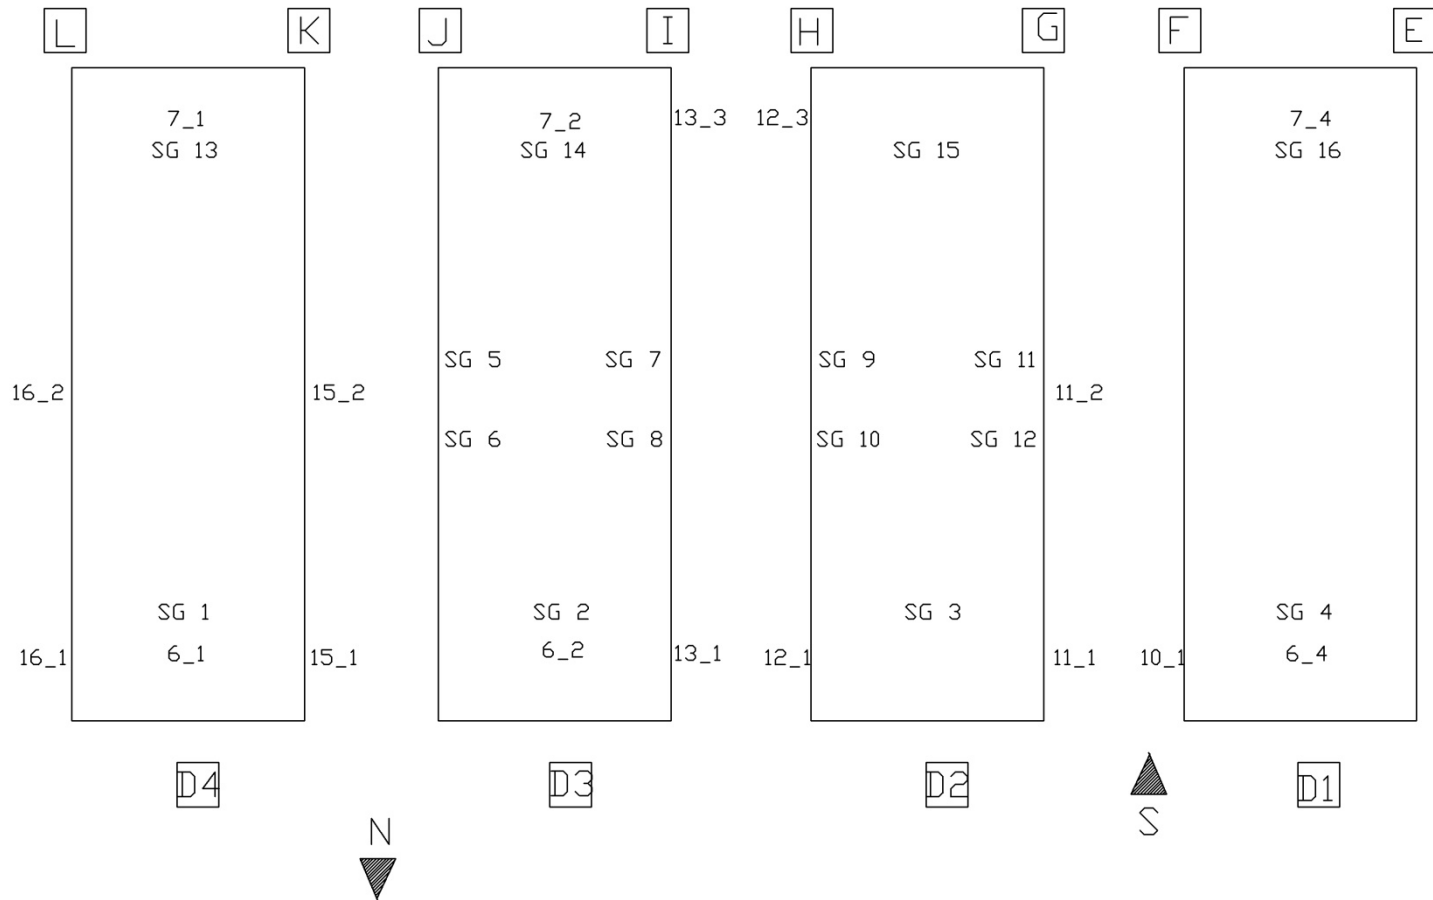
Figure 23
Plan view of all functional strain sensors attached to decks and girders during short-term test

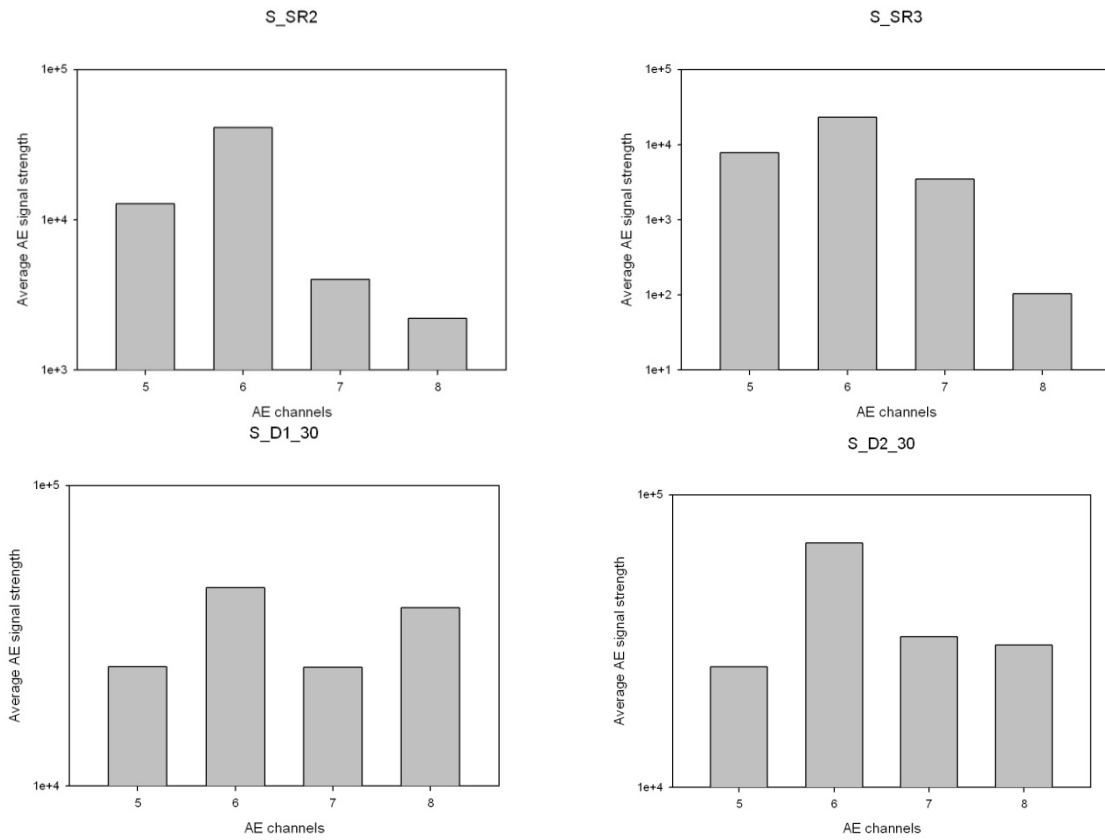
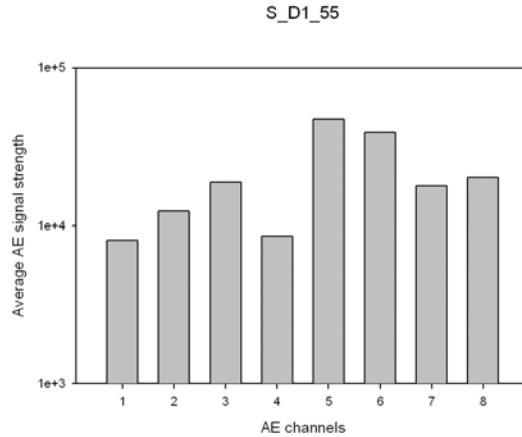
Figure 31
Average AE signal strengths observed by active channels for all live load test cases in south bound lane

To ensure genuity of the AE data collected, the AE signal strength parameter was also assessed and represented in Figure 31 for the same load cases previously mentioned. As is clear from Figure 31, the trends observed are similar to the AE counts distribution discussed in the previous section. The general trend is for signal strengths in all load cases to lie below 105 pVs. Additional AE plots with similar trends have been generated for the north-bound lane as well and can be found in Figures 48 and 49 of Appendix A.

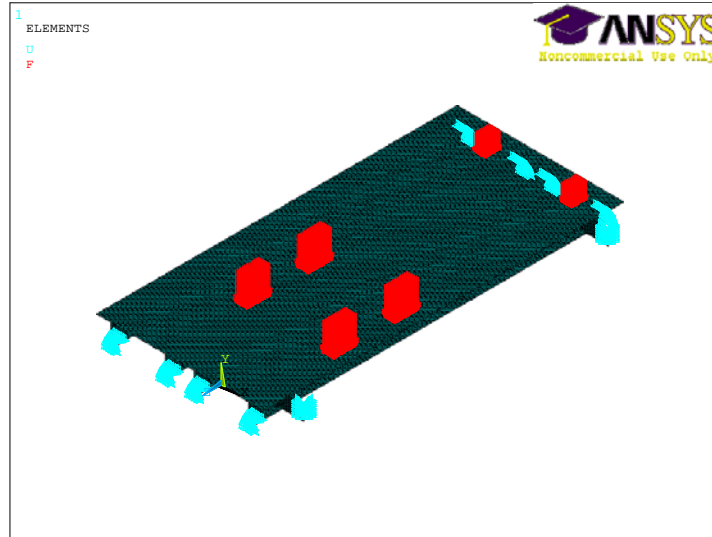
Figure 35
Isometric view of composite bridge

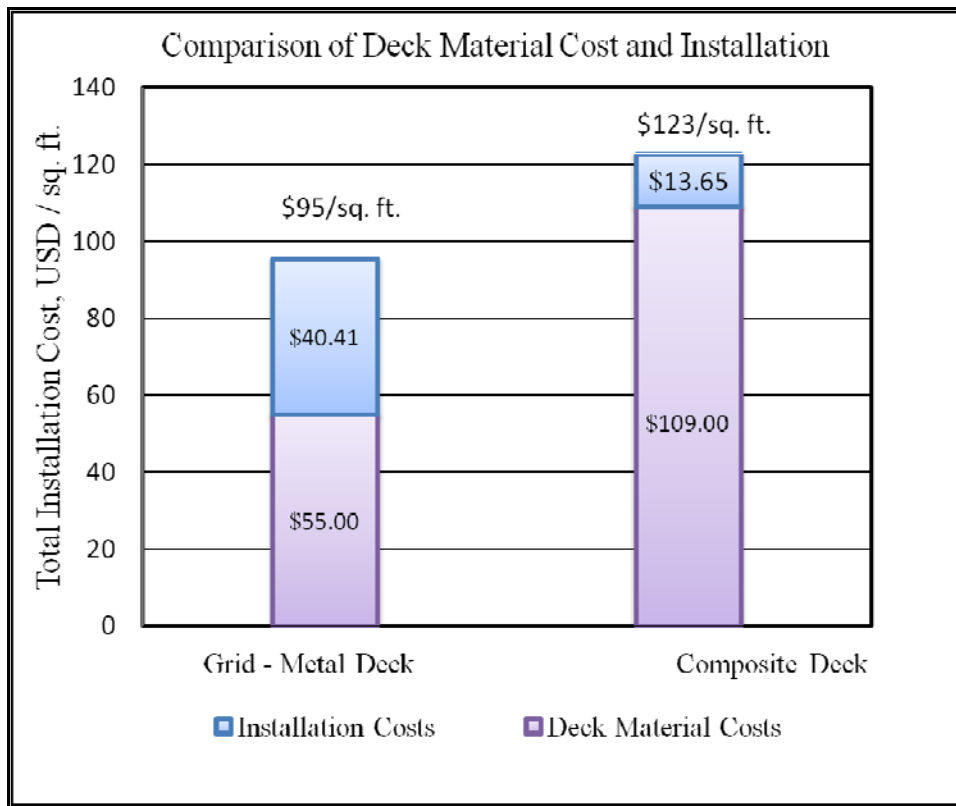
Figure 43
Comparison of deck material cost and installation

Deck Type	Cost of Materials	Cost of Installation	Total Cost
Grid-Metal	55.00	40.41	95.00
Composite	109.00	13.65	123.00

- Though the cost of purchasing the metal deck is half that of the composite deck, the composite deck lasts longer since it is corrosion resistant whereas the metal decks corrode, causing safety issues to the traveling public.

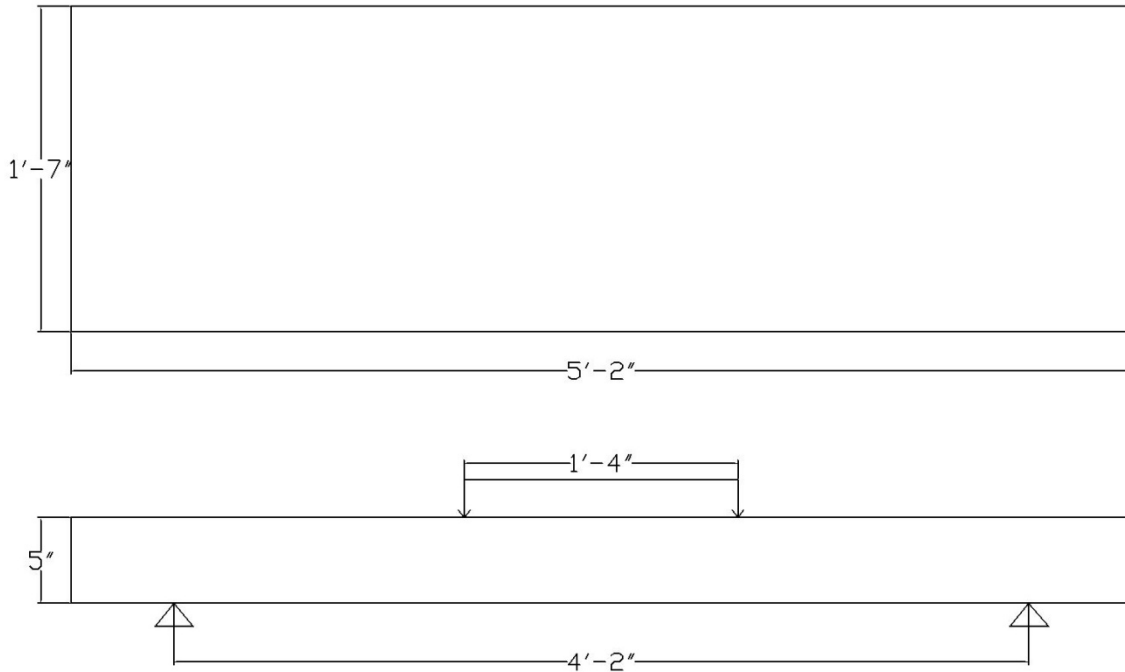
Figure 64
Test panel dimensions

On arrival at LSU, it was noted that the provided test specimen had a few dimensional irregularities at certain ends. These irregularities were a result of an improper setup during the initial trial resin vacuum-infusion process.

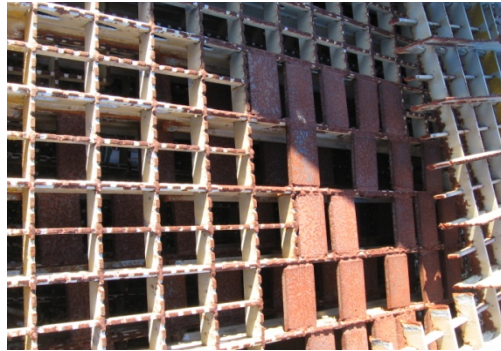
Figure 68
Repaired sections of the damaged grid deck

The bridge selected for this study is the Pierre Part Bridge on route LA 70 in District 61, Assumption Parish, Louisiana. The bridge was built in 1988 with a design load of HS20-44 and ADT about 6000. The bridge, with a total length of 145 ft. (44.2 m) and a roadway width of 46 ft. (14 m), consists of six 20-ft. (6.1-m) spans and a 25-ft. (7.6-m) span. The 20-ft. (6.1-m) spans are concrete structures and the 25-ft. (7.6-m) span consisted of a steel grid deck supported on steel girders. Figures 67 and 68 show the damaged grid deck that needs to be replaced in the 25-ft. (7.6-m) span. Under these conditions, the bridge's load rating was carried out using FEM, and the reduction in its load rating was assessed and replacement with an FRP deck was justified.

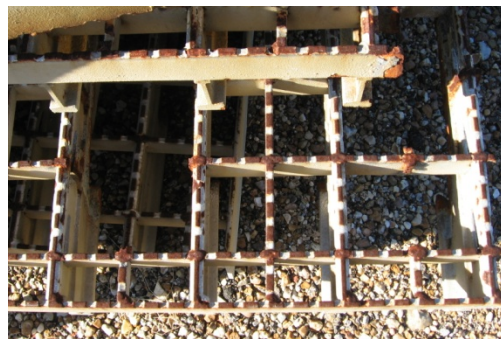
Figure 69
Lost sections in the steel bridge deck

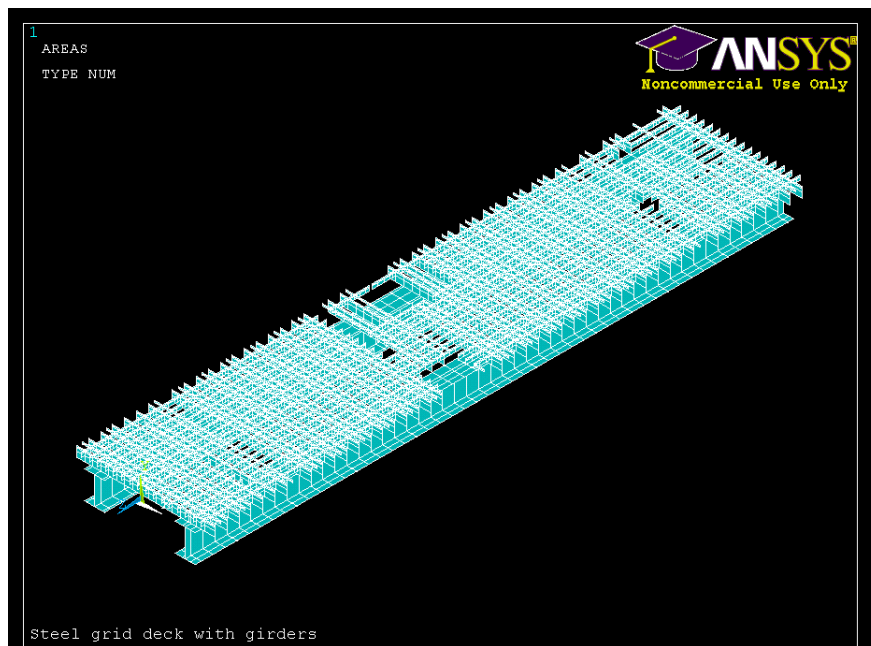
Figure 71
FEM model for damaged steel deck on steel girders (one panel)

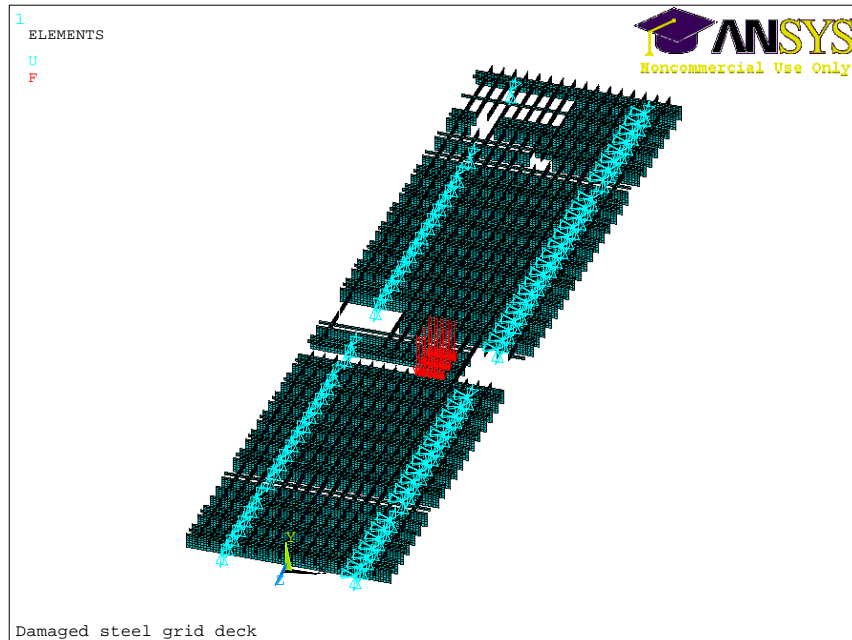
Figure 73
FEM model for damaged steel deck

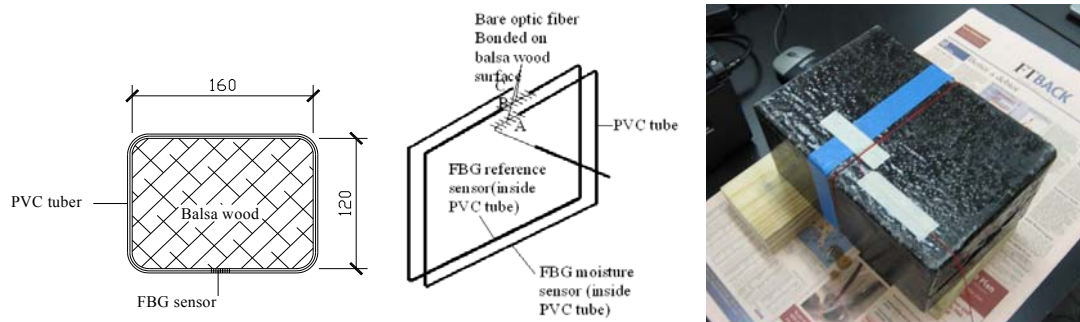
Figure 74

Specimen Description. The specimen used in this work was a small section of a FRP-wrapped balsa wood beam. The specimen cross section was 6.3 in. X 4.72 in. (160 mm X 120 mm). The sensor layout is depicted in Figure 74. The optic fiber embedded with two FBG sensors passed through two closely aligned PVC flexible tubes with each of the FBG sensors positioned in the middle of the tubes. The optic fiber terminated in the second tube. The length of the PVC tube matched the perimeter of the balsa wood cross section and the distance between the two tubes was about 1.18 in. (30 mm). Before installation, the optic fiber ends were temporarily fixed to the PVC tubes to prevent slipping. The optic fiber was then helically wrapped and bonded around the balsa wood with a winding pitch being the tube outer diameter. When winding the optic fiber, a certain force was applied to ensure firm contact between the PVC tube and balsa wood, leaving a tensile force in the fiber. Two parts of the optic fiber (A and B as shown in Figure 74) were bonded on the balsa surface, forming two fiber loops. In such a configuration, the FBG sensor in the first loop will be used to measure the specimen hoop expansion, while the other FBG sensor in the back loop, staying loosely in the PVC tube thus immune to external force influence, will be used to measure the temperature. For convenience, the first FBG sensor is referred as FRP moisture sensor, and the second one is referred as FBG reference sensor. The ends of the PVC tube were sealed with silicon gel to avoid water ingress.

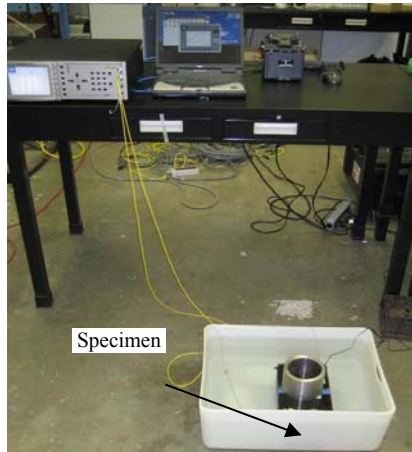
The specimen was fully soaked in water as shown in Figure 75. A steel object was placed above the specimen to hold the specimen in the water bath. Moisture can only penetrate the wood through the exposed wooden cross section.

Figure 75
Test configuration

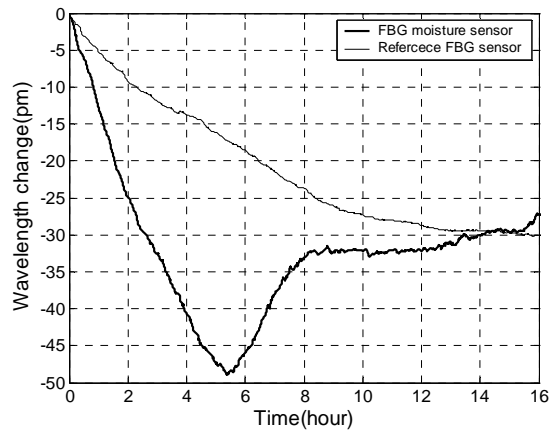
In Figure 76, the wavelength shift of the FBG moisture sensor and its reference sensor is plotted. During the first five hours, the wavelength of the FBG moisture sensor kept dropping by 50 pm. The trend changed in the subsequent three hours indicating a 17 pm rise and then maintaining a constant level. The wavelength shift of the FBG moisture sensor was caused due to both moisture expansion and temperature change. Since the temperature kept decreasing in the whole process as shown by the reference sensor, the rising fraction in the curve can only be attributed to moisture expansion.

Figure 76
Wavelength shift of FBG moisture sensor and the reference FBG sensor

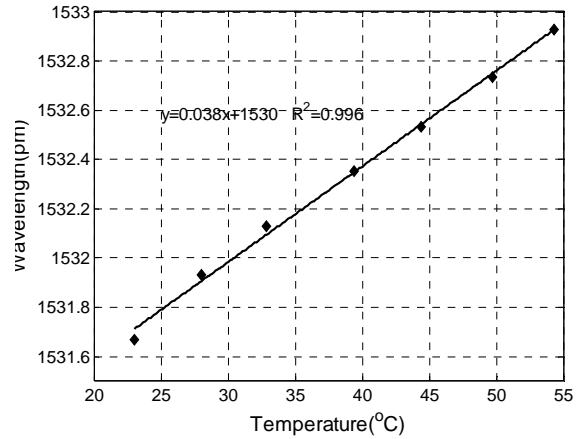
Figure 78
Calibration of round thermal expansion factor of specimen

To identify the moisture expansion part of the curve, thermal expansion influence should be eliminated. The thermal expansion coefficient of the specimen was calibrated in an adjustable temperature chamber as shown in Figure 77. The calibrated factor in terms of wavelength shift was deduced to be 38.8pm/°C as shown in Figure 78.

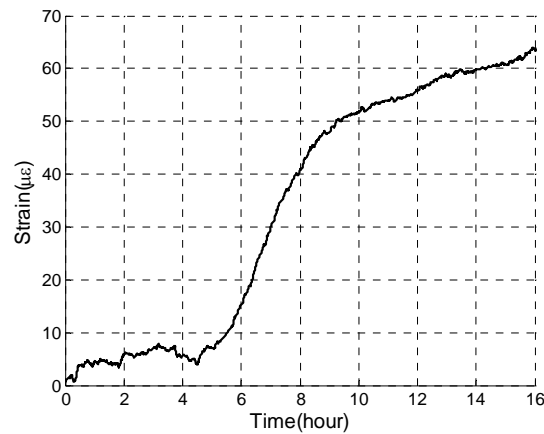
Subtracting the thermal expansion from the curve, the hoop moisture expansion is plotted as shown in Figure 79. From this plot, it can be observed that, in the first five hours, the moisture expansion changed, only slightly, in the range less than 7με. In the next five hours, the moisture expansion climbed at a faster rate, by an increment of 50με, which implies that in five hours time the moisture had reached the monitored cross section where the FBG moisture sensor was located. The decreasing trend observed after 10 hours indicated that the moisture in the considered cross section had reached the saturation state.

Figure 79
Hoop moisture expansion of the specimen

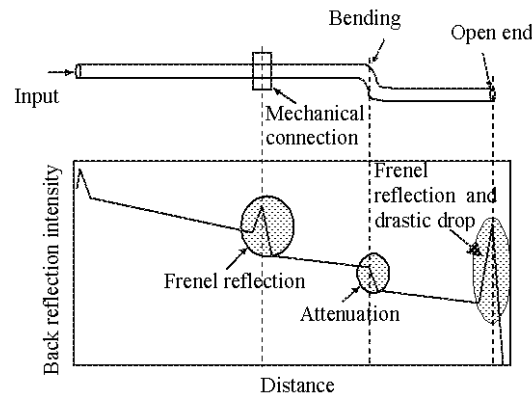
Figure 80
Typical reflection chart of OTDR

A measurement of optical backscatter as a function of linear position, OTDR (optic time domain reflectometer), is a well established method for examining fiber-optic cables. For example, areas of high loss (excessive bends) or points of fiber fracture and fiber ends are shown in Figure 80. The technology is well developed and a wide range of instruments able to resolve changes in the backscatter signal of less than 0.001dB in magnitude with a spatial resolution of centimeter magnitude is commercially available.

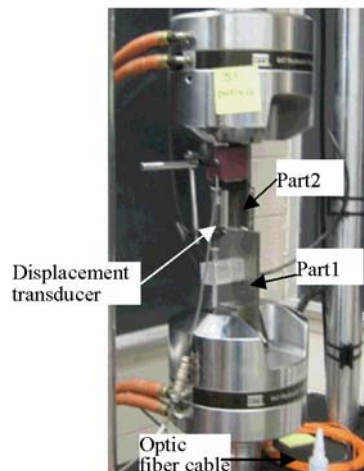
Two identical tests, namely test 1 and test 2, were conducted to validate the proposed method. The test configuration is shown in Figure 85. The two parts of the steel specimen were bonded together with the sensing optic fiber instrumented as described in Figure 83. The specimen was loaded monotonically by the MTS machine from its two ends. A displacement transducer with a resolution of 1.64 in. (0.5 m) was used to measure the slip between the two parts. During the loading process, the optic fiber was interrogated through OTDR. Before the interface failure, no signal change on the optic fiber was observed. Once the interface fails, the optic power loss was identified by OTDR.

Figure 85
Test configuration

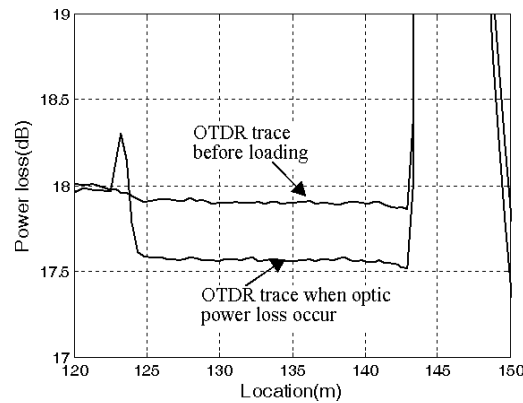
Figure 86 compares the two OTDR traces in the states before the loading and after interface failure for test 1. When the interface failed, a significant power loss was observed. The interface failed at 0.0137 in. (0.348 mm), inducing the optic power loss of 0.416 dB in the sensing optic fiber. Figure 87 shows the typical OTDR traces during the loading process, indicating the continuously increased power loss against the increasing slip. Figures 88 and 89 show the cases for test 2. The interface failed at 0.0066 in. (0.17 mm), causing an optic power loss of 0.24 dB. After the interface debonding, the inner part of the optic fiber, including the fiber core and the cladding in the polymer coating, remained undamaged. With the increase of the interface slip, the optic power loss in the optic fiber kept increasing. The relationship between the slip and the optic power loss and slip is shown in Figure 90. The two curves show a similar trend. Thus the event of the debonding can be detected by the proposed method and the extent of slip can also be evaluated.

Figure 86
Comparison of OTDR traces between the state before loading and the state after interface failed for test 1

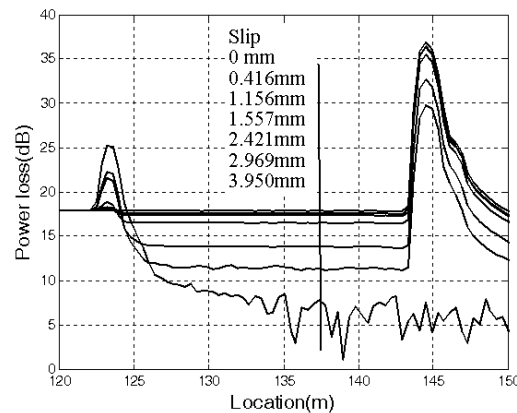
Figure 87
Typical OTDR reflection traces of test 1

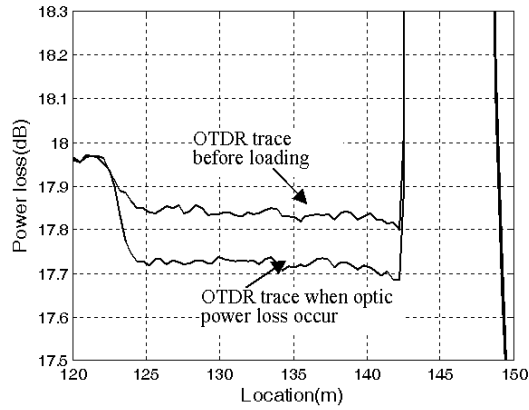
Figure 88

Comparison of OTDR traces between the state before loading and the state after interface failed for test 2

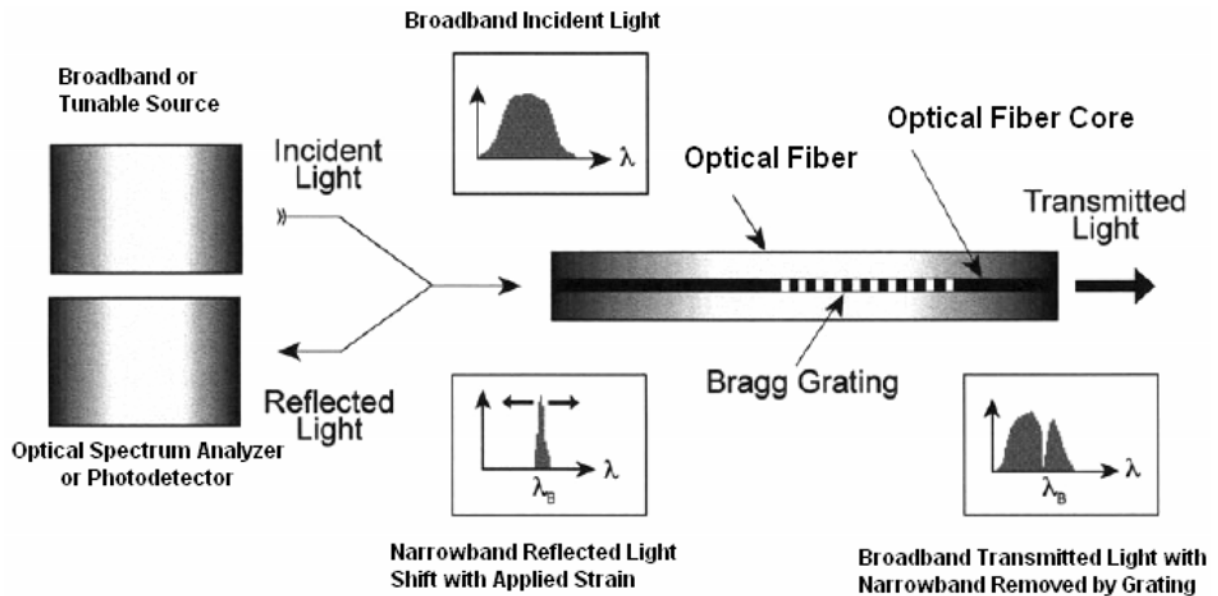
Figure 92
Principle of FBG

FBG (Fiber Bragg Gratings) forms the integral sensing unit of this FOS. The FBG are intrinsic spectrometric sensors with local and multiplexing sensing abilities. An FBG is generated by engraving a periodic modulation of the refractive index of about 0.393 in. (1 cm) in the core of an optical fiber. The basic principle involved in the functioning of a FBG sensor is shown in Figure 92. Usually, the FBG sensor measures strain but can be modulated to measure displacement, acceleration, etc. The achievable resolution for these sensors is 1 μ strain and they can have a working range of over 5000 μ strains [15].

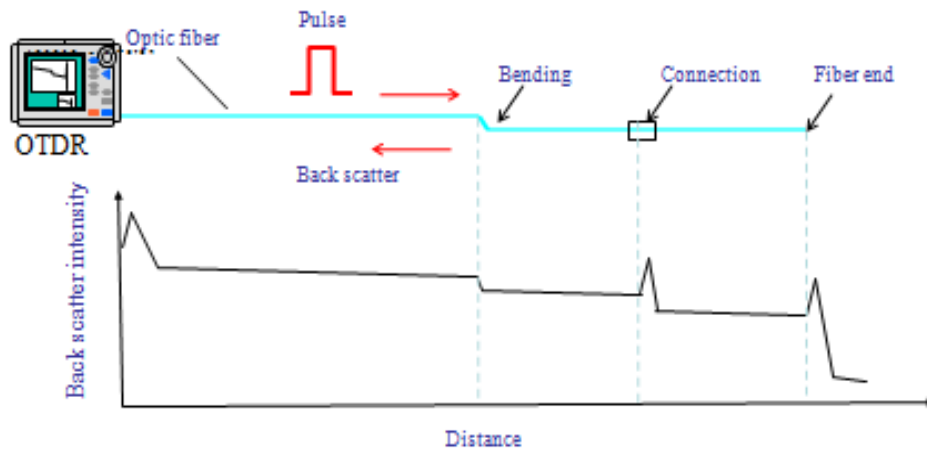
The principle by which these sensors function is illustrated in Figure 94. These sensors are efficient for use in large structures like bridges as all portions of the fiber acts as a sensor, thus enabling monitoring changes along its length. Cracks or local strain changes can lead to a light intensity variation within the fiber that reflects as a power loss [15].

Figure 94
Principle of OTDR based optical fiber

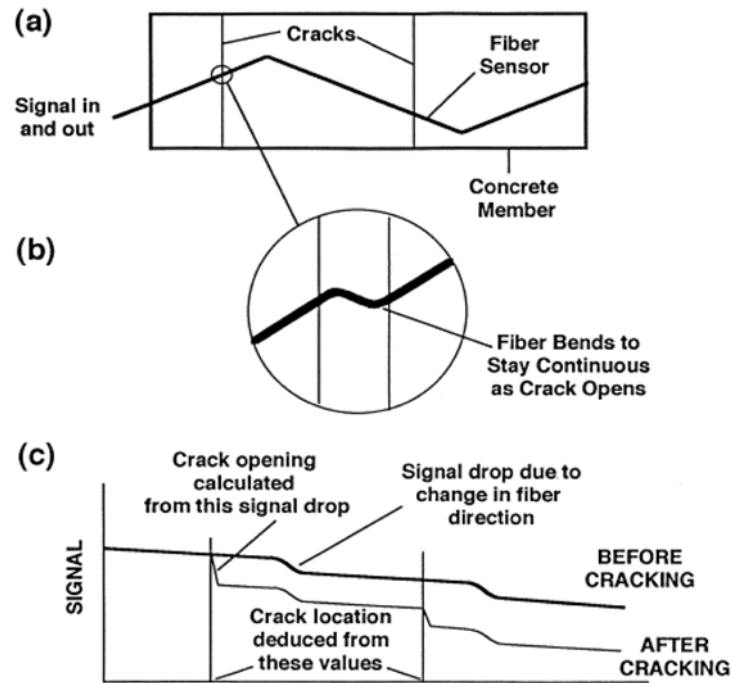
Figure 95
OTDR based optic fiber crack sensor [16]

The pulsed laser input signal sent from the OTDR equipment is reflected at each of the perturbations along the length of sensor as a power loss. This power loss is considered to be the outcome of mainly two effects in the optic fiber: bending/curvature or breaking. This intensity change can directly relate to the damage state when appropriately calibrated.

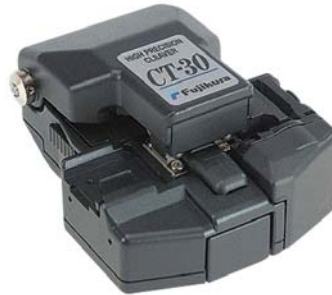
Figure 96
The Fiber Cleaver unit - Fujikura CT-30

The CT-30 (Figure 96) provides a clean, straight fiber cut on both ends, making it suitable for splicing later. The 16-position blade yields 48,000 single-fiber cleaves and the built-in scrap collector stores fiber shards until they can be safely discarded.

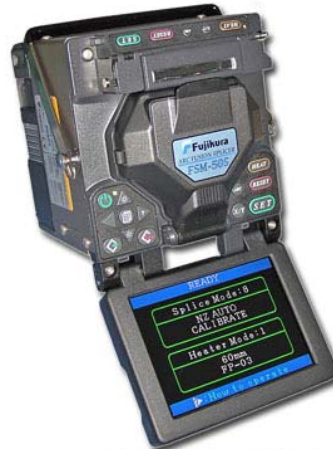
Figure 97
Fiber splicing unit - Fujikura FSM-50S

The FSM-50S Fusion Splicer uses a high temperature welding process to provide a better optical connection. The unit, shown in Figure 97, has both a splicing section and shrinking tube/protective sleeve heating section, which provides further protection to the newly spliced components. The unit also includes user friendly features such as calibration-free arc adjustments (with auto splice mode), automatic fiber type identification, and reduced operational steps. The device is operated by an easy-to-use touch screen menu.

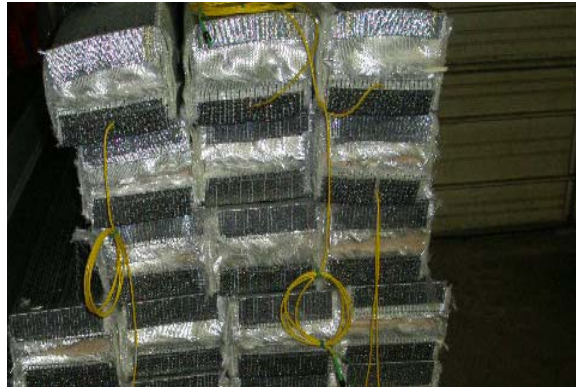
Figure 106
Hardwire wrapped individual beams

The next step involved the laying of 3SX-21-12 hardwire cut to length of 75 in. (1.905 m) along both top and bottom surfaces of the balsa wood beam core. Once each beam was individually wrapped with hardwire (Figure 106), they were assembled onto a platform that held all 50 beams that constituted the actual bridge deck. The bottom of the platform was lined with sufficient E-glass fabric and CFM. The beams were then placed on this arrangement and held tightly together using a jack (Figure 107). Transverse and longitudinal pieces of hardwire were laid along the entire deck as shown in Figure 108.

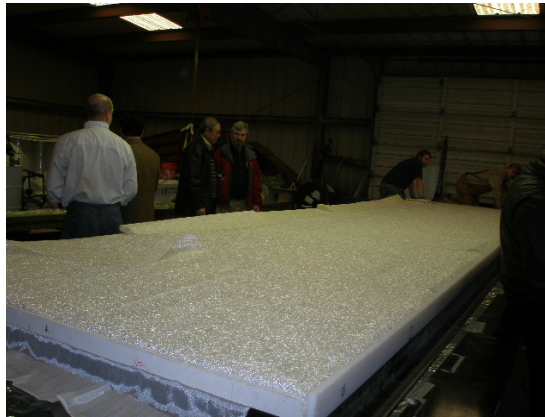
Figure 110

The final layup consisted of the CFM on the top surface of the deck (Figure 110). Since the entire panel was intended to be vacuum infused in a single step, the vacuum bag was customized accordingly. Thus, polythene sheets and peel ply fabric were inserted both at the top and bottom surface of the panel across the entire panel length.

Final layer of CFM placed over deck panel

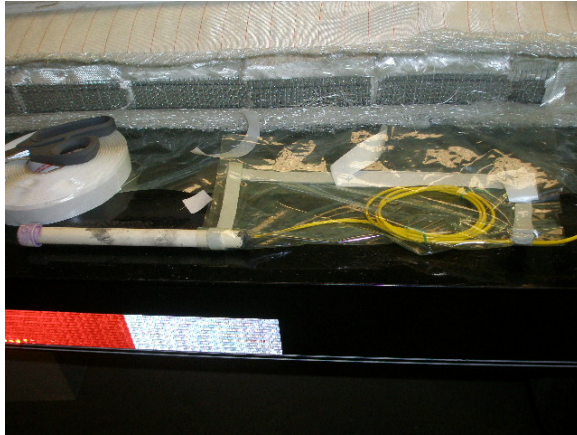
Figure 111
Optic fiber cables in customized packaging

To secure the optic fiber cables during the vacuum infusion process, customized packaging was adopted. Each pair of connector ends were inserted in PVC pipes open at one end and sealed with epoxy that allows for easy removal after infusion. The rest of the cable lengths were placed into polythene bags as shown in Figure 111 secured with butyl rubber sealant tape. The final step was to set the polythene bags with optic fiber cables to the sides of the panel along with the removable peel ply fabric (Figure 112). All sides of the panel were finally secured with 4 in. (0.1016 m) wide plastic plates after appropriate vacuum and resin inputs were placed.

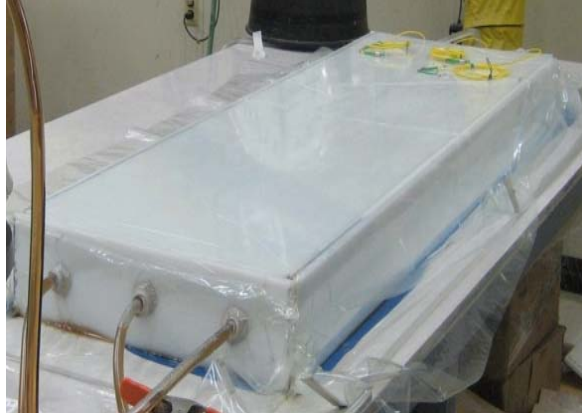
Figure 113
Vacuum infusion process

The entire assembly was vacuum-infused with vinyl ester resin and allowed to cure for a day in a similar setup as seen in Figure 113. A non-skid surface was applied after the deck was cured (Figure 114).

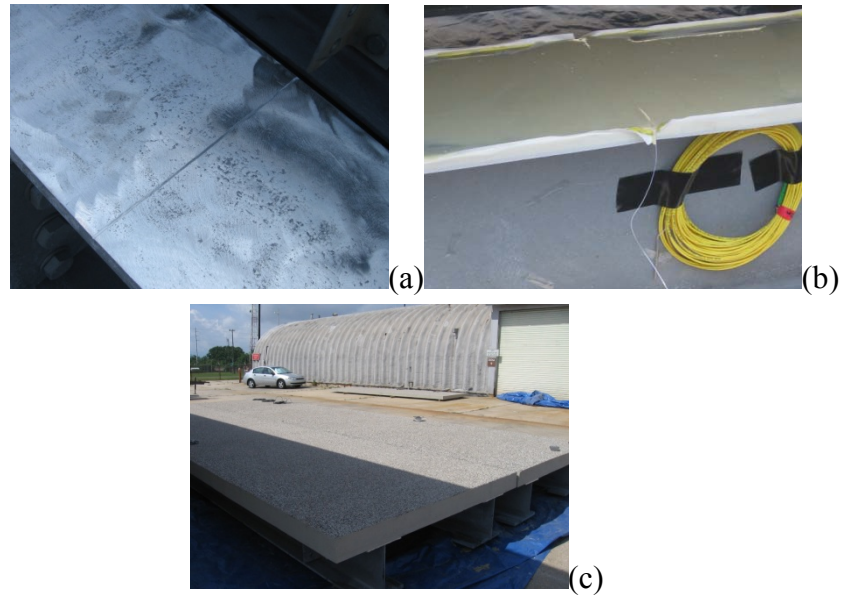
Figure 115

The proposed monitoring system was applied on the FRP-wrapped balsa wood bridge deck as shown in Figure 115. Before the instrumentation, a 0.0393 in. (1 mm) deep v-shape notch was cut on the surface of the steel bridge girder. The sensing optic fiber was then embedded into the v-shape notch, and the epoxy was evenly poured upon the surface of the bridge girder for bonding the bridge deck. Figure 116 shows one of the typical OTDR trace after the instrumentation of the monitoring system. The first reflection peak is induced from the mechanical connector and second one is from the optic fiber end. The sensing fiber position is at the position of 393.7 ft. (120 m) away from OTDR device. From this plot, no significant optic power loss is found at the sensing fiber position, indicating the integrity of the interface.

Instrumentation process of the monitoring system, (a) cut a v-notch in the bridge girder, (b) embedded the sensor (c) bond the deck on the girder

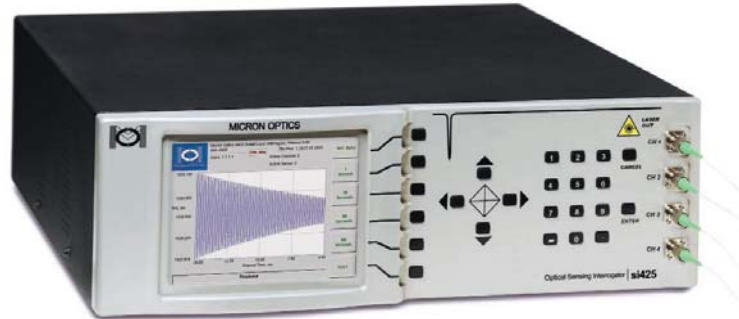
Figure 118
Front and rear panel view of si425

The front control panel of the si425 mainly consists of an LCD display screen that allows real time data viewing, menu keys for navigation through options menus, arrow keys for

incrementing integer data inputs, number keys for numeric data entry, and FC/APC connectors for connecting the optical sensors as seen in Figure 118(a). The alternating action power switch of the system is located at the rear of the unit, as shown in Figure 118(b).

(a) Front panel view
