1. Report No. FHWA/LA.10/472		2. Government Accession No.	3. Recipient's Catalog No.
4. Title and Subtitle Development and Performance Evaluation of Fiber Reinforced Polymer Bridge		5. Report Date March 2014

11. Contract or Grant No. LTRC Project Number: 05-5ST State Project Number: 736-99-1370	
12. Sponsoring Agency Name and Address Louisiana Department of Transportation and Development P.O. Box 94245 Baton Rouge, LA 70804-9245		13. Type of Report and Period Covered Final Report Nov. 2005-Nov. 2010

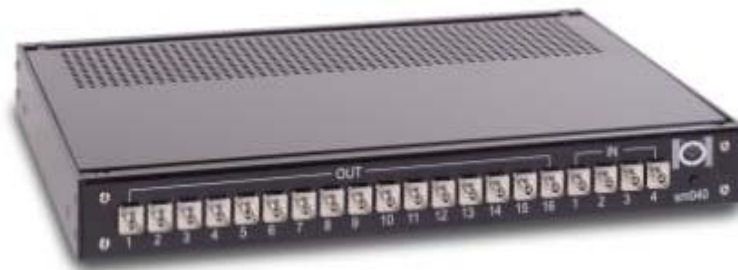
Figure 119
sm040-016 (16-ch. coupler extension)

This 1U chassis contains four 1 x 4 couplers to accommodate connections of up to four fibers to each si425-500 optical channel. All fibers are scanned simultaneously. It is solely intended to provide more fiber connection options. When structural strain monitoring requires several fiber optic sensors and more than just four optical fibers, the expansion module sm040-016 facilitates this (Figure 119).

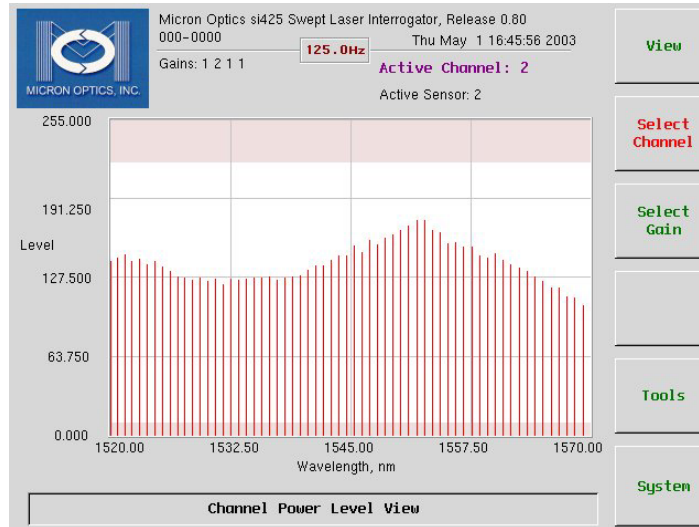
Figure 122
Channel power view screenshot

3. Channel Power View: gain level for each channel can be set here ensuring that the sensors are in the proper power band for optimal measurements, as shown in Figure 122.

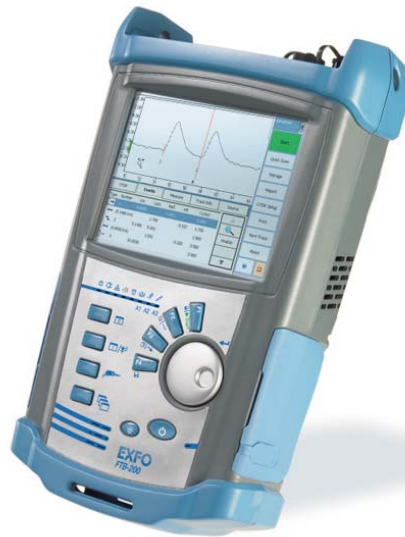
Figure 134
FTB-200 front panel view

The front panel of FTB 200 (Figure 134) consists of an LCD touch screen, keypads that give access to various functions such as switching on the unit, saving files, etc. Pressing on the on/off button turns the system on. Holding down the on/off button for a few seconds until the unit beeps twice shuts down the unit.

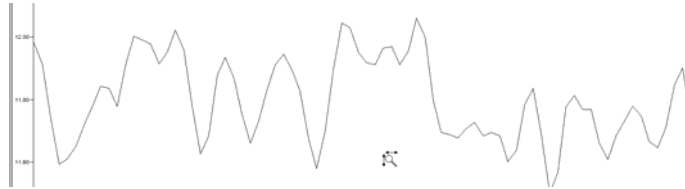
Figure 138
A typical trace obtained from EXFO FTB 200

The traces in the system are usually in .trc or .sor format (Figure 138). This can be saved into other formats by using EXFO toolbox software installed in any standard computer. To copy, move, rename, or delete trace files, the user have to process the files manually via File Manager available from EXFO ToolBox.

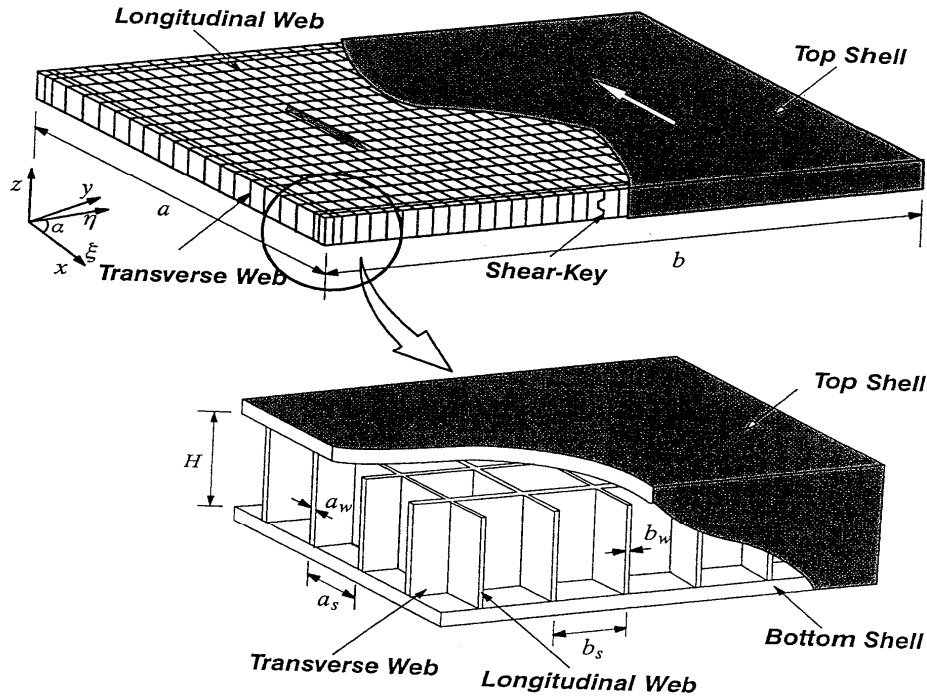
Figure 144
Web core sandwich bridge deck system

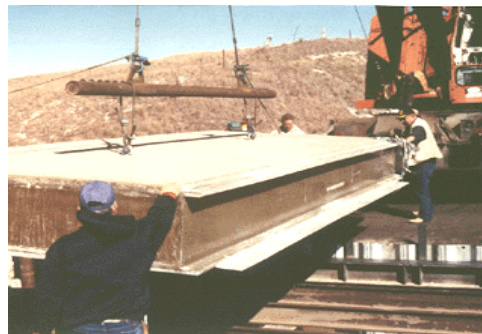
Figure 146
Installation of No-Name Creek Bridge, Russell, Kansas

On November 8, 1996, the nation’s first all-composite FRP bridge on a public road was installed over No-Name Creek, just three miles west of Russell, Kansas, and this was done by Kansas Structural Composites, Inc. (KSCI) of Russell, Kansas [26]. It is a short-span, self-supporting bridge of 23 ft. (7 m) in length and 27 ft. (8.22 m) in width and demonstrates the viability of the structural panel concept. It was built with the capability of supporting an AASHTO HS-25 load in both lanes. The bridge was constructed of three adjoining longitudinal sandwich panels with a depth of 22.5 in. (0.57 m). The sandwich structure composed of a 20.5 in. (0.52 m) thick core with a 0.75 in. (0.019 m) lower face and a 0.5 in. (0.0127 m) upper face. The core has a sinusoidal wave configuration in the plane extending vertically between the faces as seen in Figure 142. Demonstrating the simplicity of the project, the whole installation process required just one and a half days. Part of the construction is shown in Figure 146.

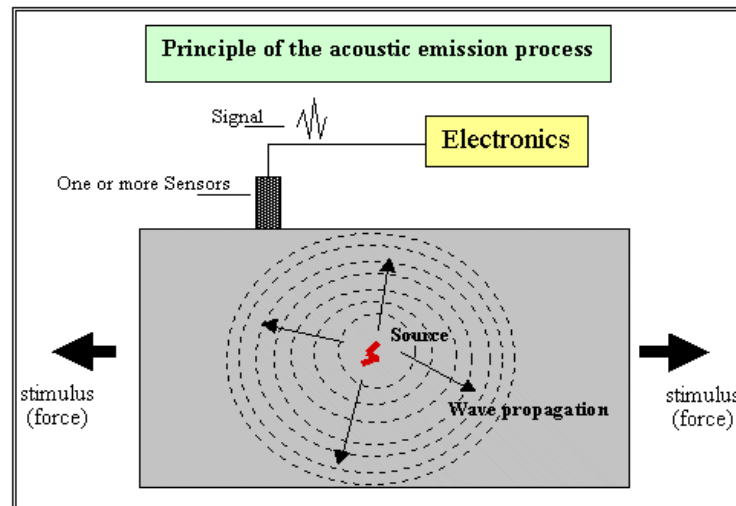
Figure 147
Principle of acoustic emission [38]

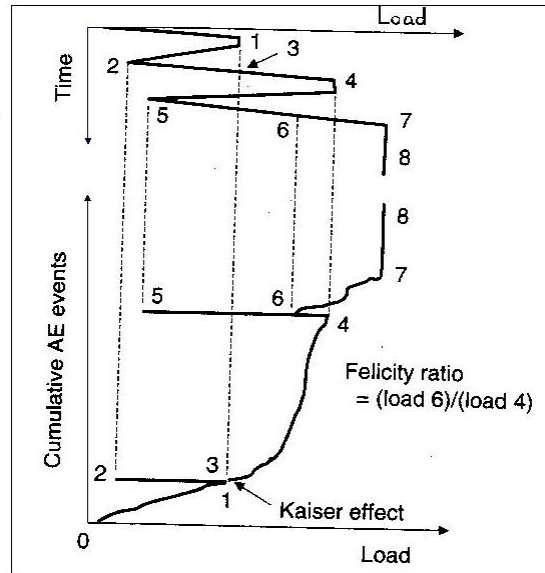
Figure 148
Kaiser and felicity effects [39]

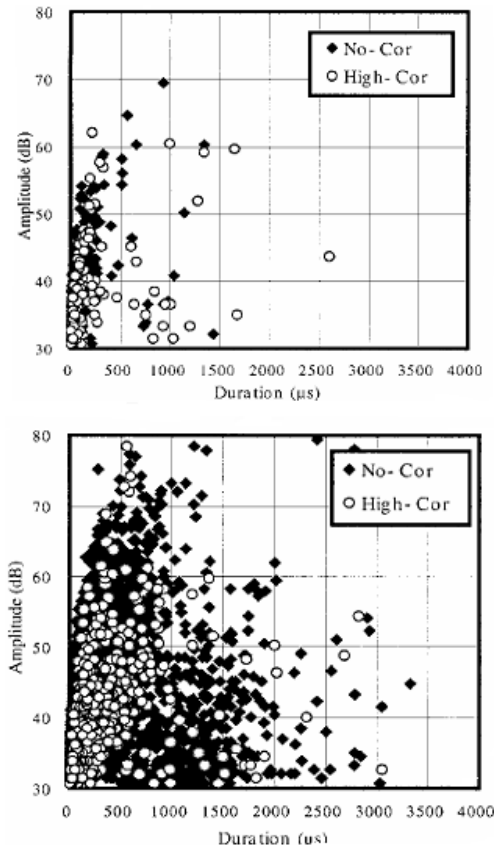
Figure 149
Amplitude-duration plot of AE signals for initial and ultimate stages
of damage in an RC specimen [53]

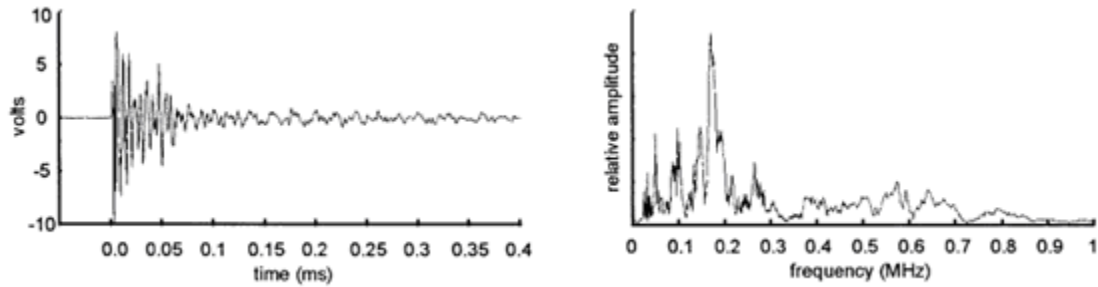
Figure 151
Waveform and frequency spectra from a typical crack in a steel
bridge hanger

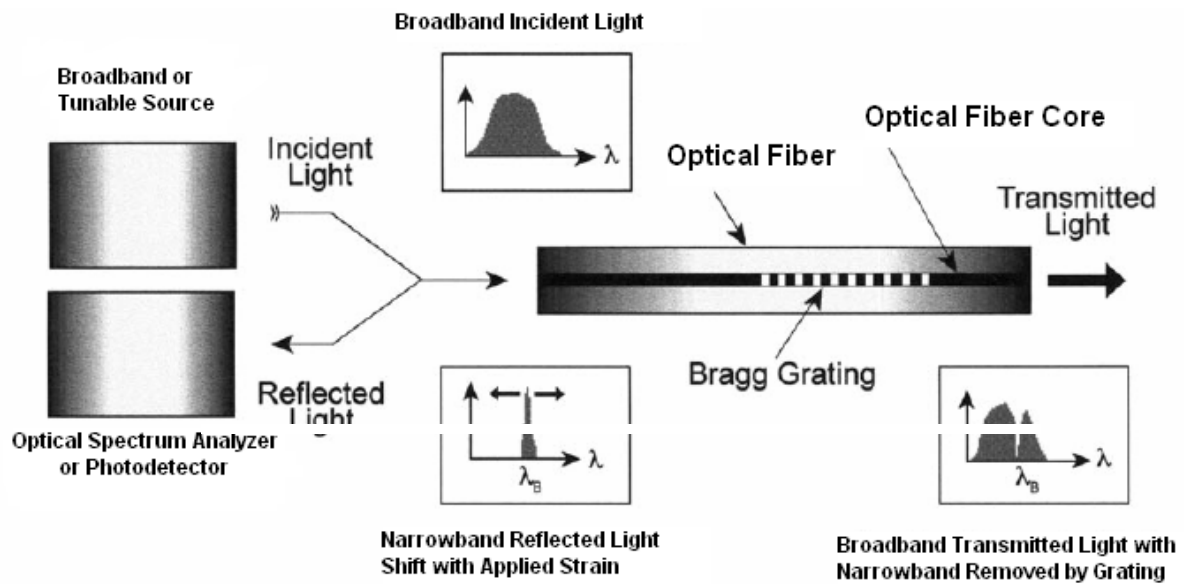
Figure 155
Fiber Bragg grating concept

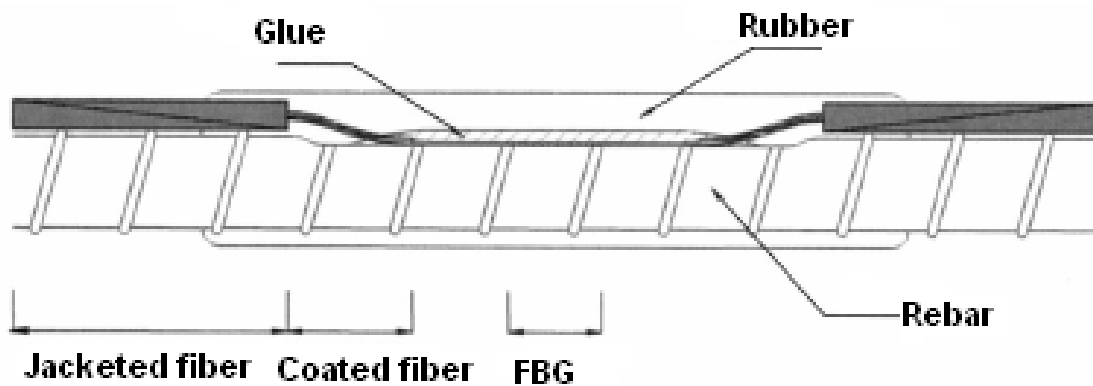
Figure 157
Scheme of the fiber Bragg grating strain sensor [14]
