Technical Assistance Report 14-01 TA-P

Joor Road Noise Level Assessment

S.P Project 817-08-0023

LA 946 (Joor Road)

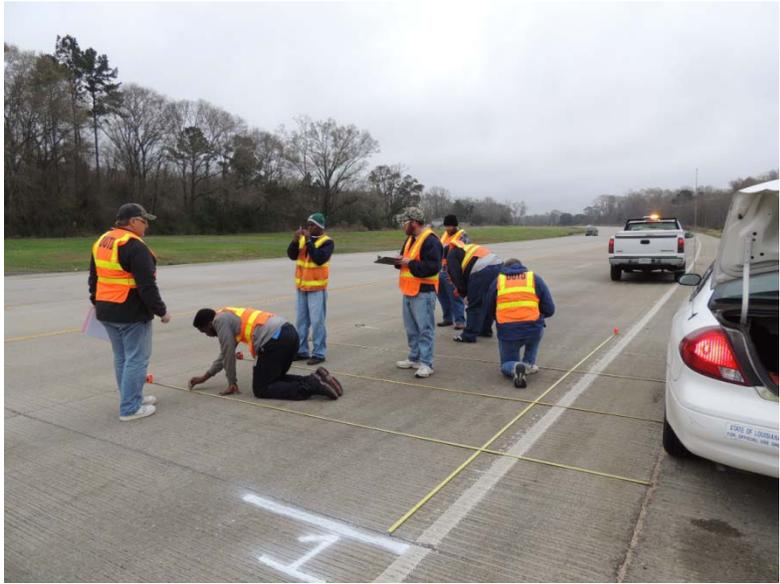
Figure 4
PCC tine measurements

Spacing between tines and tine widths were determined by examining photographs taken of the slabs as presented in Figures 4, 6, and 7. A tape with metric units was placed on the pavement slab (approximately 20 ft. in length) from joint to joint and photographed with a 16.1 megapixel camera as presented in Figure 6. The spacing between each tine was recorded into an excel sheet and used in the statistical analyses, which in this case included a statistical test for randomness [19, 20, 21]. Tine widths were tabulated by recording the width of the first tine from the joint and measuring the tine nearest each foot mark on the tape as it progressed along the slab, which generally produced about 20 tine width measurements per slab. Both the spacing between tines and test for randomness were conducted to determine if DOTD section 601 specifications were met. Since DOTD does not specify a specific tine spacing sequence such as "32/19/22/25/35/22/22/22/22/25/35/13/38 mm," an assessment for that could not be conducted. The researchers did attempt to identify if any pattern of tining intervals was present.

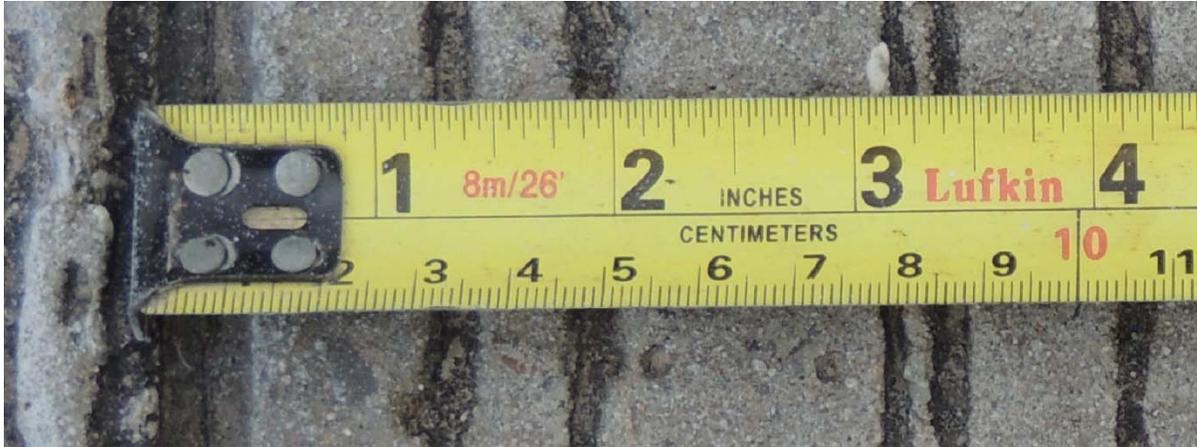
Figure 6

Photo of tape measurement used for tine width and spacing measurements

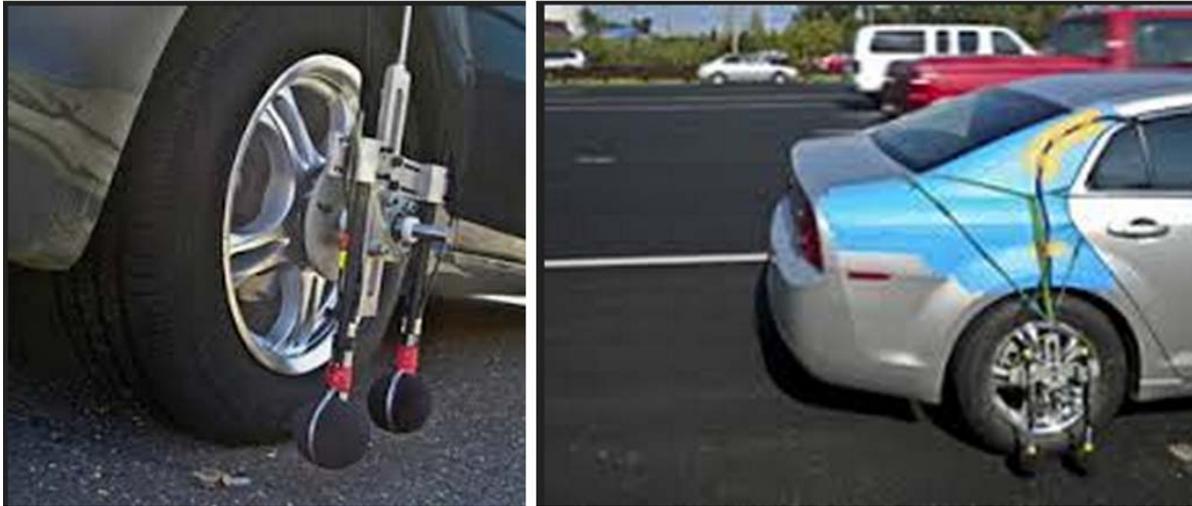
Figure 8
OBSI system

OBSI noise measuring devices provide a consistent way to determine the noise emission from the tire-pavement contact. OBSI measurements were conducted in accordance with AASHTO TP 76-09 as presented in Figure 8 [25]. OBSI measurements were taken in both directions and in the inside and outside travel lanes within the noisy areas. Measurements were also taken in the outside lanes of the quieter areas for comparison purposes.
