TECHSUMMARY *April 2016*

SIO No. 3000724 / LTRC Project No. 12-3ST

Repair of Morganza Spillway Bridge Bent Pile Cap Using Carbon Fiber Reinforcement (CFR)

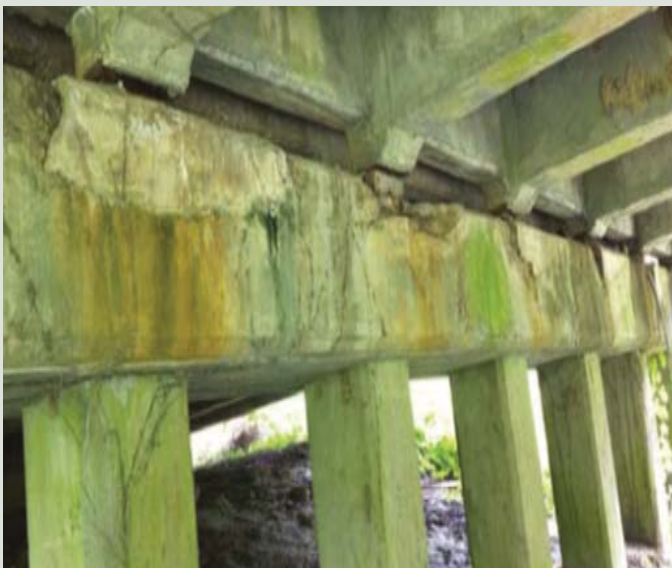
The pile cap of an end bent of the Morganza Spillway Bridge suffered extensive damage at the girder bearing locations, particularly on the side where the pounding of the girders by the adjacent concrete deck located on the approach side of the bent. The primary repair of the damaged pile cap and the replacement of the bearing plates were completed by the contractor working on the project. Structural grade high-adhesive material epoxy concrete was utilized to patch the damaged areas of the pile cap. In similar repairs conducted in the past, the patched area under the bearing plates delaminated. In order to prevent this delamination of the repair material, the repaired areas, i.e., the bearing plate locations, were strengthened by confining them with high modulus carbon composite wrapping. An inorganic polymer coating that provides UV protection and prevention of deterioration was applied to the entire pile cap surface. This coating also has self-cleaning properties that will prevent and eliminate the growth of any mold or mildew and deposits of organic materials. The project was conducted to demonstrate the application of high strength composites for rehabilitation of transportation infrastructure. Two years of monitoring of the repaired areas has shown no evidence of distress of any kind in either the repair zone or the coating. The inorganic repair system is expected to perform satisfactorily for 10 to 30 years.

Pier-cap pre-repair: delamination under the bearing plate

The primary objective of this micro-repair project was to prevent the delamination of the repair done under the bearing plate using polymer-modified mortar. A confinement scheme was designed using high modulus carbon tows and inorganic polymer to create a concrete-compatible composite. The retrofit operation was carried out to demonstrate the use of high strength composites for intricate repair of transportation infrastructures under the sponsorship of the Louisiana Transportation Research Center (LTRC).

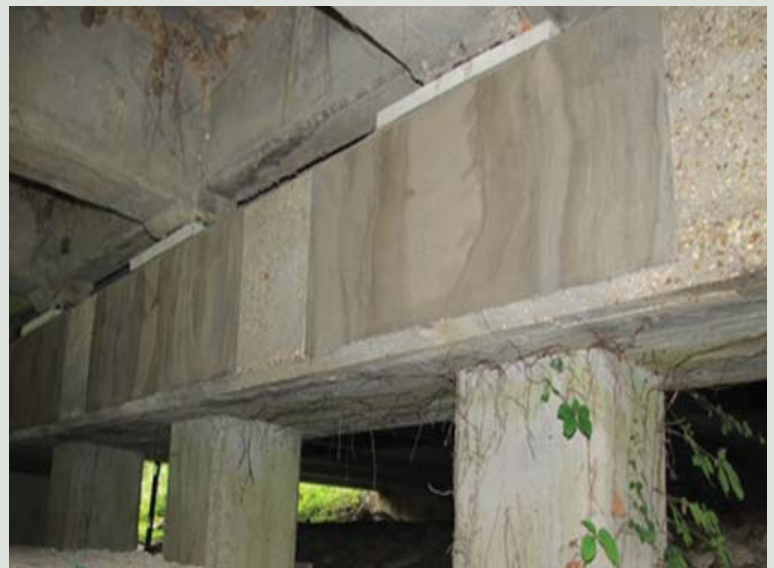
The inorganic resin was chosen because of its unique properties: complete compatibility with concrete and chemical bonding, long-term durability, high-abrasion resistance, and self-cleaning properties. Carbon tows with a high modulus of 60 million psi were chosen to satisfy the special requirement of high stiffness to prevent possible cracking. The performance of the repair was monitored for 2 years and the inspections focused on distresses of carbon fibers, adhesion of the carbon fibers to the concrete, cracking or peeling of the coating, color fading of the coating, effects of debris falling from the construction joint, and the effectiveness of the self-cleaning properties. The inspections revealed that the repair is performing very well.

View of the bent after the repair
