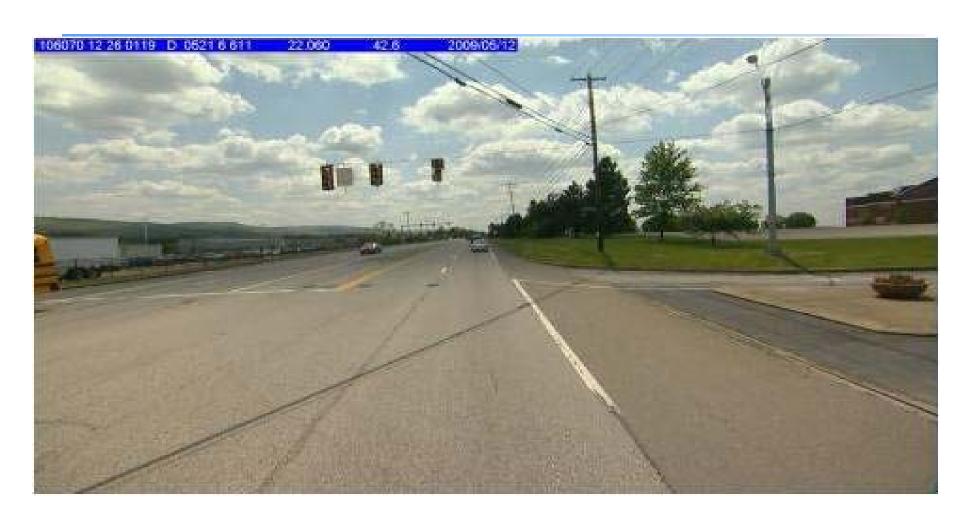
US 119 Near Uniontown, PA (turn lanes and mountable curb)

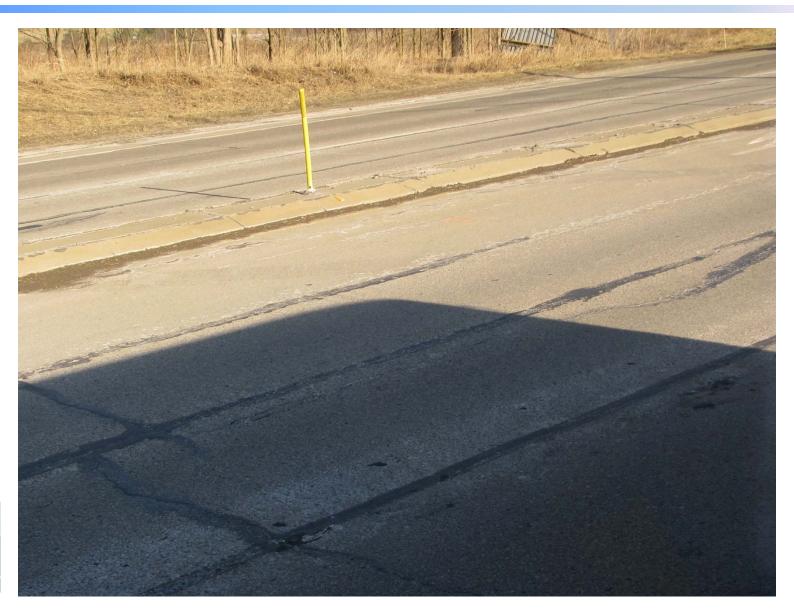
Concrete and composite pavement at south end!

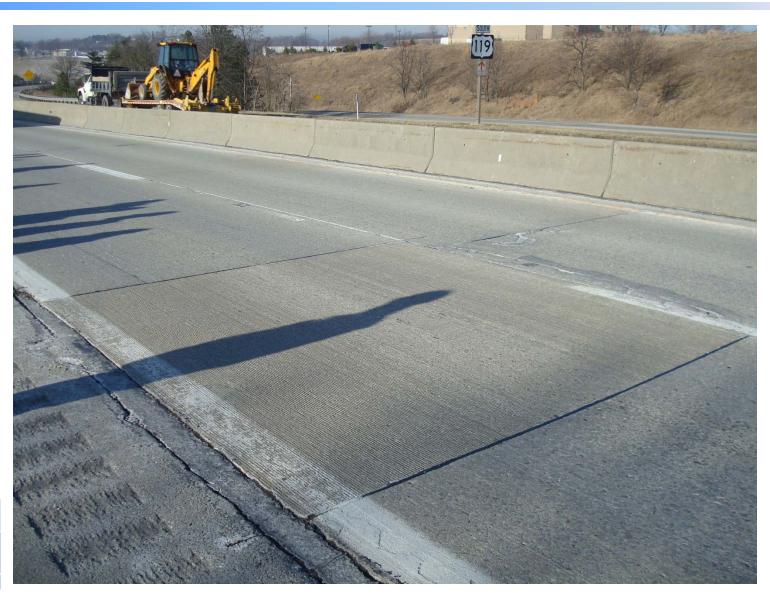
US 119 Raveled Shoulder Joint

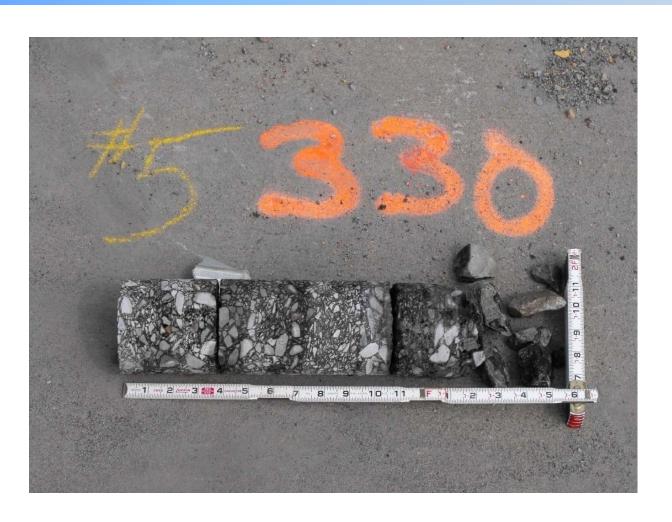
Average Depth of Asphalt = 13 - 16"
