Technical Assistance Report 19-03TA-P

Structural Assessment of Inundated Roads in Livingston Parish, Louisiana with the Falling Weight Deflectometer

Kevin Gaspard, P.E.
Zhongjie Zhang, Ph.D., P.E.
Mark Martinez, P.E.

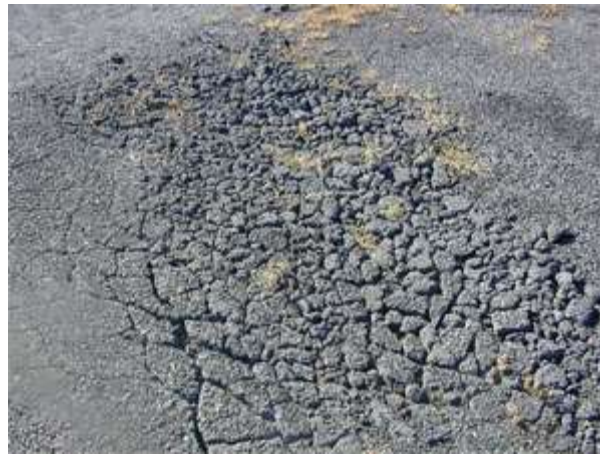
Figure 4 [44-48]. As a result of continual bending, alligator cracking patterns have been known to occur in the asphaltic (AC) surface as presented in Figure 5. The volume change also occurs longitudinally along the travel lane(s) which can lead to bumps and depressions in the pavement. This in turn contributes to decreased ride quality due to the changes in the roadway profile.

Figure 5
Alligator cracking in AC surface
