Hale Boggs Memorial Bridge (I-310 Luling-Destrehan) Stay-Cable Replacement Outside New Orleans, Louisiana

By Michael W. Smart

**INTERNATIONAL
BRIDGE
TECHNOLOGIES, INC.**

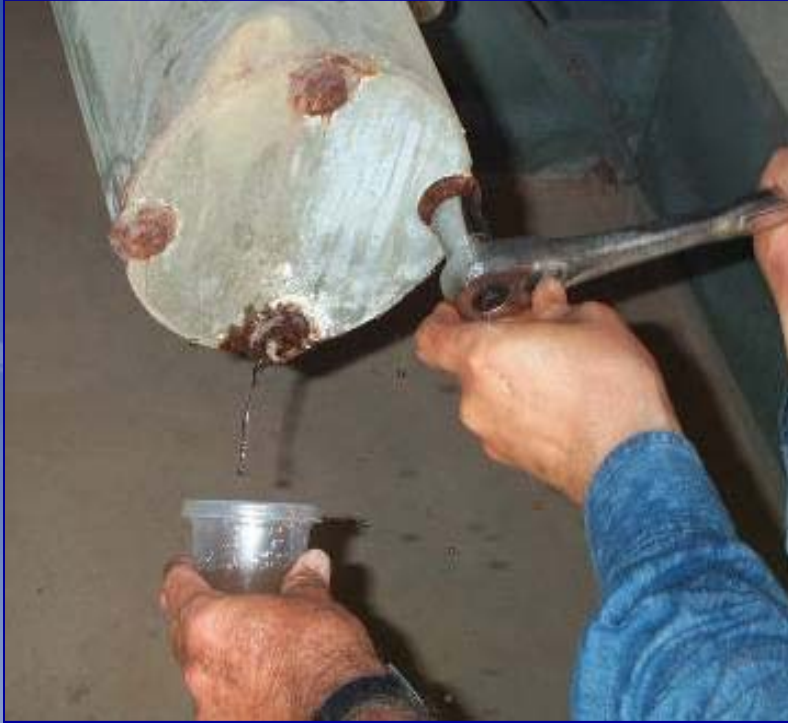
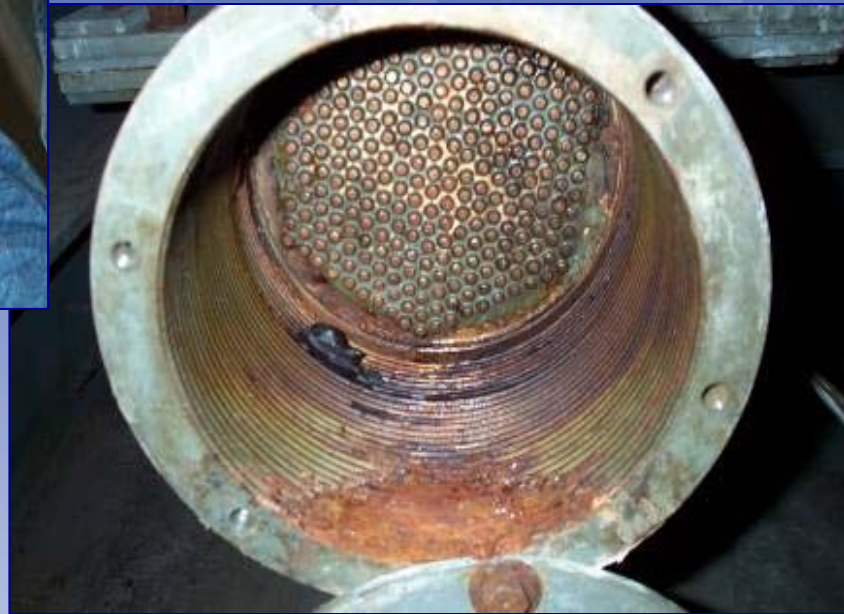
Anchorage Condition

- Corrosion and water leakage at anchorages
- Cracking/splitting of cable cover pipes
- In 2002, LaDOTD initiated a project for structural evaluation of the stays

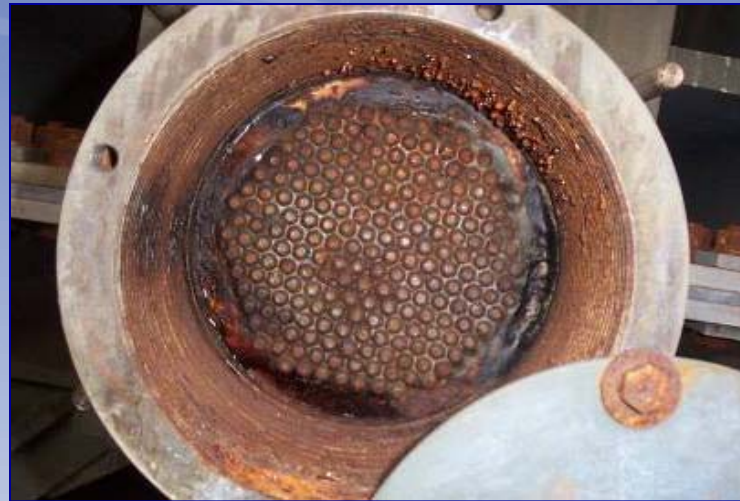
Stay System Condition

- 40 out of 72 cables rated critical
- Less severe damage in remaining cables
- Increasing rate of deterioration evident
- Timely corrective action required

Completely replace stay system – all 72 cables and other stay components

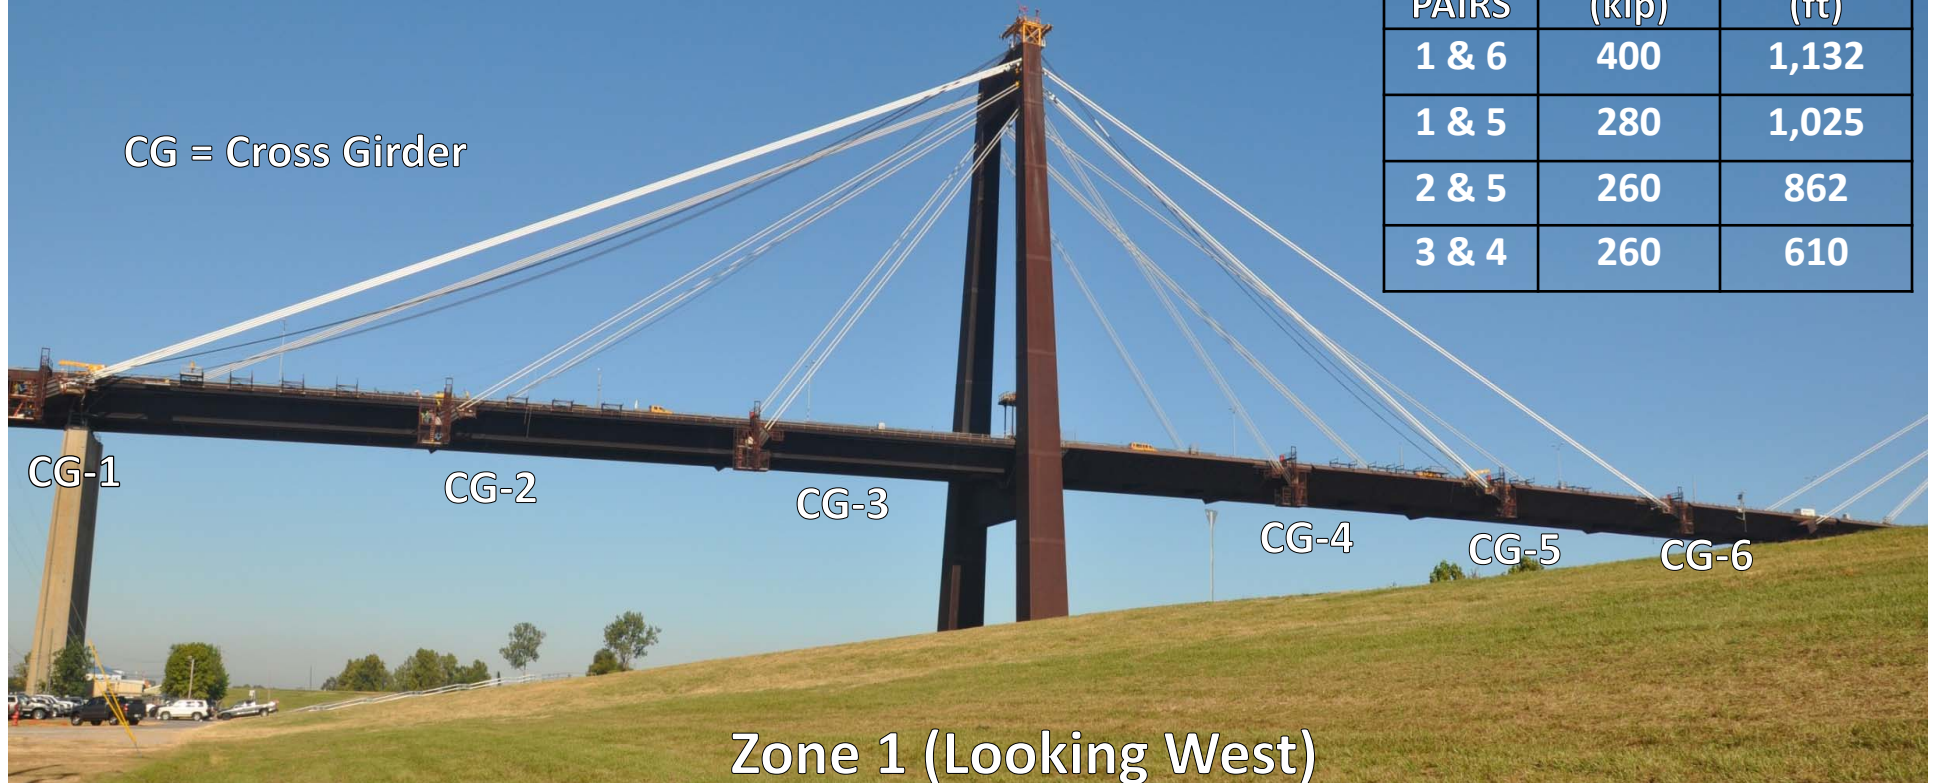
TEMP STAY CG PAIRS	TEMP STAY FORCE (kip)	TEMP STAY LENGTH (ft)
1 & 6	400	1,132
1 & 5	280	1,025
2 & 5	260	862
3 & 4	260	610

CG = Cross Girder

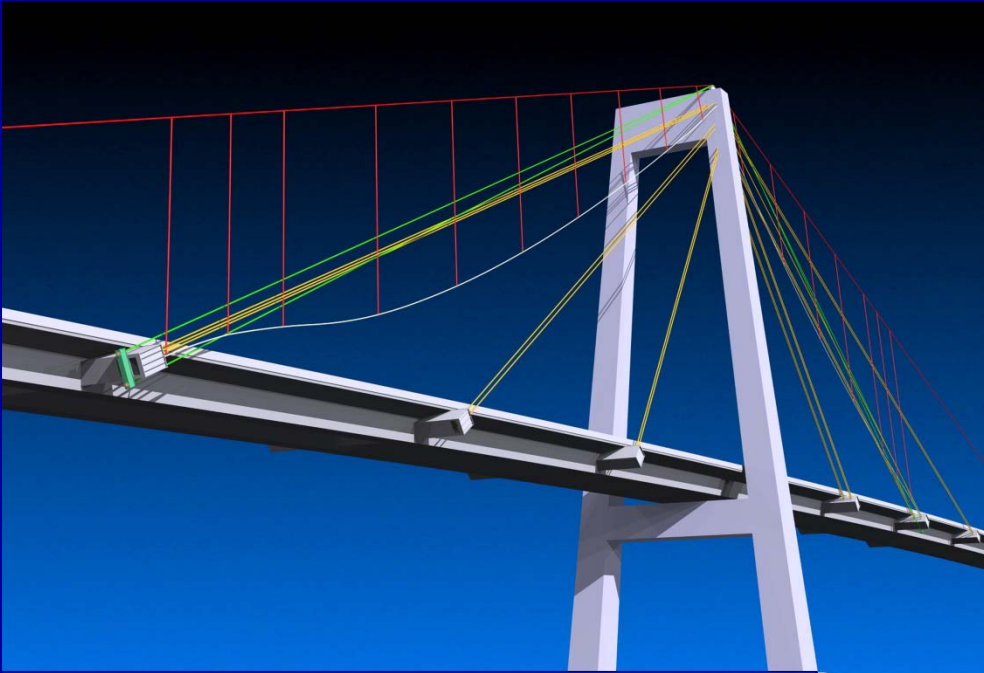
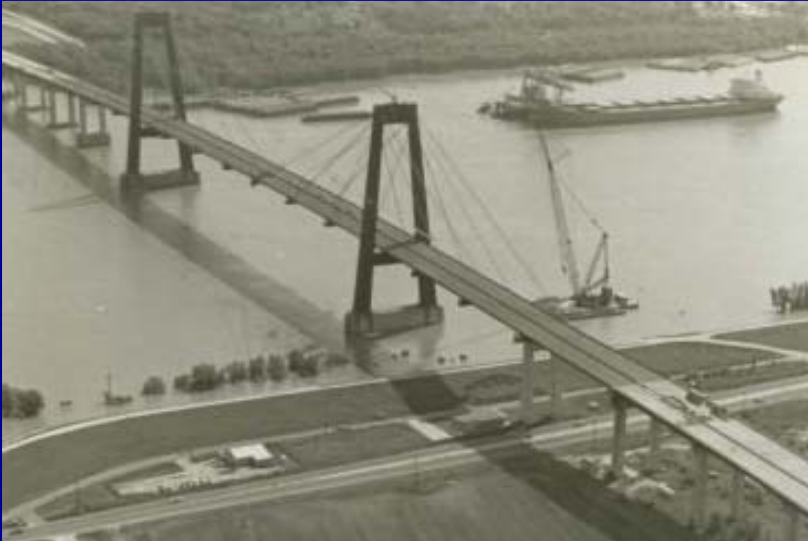
Temporary support system

- Highline or cableway
- Tower mounted hoist
- Barge mounted crane

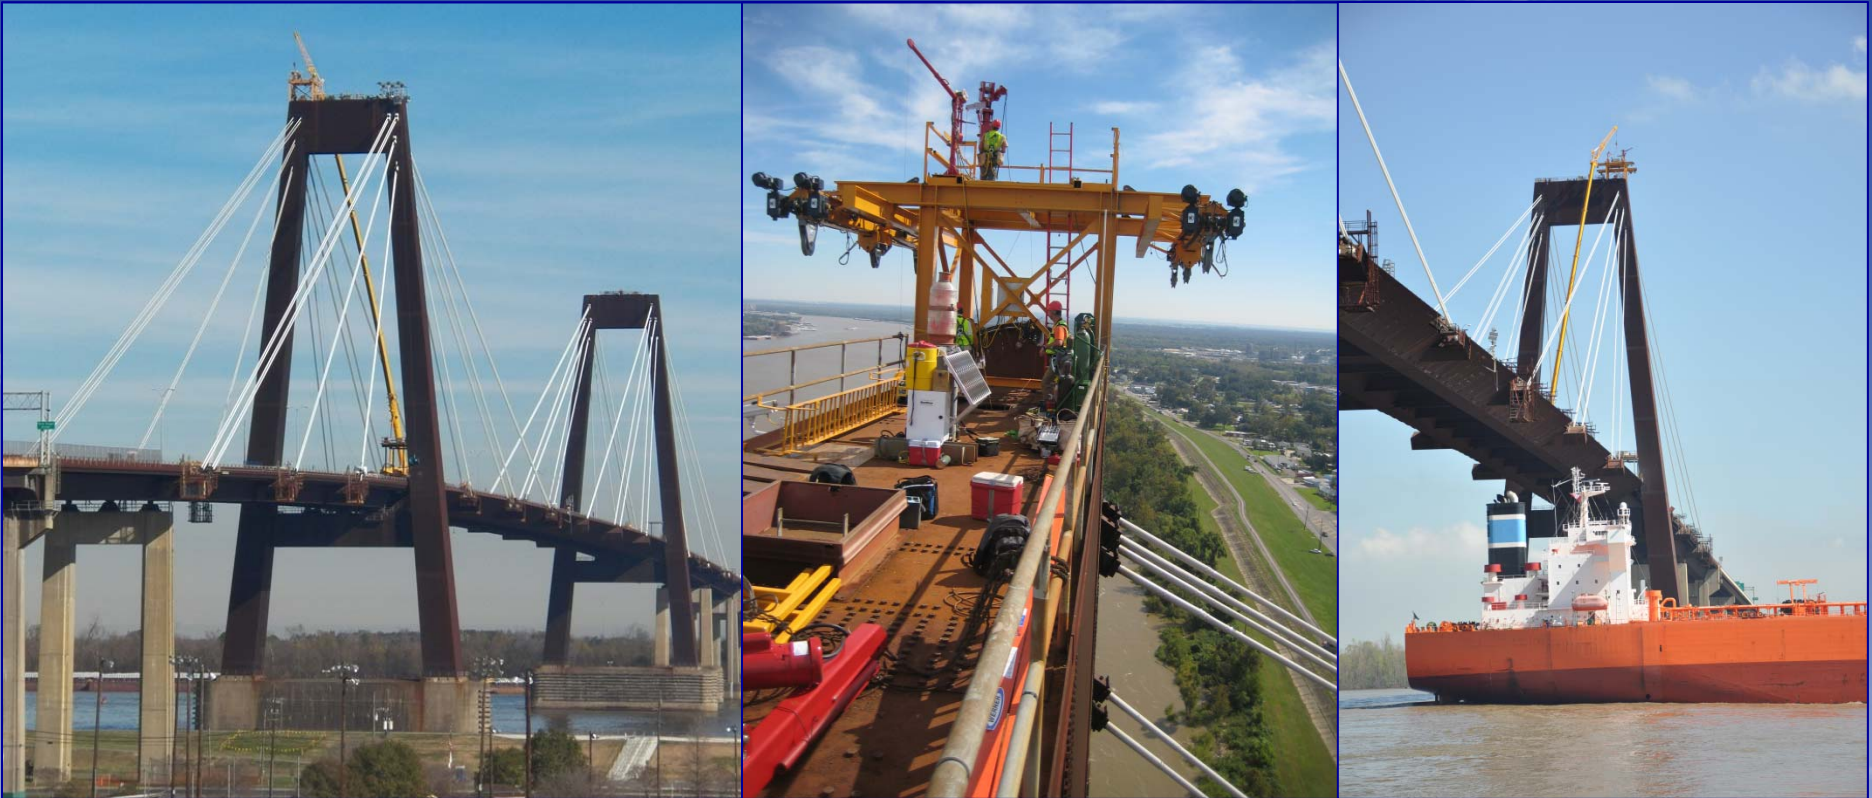
Install temporary support system

Service platform installed on top of tower to hoist equipment and stay system components

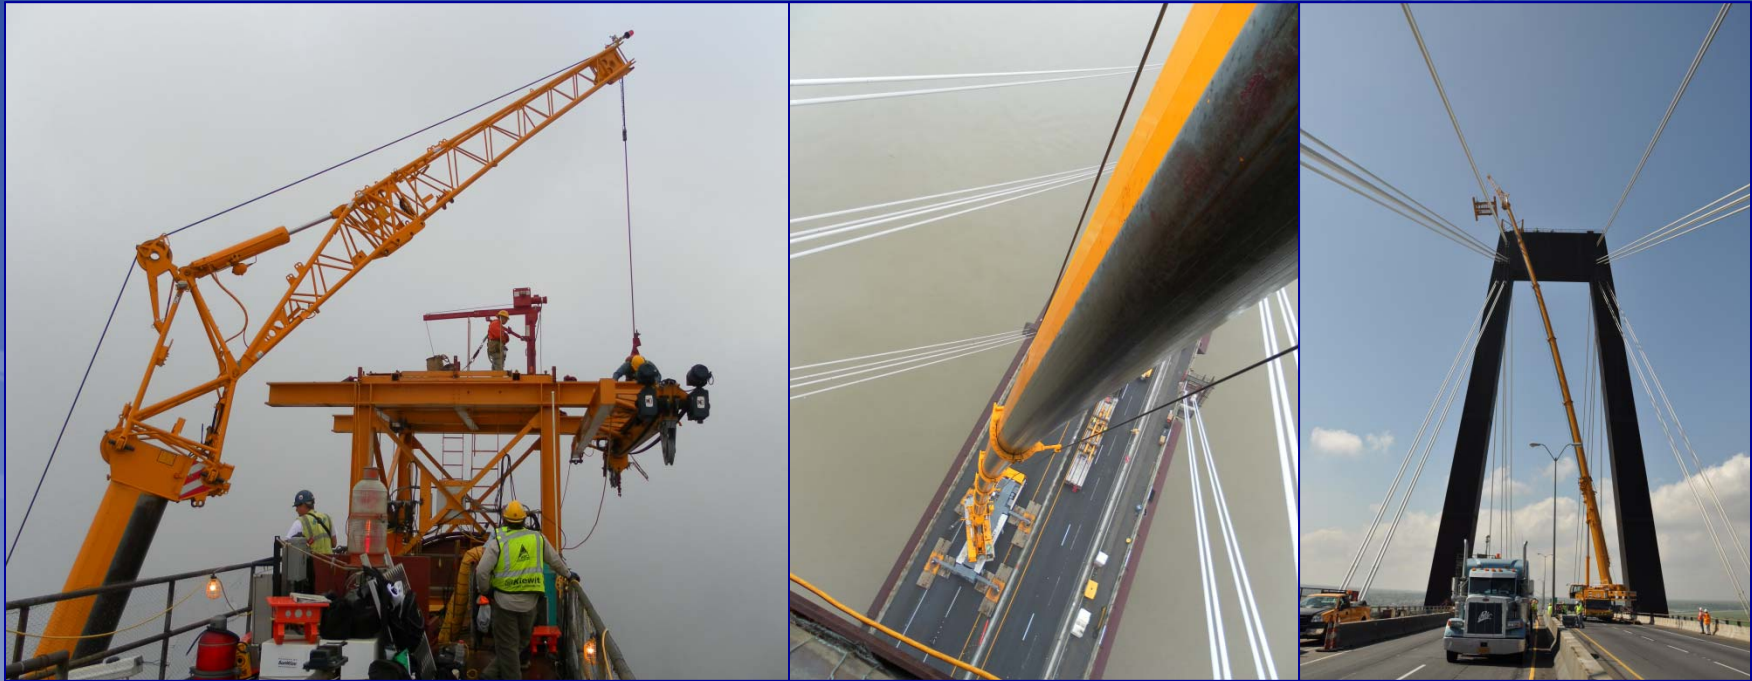
Install temporary support system

Service platform installed on top of tower to hoist equipment and stay system components

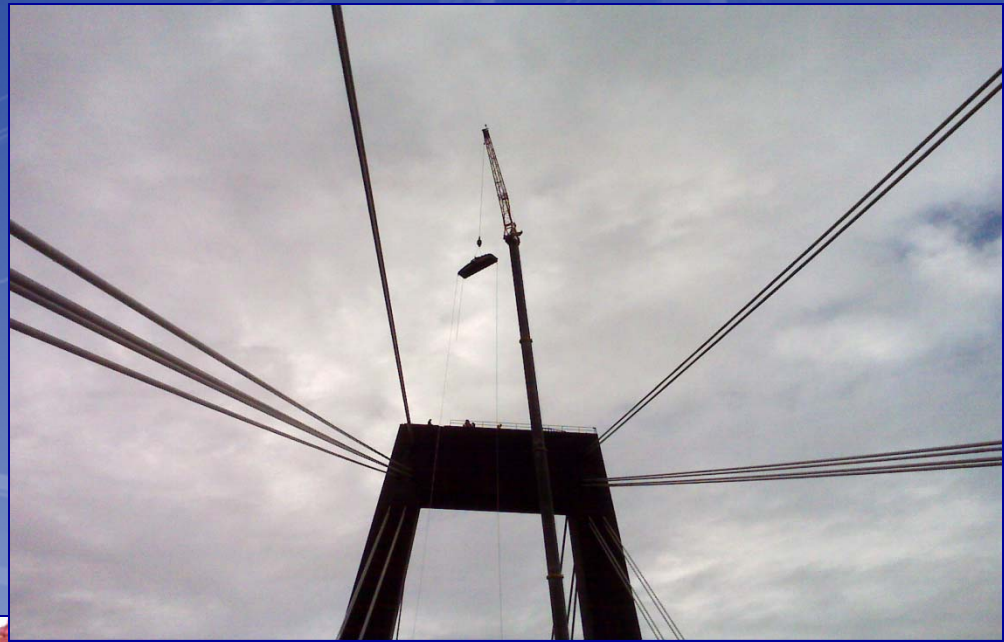
Install temporary support system

- Temporary cable saddle mounted at top of tower
- Top of tower strengthened locally beneath saddle

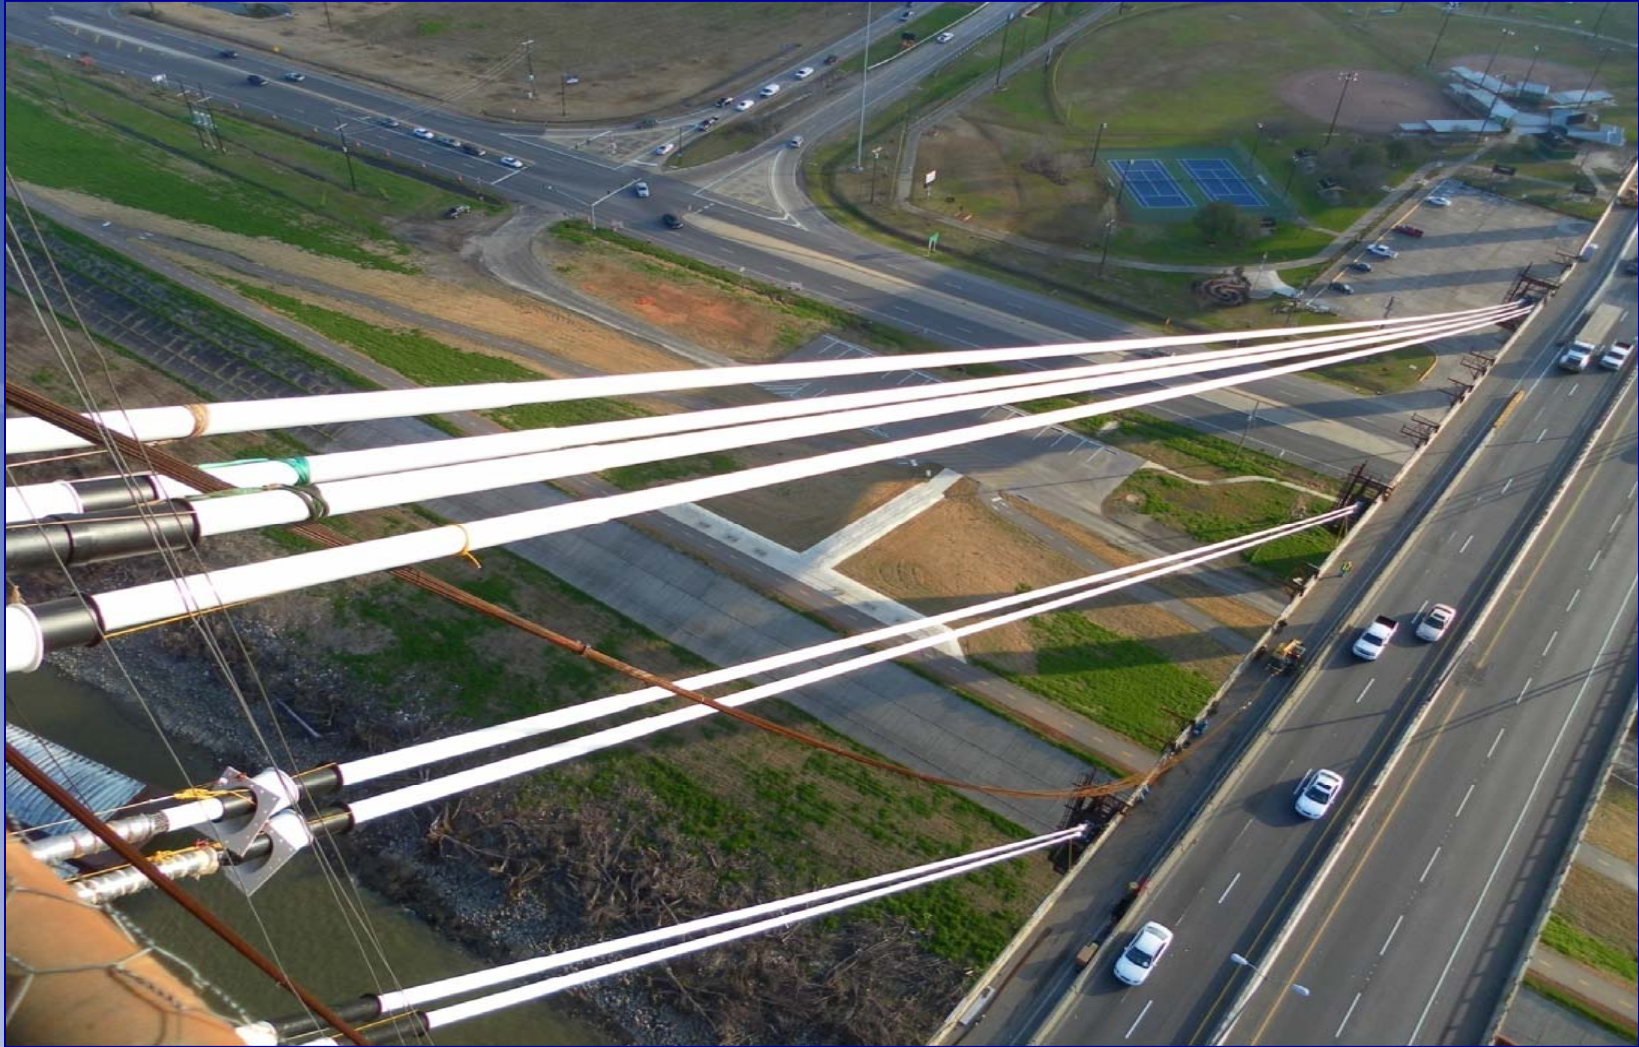
Install temporary cables

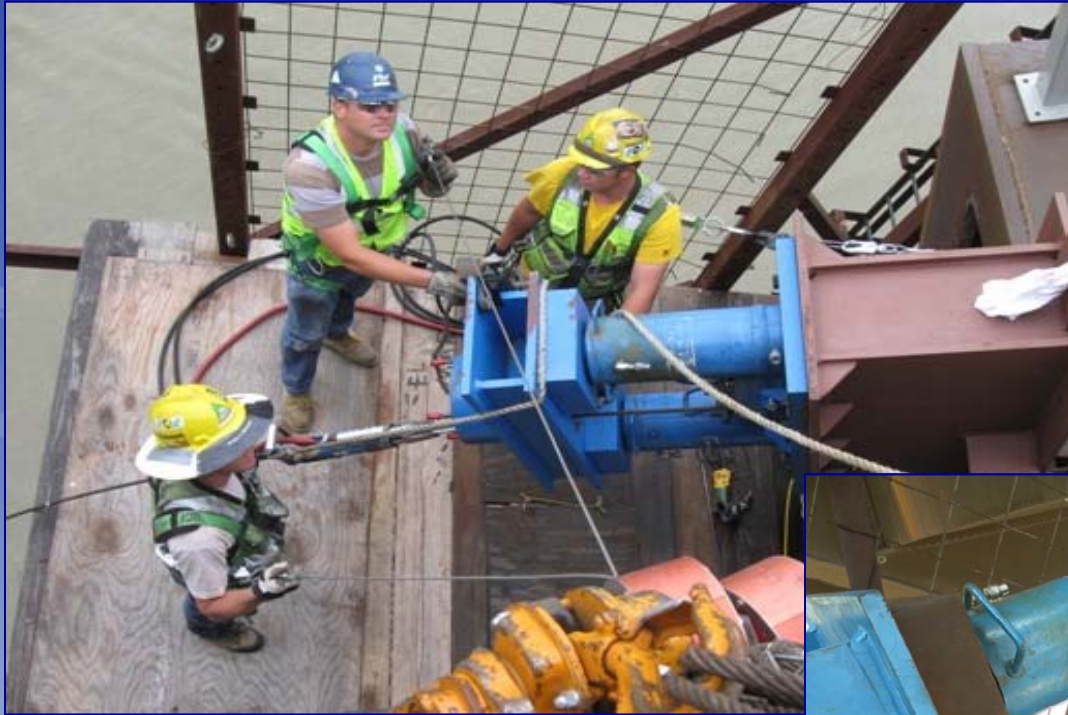
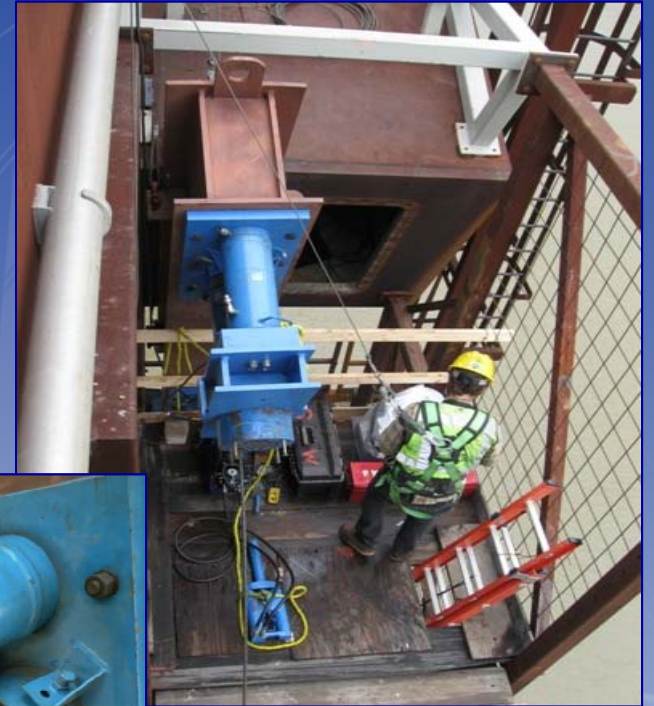
**Stress temporary cables
at deck cross-girder**

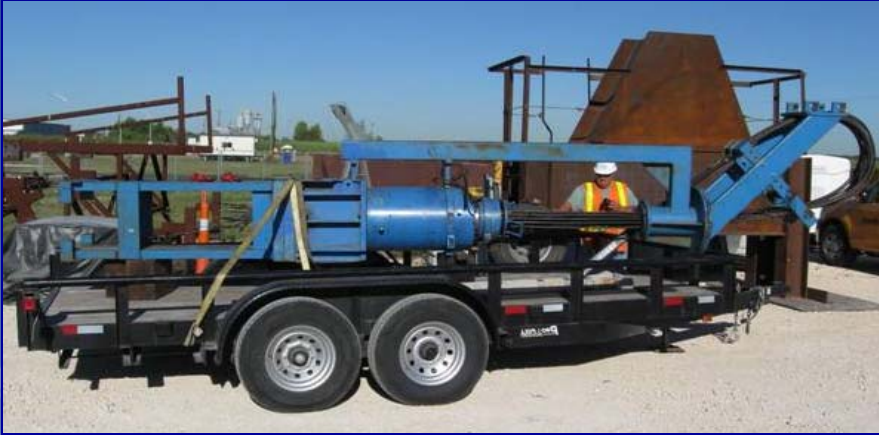
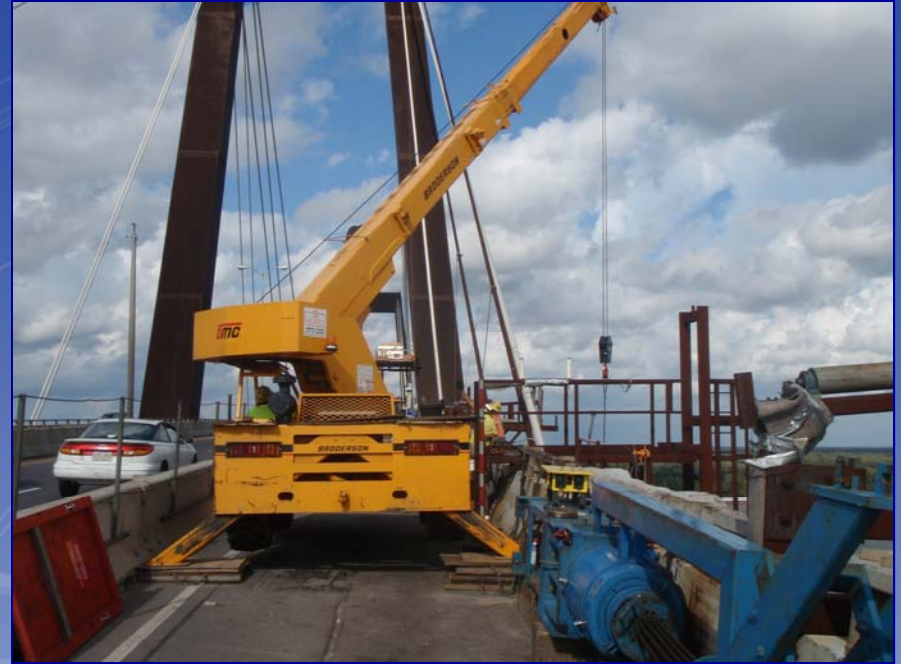
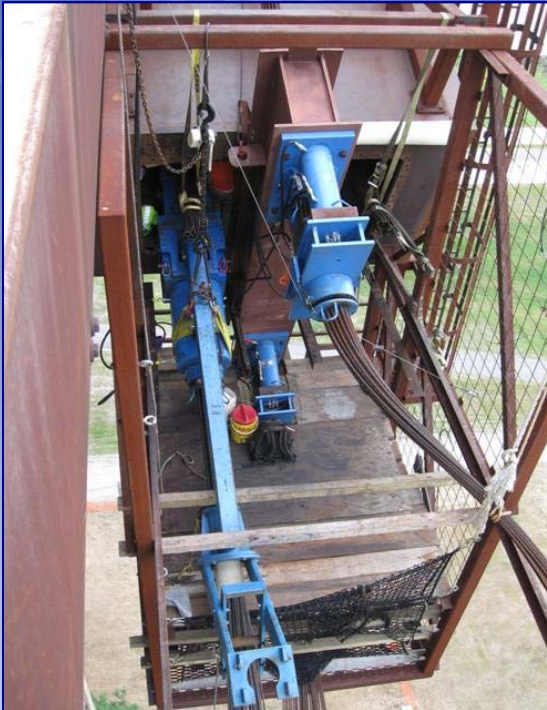
Mobilize pair of jacks to simultaneously de-tension pair of existing stays

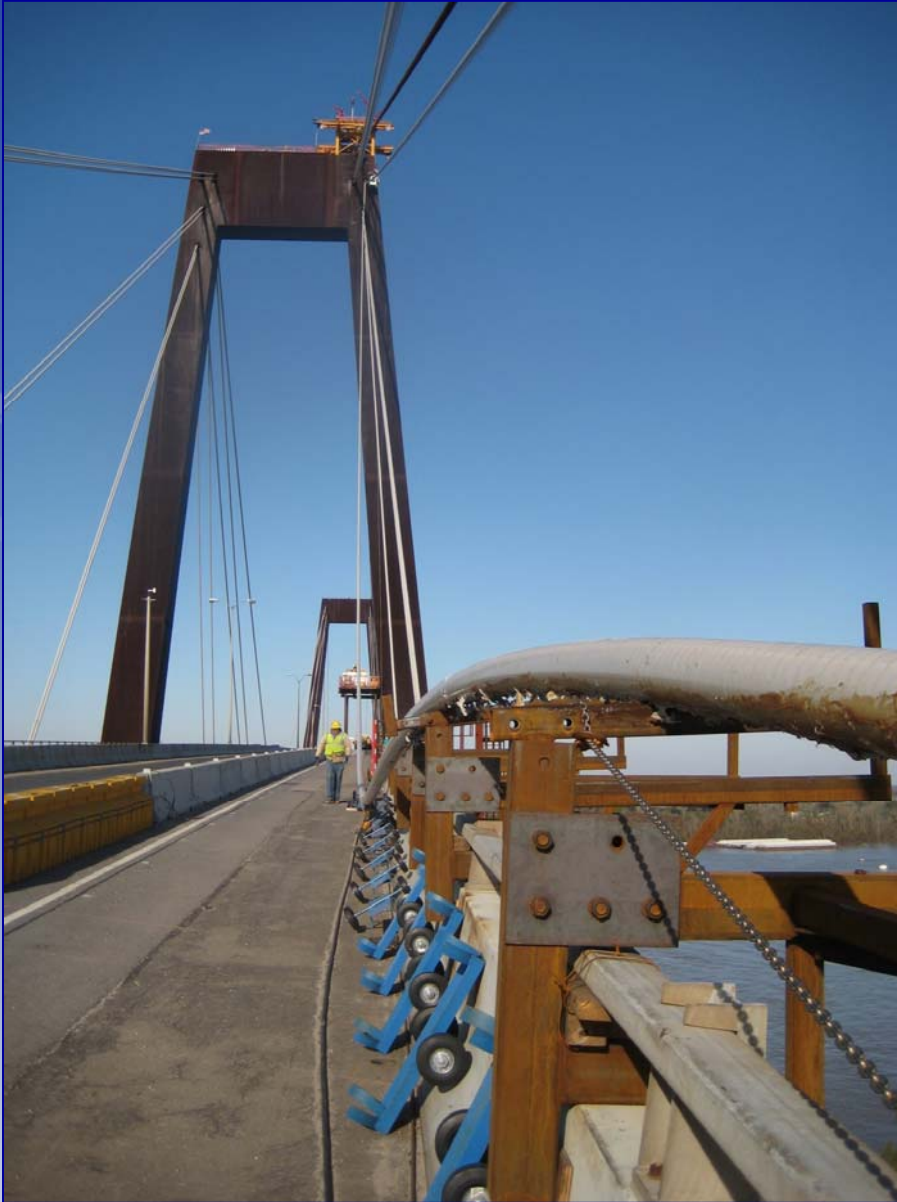
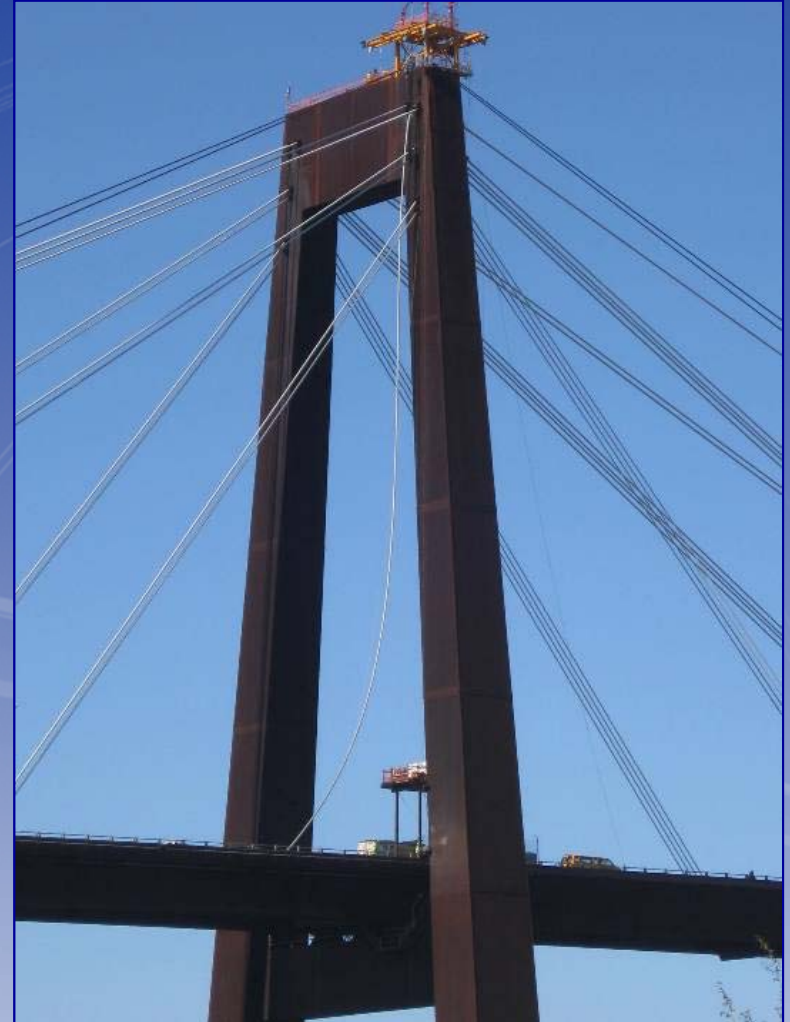
Extract de-tensioned existing stay

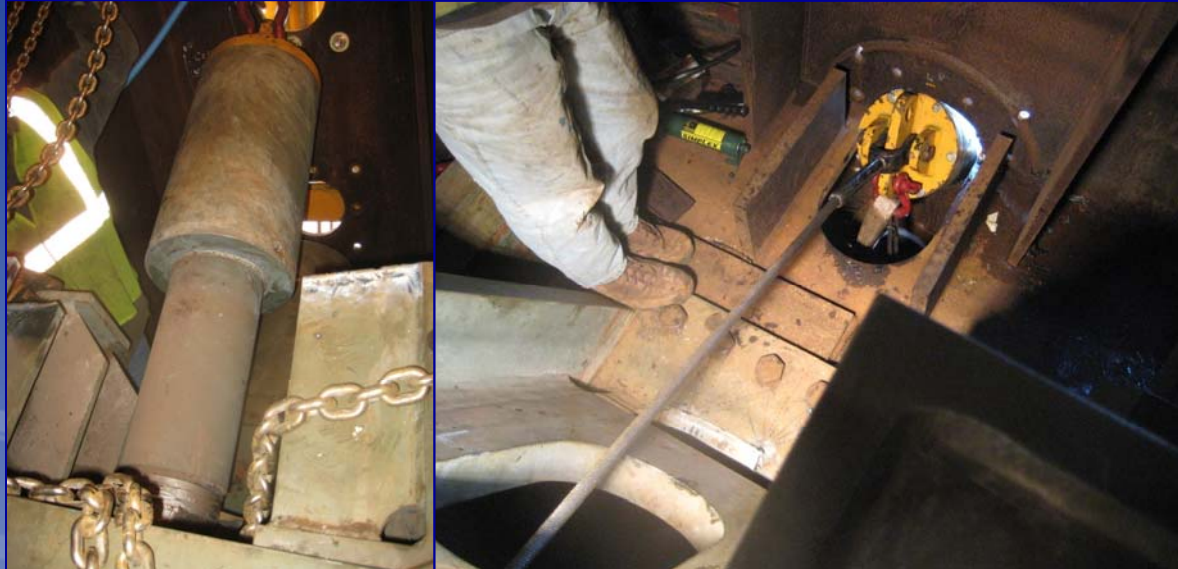
Extract de-tensioned
existing stay

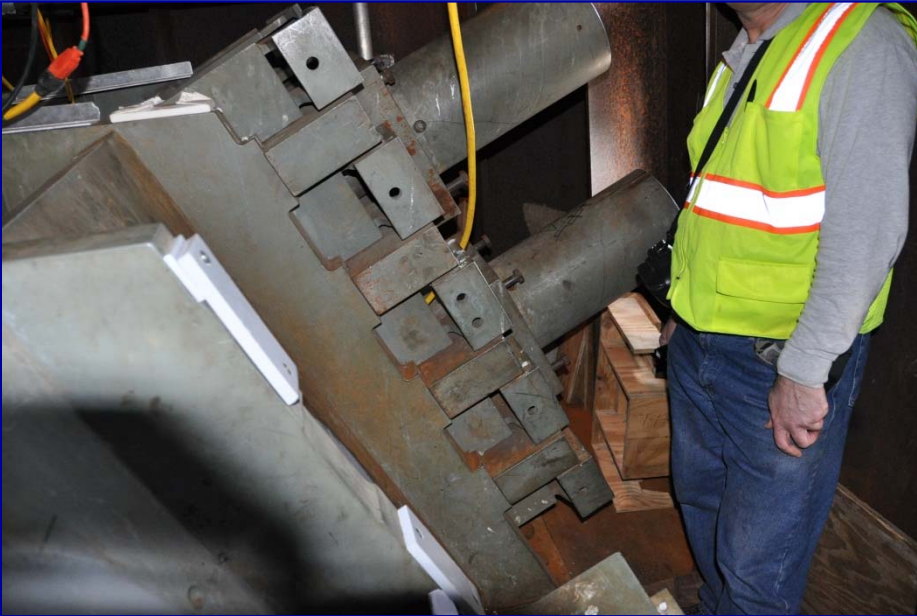
Existing Anchors

New Anchor

Modify existing structure at anchor locations

Tower anchor modifications

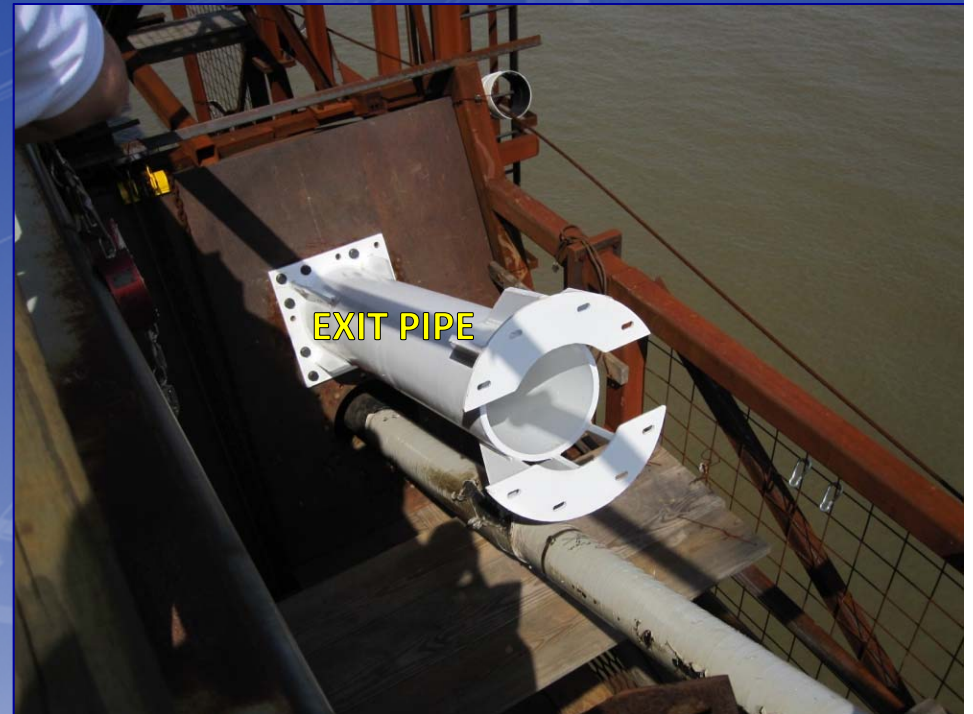
Modify existing structure at anchor locations

Deck anchor modifications

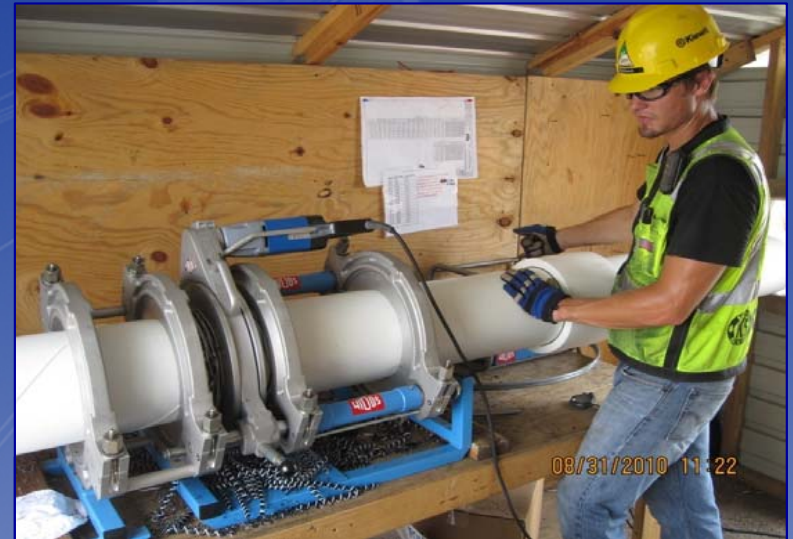
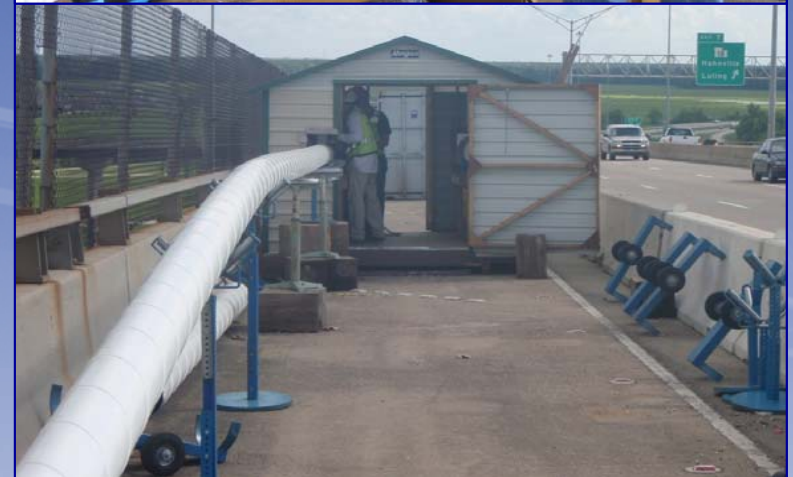
Install new stay

Assemble new stay pipe on deck

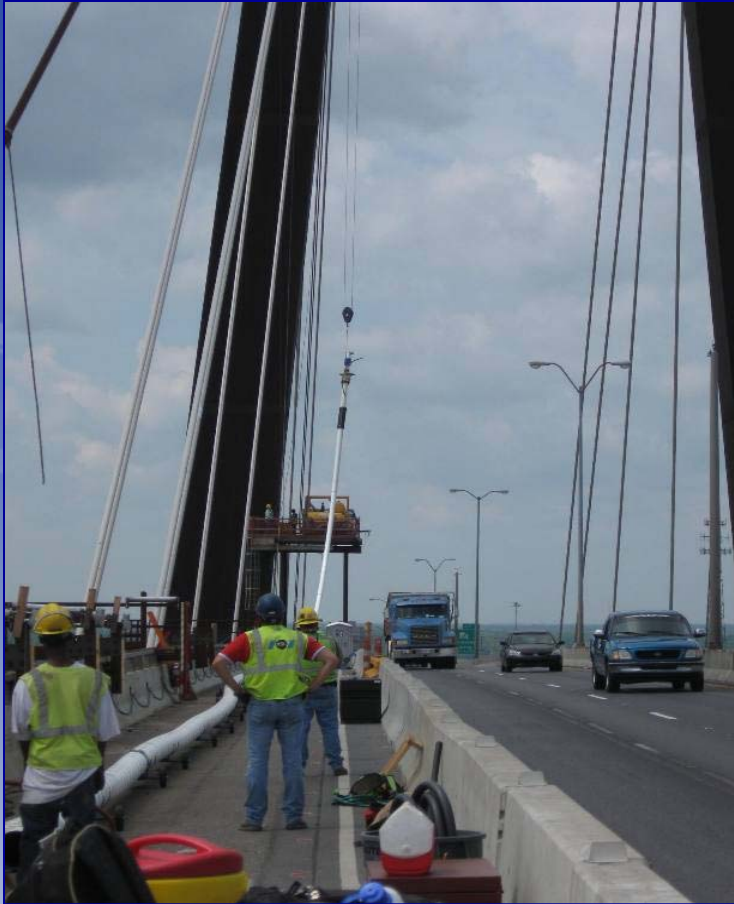
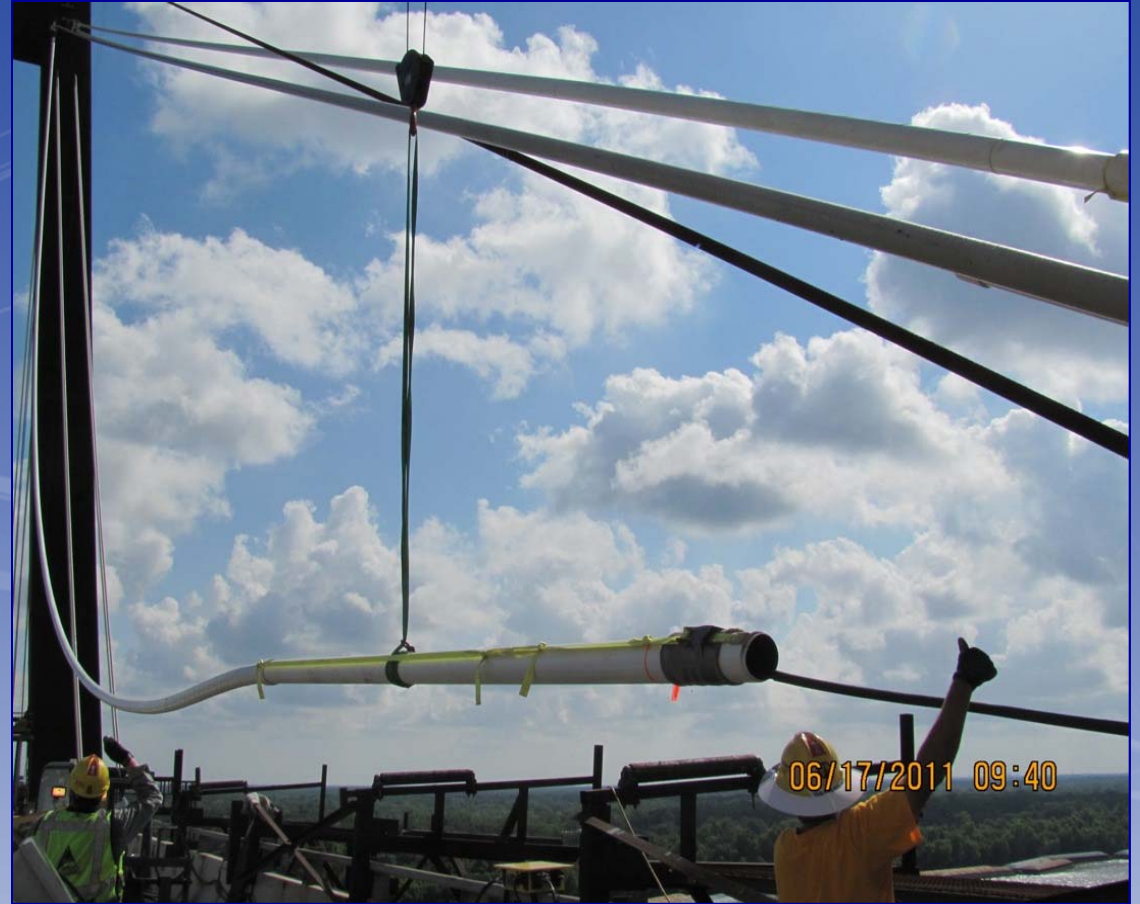
Install new stay

Hoist new stay pipe from deck
