# I-20 Mississippi River Bridge Truss Rehabilitation-Repairs and Monitoring

Zolan Prucz, Ph.D., P.E.,  
*Modjeski and Masters, Inc*

**Annual SASHTO Conference**

August 23-27, 2014

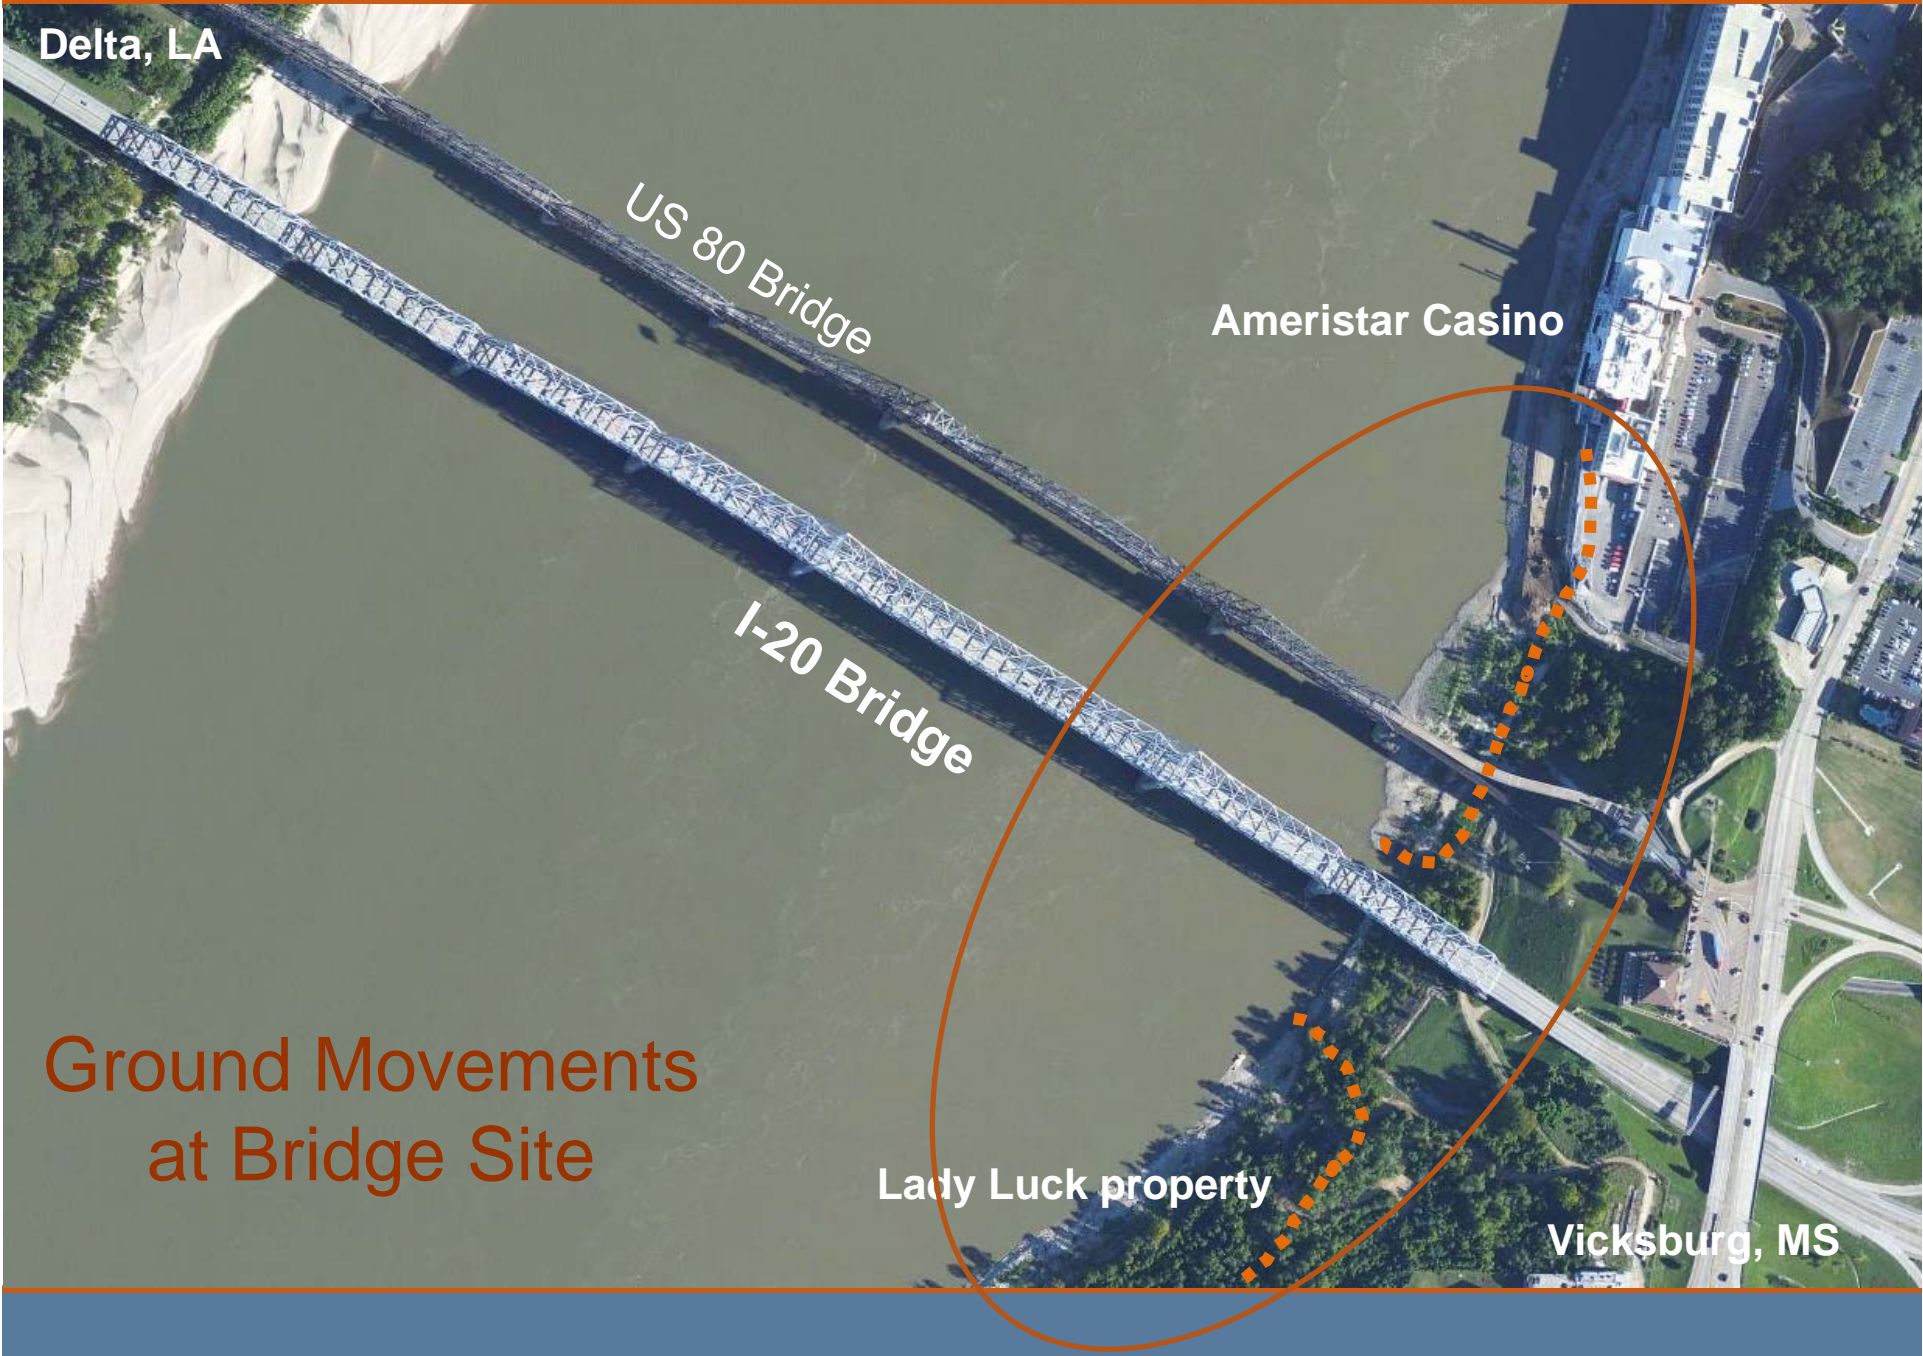
Ground Movements  
at Bridge Site

- Project started in 2001 in response to the westerly movement of two of its east bank piers of about 6 inches in 2000/2001 .
- The first step was realignment of bearings that reached maximum capacity.
- Since May 2001 the bridge has been monitored for additional movements, and structurally modified in 2004, 2010 and 2014 to accommodate more movements.

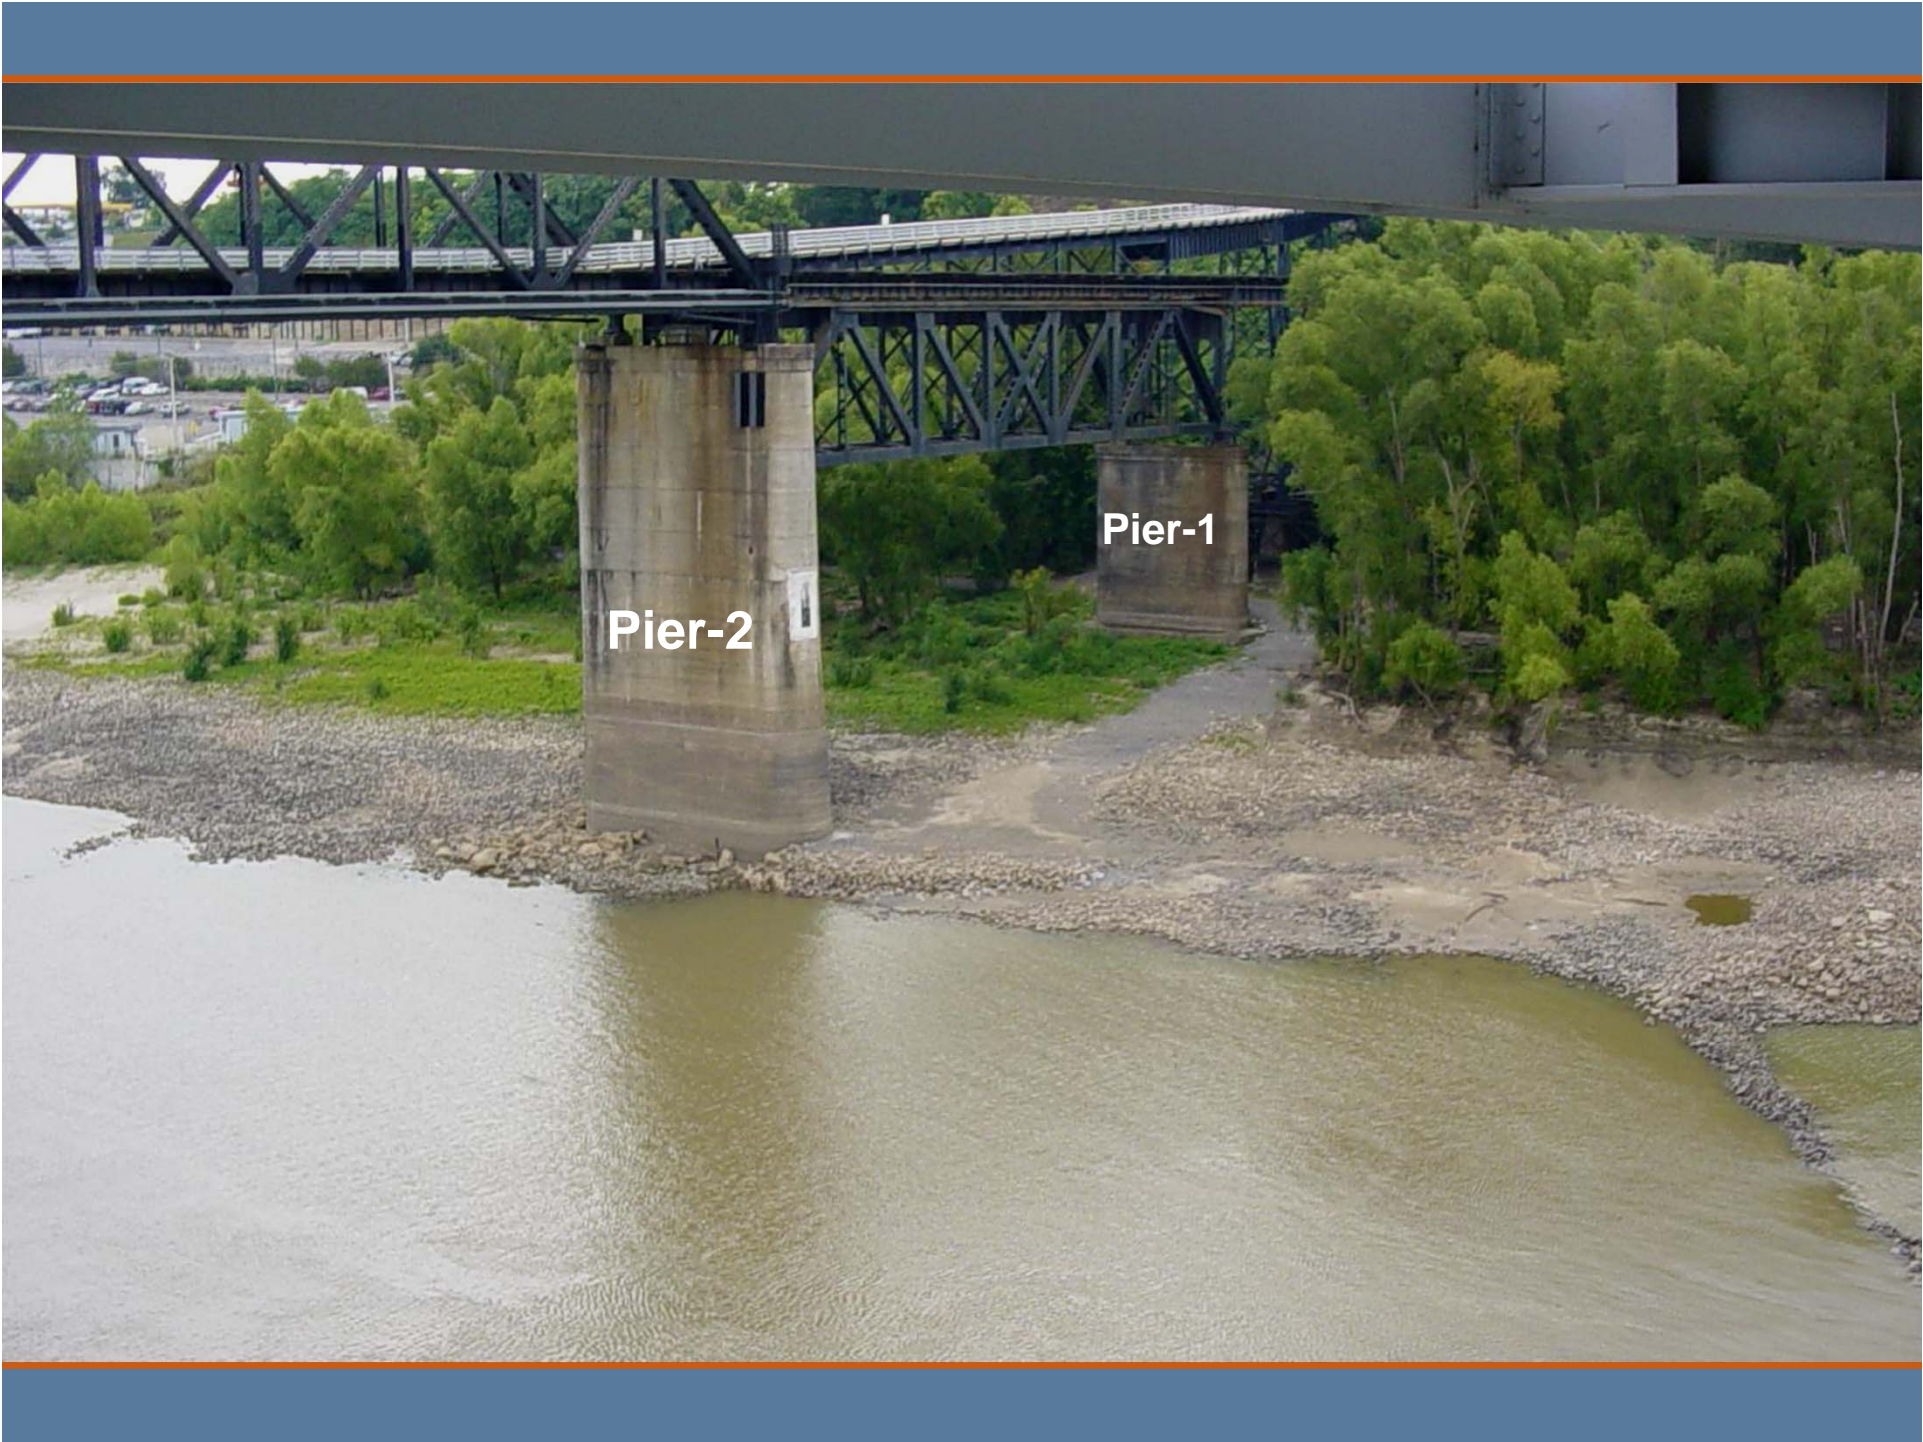
## Bridge Movements

### US80 Bridge (1929):

- 1929 – 1939 and after 1994
- 35" +/- total at Pier 2

### I-20 Bridge (1973):

- 2000/2001: 6" +/-
- After 2001: 4.5"

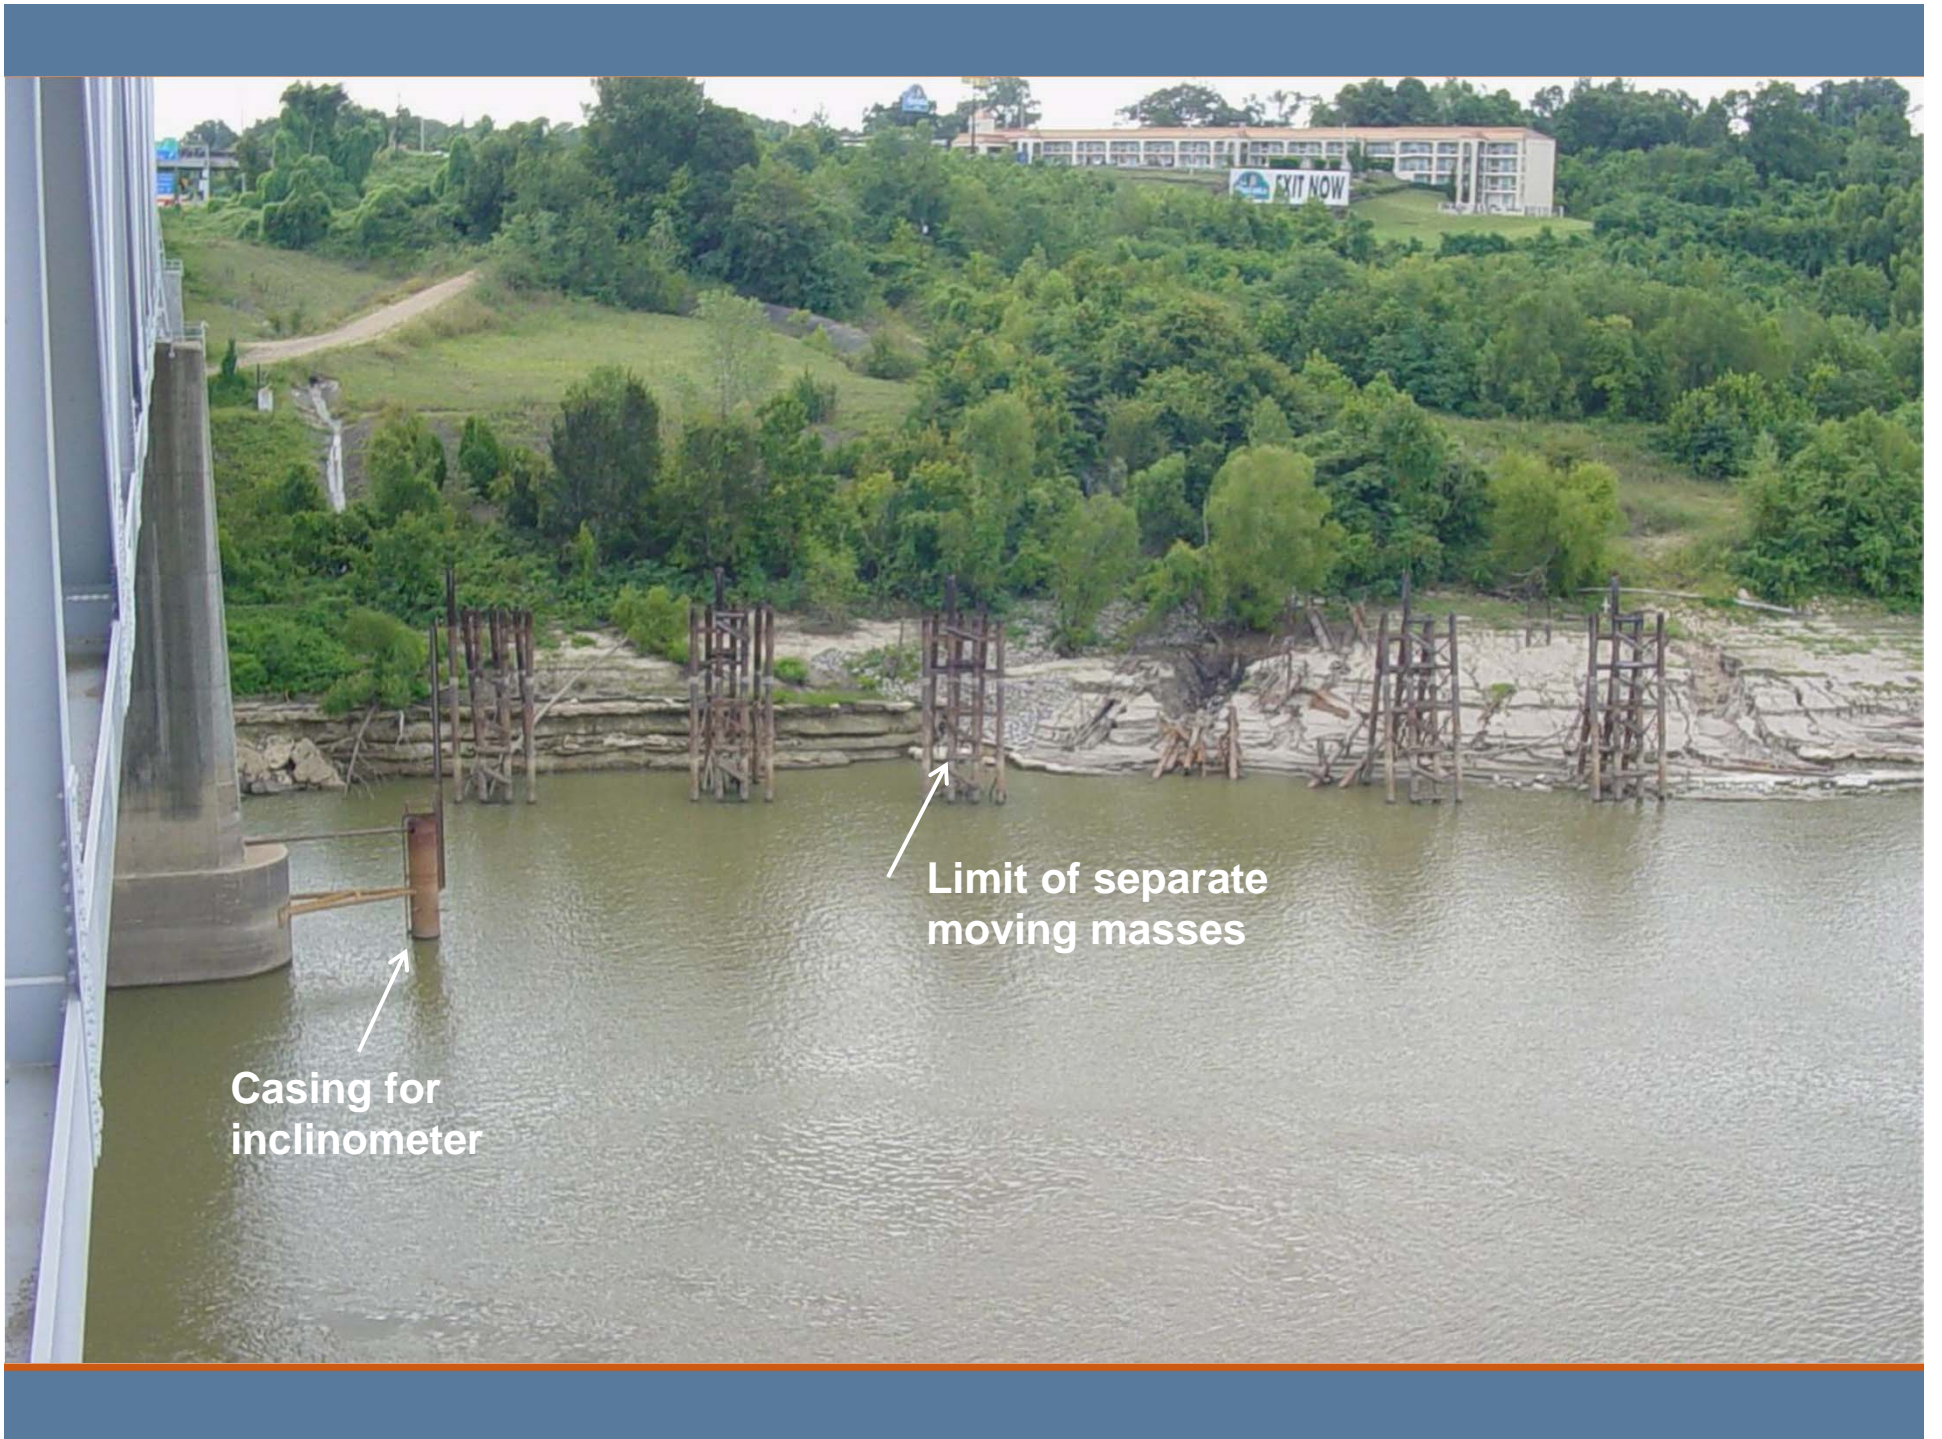
Casing for  
inclinometer

Limit of separate  
moving masses

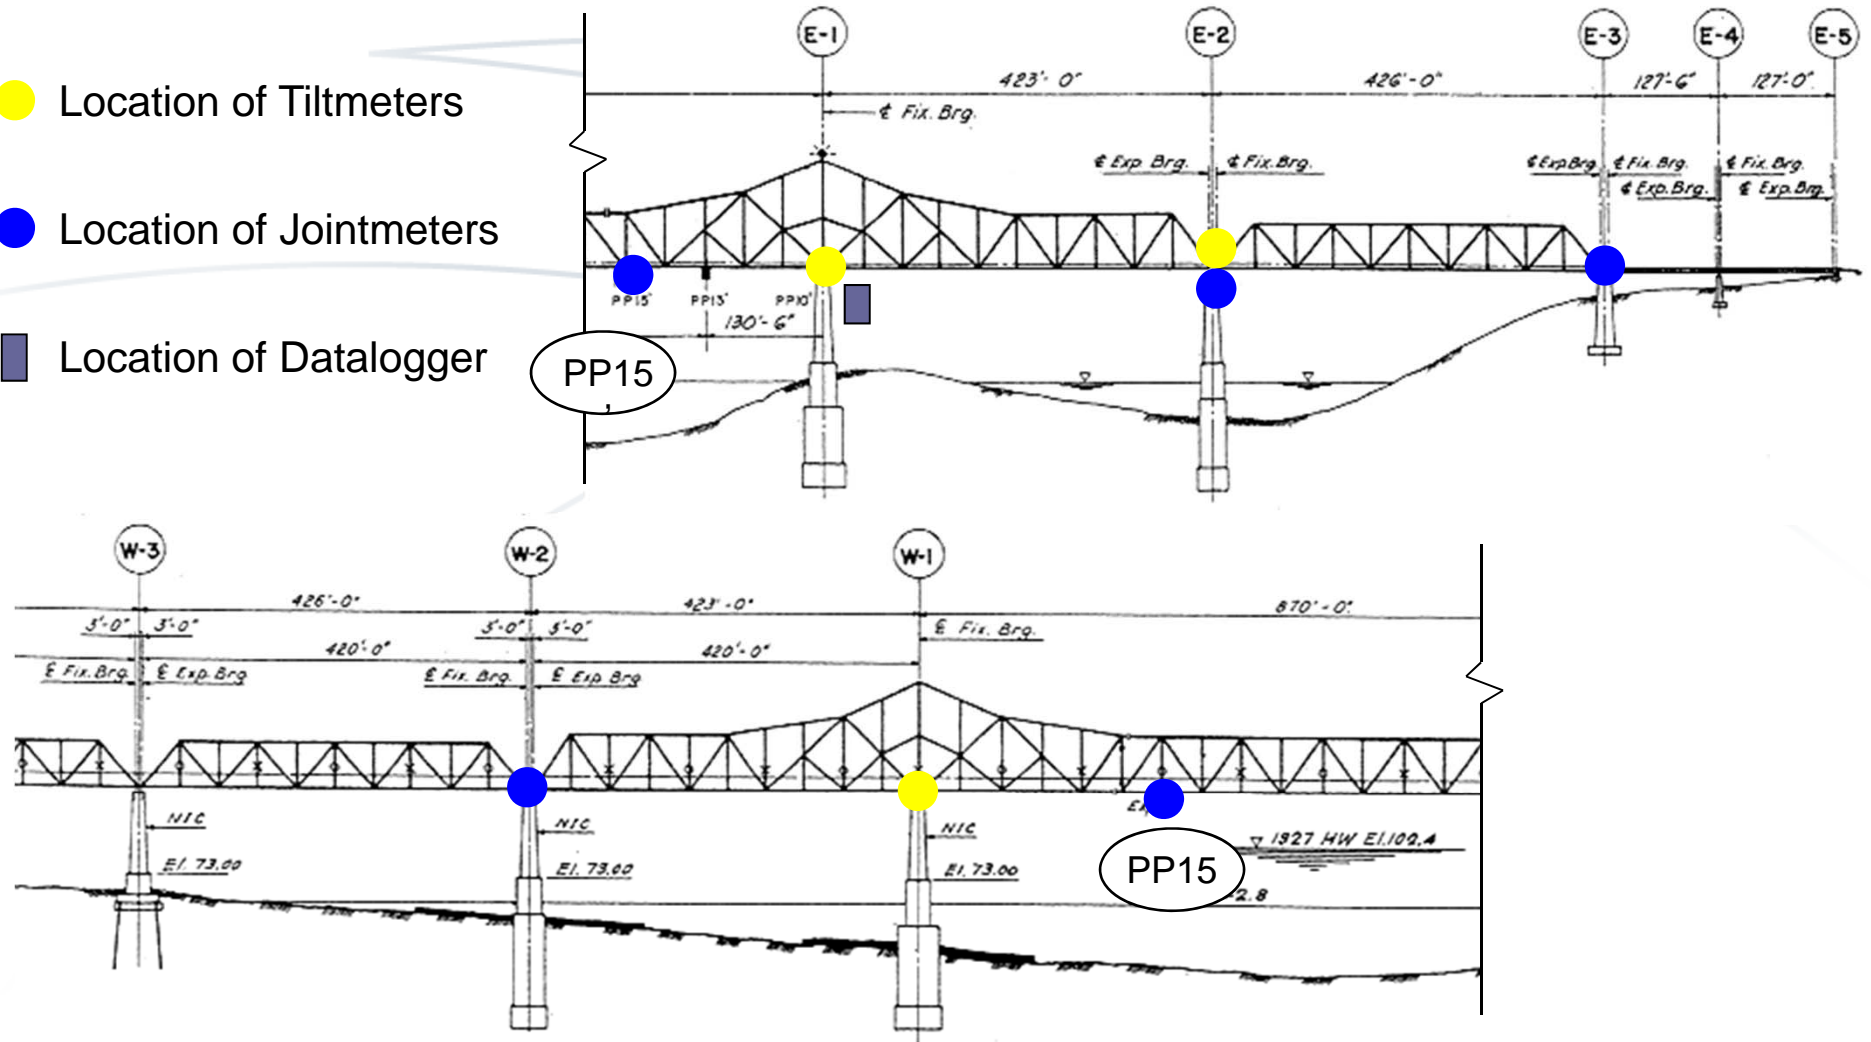
# Bridge Instrumentation

TYPE	MEASUREMENTS
Survey	Top of Piers - Longitudinal, Lateral and Vertical
Manual Measurements	Deck Joints, Barriers and Bearings
Instrumentation	Top of Piers - Tiltmeters Deck Joints – Jointmeters

- Location of Tiltmeters
- Location of Jointmeters
- Location of Datalogger

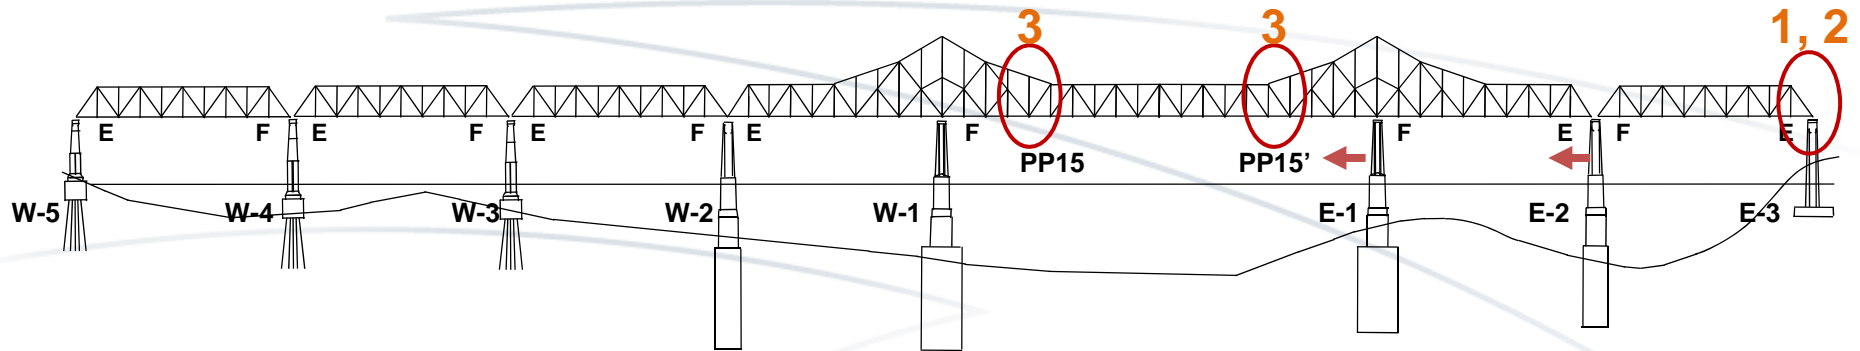
## 2004 Bridge Modifications (Remedial)

Measure	Objective	Retrofit
1	Prevent roadway traffic hazard at expansion dam at Pier E-3.	Replace expansion dam at Pier E-3.
2	Prevent Span Drop at Pier E-3.	Widen top of pier area. Add catch blocks under the trusses.
3	Eliminate locked-in stresses between Piers E-1 and W-1.	Shorten span between Piers E-1 and W-1. Repair longitudinal strut L15'-L14'.

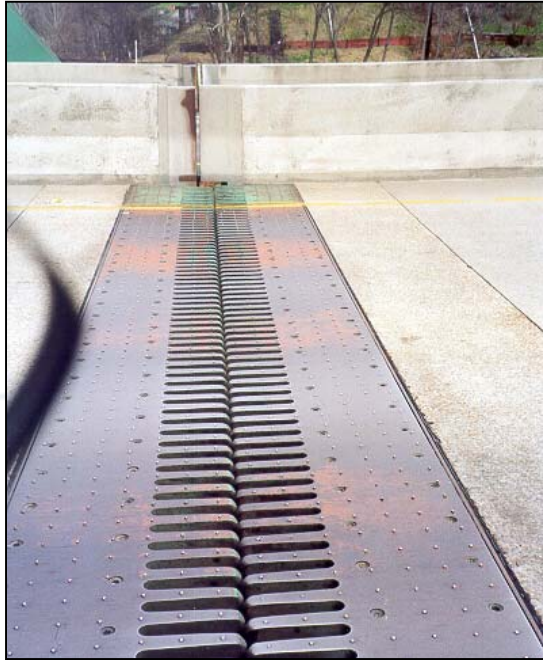
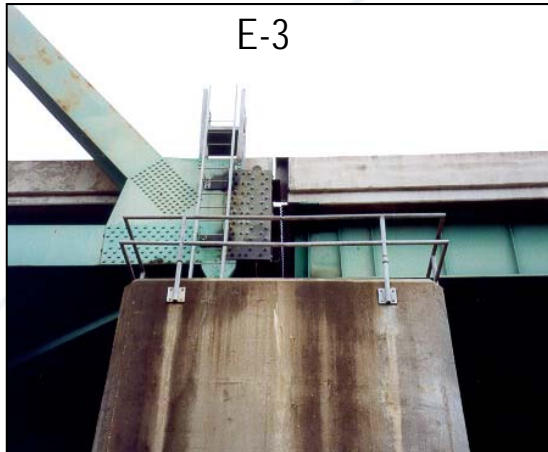
EXISTING CONDITION

# Expansion Dam Modifications at Pier E-3

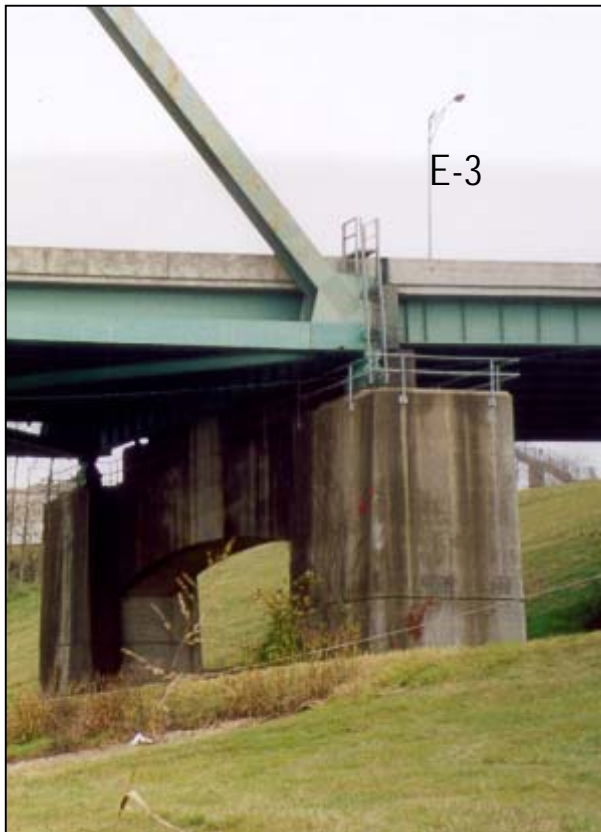
EXISTING CONDITION

# Pier Top Widening and Catch Block at Pier E-3

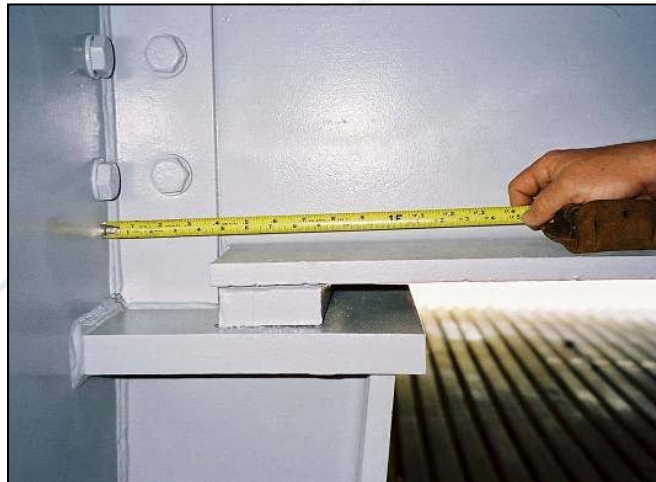
EXISTING CONDITION

# Shortening of Span L14 – L15

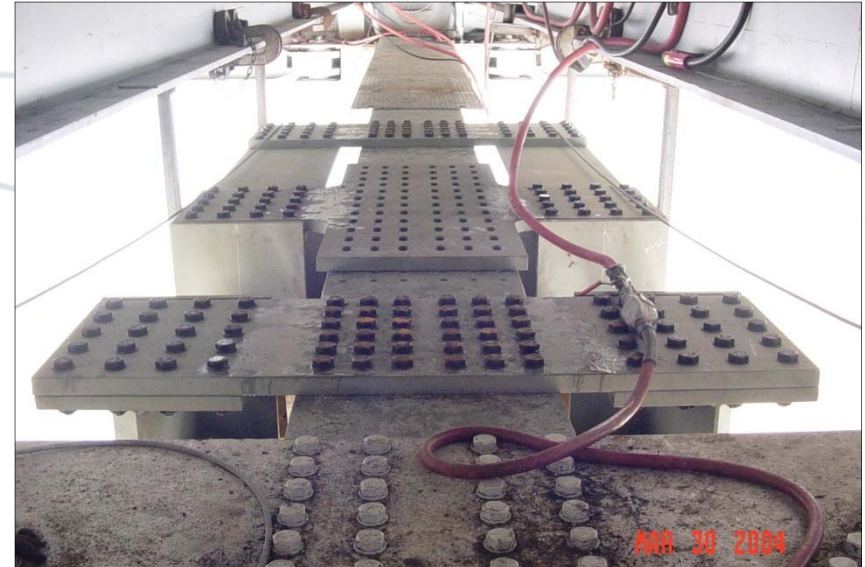
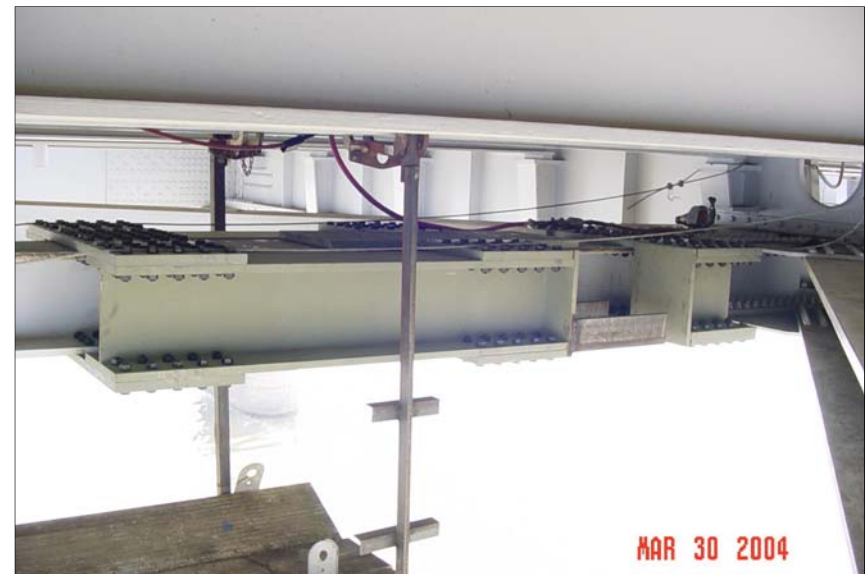
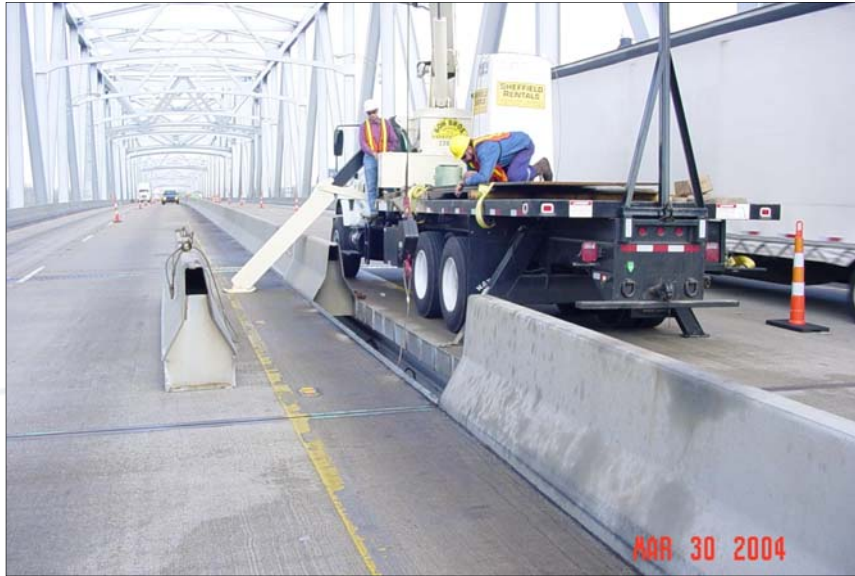
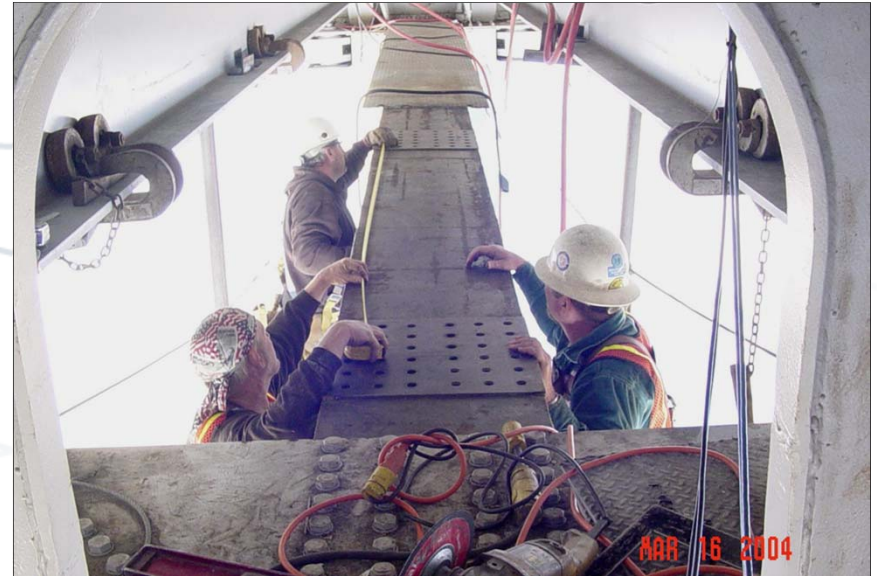
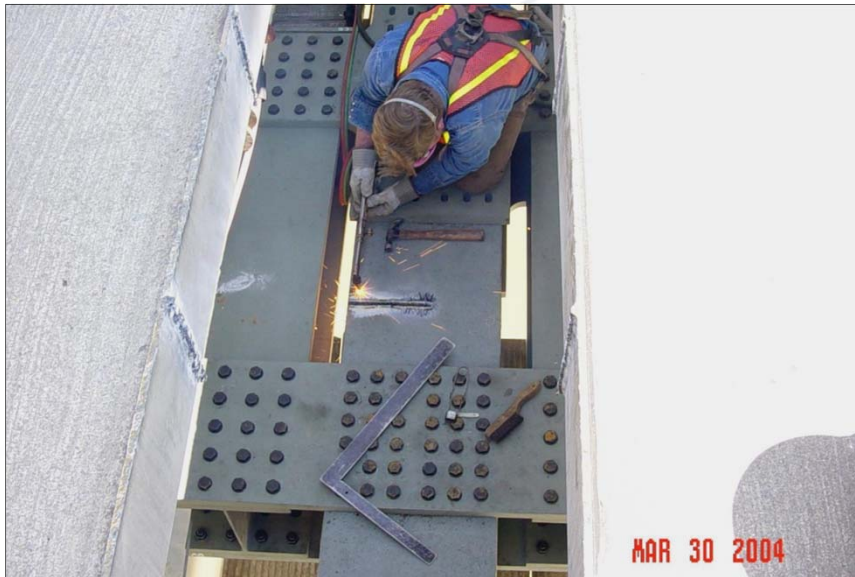
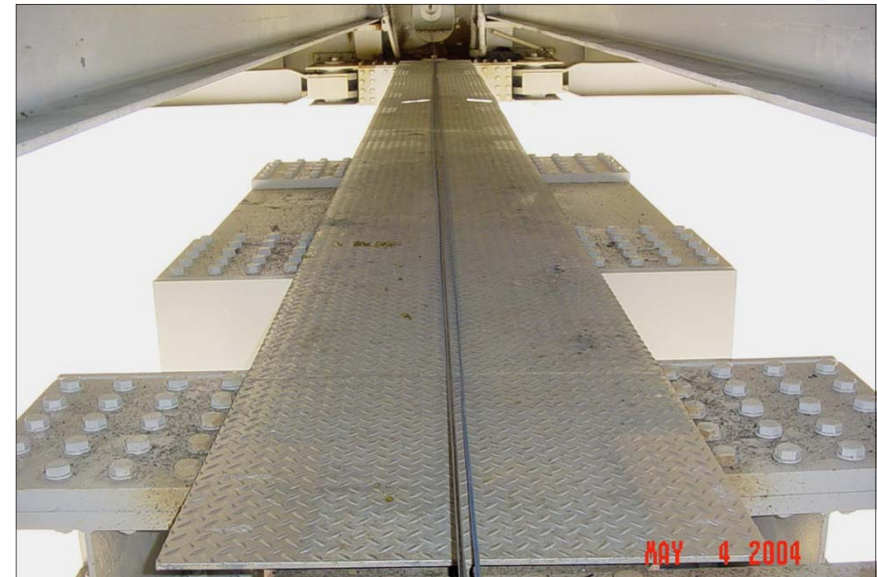
MODIFICATION OF LONGITUDINAL STRUT

## Longitudinal Strut Shortening at Span L14' – L15'

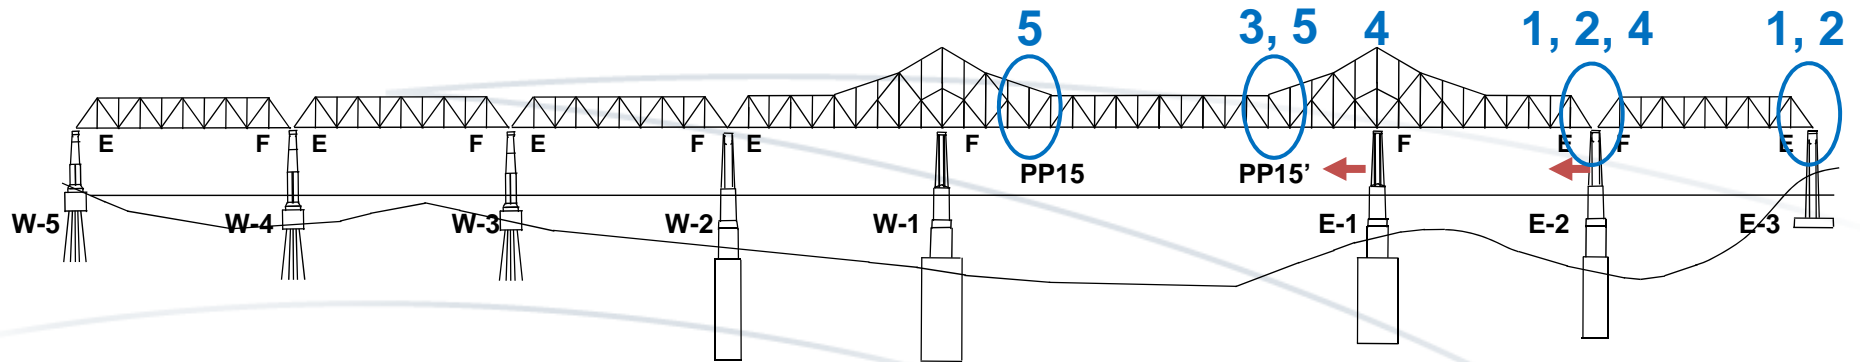
## 2010 Bridge Modifications (Proactive)

Measure	Objective	Retrofit
1	Increase movement capacity of expansion dam at Pier E-3 and E-2	Replace expansion dam at Pier E-3 and Pier E-2.
2	Increase movement capacity of bearings at Piers E-3 and E-2.	Replace bearings at E-3 and E-2 with inverted sliding disc bearings.
3	Increase movement capacity within the deck, between Pier E-1 and W-1.	Shorten span PP14'-15' and replace expansion dams at PP15'.
4	Prevent span drop at Pier E-2 and E-1.	Widen top of pier area at E-2 and E-1. Add bearing blocks at E-2 and E-1.
5	Provide redundancy to the suspended span hangers.	Add eyebars at the suspended span hangers.

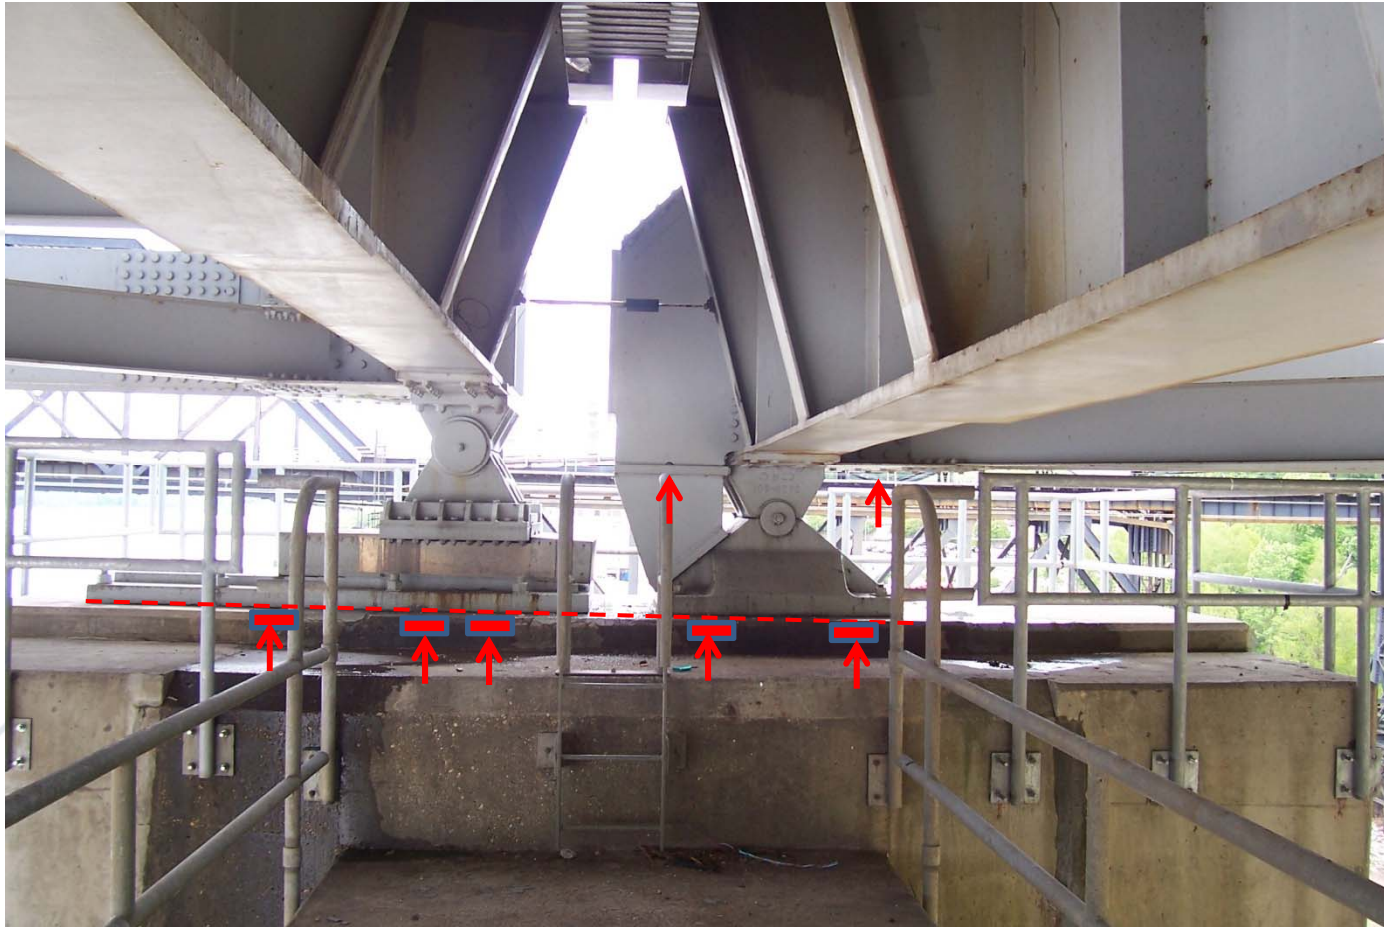
## Installation of Transverse Jacking System at Pier E-2

Measure	Objective	Retrofit
1	Provide transverse movement capacity at Pier E-2	Install transverse sliding assembly at Pier E-2: <ul style="list-style-type: none"> <li>• jack bearings vertically</li> <li>• install PTFE assembly underneath</li> <li>• perform horizontal jacking</li> </ul>
2	Reset expansion dam at PP15	Push (and pull) the suspended span towards PP15'
