# Images at Depth

Presented by **Ken LaBry**  
Underwater Acoustic Manager  
FENSTERMAKER

# Underwater Acoustic Imaging For Underwater Bridge Inspection

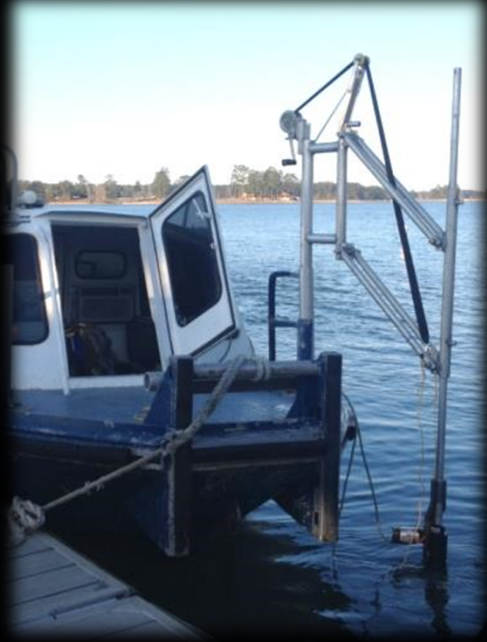
*Boat deployment*

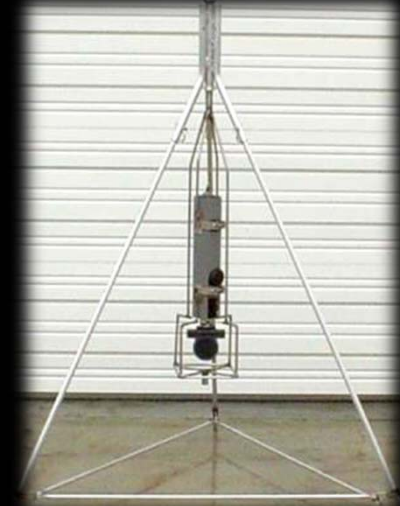
*Tripod mounting for stationary, free standing deployment*

*Deep, high water current - deployment and maneuvering system*

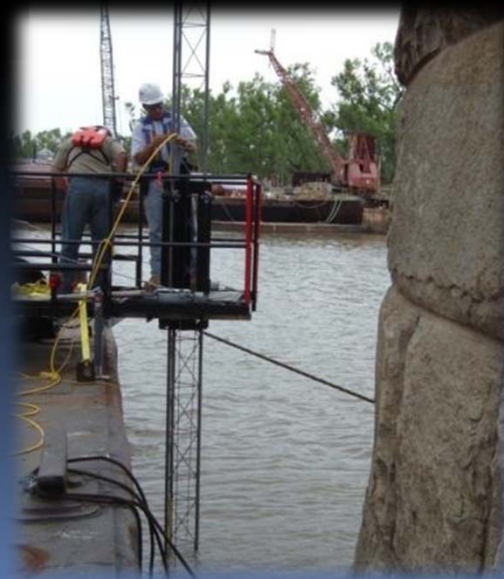
*Mobile deployment and maneuvering system*

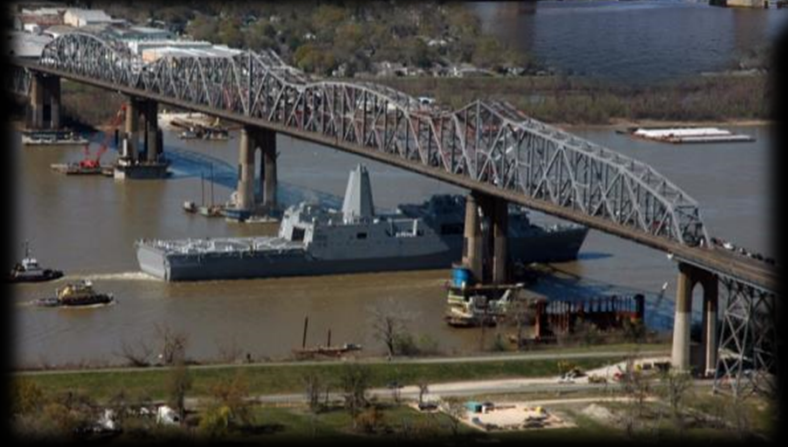
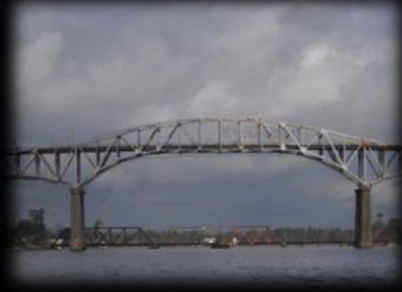
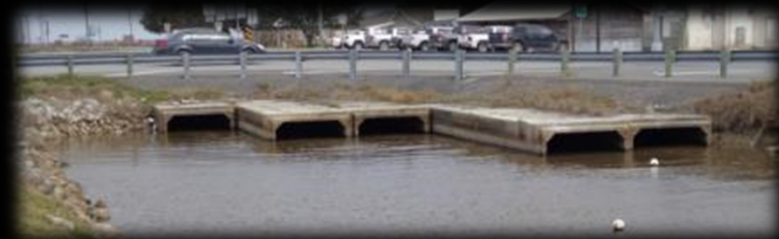
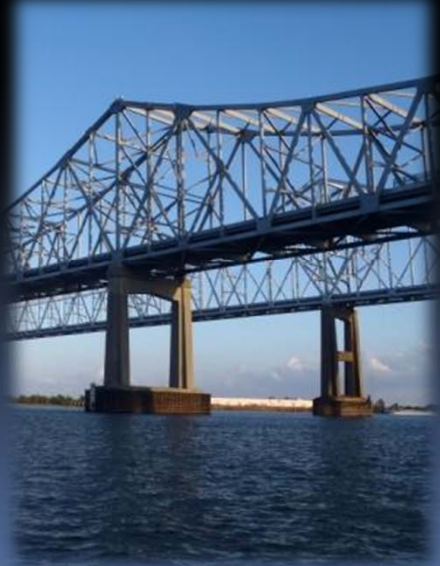
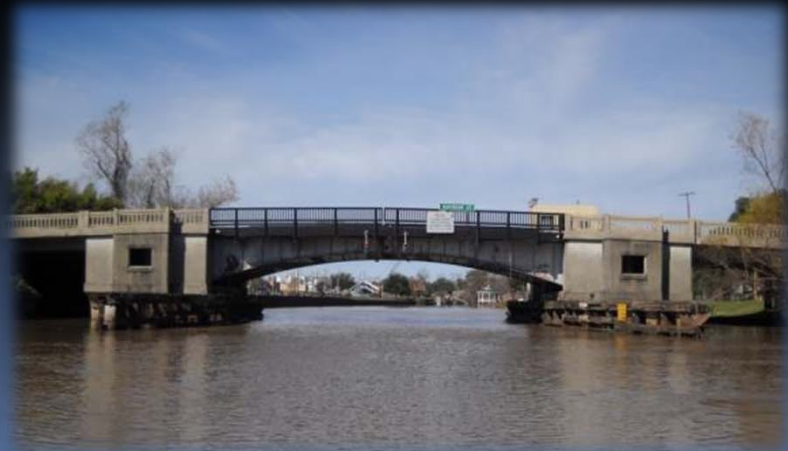
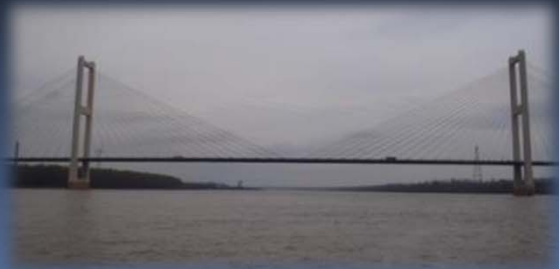
# Bridge Substructure Types Examined

- *Caisson founded monolithic piers*
- *Pile-supported spread footings with columns*
- *Mid-water footings supported by Drilled shafts*
- *Pile-supported waterline and above water footings*
- *Flooded culverts*

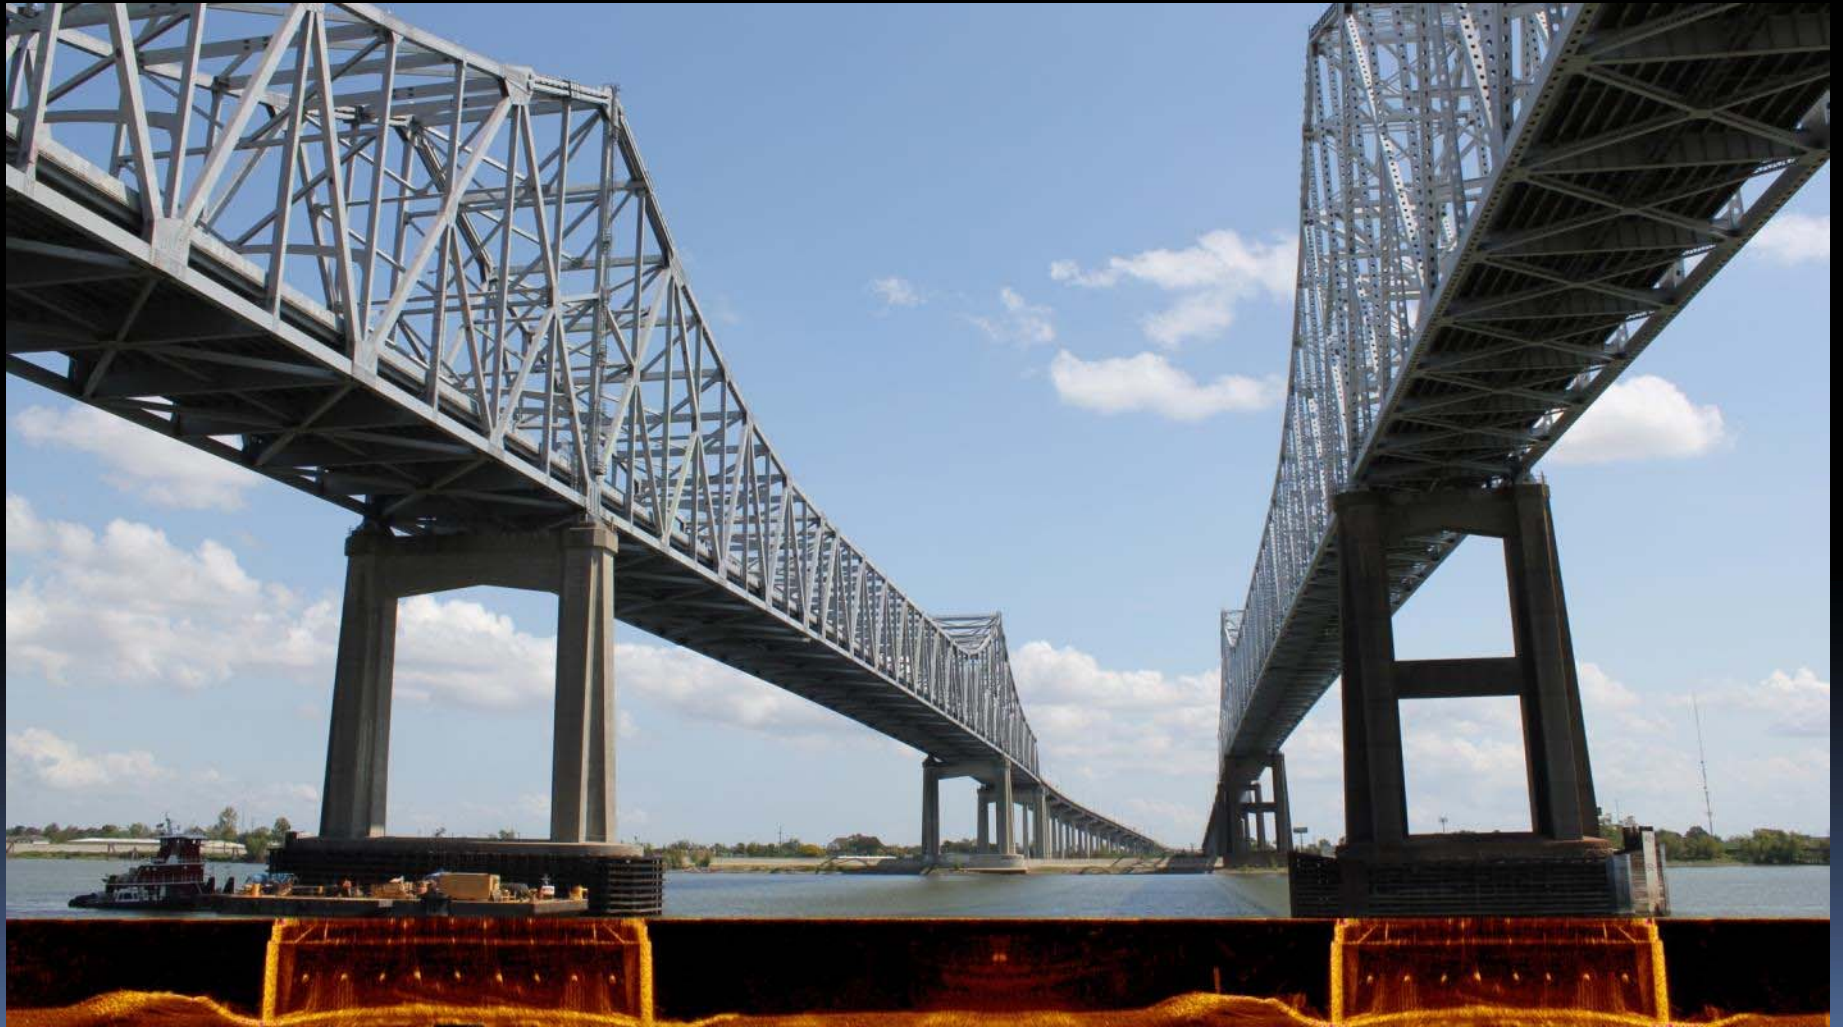
# Mississippi River Massive Monolithic Pier Structures

*Crescent City Connection, and Greater New Orleans Bridges New Orleans, LA*

Large monolithic pier with significant and dense debris field surrounding the structure

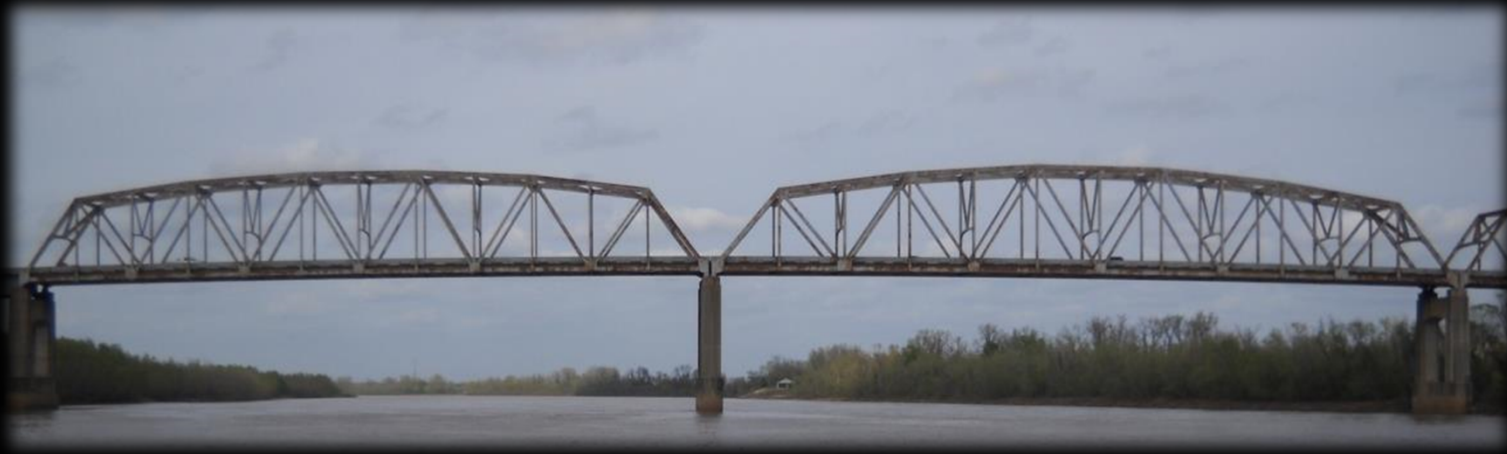
# Red River

Large structures, rapid flow and rapidly changing river bed

*Localized scour and exposed sheet pile encasement shown*

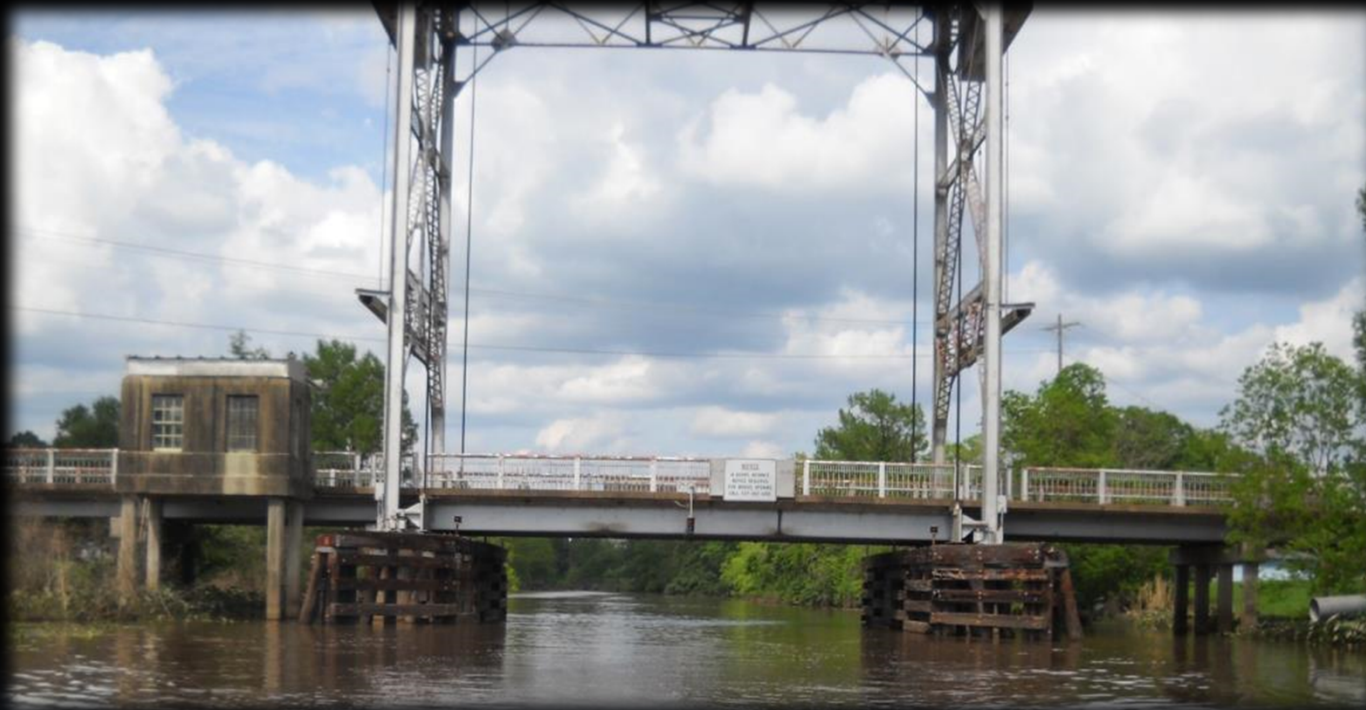
# The Bayou Teche

*Very shallow and  
minor waterway;  
however, UAI  
provides value in  
graphic  
documentation of  
voids*

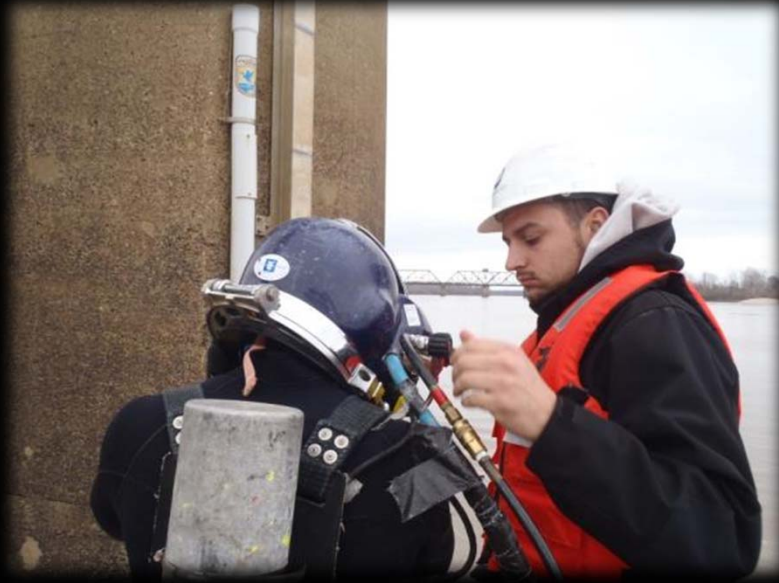
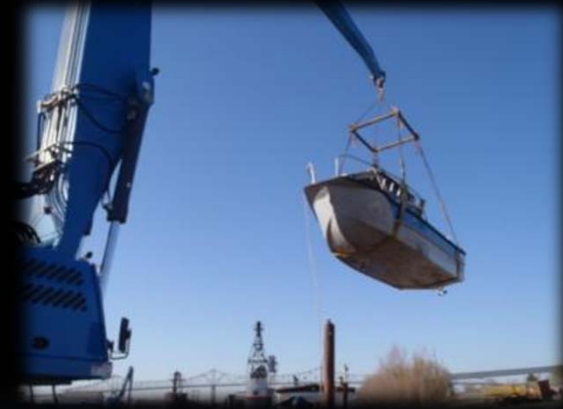
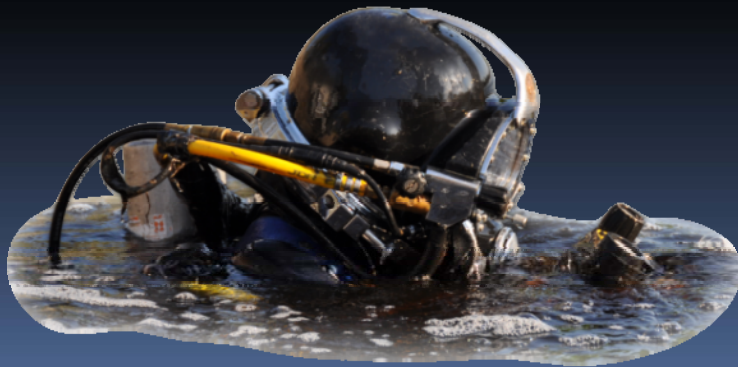
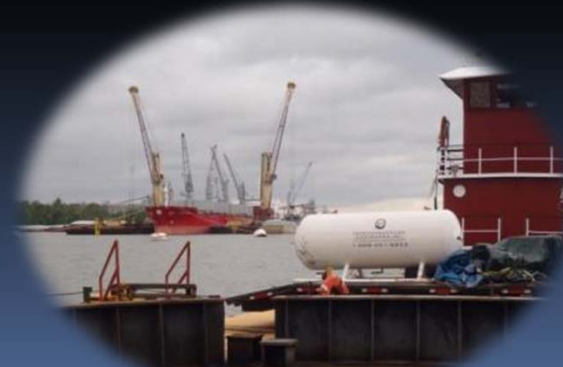
# Diving Inspections

## As Dictated by UAI Observations

- *Inspected “anomalies”*
- *Verification of procedure*

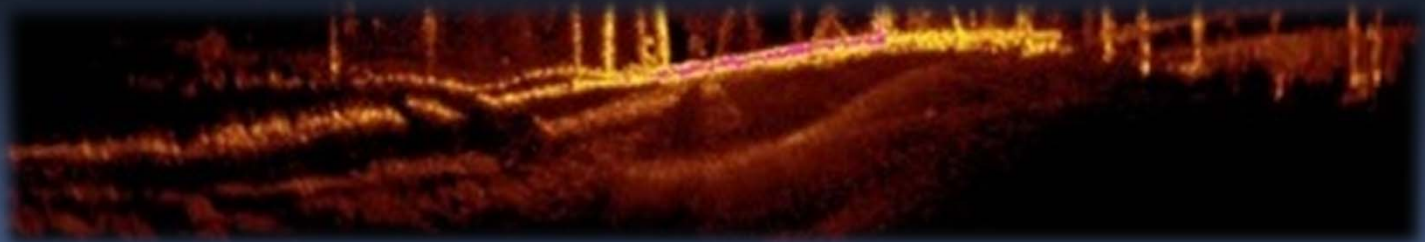
# Mermentau River

*High density of closely spaced piles and close proximity of fender system produces difficulties for UAI effectiveness*
