PAVEMENT MAINTENANCE ISSUES & POTENTIAL SOLUTIONS

NICK VERRET, P.E. CITY OF NATCHITOCHES & PARISH OF NATCHITOCHES

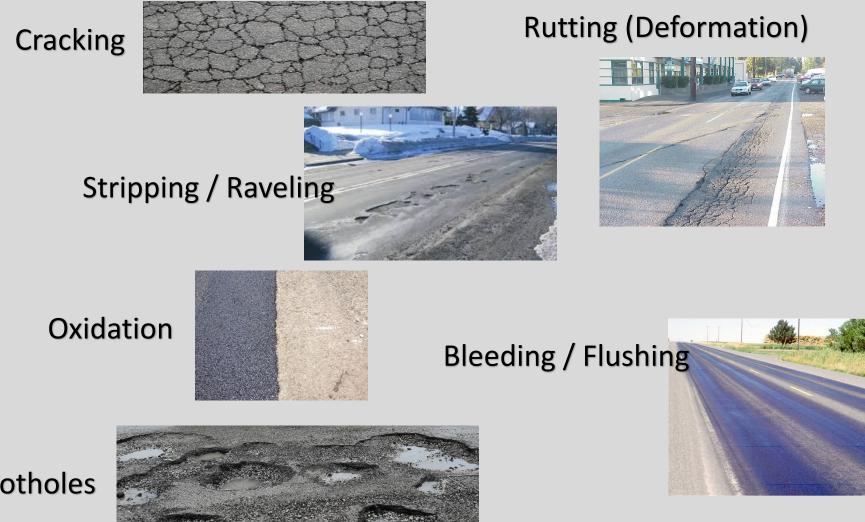
Potholes

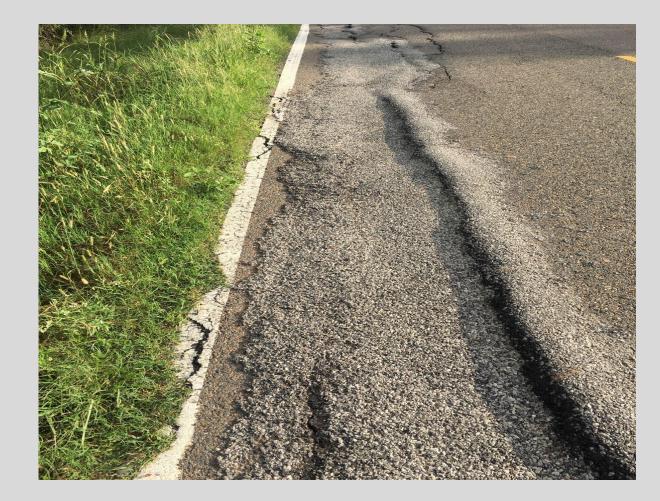
DESSICATION CRACKING SOMETIMES RESULTS IN PAVEMENT FAULTING

ON THE 3,000-LINEAR FOOT SECTION OF ROADWAY SHOWN IN PREVIOUS SLIDES

- SOIL BORINGS INDICATED PRESENCE OF CLAY SUBGRADE SOILS WITH
 PLASTICITY INDEX OF 21
- DESIGN PAVEMENT TYPICAL SECTION WAS 12" THICK SUBGRADE LAYER [6% LIME TREATMENT FOLLOWED BY 6% CEMENT TREATMENT] AND 8.5" THICK CEMENT STABILIZED BASE COURSE [6% CEMENT]
- COUPLED WITH PROXIMITY TO TREES ALONG ROADSIDE = A RECIPE FOR DESSICATION CRACKING

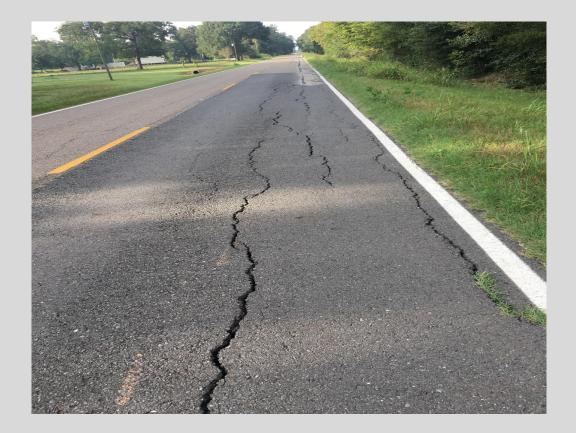
LEVELING CAN CORRECT FAULTING, BUT . . . CRACK REFLECTION USUALLY OCCURS

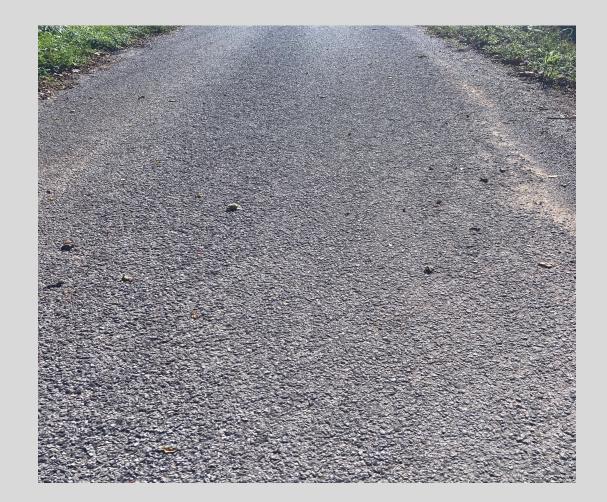
RESULT -- NO CRACKS!

- LABORATORY TESTING INDICATED THAT <u>300 PSI</u> COMPRESSIVE STRENGTH COULD BE ATTAINED BY UTILIZING <u>3% PORTLAND CEMENT</u> WITH A PROPRIETARY <u>LIQUID POLYMER ["BASE SEAL"]</u> ADDED TO MIXING WATER AT RATE OF <u>0.6 OUNCES PER GALLON</u>.
- ALLOWED FOR 8" THICK BASE COURSE INSTEAD OF 12" THICK

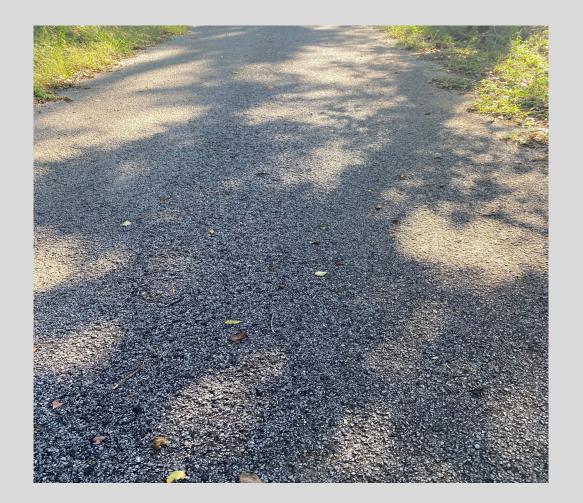
... EVEN 3 YEARS LATER
