1. Report No.		2. Government Accession No.		3. Recipient's Catalog No.	
4. Title and Subtitle <b>Mitigation Strategies of Reflective Cracking of Pavement</b>		5. Report Date October 2014

11. Contract or Grant No.			
12. Sponsoring Agency Name and Address Louisiana Department of Transportation and Development P.O. Box 94245 Baton Rouge, LA 70804-9245		13. Type of Report and Period Covered <b>Final Report</b> <b>2013-2014</b>

# Mitigation Strategies of Reflective Cracking in Pavements

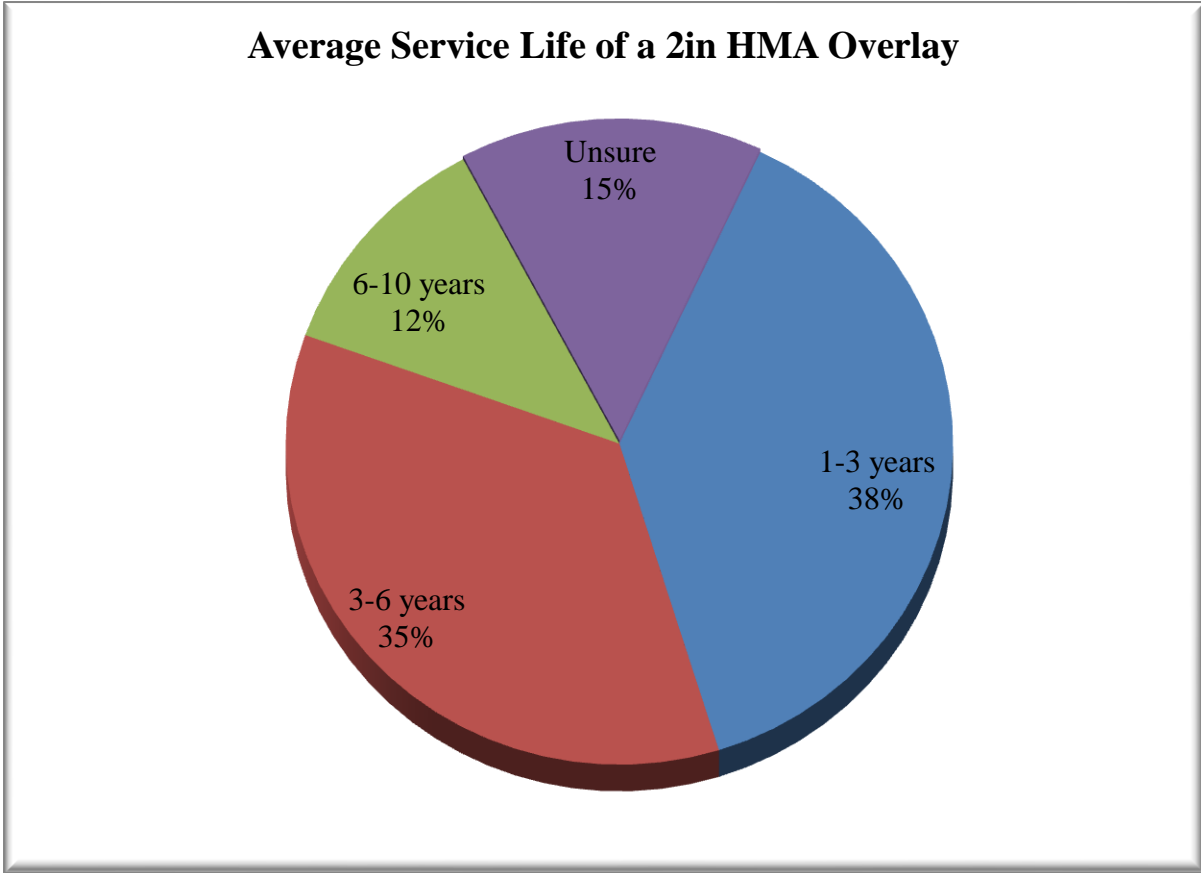
**Figure 3**  
**Average Service Life of a 1.5 to 2.0 in HMA Overlay against Reflective Cracking**

28 these states are located in the northern region of the US and Canada. This trend was  
29 expected due to the impacts of thermal movement on the fast propagation of reflective  
30 cracking.

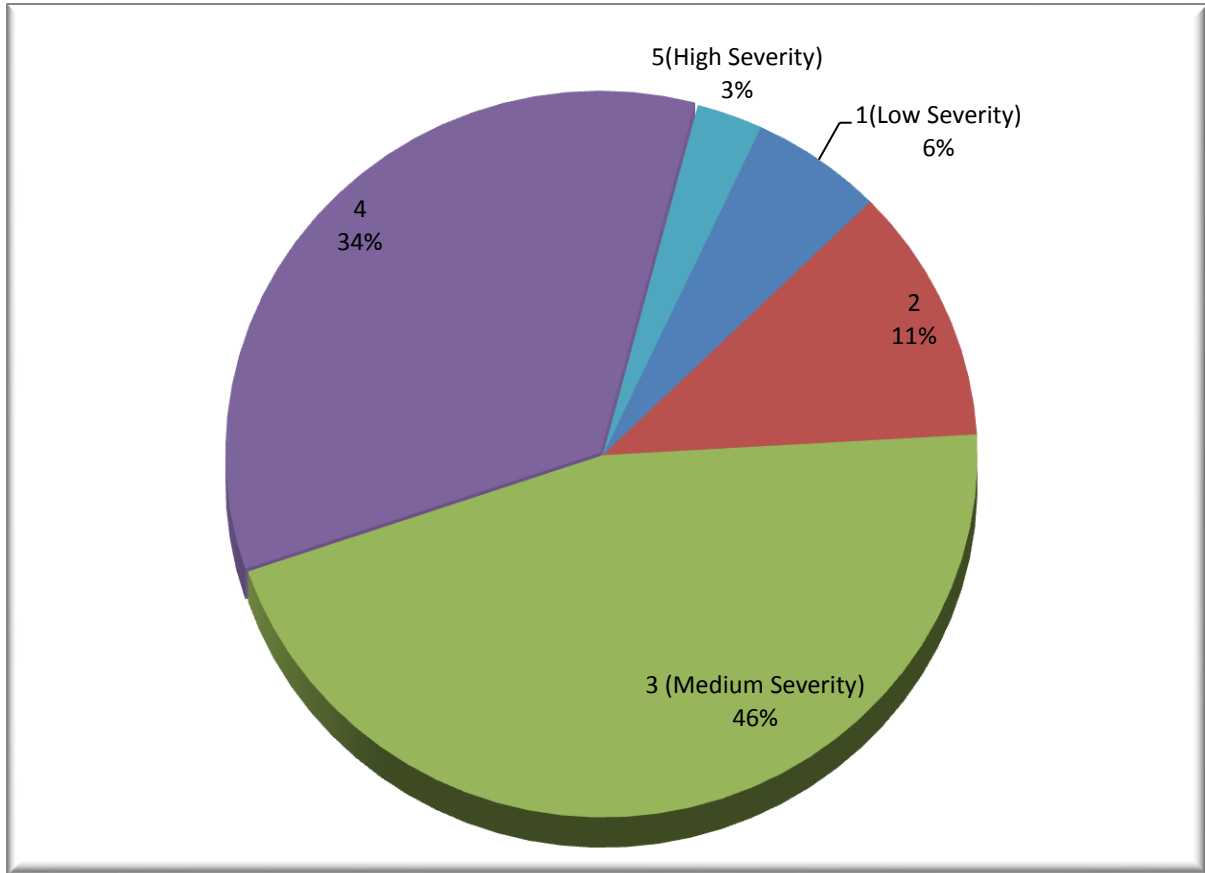
1  
2  
3 **Figure 4**  
4 **Severity of the Problem of Reflective Cracking**

The second question in the survey gaged the importance of reflective cracking for highway agencies. The responses were collected on a scale from 1 to 5 as 1 being the lowest severity and 5 being the highest severity. Figure 4 presents the criticality of the reflective cracking problem for highway agencies. The majority of the respondents perceive the problem of reflective cracking as a medium to high level of severity. Given that not all roads would be subjected to reflective cracking, this response is indicative of a serious problem that should be addressed especially when dealing with rehabilitation of existing pavements.

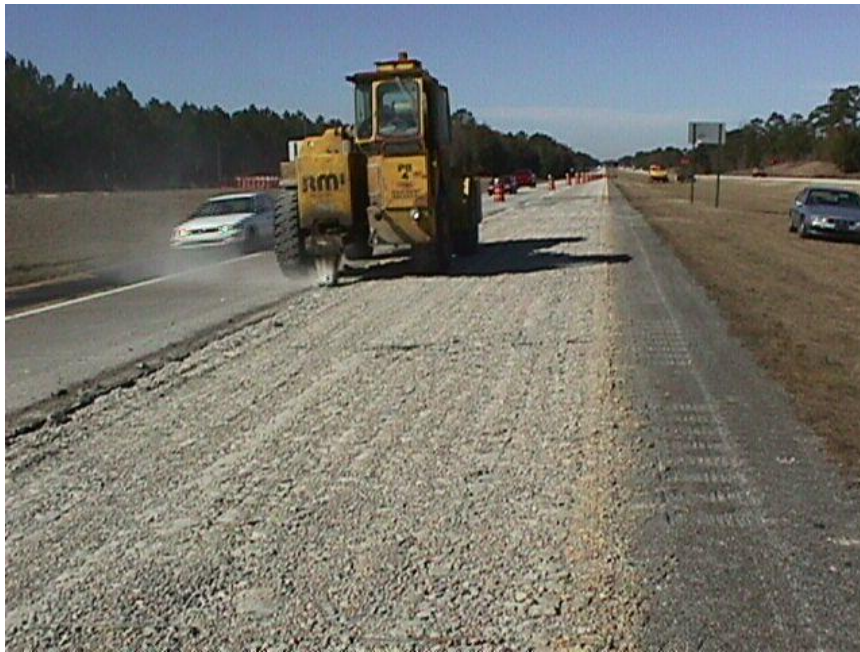
Rubblization, which is the most promising fracturing slab techniques, has been used with all types of concrete pavements. It consists of completely destroying slab action by transforming the concrete layer into an aggregate base [58]. The size of the broken concrete pieces usually ranges from 2 to 6in and therefore, this process results in a significant loss of concrete strength, see Figure 26. A study reported that the resulting rubblized layer has a

14 **Figure 26**  
15 **Rubblized Concrete Pavement [63]**

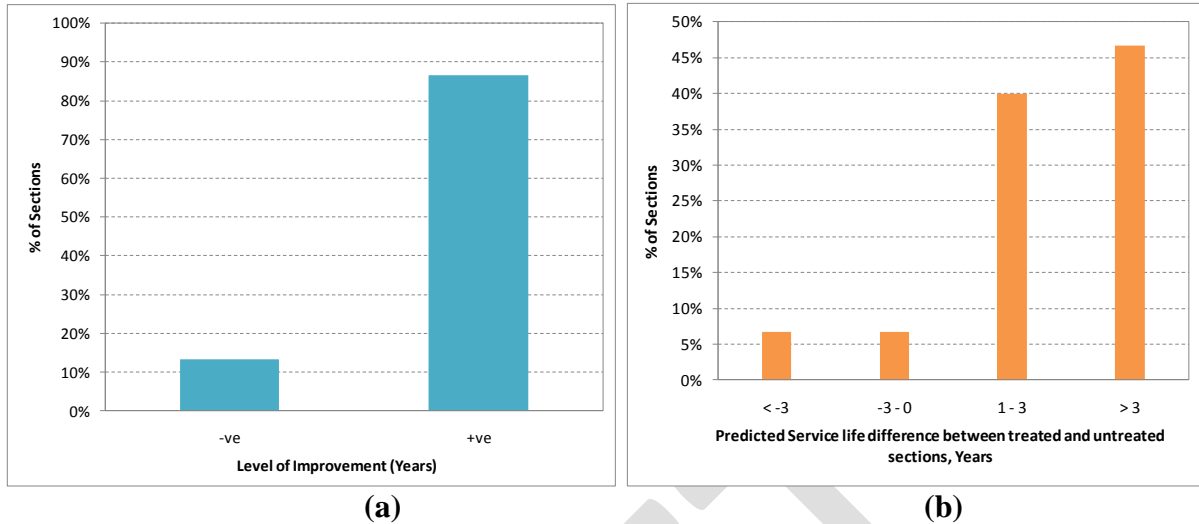
**Figure 30**  
**Contribution of the Saw and Seal method to the Predicted Pavement Service lives [84]**

22 perform well or similar to the untreated sections was 0.6%. This low level of secondary  
23 cracks in the evaluated sites indicates that the approach adopted in Louisiana to locate the  
24 joints after placement of the overlay is effective in minimizing secondary cracks. Theoretical  
25 investigation conducted using 2 dimensional FE analysis indicated that the use of saw and  
26 seal method significantly reduced the strains levels at the PCC joints. This will result in the  
27 control of crack initiation at bottom of overlay and propagation with repetition of loads. The  
28 saw and seal dissipated the energy due to wheel loading and expansion and contraction of the  
29 concrete and allows the movement of the slabs underlying the HMA without formation of the  
30 cracks.

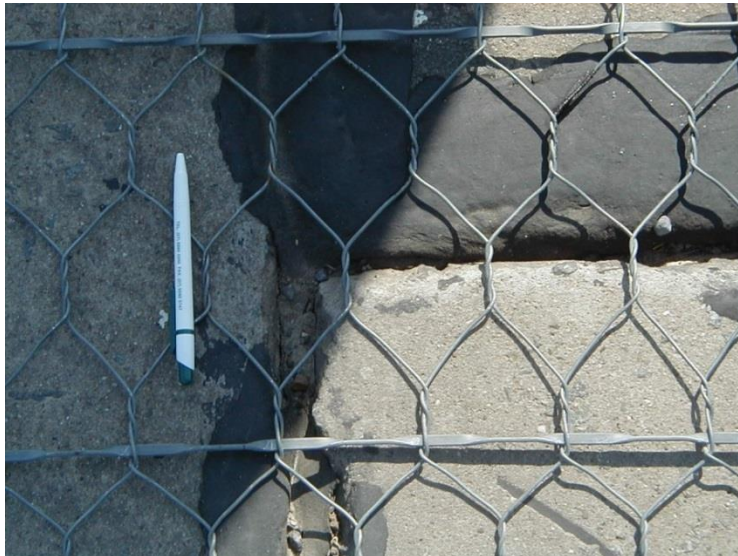
One of the oldest interlayer systems used in flexible pavement is steel reinforcement. The idea, which appeared in the early 1950s, was based on the general concept that if HMA is strong in compression and weak in tension, then reinforcement could be used to provide needed resistance to tensile stresses [85]. However, the concept of using steel reinforcement in HMA materials was abandoned in the early 1970s after tremendous installation difficulties were encountered. The idea reappeared in Europe in the early 1980s with the development of a new class of steel reinforcement products. Many of the problems encountered earlier appeared to have been solved, and satisfactory experiences with the new class of steel reinforcement were reported. The current steel mesh product consists of a double-twist, hexagonal mesh with variable dimensions, which is transversally reinforced at regular intervals with steel wires (either circular or torsioned flat-shaped) inserted in the double twist, as shown in Figure 32. No welding is used in the new generation of steel reinforcement. This eliminates installation difficulties and any variation in HMA densities caused earlier by welded reinforced steel.

**Figure 32**  
**Steel Reinforcing Mesh [85]**

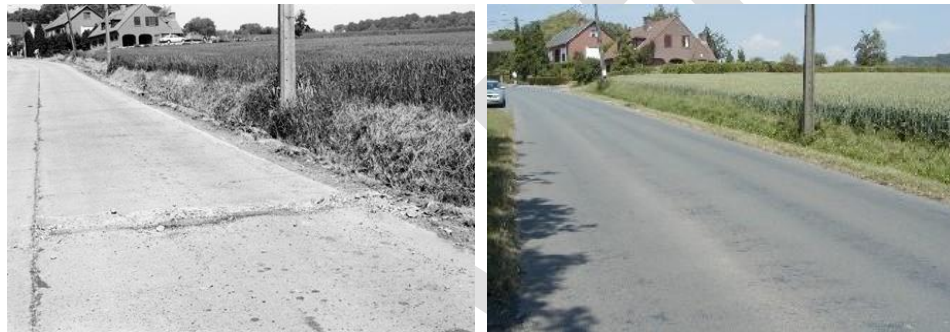
1 deteriorated rigid pavement structure with a traffic pattern classified as light to medium; see  
2 Figure 33. In 1989, steel reinforcement was installed after minor repairs to the existing  
3 pavement structure. A 3-in. overlay was then applied on top of the steel netting. Figure  
4 33(b) illustrates the same road after 11 years of service (2000). After 10 years of service,  
5 inspections of this site showed a reflective cracking occurrence of only 1%. To date, the new  
6 class of steel reinforcement has only been installed in the US in a limited number of  
7 experimental sections starting with the Virginia Smart Road in 1999 and several test sites in  
8 Pennsylvania, Delaware, and Maryland. Pioneer work conducted in the evaluation of the  
9 new class of steel reinforcement in the US has been conducted by Al-Qadi and co-workers  
10 [85, 86].
