# ***Louisiana Transportation Research Center***

Final Report 532

## **Investigation of Best Practices for Maintenance of Concrete Bridge Railings**

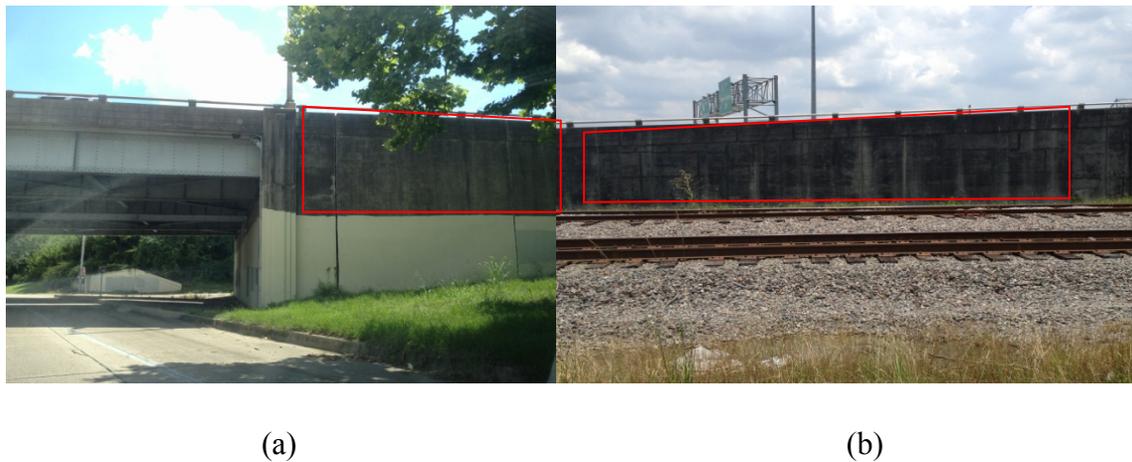
**Figure 1**  
**Development of biofilms on concrete structures in Louisiana**

The development of biofilms on concrete structures has a negative impact on aesthetics as well as on the performance and integrity of concrete structures [1-5]. Biofilms develop and grow easily when the right conditions are present, such as high relative humidity (60 to 100%) and temperature (70 to 95°F). These conditions are encountered in the hot-humid climatic region, which includes the state of Louisiana [6]. As a consequence, visible stains and a relatively fast deterioration of bridges, roads, highways, and other structures are encountered in the state of Louisiana. This issue has triggered public complaints which, as a result, have raised the need to find a practical and economic solution to be used by the Department. Figure 1 (a and b) illustrates concrete elements with biofilm growth in LA (concrete walls), in Baton Rouge, Louisiana. Figure 1(a) is located on the I-10 overpass on Dalrymple Drive, and Figure 1(b) is located on the I-10 exit towards Lafayette in Port Allen. Both concrete surfaces show clear signs of biofilm activity, characterized by black stains.

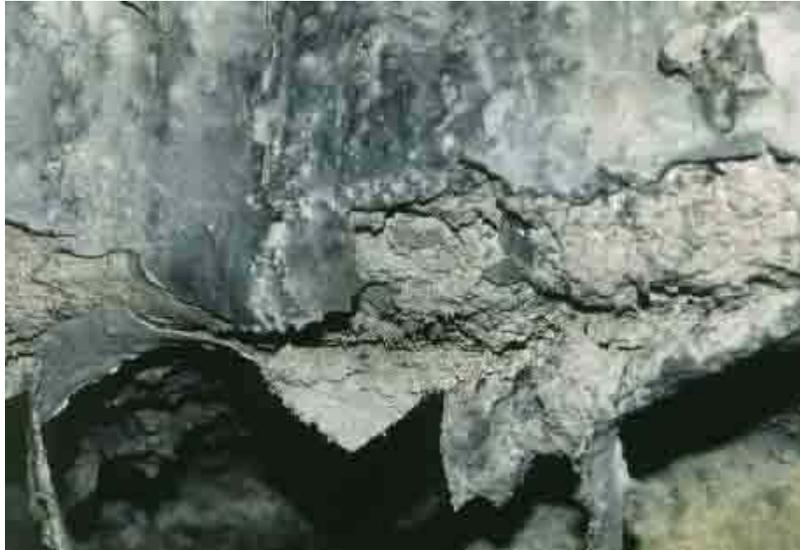
**Figure 3**  
**Acid producing bacteria penetrating and colonizing concrete [18]**

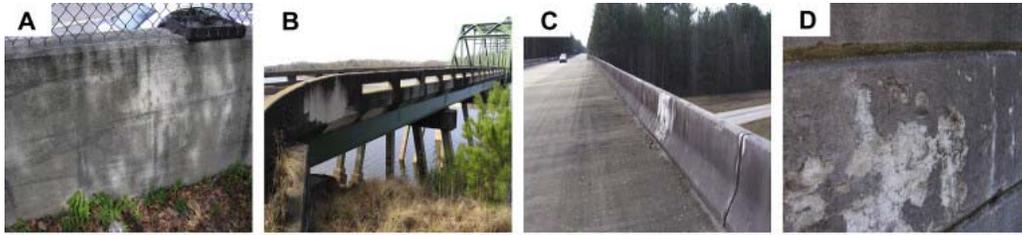
**Figure 4**  
**Concrete damage caused by fungi [19]**

Fungi are different from plants; while plants get their nutrients through photosynthesis, fungi absorb nutrients from the substrate on which they grow, by secreting enzymes that breakdown cellulose material around them. Just like bacteria, fungi can be found under a wide range of climatic conditions. However, fungi accounts for a larger fraction of the biomass of the planet than humans [7]. That is why humans always come in contact with different species of fungi. Out of approximately 100,000 species of fungi that have been identified, only several hundred can produce mycotoxins, which are toxic compounds thought to be produced by the organism to defend itself [7]. Figure 4 shows concrete damage caused by fungi.

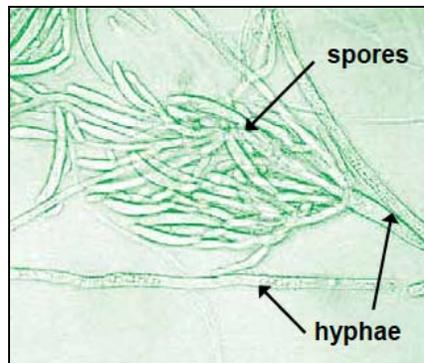
**Figure 5**  
**Fungi parts [20]**

Fungi consist of two main components: the *Hyphae* and the *Spores* (See Figure 5). *Hyphae* are large vegetative filaments that are part of fungi. As a fungus grows, more *hyphae* will be created. Large mass of *hyphae* is also known as mycelia. *Spores* are the reproduction mechanisms of fungi. *Spores* are very small, ranging from 2 to 20  $\mu\text{m}$  (microns). When a fungus matures, it will produce spores and send them airborne or waterborne to create new colonies. Because of their small sizes, spores are respirable, and some fungi species create spores that may be allergenic to some humans. Spores can travel in water or air, landing on surfaces; when provided with the right conditions such as humidity and nutrients, they can form new colonies [7]. Generally, fungi can be found in places where temperatures range from 25 to 30°C [2].

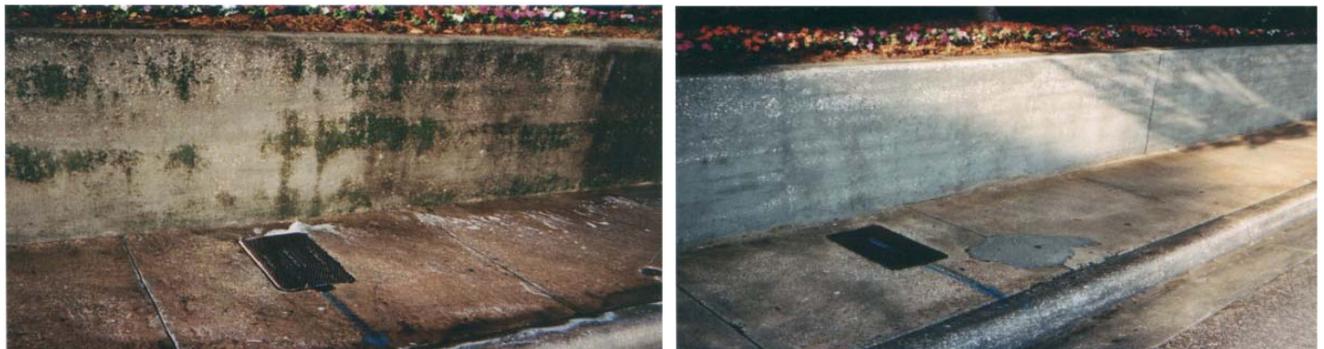
**Figure 8**  
**Concrete colonized by algal species (green algae); before and after cleaning [23]**

as calcium, magnesium, and silica [2]. Figure 8 shows example of concrete stained by algae and how it was restored by cleaning.

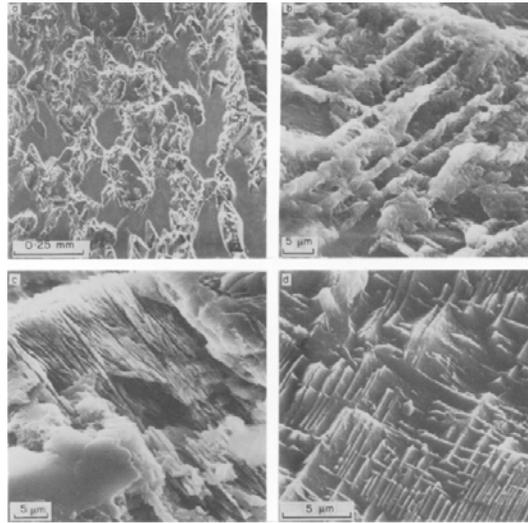
**Figure 9**

**Surface damage caused by crustose lichens. Images show etched out minerals from granite (SEM images) [1, 24]**

Lichen is a combination of fungi and green algae. These two organisms support each other symbiotically to survive. Fungus provides water to algae and algae take from the fungus inorganic substances. This characteristic of the lichen allows it to survive in very hostile habitats. Lichens are usually the first organisms to colonize newly exposed surfaces [13]. These organisms excrete organic acids that can deteriorate (weather) the substratum on which they grow (chemical bio-deterioration), and also can physically deteriorate it by disaggregating the minerals by expanding and contracting its mycelium [1, 24]. Figure 9 shows damage induced on a granite surface by lichens.

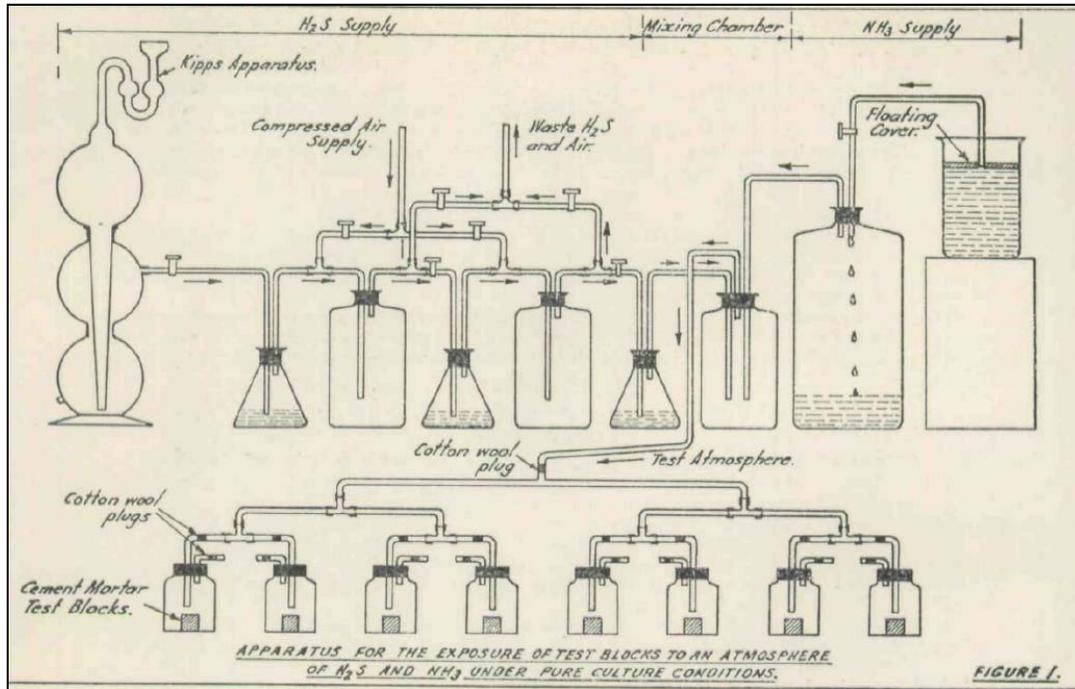
**Figure 10**

**Laboratory test performed by Parker to test the effects of the bacterium on concrete [16]**

Using the laboratory setup presented in Figure 10, concrete blocks were inoculated with specimens found in corroded concrete inside sewer pipes for a period of 3 to 4 months until the corrosion was visibly evident, as shown in Figure 11. This research provided evidence that demonstrated that more investigation on microorganisms and their deteriorating effects on concrete surfaces is needed.

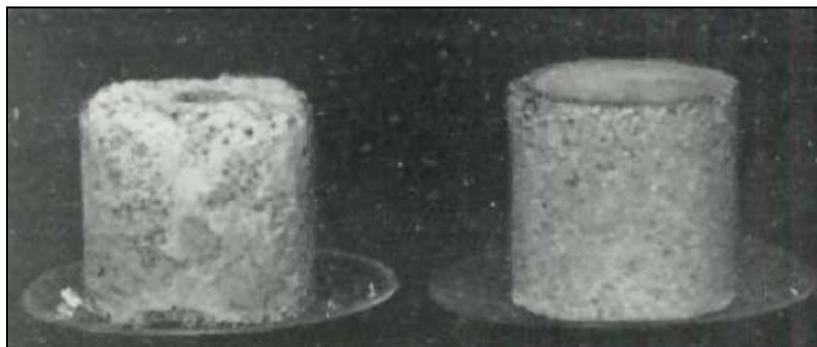
**Figure 11**

**Corroded concrete block after removal of corroded material [16]**

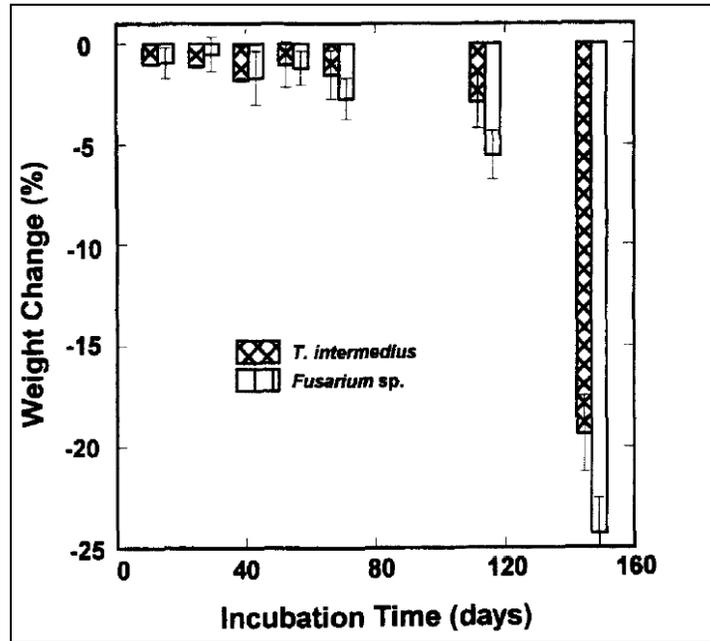
Figure 12

Percentage of weight change of concrete blocks inoculated with *Thiobacillus intermedius* and *Fusarium sp.* [17]

**Deterioration of Highway infrastructure Concrete Elements Due to Presence of Micro-Organisms.** Gu et al. demonstrated the effects of fungi on the degradation of concrete [17]. In this experiment, concrete samples were inoculated with *Fusarium* sp. (fungal specie) and *T. intermedius* (bacteria). During the first month of inoculation, the Portland cement samples demonstrated similar Ca<sup>2+</sup> release for both species. For the remainder of the experiment, the concrete inoculated with *Fusarium* sp. showed higher levels of calcium release with 24% of weight loss compared to the 18% weight loss of the concrete inoculated with *T. intermedius* as shown in Figure 12. This experiment was the first to show that biofilms composed by, not only bacteria, but also fungal species have deteriorating effects on concrete. Furthermore, it showed how significant the weight loss of concrete elements can be when exposed to microorganisms.

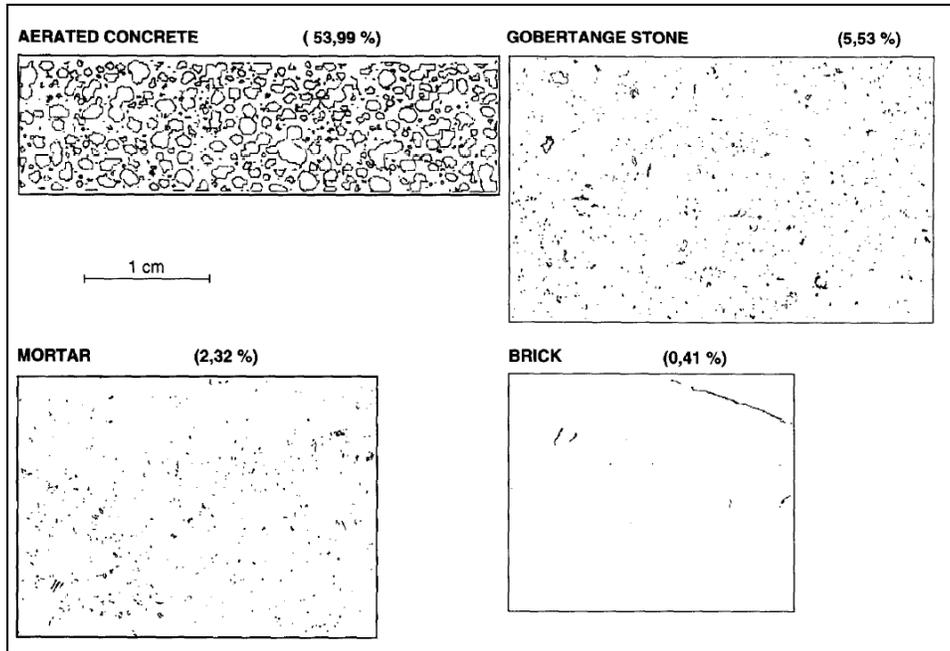
**Figure 13**

**Macro-porosity values in percentage of the materials tested in the experiment. The values were obtained through automated image analysis [26]**

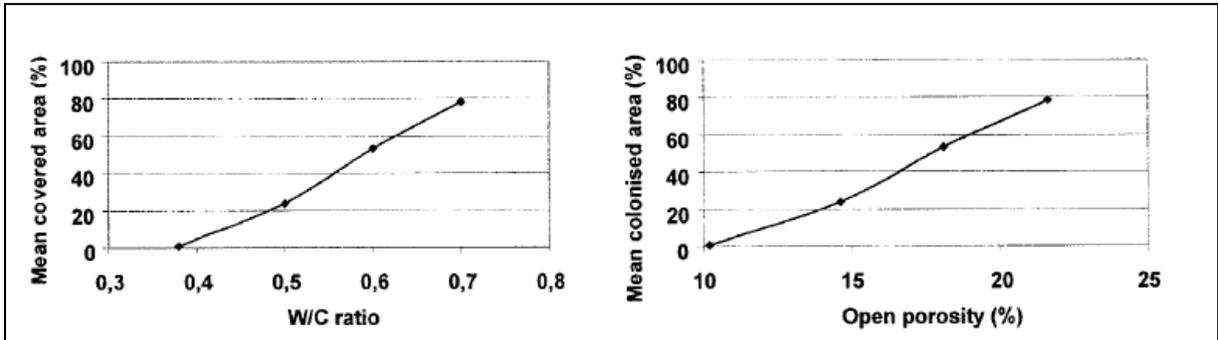
**Figure 14**

**Percentage of mean covered area vs. water-to-cement ratio (left) and open porosity (right) [31]**

Another study investigated how the percentage of the covered area varied with porosity and water cement ratio. Results are shown in Figure 14 [30, 31]. As surface roughness of concrete increased, void ratio also increased, creating more space for water retention, which can support microorganism growth. In addition, water/cement ratio has been proved to influence the bioreceptivity of concrete to certain deteriorating species of microorganisms. As the water

proportion in a concrete mix increased, the permeability of concrete also increased, thus resulting in larger areas for moisture and nutrient retention [30, 31].

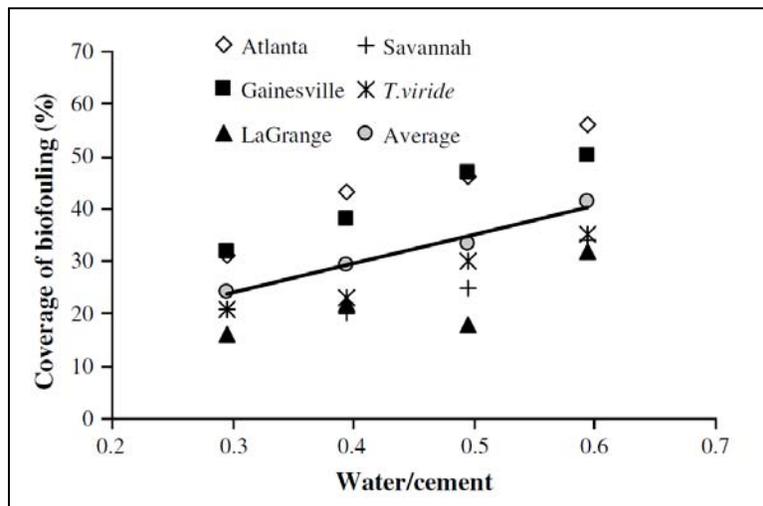
**Figure 15**

**Coverage of Biofouling vs. water-to-cement ratio [30]**

A similar relationship was observed in the experiment conducted by Giannantonio et al. and is shown in Figure 15 [30]. The coverage of the biofilm layer increased as the water-to-cement ratio increased.

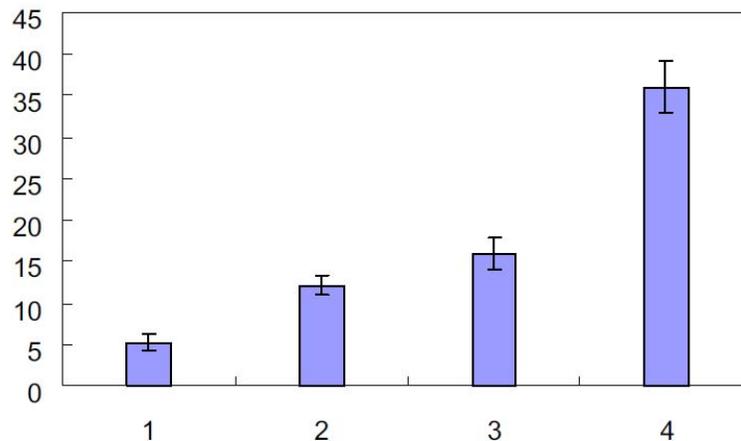
**Figure 16**

**Concrete deterioration state versus quantity of microbes present in x10<sup>6</sup> cells/g (1 - undeteriorated concrete, 2 - slightly deteriorated, 3 - moderately deteriorated concrete, and 4 - severely deteriorated concrete) [32]**

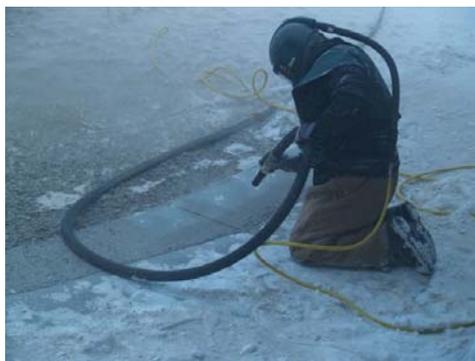
**Figure 17**  
**Abrasive blasting [35]**

**Sandblasting.** Abrasive blasting, shown in Figure 17, is commonly known as *sandblasting*. This is a process that consists in propelling a stream of abrasive materials towards a given surface at high pressure in order to clean it from contaminants, remove paints and coatings, smoothen or roughen the surface, or even shape it [34]. Compressed air or centrifugal wheels are the most common mechanisms to propel the blasting media. There are several variants of this process, such as shotblasting, which uses copper, zinc, aluminum, and steel as the blasting medium; dry ice blasting, which employs CO<sub>2</sub> pellets; bead blasting, which uses glass particles as the blasting medium; sandblasting, which employs sand (silica) as the blasting method, but has been related to lung problems; and soda blasting, which uses Sodium Bicarbonate (NaHCO<sub>3</sub>) as the blasting media.

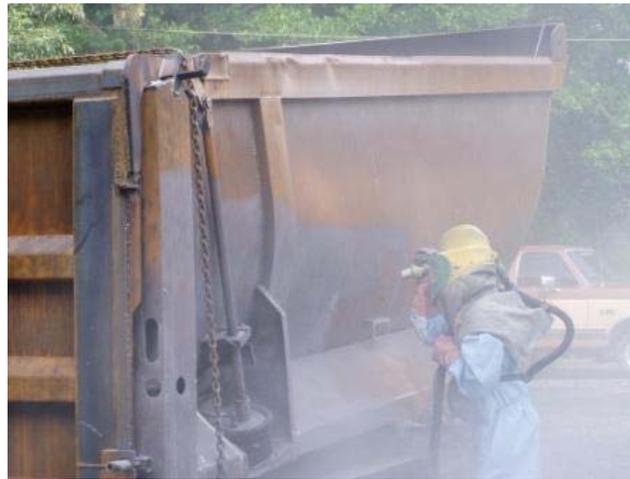
**Figure 18**  
**Soda blasting of a steel container prior to repainting [37]**

**Soda Blasting.** Soda blasting, shown in Figure 18, is an abrasive but gentle cleaning method that is increasing in popularity. The process involves the use of Sodium Bicarbonate ( $\text{NaHCO}_3$ ) as the cleaning medium, applied against a surface using compressed air. This method is very effective for cleaning surfaces, paint stripping, automotive restoration, industrial equipment maintenance, rust removal, graffiti removal, masonry cleaning, and boat hull cleaning. Soda blasting became very popular in the early 1980s when it was selected by the engineers of the state of New York to clean the Statue of Liberty without causing any harm to its exterior. Other methods such as sand blasting were discarded because they could cause damage to the materials of the Statue of Liberty [36].

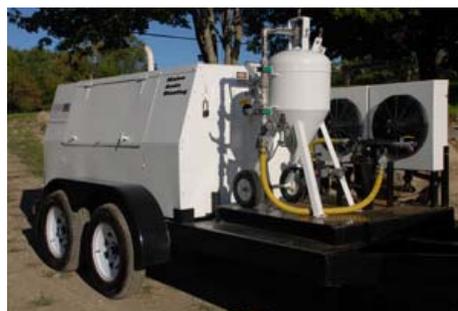
**Figure 19**  
**Soda-blasting machine [38]**

The equipment used to perform soda blasting operations is called a soda-blaster, shown in Figure 19. The soda-blaster consists of a blast generator, high pressure compressed air, moisture decontamination system, blast hose, and a blast nozzle [36].

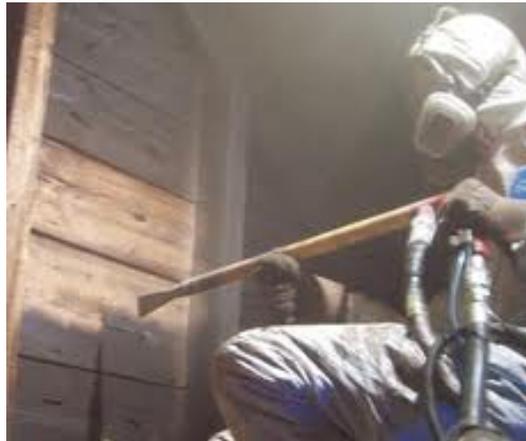
**Figure 20**  
**Dry-Ice blasting process [40]**

**Dry Ice (CO<sub>2</sub>) Blasting.** Dry ice blasting shown in Figure 20, uses CO<sub>2</sub> as the blasting medium. Carbon dioxide, shown in Figure 21, is a non-poisonous, liquefied gas, which is relatively cheap when compared to the other blasting materials. One of the advantages of this method is that it is environmentally- friendly and contains no secondary contaminants such as solvents or grit media, which can be found in other blasting materials [39].

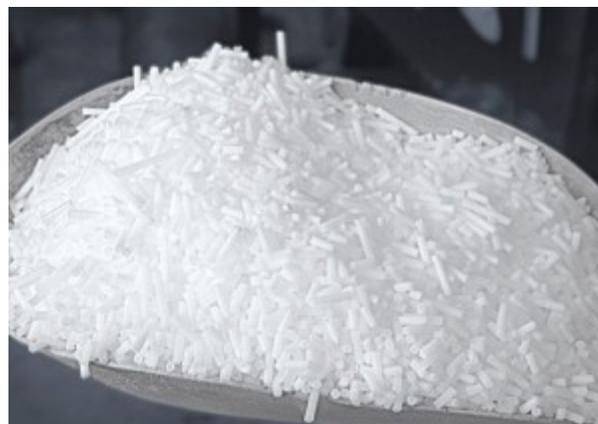
**Figure 21**  
**Dry-ice blasting medium (pellets) [34]**

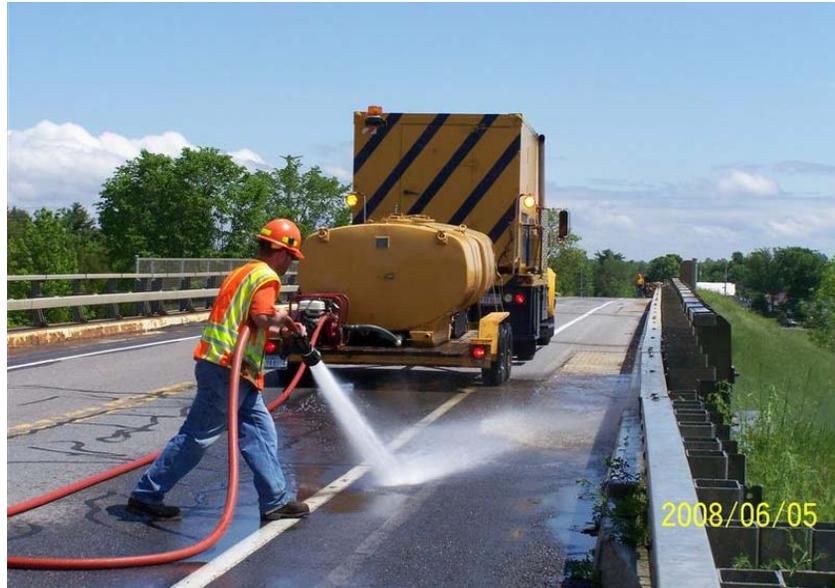
**Figure 22**  
**Pressure washing of a concrete deck [41]**

**Pressure Washing.** Pressure washing, shown in Figure 22, is a method that is used in order to remove contaminants from surfaces. The process consists in pumping water at high pressures against a surface to remove dirt, paint, coatings, or any other undesired loose particles. It is a common practice for highway maintenance agencies to implement this method in order to clear their roads and bridges from debris, dirt, grease, and contaminants. The New York State

Department of Transportation employs this cleaning technique in their bridges and roads to either clean the surface, or to prepare the surface for the application of sealants or coatings [41, 42].

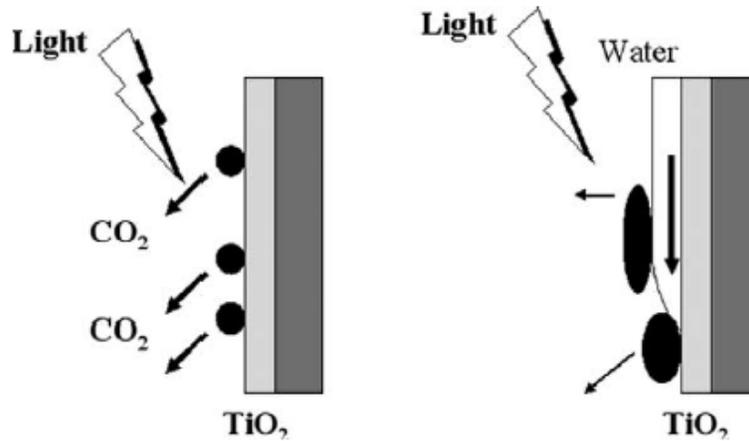
**Figure 23**  
**Super-hydrophilic process of TiO<sub>2</sub>[43]**

**Titanium Dioxide Photocatalyst Coating.** Titanium dioxide can be used to construct surfaces that are capable of self-cleaning when irradiated with UV from sunlight and washed by rainwater. TiO<sub>2</sub>'s self-cleaning ability is a result of a combination of the photo induced super-hydrophilic and photocatalytic properties of the material [43]. Super-hydrophilicity is defined as the ability of the material to have a water contact angle of approximately 0° while photocatalysis is defined as the ability of the material to decompose pollutants when irritated by UV light. In this process, bacteria and organic build is decomposed by photocatalysis while dust and organic contaminants are washed away by rain by the photo induced super-hydrophilicity as shown in Figure 23. Both processes take place simultaneously on the TiO<sub>2</sub> surface. The following section explains the mechanism behind both processes.

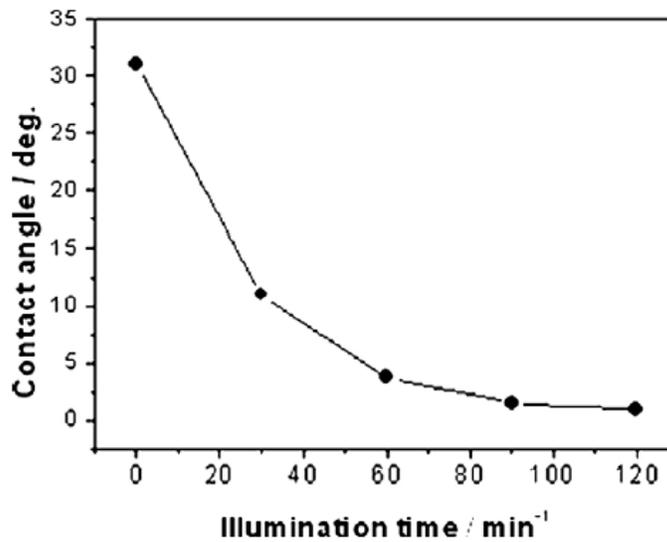
**Figure 24**  
**Water contact angle as a function of time under UV illumination [43]**

*Photo induced super-hydrophilicity.* The anatase form of TiO<sub>2</sub> is considered to be a super-hydrophilic (hydro: water; philic: attraction) component when exposed to UV light. When irradiated by UV light, very low contact angles (approximately 0°) between water and supporting solid is obtained (Figure 24). This causes the water droplets to behave as a layer or a sheet, instead of individual circular droplets as shown in Figure 25.

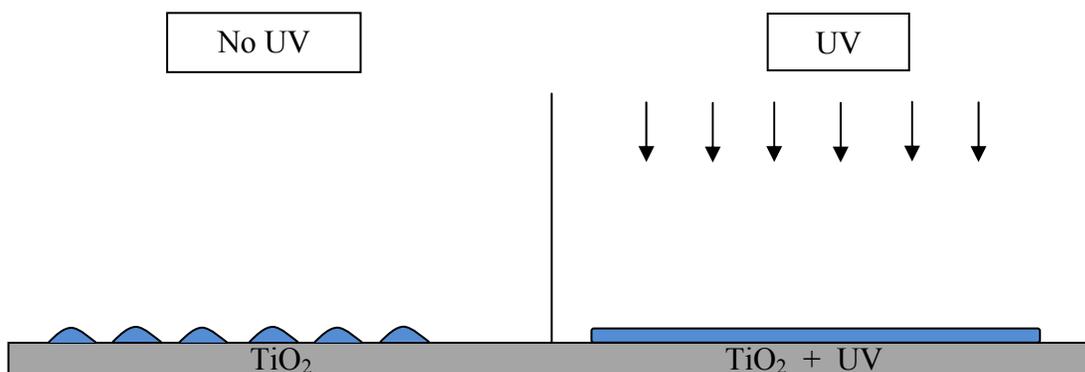
**Figure 25**  
**TiO<sub>2</sub>'s super-hydrophilicity**

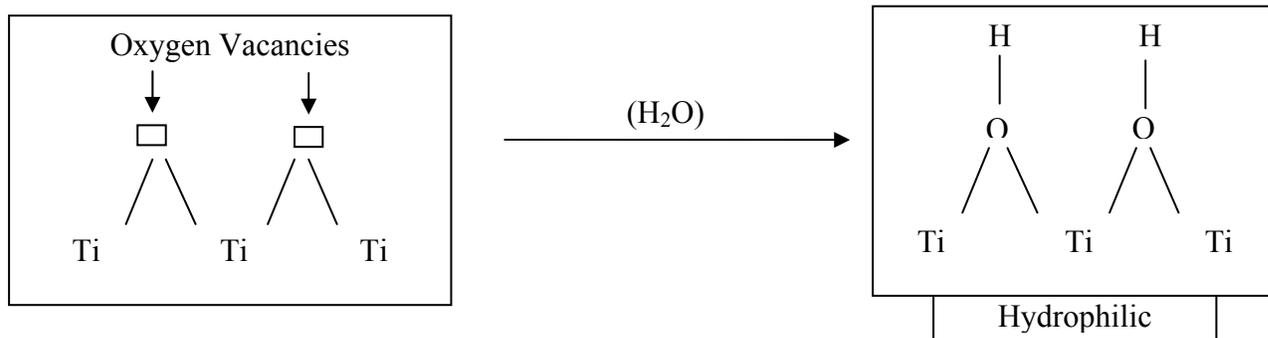
**Figure 27**  
**TiO<sub>2</sub>'s super-hydrophilicity (Part II)**

When the surface is washed, water molecules occupy these vacancies, as shown in Figure 27, producing adsorbed OH groups and making the surface hydrophilic.

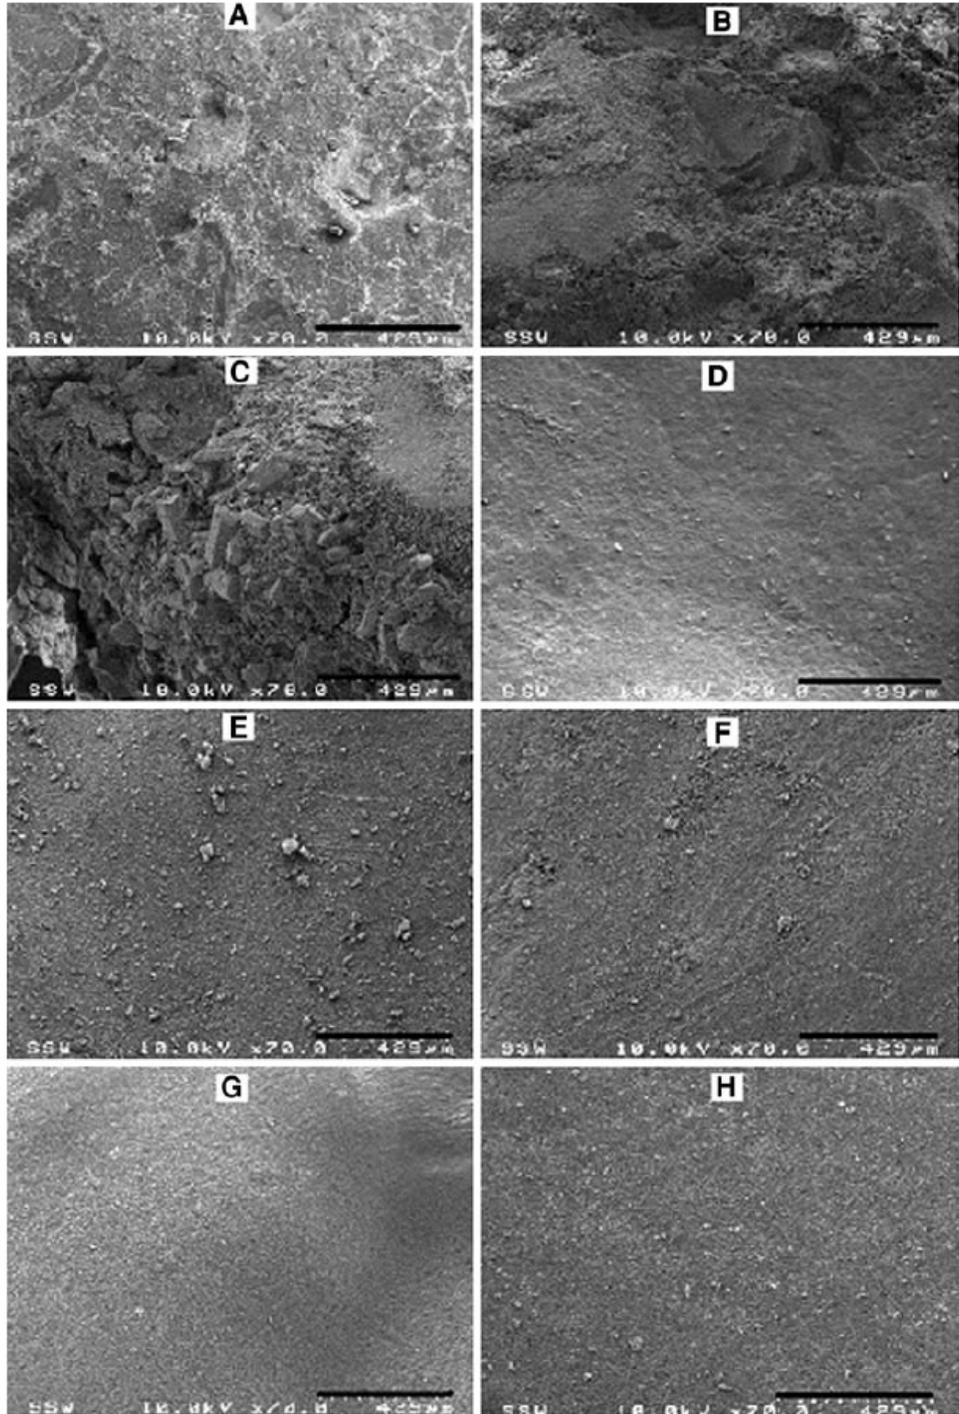
**Figure 28**

**SEM images of concrete tiles. A, B, and C: concrete tiles without zeolite coatings. D, E, and F: concrete tiles coated with zeolite without antimicrobial agent. G and F: concrete tiles coated with antimicrobial zeolite [10]**

Images A, B, and C in Figure 28 correspond to concrete tiles without zeolite coatings before (A) and after (B and C) exposure to the bacterium. The deterioration of the concrete surface of these specimens after exposure is visible (B, C). Concrete specimens coated with both antimicrobial zeolite and blank zeolite, demonstrated the resistance of zeolite to bacterial induced corrosion (images D, E, F, G, H). It was concluded from this experiment that concrete specimens with zeolite coatings are resistant to bacterial induced corrosion by th. Thiooxidans.
