Southeast Transportation Consortium

Final Report 541

Mitigation Strategies of Reflection Cracking in Pavements

Mostafa Elseifi, Ph.D., P.E.
Nirmal Dhaka

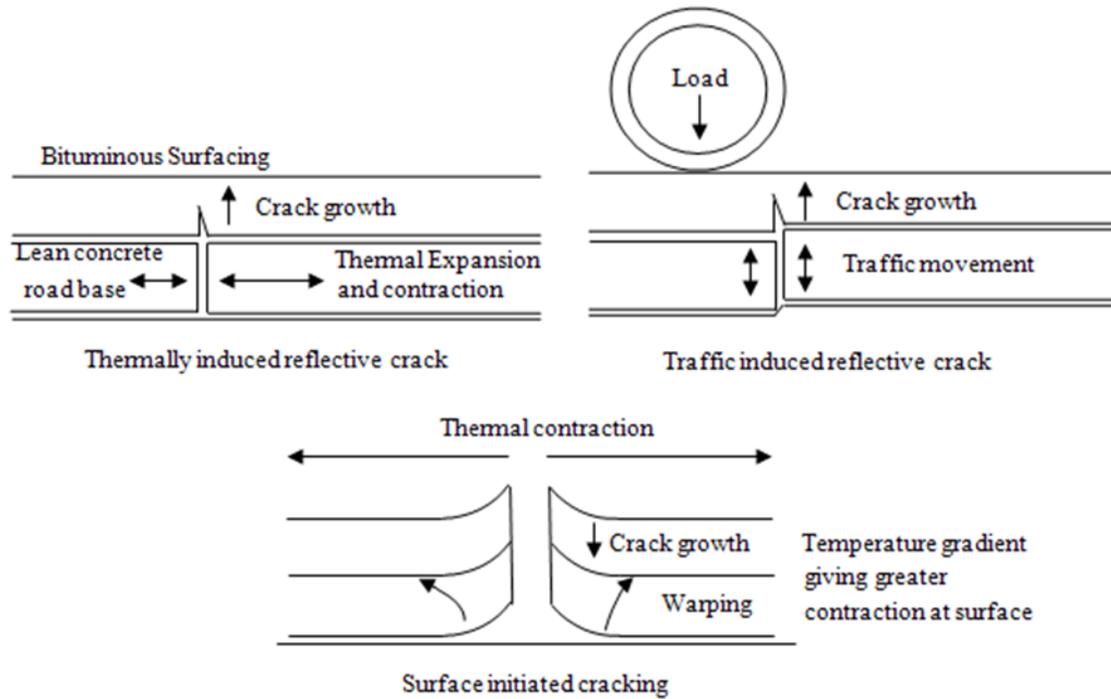
Figure 1
Mechanisms of reflection cracking [15]

According to Lytton, the passing of a wheel load over a crack in the existing pavement causes three critical pulses, one maximum bending, and two maximum shear stresses [13]. As the movement of the crack increases, the propagation of the crack to the overlay occurs faster, as in Figure 1. A difference in temperature can also contribute to the crack propagation. Contraction and curling of the old pavement caused by temperature variation may result in the opening of the cracks, which may induce horizontal stresses in the HMA overlay.

Generally, loads can be applied on a pavement structure in a combination of three fracture modes, which represent the worst cases of loading [14]:

- **Mode 1** loading results from loads that are applied normally to the crack plane (thermal and traffic loading).
- **Mode 2** loading results from in-plane shear loading, which leads to crack faces sliding against each other normally to the leading edge of the crack (traffic loading).
- **Mode 3** loading (tearing mode) results from out-of-plane shear loading parallel to the crack leading edge. This mode of loading is negligible for pavements.

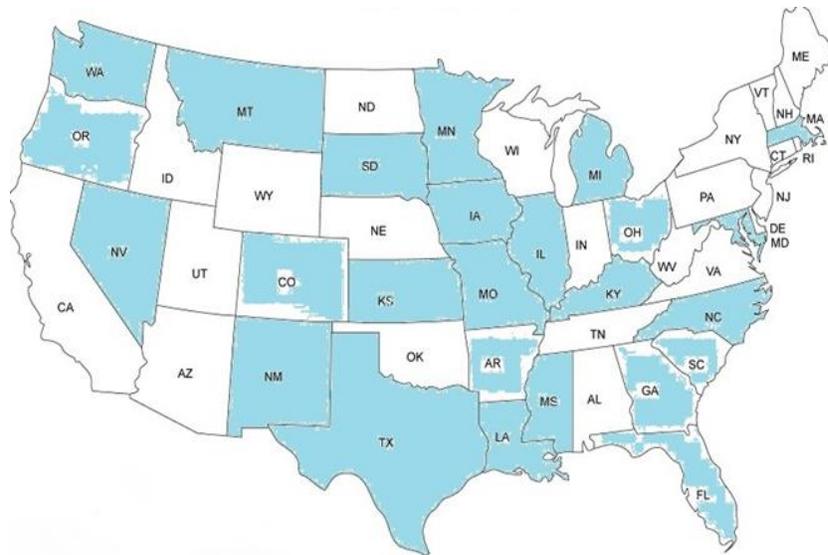
Figure 2
States' response to the survey

A nationwide survey was conducted to collect information from highway agencies in the United States (US) and Canada on the current state of practices to address reflection cracking. Figure 2 shows the states that responded to the survey. In total, 35 responses were received from 25 states, the Quebec Department of Transportation, and the Saskatchewan Ministry of Highway and Infrastructure (Canada). A list of respondents is provided in Appendix A.

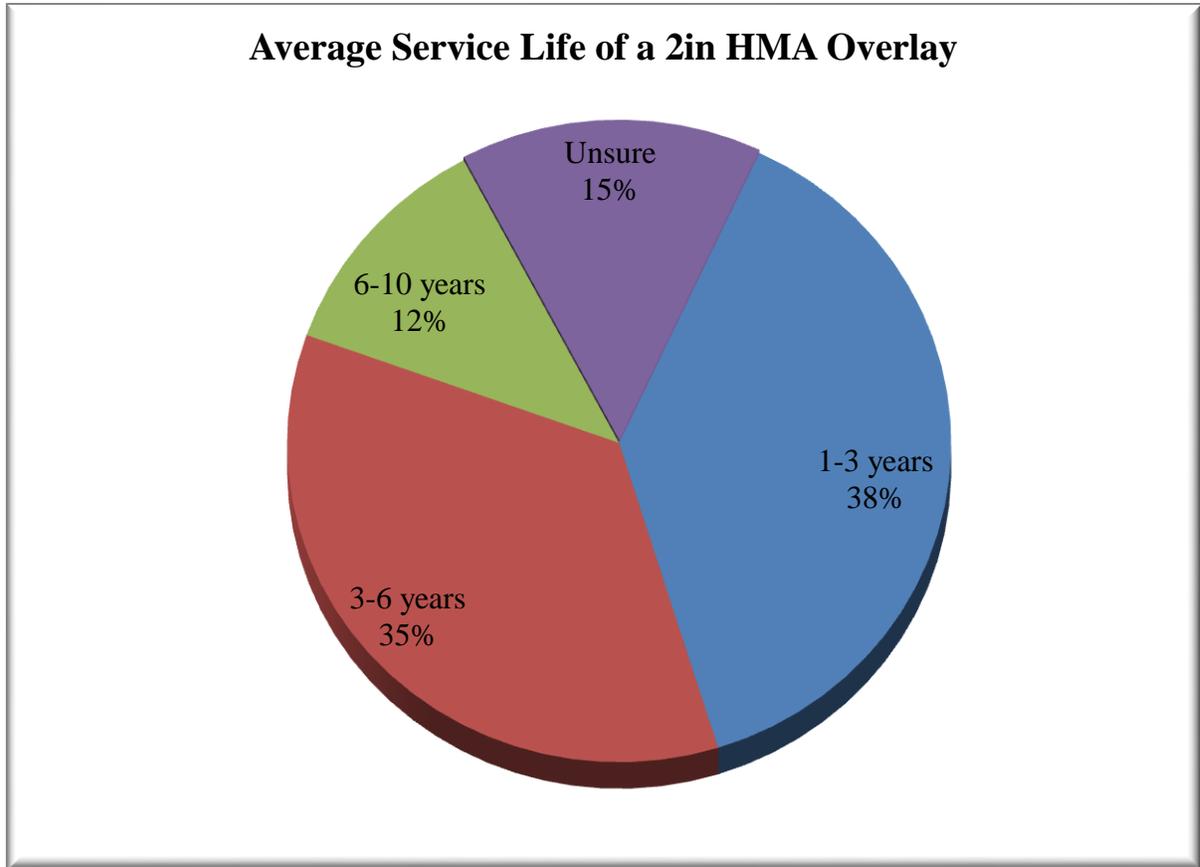
Figure 3
Average service life of a 1.5 to 2.0 in. (38.1 to 50.8 mm) HMA overlay against reflection cracking

Figure 3 presents the average service life of a 1.5 to 2.0 in. (38.1 to 50.8 mm) HMA overlay against reflection cracking. The majority of the respondents (73%) indicated that average service life of a 1.5 to 2.0 in. (38.1 to 50.8 mm) HMA overlay against reflection cracking is between 1 to 6 years, which is a very short service life. Only 12% reported that the average service life of the overlay against reflection cracking is between 6 to 10 years while 15% reported that they were unsure due to limitation in data collection. The high average service life of HMA overlay was observed in the states (e.g., GA, MD, FL, and MA) that take regular actions to address reflection cracking. These responses clearly indicate that in spite of the numerous studies conducted in the past 40 years on this topic, the majority of the states are still unable to control this failure mechanism. It was also noticed that for those states reporting a short service life (1-3 years), they are located in the northern region of the US and Canada. This trend was expected due to the impacts of thermal movement on the fast propagation of reflection cracking.

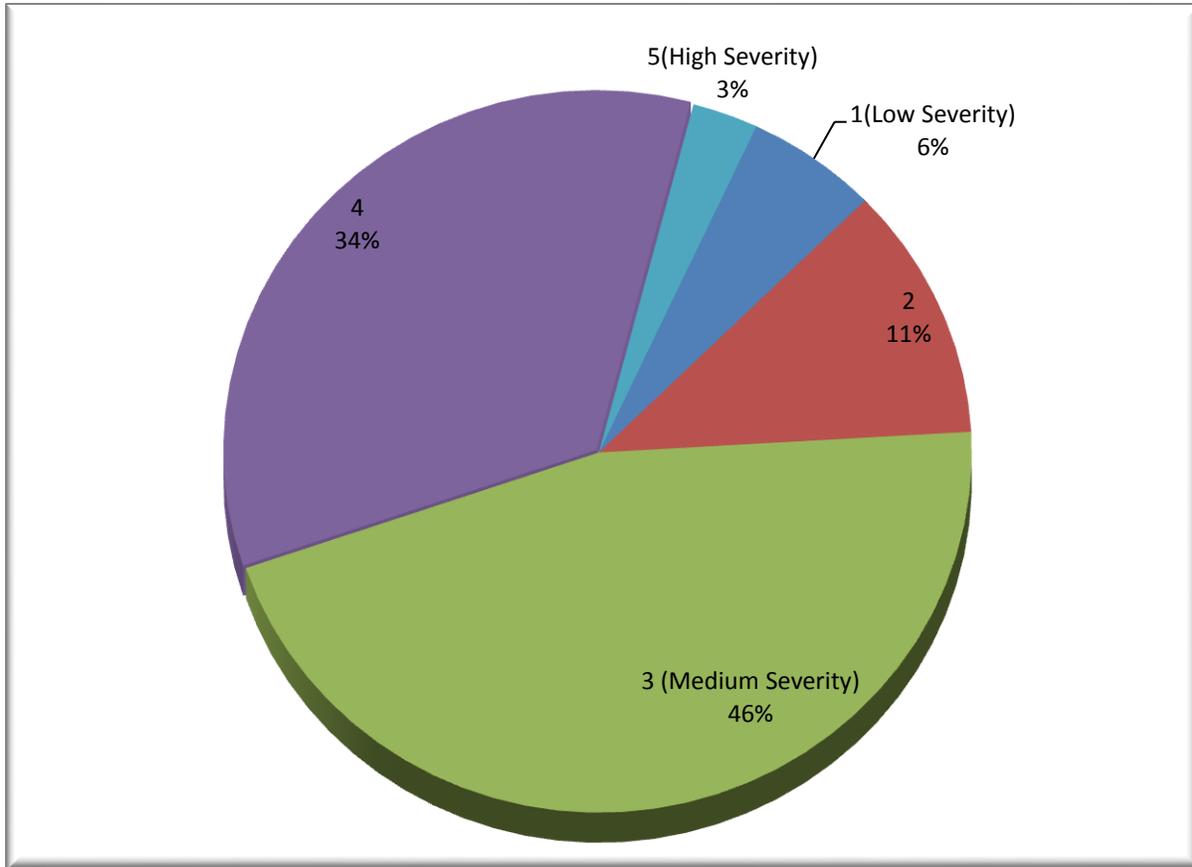
Figure 4
Severity of the problem of reflection cracking

The second question in the survey gaged the importance of reflection cracking for highway agencies. The responses were collected on a scale from 1 to 5 as 1 being the lowest severity and 5 being the highest severity. Figure 4 presents the criticality of the reflection cracking problem for highway agencies. The majority of the respondents perceive the problem of reflection cracking as a medium to high level of severity. Given that not all roads would be subjected to reflection cracking, this response is indicative of a serious problem that should be addressed especially when dealing with rehabilitation of existing pavements.

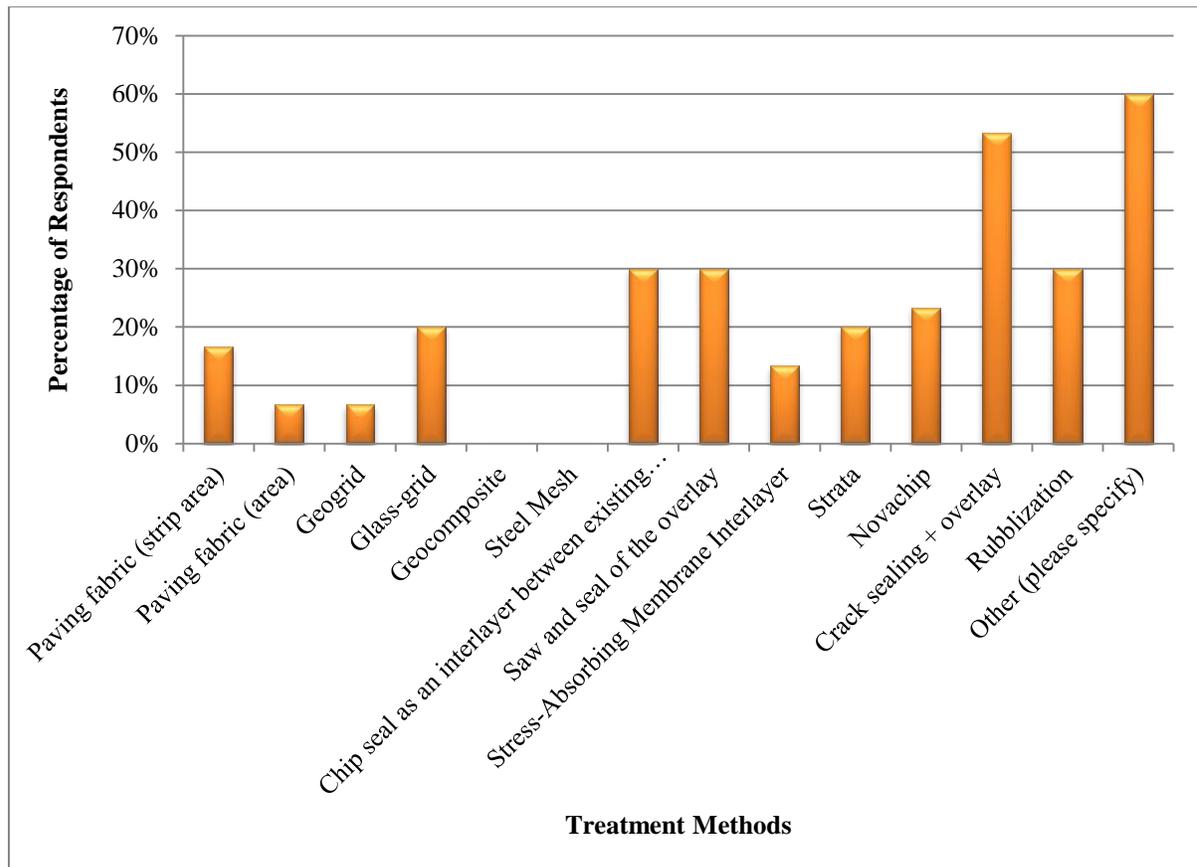
Figure 5
Treatment methods commonly used to delay reflection cracking

seals, and open-graded crack relief interlayer are also used. A respondent indicated that with crack sealing, at least a year passes before overlaying to avoid rubber sealant expansion. From these results, one may conclude that saw and seal, chip seal, and rubblization are commonly used among state agencies to delay reflection cracking. The use of geosynthetics including paving fabric and fiberglass grid appears to be less common on a regular basis.

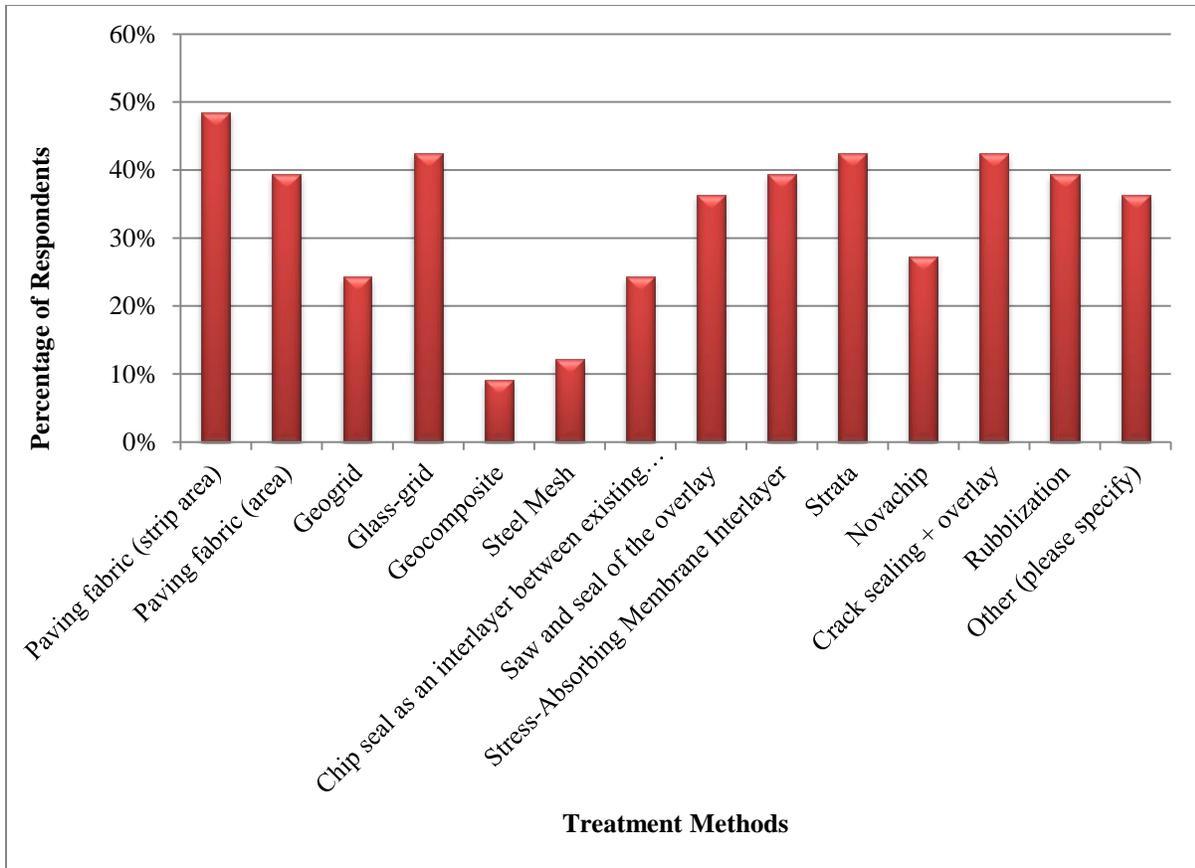
Figure 6
Evaluation of treatment methods

Almost all of the treatment methods available were found to have been evaluated on a trial basis by highway agencies, see Figure 6. However, one state did not evaluate any of these treatment methods in the past 10 years. The treatment methods in the “other” category include cold in place recycling, rubber seals, full-depth reclamation, open-graded interlayer, crack seat and overlay (CSOL), spray paver with polymer modified emulsion, crack relief layer, and Interlayer Stress Absorbing Composite (ISAC). Georgia mentioned that the state is currently evaluating an open-graded interlayer in a section at the NCAT test track.

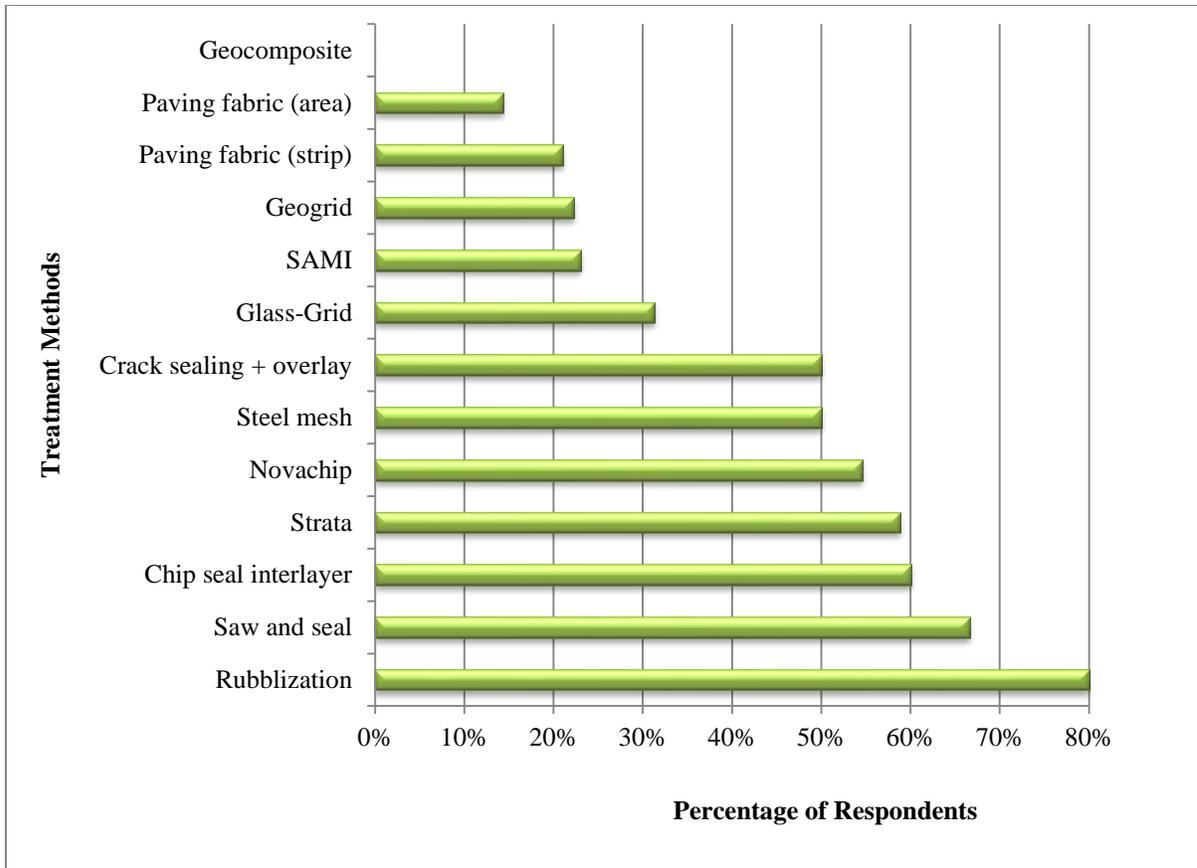
Figure 7
Treatment methods that positively contribute to delay reflection cracking

Figure 7 presents the percentage of respondents who reported an improvement for the different treatment methods evaluated in their state as compared to conventional overlay. As shown in this figure, rubblization and saw and seal appear to be the most positively perceived method to address reflection cracking in PCC pavements. However, one should acknowledge that rubblization is a long-term treatment that requires significant time and monetary investments and that is expected to significantly improve pavement performance. In contrast, the least beneficial treatments as reported by highway agencies were paving fabric and geogrid. Colorado indicated that fiberglass grid and Strata[®] are currently being evaluated. Further, Georgia indicated that open-graded interlayer appears promising in delaying reflection cracking. Two other agencies (Iowa and Quebec) indicated that CIR was the most effective in their states.

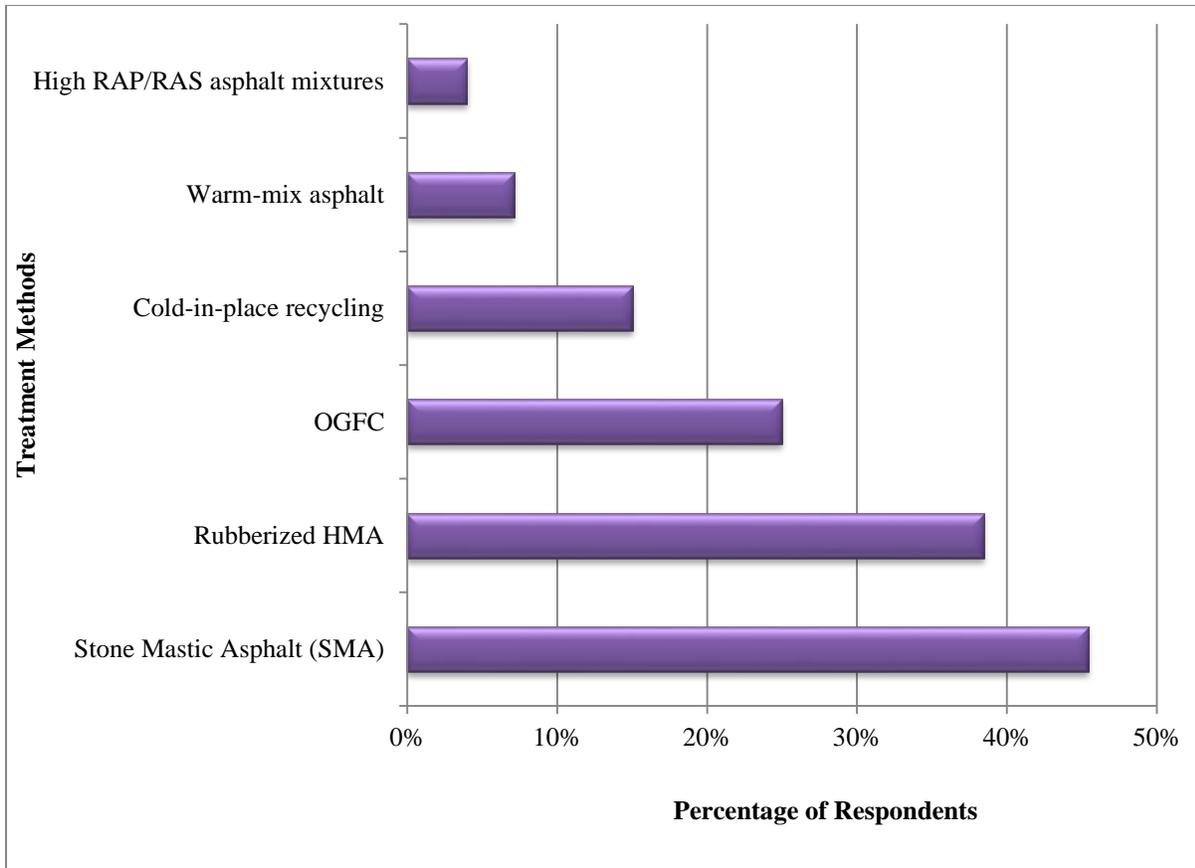
Figure 8
Asphalt mixtures that positively contribute to delay reflection cracking

Figure 8 presents the percentage of respondents who reported an improvement for special purpose asphalt mixtures in their state as compared to conventional HMA overlays. As shown in this figure, SMA, Rubberized HMA, OGFC, and CIR have been found to be effective in addressing reflection cracking as compared to conventional HMA. As expected, mixes with high RAP/RAS were not reported to provide an improvement against reflection cracking. Missouri DOT, which is one of the leading states in using RAS, indicated that asphalt mixes with RAS holds up very well against rutting but are more prone to cracking because of their brittleness.

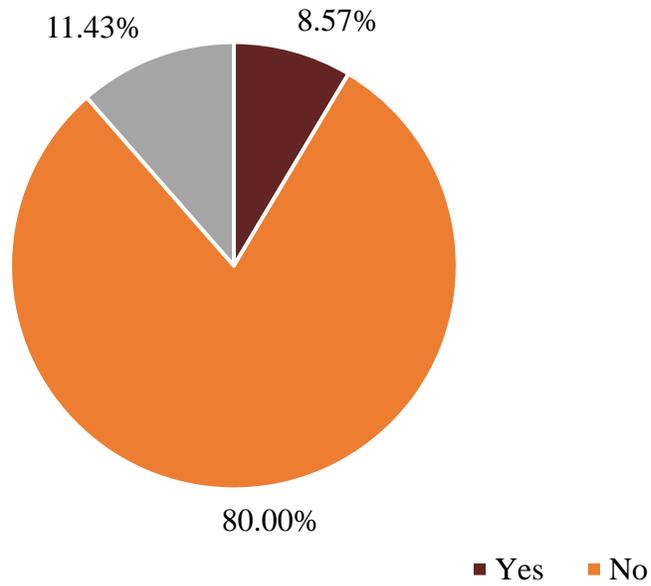
Figure 9
Use of a crack control policy to prevent reflection cracking

The survey results indicate that most of the states do not follow a systematic crack control procedure to prevent or delay reflection cracking. Figure 9 shows that the majority of highway agencies do not have a systematic approach adopted to prevent reflection cracking in rehabilitated pavements. As reflection cracking is one of the major distresses in rehabilitated pavements, a systematic crack control procedure is needed to ensure that positively contributing treatment methods are regularly used.

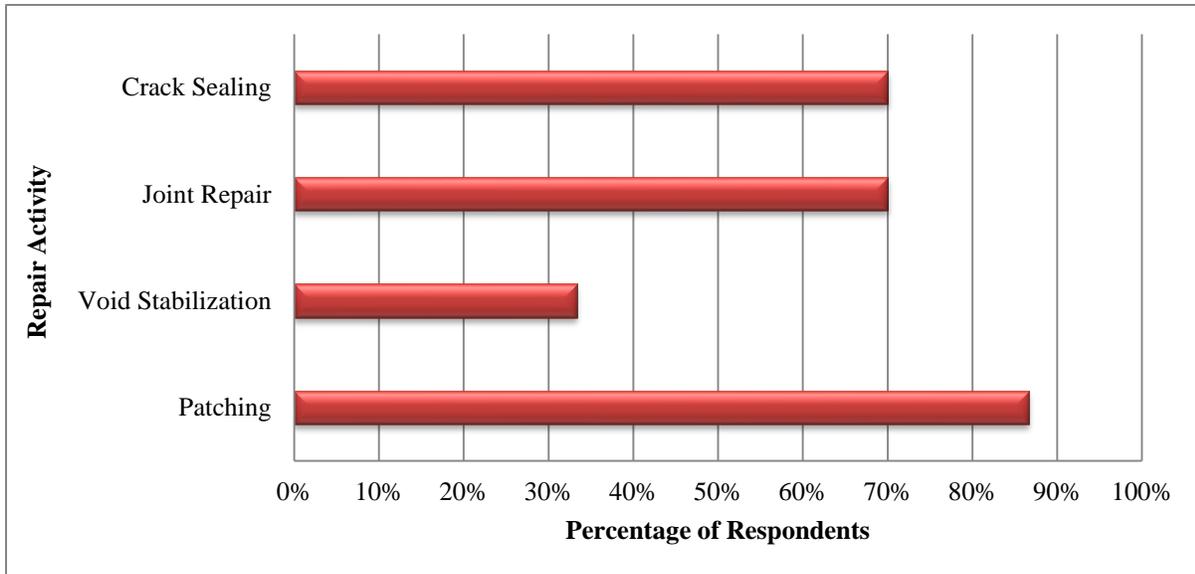
Figure 10
Pre-construction repair activities prior to overlay

Most of the respondents recommend patching, crack sealing, and joint repair as pre-construction repair activities prior to the overlay to control reflection cracking, see Figure 10. Void stabilization is less common than other repair activities possibly due to its cost (Figure 10). Joint repair and void stabilization are performed for PCC pavements while crack sealing and patching can be performed on either flexible or rigid pavements.

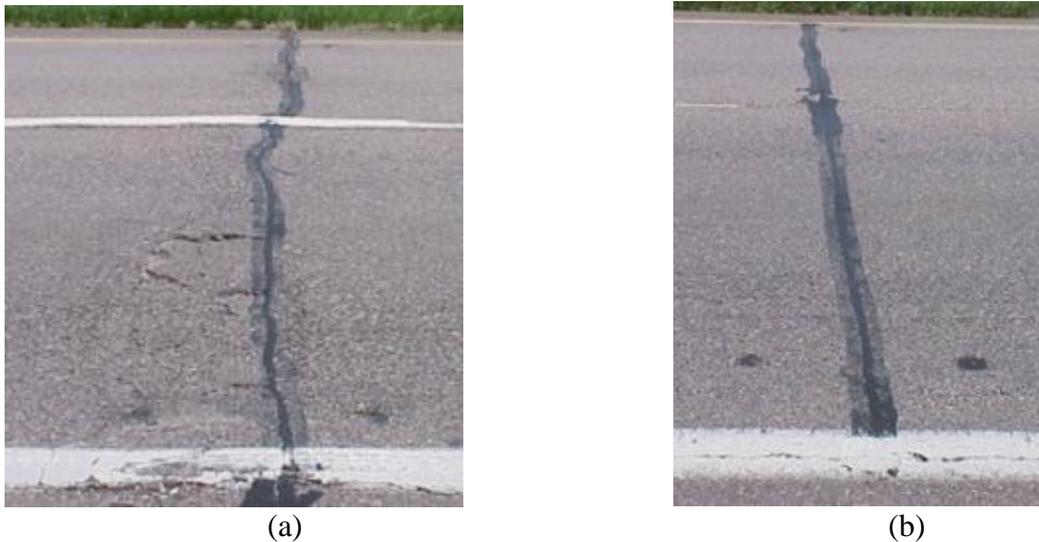
Figure 11
Comparison of reflection cracks in (a) unsawed joints and (b) sawed joints [30]

through the overlay regardless of whether a fabric was used. Based on an economic analysis, the most cost effective repair strategy was the one with minimum rehabilitation, with no fabric, and in which joints were sawed. When the joints were not sawed, reflection cracks appeared in an irregular shape, making sealing the cracks more challenging, Figure 11. The researchers summarized the number of cracks and movement of slabs in the different sections, see Table 6. As shown in this table, the size of the field experiment was limited.

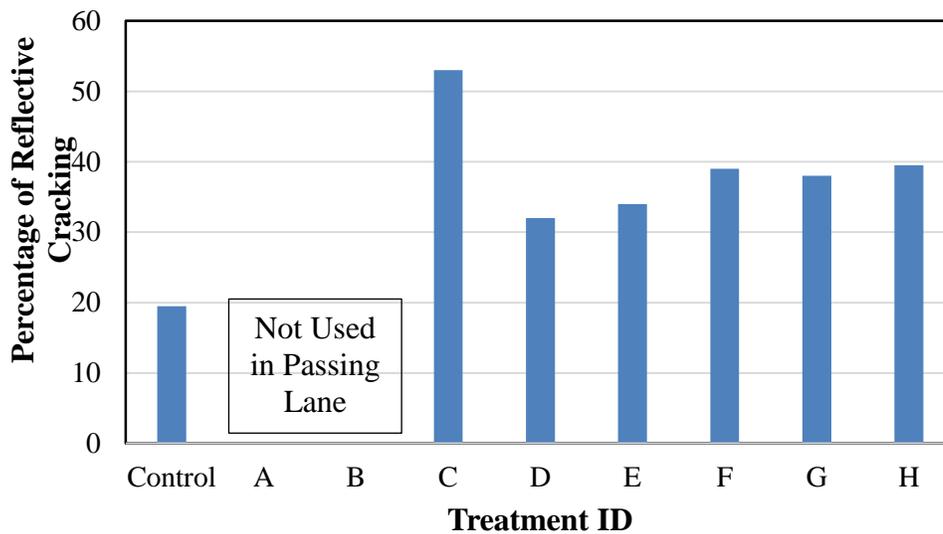
Figure 12
Total cost of treatments after 5 years for passing lane [32]

during the first and the second year after construction. It was observed that treatments A, B, C, F, G, and H performed better than the control section in the first section and treatments B, C, D, E, and H performed better than the control section in the second section after five years. However, no section with geotextile performed better than the control section in the passing lanes; see Figure 12. Results from the economic analysis indicated that the construction and repair costs were the least for the control section. Among the treatment methods test in the driving lane, the highest cost was associated with the 90-pound and 120-pound Petromat and the lowest cost was associated with the Petrotac and the crack sealers without routing.

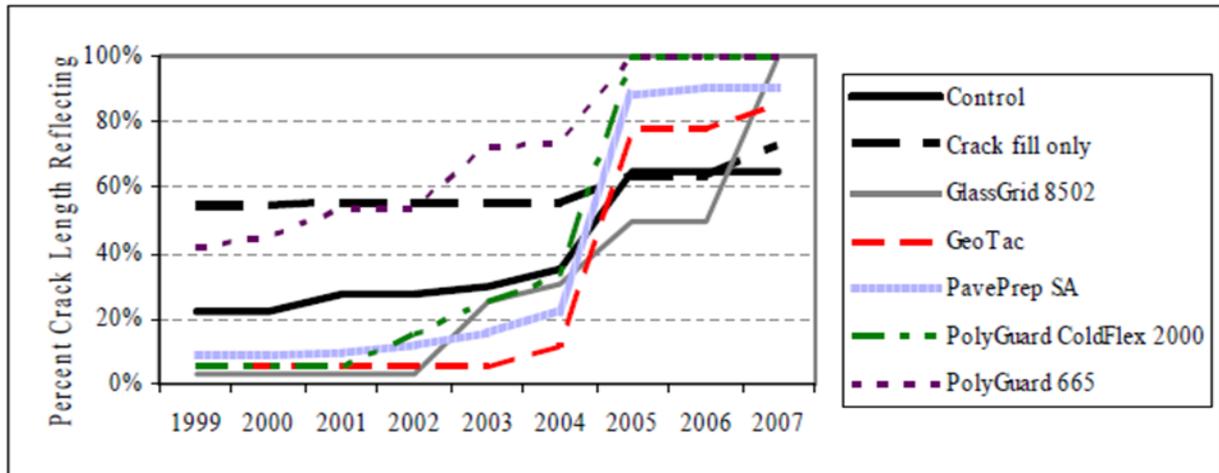
Figure 13
Performance of different types of geosynthetics from 1999 to 2007 [33]

geotextiles reduced the total number of reflection cracks, see Figure 13. However, the use of geosynthetics reduced the high severity of cracks by 80%. Among the five geosynthetics used, the best performer in reducing crack severity was fiberglass grid. Though all 20 cracks reflected in the section using fiberglass grid, 95% of these cracks were low severity cracks with short length.

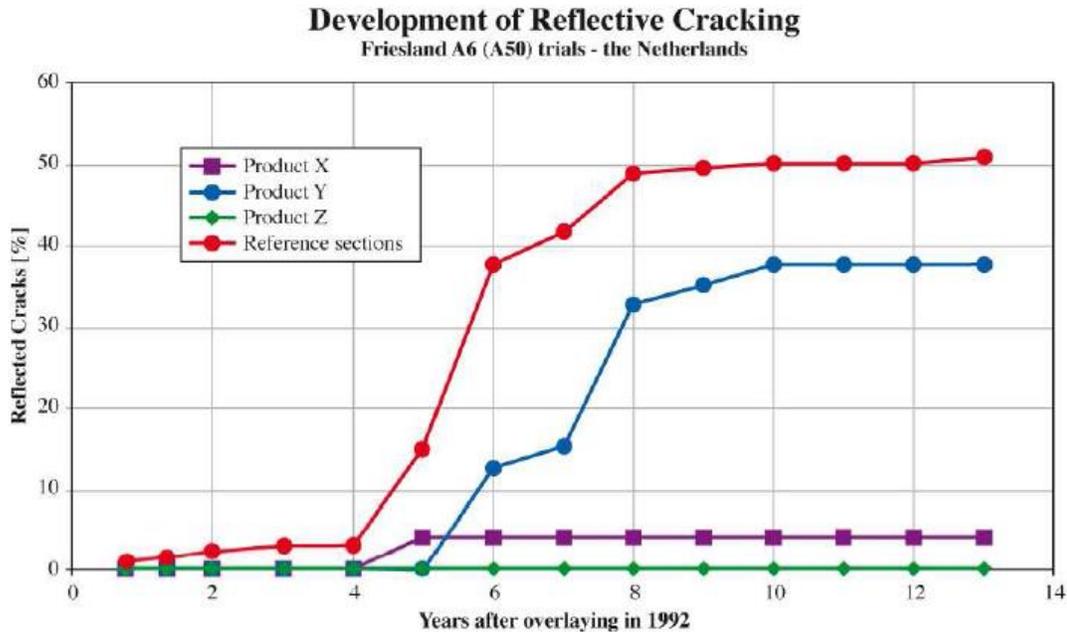
Figure 14
Long-term performance of grid in semi-rigid pavements in the Netherlands [34]

Bondt (2009) conducted a comprehensive review of the use of grid (fiberglass, geogrid, etc.) in Europe to retard reflection cracking in semi-rigid pavements [34]. The author observed that the performance of the grid can range from positive to negative depending upon the application, characteristics of the project, and the quality of the installation. The designers and the concerned authorities should ensure the suitability of a particular grid for a particular site condition. It was postulated that grid reinforcement has outperformed regular overlay against reflection cracking in semi-rigid pavement. A long-term evaluation of grid performance in the Netherlands is presented in Figure 14. The author noted that further research should be carried out to determine the adhesive property, design procedures, mechanical and durability properties, and cost effectiveness of the grid in semi-rigid pavements.

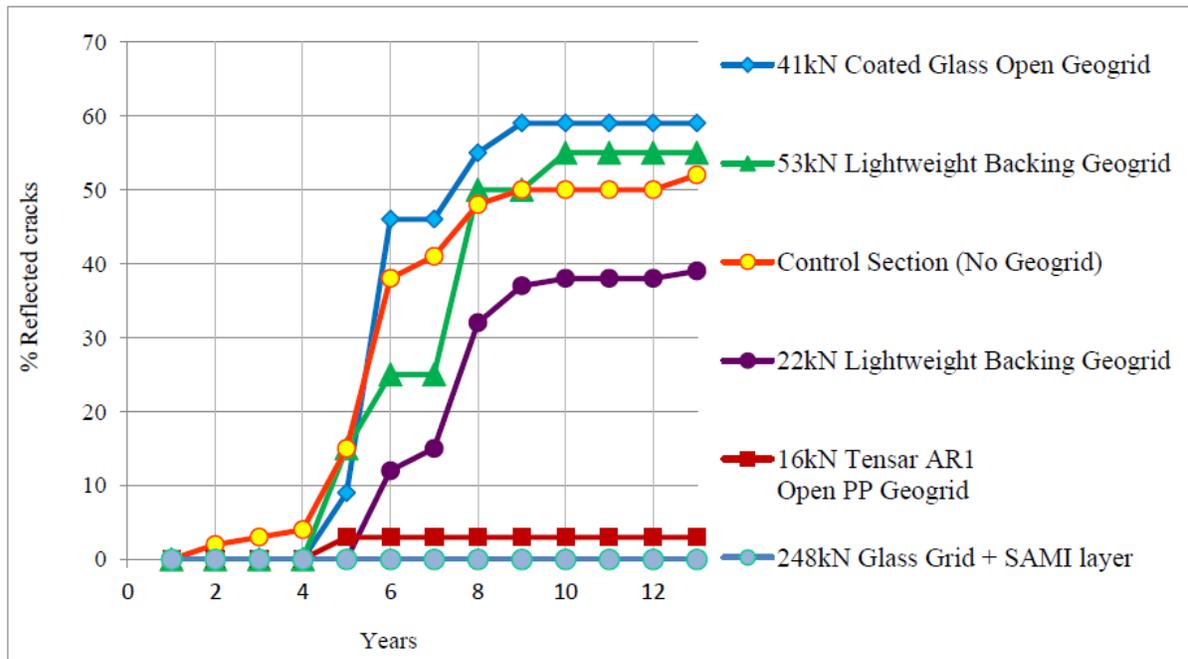
Figure 15
Field evaluation of different grid products [36]

monitoring of numerous sites constructed with a wide range of geosynthetics. Field performance of the grid was found to be excellent. Geogrid was found to increase pavement life, decrease the thickness of the asphalt layer, and to maintain the structural integrity of the pavement in most of the cases. Figure 15 presents the comparative performance of different grids as tested in a site in the Netherlands.

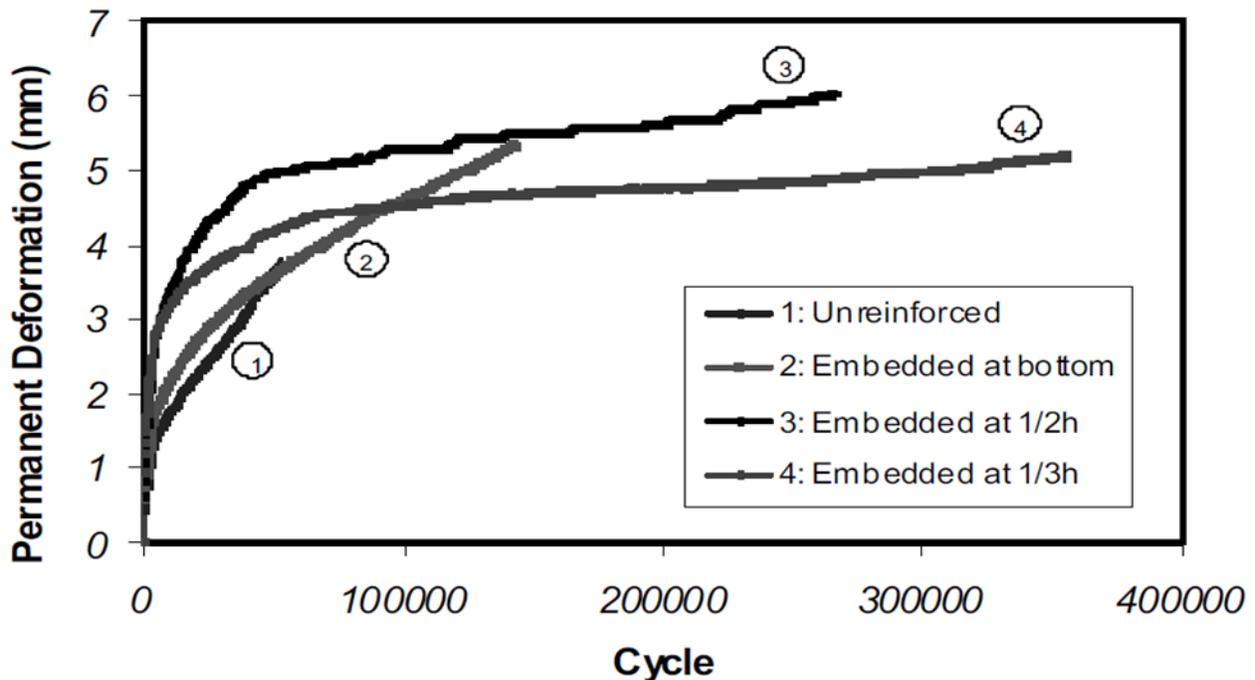
Figure 16
Permanent deformation for overlays on top of a concrete block and with a 0.4 in. (10 mm) gap at 20°C [41]

specimen with a geogrid embedded in the concrete or asphalt concrete block, 3) specimen with a geogrid placed at a depth of one-third from the bottom of the concrete or asphalt concrete block and 4) Specimen with a geogrid placed at mid-depth. The four specimens were placed on a rubber foundation and a repetitive loading using hydraulic dynamic loading frame was applied. The initiation and propagation of reflection cracking was monitored for each specimen. It was observed that the geogrid was effective in controlling reflection cracking and improving pavement performance. The best performance was obtained by Specimen 3 where the geogrid was placed at a depth of one-third from the bottom. The authors also observed that top-down cracking on the overlay depended upon the geogrid position and relative stiffness of the overlay with existing pavements. Figure 16 presents the permanent deformation of different specimens under repeated loading for an asphalt overlay on top of a concrete pavement.

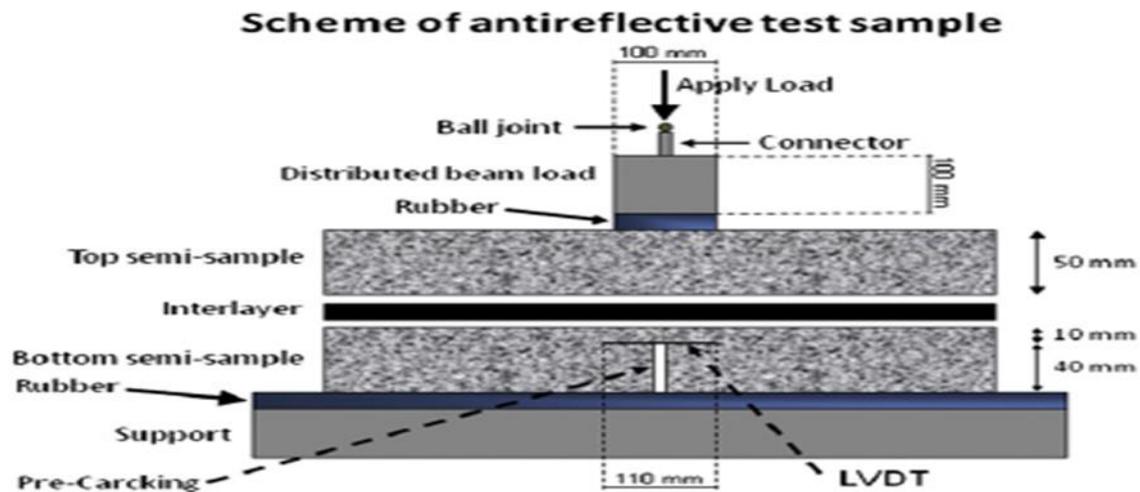
Figure 17
Anti-reflection cracking test piece schematic [42]

layer is used to support the lower part of the test specimen and to propagate the cracks. The experimental program evaluated six different anti-reflection systems as well as a number of tack coat application rates. The most effective treatment was identified based on the average number of cycles before failure. Results identified the geogrid to be the best performer in the laboratory. The geogrid was observed to have the potential to withstand a load cycle of three to six times the one for the control sample. Increasing the modulus and stiffness of the geogrid increased the resistance to cracking. The authors recommended proper installation in the field to ensure similar performance is achieved.

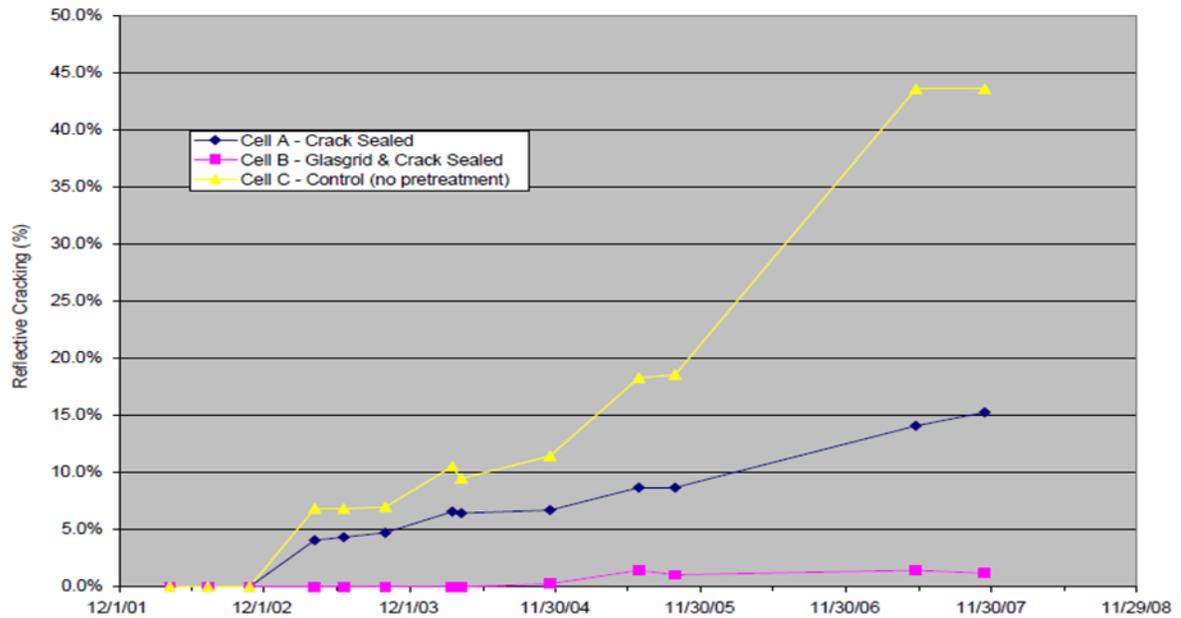
Figure 18
Test Section no. 1 [55]

pavement distresses. Figures 18 and 19 present the overall performance of the test and control sections.

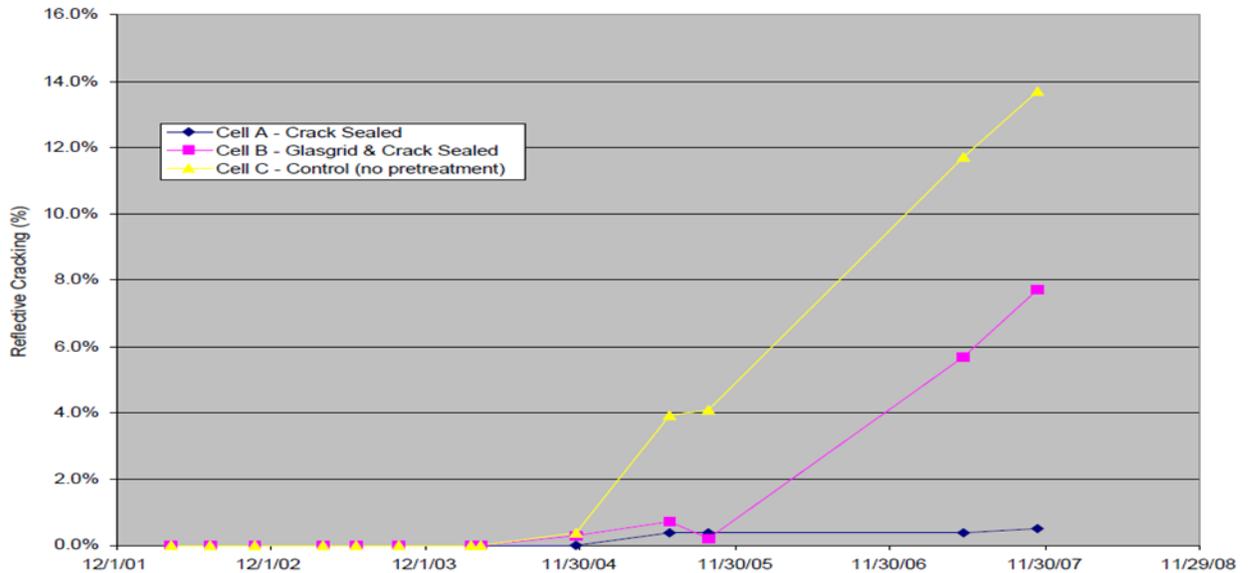
Figure 19
Test Section no. 2 [55]

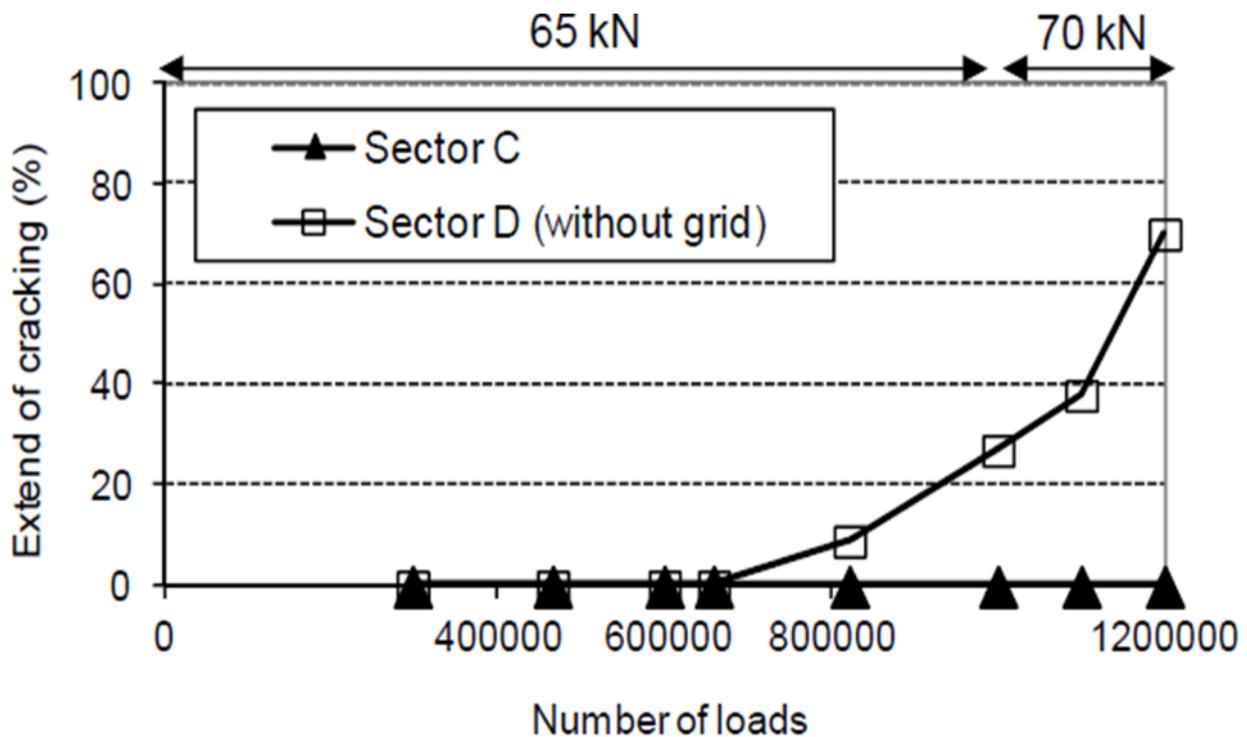
Figure 20
Extent of cracking in percent, on the 2 sections [56]

fiberglass grid has shown mixed performance, especially in the field. This was attributed to poor bonding between the grid and the asphalt material. The authors also presented the results of two full-scale fatigue experiments conducted at the IFSTTAR accelerated pavement research facility. The experiment was carried out for comparison between the performance of a reinforced section with fiberglass grid (Section C) and an unreinforced section (Section D). The grid was placed in the lower part of the asphalt layer, 0.8 in. (20 mm) above the interface with the granular subbase. The test results showed that the fiberglass grid placed at the bottom of the asphalt layer improves the fatigue life of the pavement provided good bonding is achieved with the grid. A significant increase in crack resistance was observed in the section with fiberglass grid as presented in Figure 20. However, the levels of pavement deflection and rutting were similar in the reinforced and unreinforced sections.

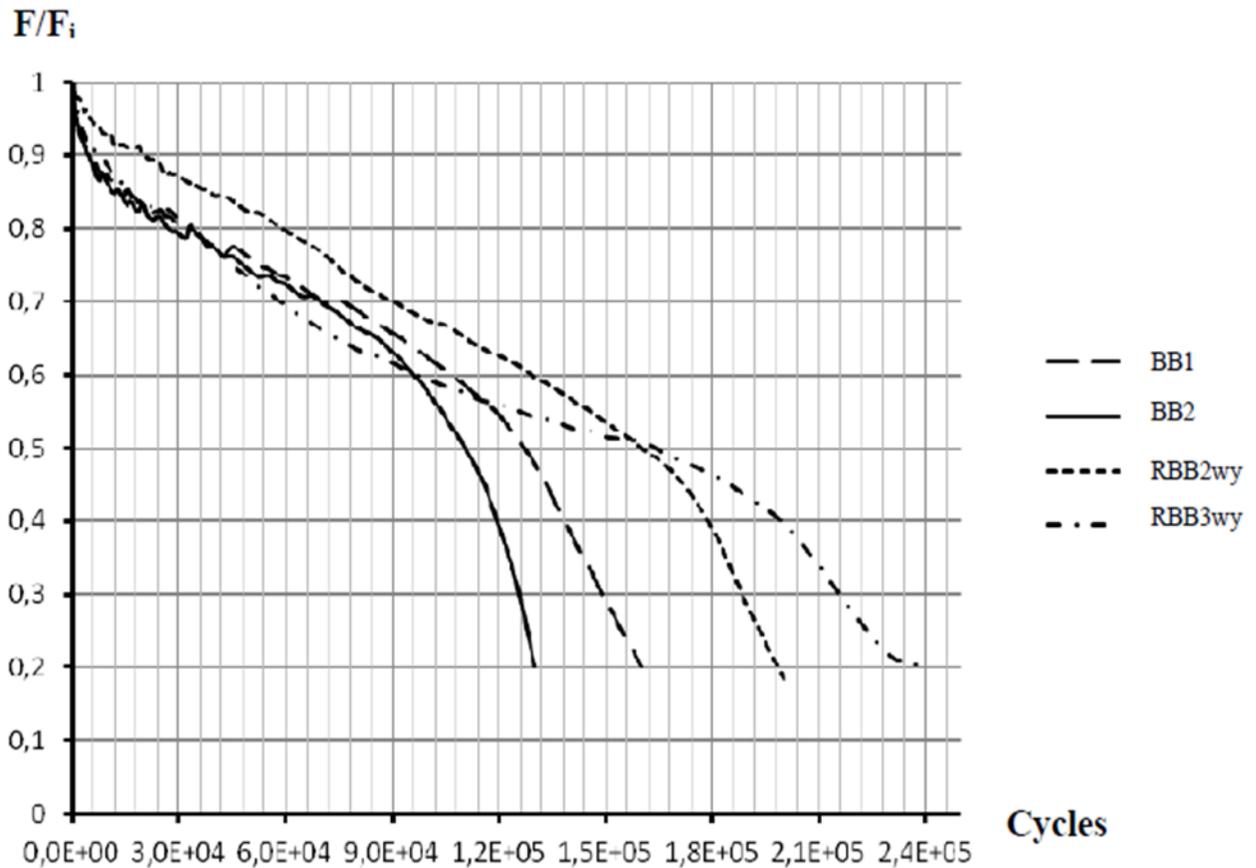
Figure 21
Evolution of the force during four fatigue tests [57]

(4PB) mode at 10°C and 25Hz. The Four Point Bending Test (4PB) was selected as it has the configuration to form the cracks in the central part of the specimen where tension and compression stresses are uniform. Results presented in Figure 21 show the evolution of the ratio between the measured force and the initial force for the reinforced and unreinforced beams. Analysis of the test results showed that the use of fiberglass grid increased the fatigue life by a factor ranging from 35.2 to 65.5%. Based on these results, the authors recommended the consideration of grid reinforcement in the pavement design.

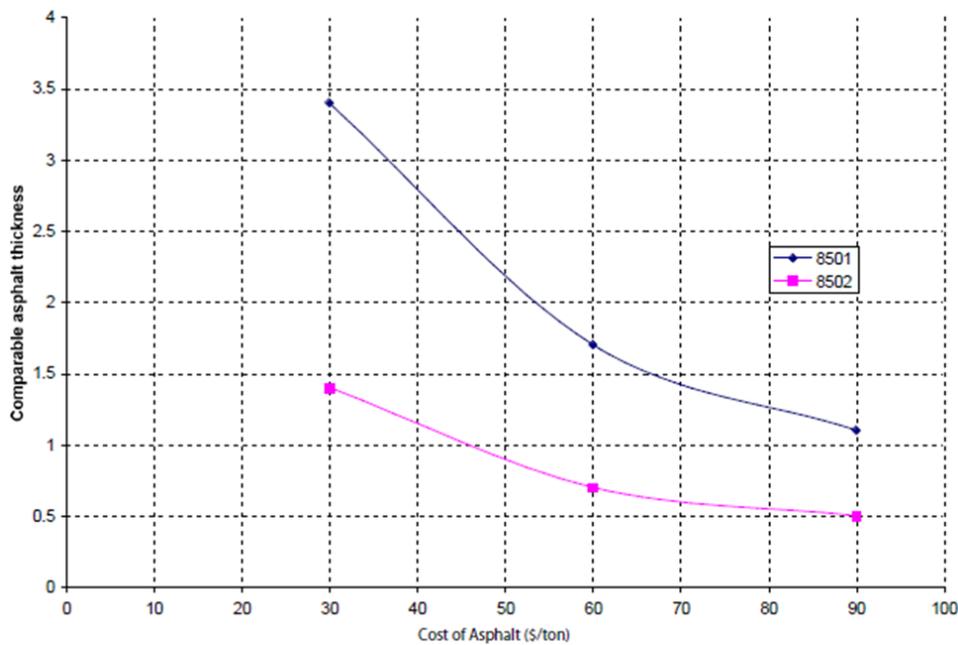
Figure 22
Comparison of the cost of fiberglass grid to the cost of asphalt [55]

Hanek (2009) calculated the material and installation costs of fiberglass grid to determine the cost effectiveness of the products [55]. Fiberglass grid was observed to provide a significant life cycle cost savings, given its effectiveness in mitigating medium to high severity transverse and longitudinal cracks. Based on the results of the cost analysis that was conducted in 2008, the author found that the use of 33% coverage fiberglass grid is equivalent to a 0.75 in. (19.05 mm) asphalt thickness assuming a cost of asphalt of \$60/ton; see Figure 22.

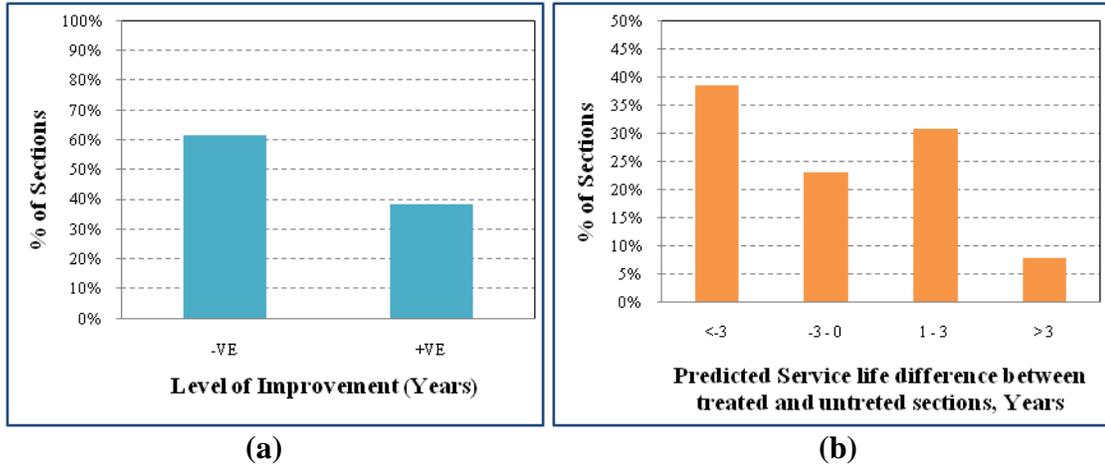
Figure 23
Contribution of fiberglass grid to predicted pavement service lives

into classes that exhibited similar levels of contribution from fiberglass grid. As these results showed, 62% of the sites reflect a negative impact in which the untreated sections outperformed the treated sections by a range of 0 to 7 years, while the remaining 38% of the sites showed a positive contribution ranging from 1 to 6 years.

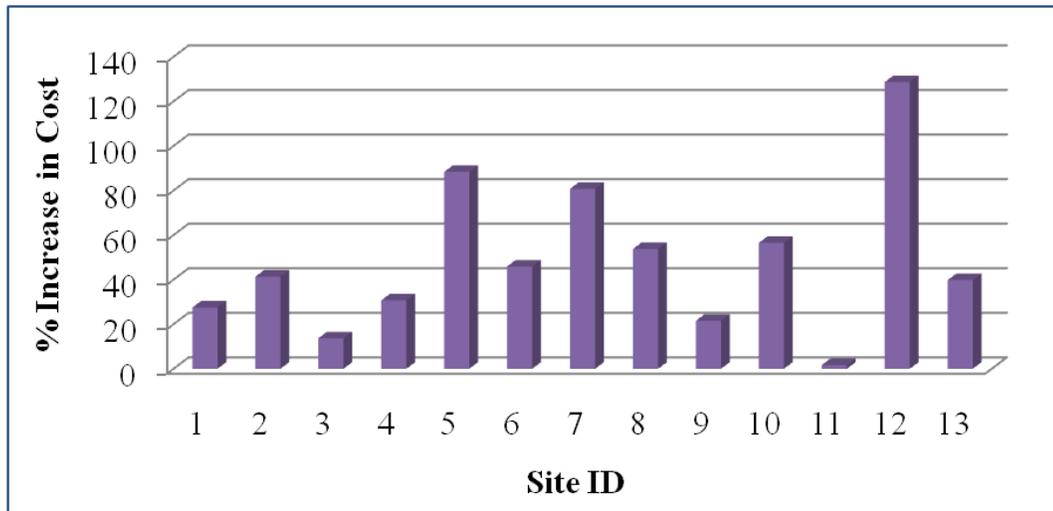
Figure 24
Increase in cost of the HMA overlay due to fiber-glass grid

Cost data for the fiberglass grid as well as HMA overlays were obtained from actual bid items for each project. Figure 24 presents the percentage increase in the cost of the HMA overlay, due to the fiberglass grid treatment. The increase in cost ranged from 1.6 to 128% averaging 48% of the HMA overlay cost.
